NASA TM-75448

CHEVRON CUTTING--EXPERIMENT WITH NEW
RUNWAY MIXTURES

K. Tyran

Translation of "CHEVRON CUTTING--Versuch mit
neuen Laufflachenmischungen," Swissair, Dept. _____
Technik, Versuchsbericht, Publ. No. 72'758
 Dec. 22, 1977, 20 pages.

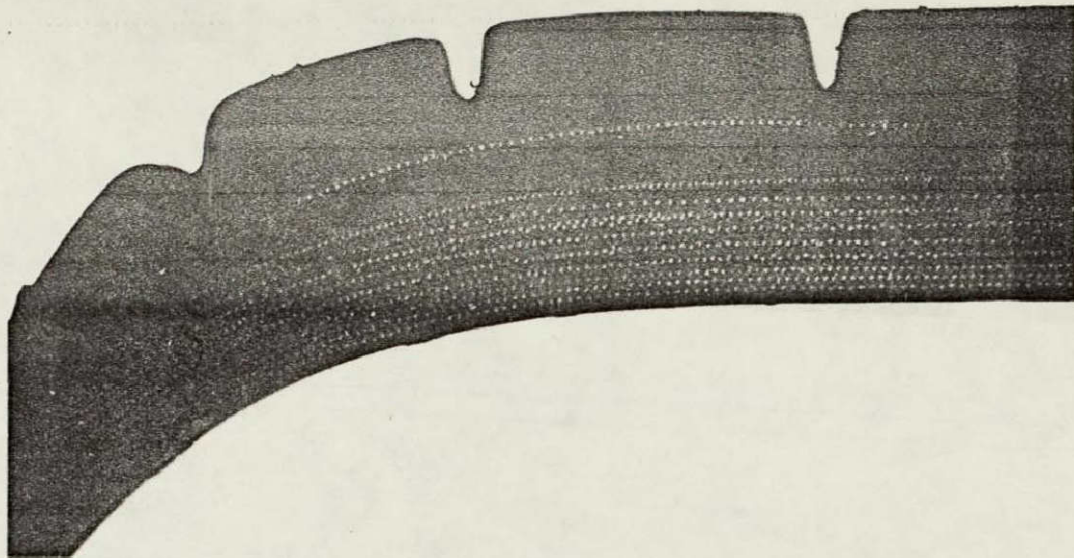
A so-called "spiral wrap" running surface construction was developed by the Goodyear Company. This is a reinforcement of the running surface through cord threads in the rubber of the running surface. The threads are applied with the unvulcanized rubber strip, circumferential in spiral-form, through a special rubbercapping process (Orbitread). Tires of such construction have been made in the USA for the past 5 years. Fig. 4 shows the distribution of the cord threads in the running surface.

Fig. 4 "Spiral wrap" construction contains cord threads in the running surface rubber which are wound in the direction of the circumference.
