NASA Technical Paper 1210

Light Airplane Crash Tests
at Three Flight-Path Angles

Claude B. Castle and Emilio Alfaro-Bou

JUNE 1978

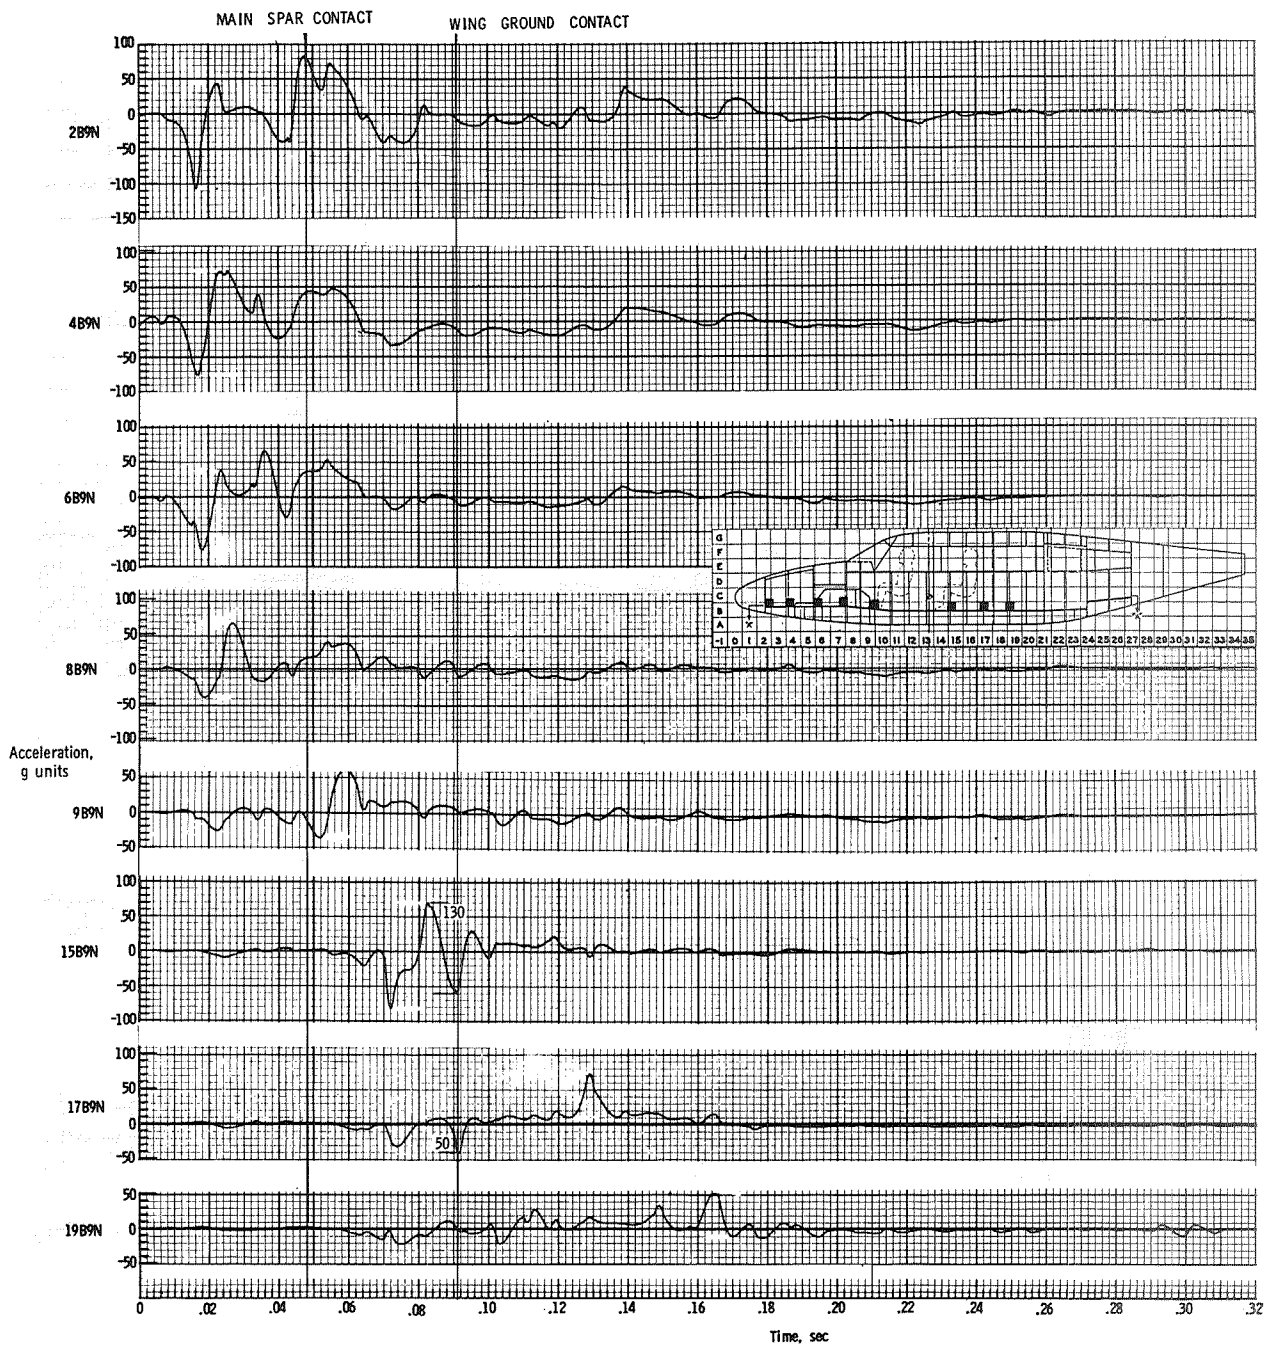
(a) -15° test specimen.

-15° test specimen.- In figure 18(a), eight acceleration time-history traces in the normal direction from the -15° impact are presented with timed events from photographic data superimposed on the traces for correlation and interpretation. The eight accelerometers are spaced along the floor beam of the airplane from the first nose frame (2B9N) to the door of the cabin (19B9N). The response of initial ground contact is felt immediately at the first frame (2B9N) and is seen to progress rearward to the instrument panel (9B9N), with diminishing intensity and with a slight time lag associated with the rear progression of the contact surface. The nose of the airplane exhibits high amplitude oscillatory behavior caused by the repeated sequence of negative accelerations. This oscillatory behavior is due to load transmission through structural failures and load build-up, thereby relieving load momentarily on undamaged structure and causing subsequent structural deceleration loading. This cycle is repeated as various structural elements are loaded and successively fail. Main spar ground contact (0.048 sec) produces a downward force in the nose of the airplane (positive acceleration) and signals the initiation of cabin compartment excitation. Acceleration peaks in the cabin compartment are a maximum in the vicinity of the main spar and diminish progressively from that point rearward. At 0.091 sec (fig. 18(a)) the loss of wing dihedral angle and wing ground contact occurs, thus resulting in the twisting of the main spar. At this time, peak-to-peak accelerations of 130g and 50g are produced in the first-passenger aisle seat legs (15B9N and 17B9N).

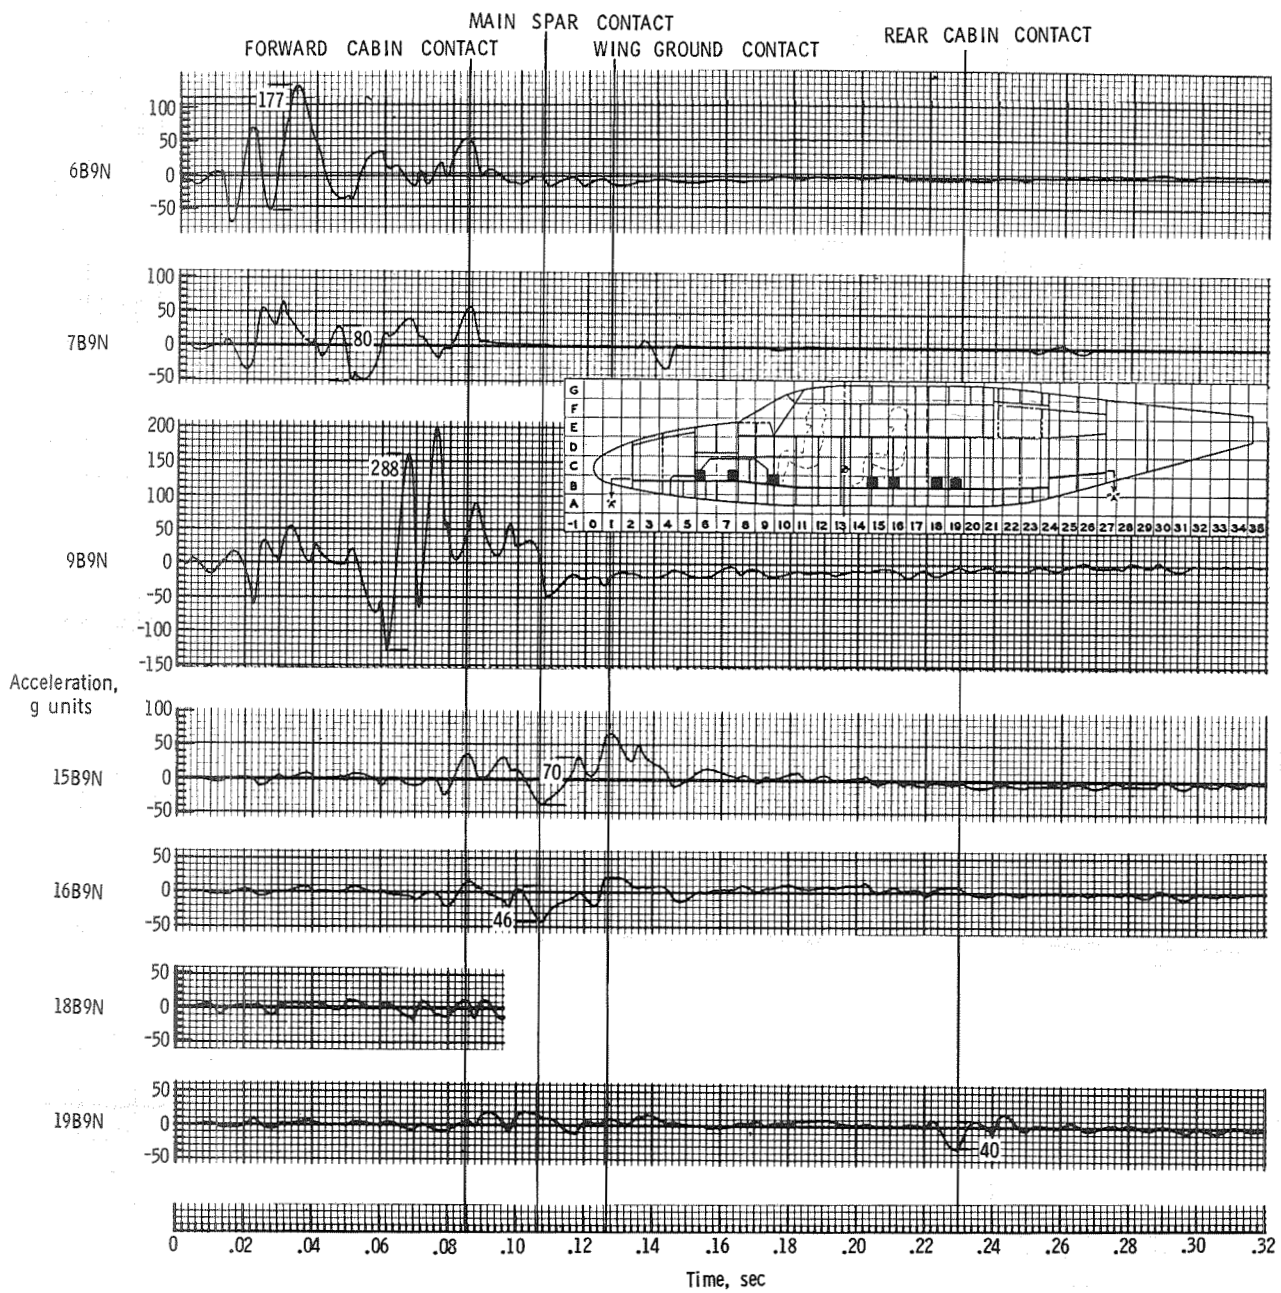
(b) -30° test specimen.

-30° test specimen.- Seven normal accelerations along the floor beam for the -30° impact are shown in figure 18(b). Accelerometer locations are similar to those of the -15° impact (fig. 8), except for the removal of the accelerometer from the middle of the luggage compartment in the nose of the airplane (4B9N at -15° impact). The response at initial ground contact in the nose of the airplane is severe and is seen to progress rearward to the instrument panel (9B9N) with diminishing intensity. The maximum peak-to-peak acceleration at the fire wall (9B9N) is 190 percent higher for the -30° impact than for the -15° impact.

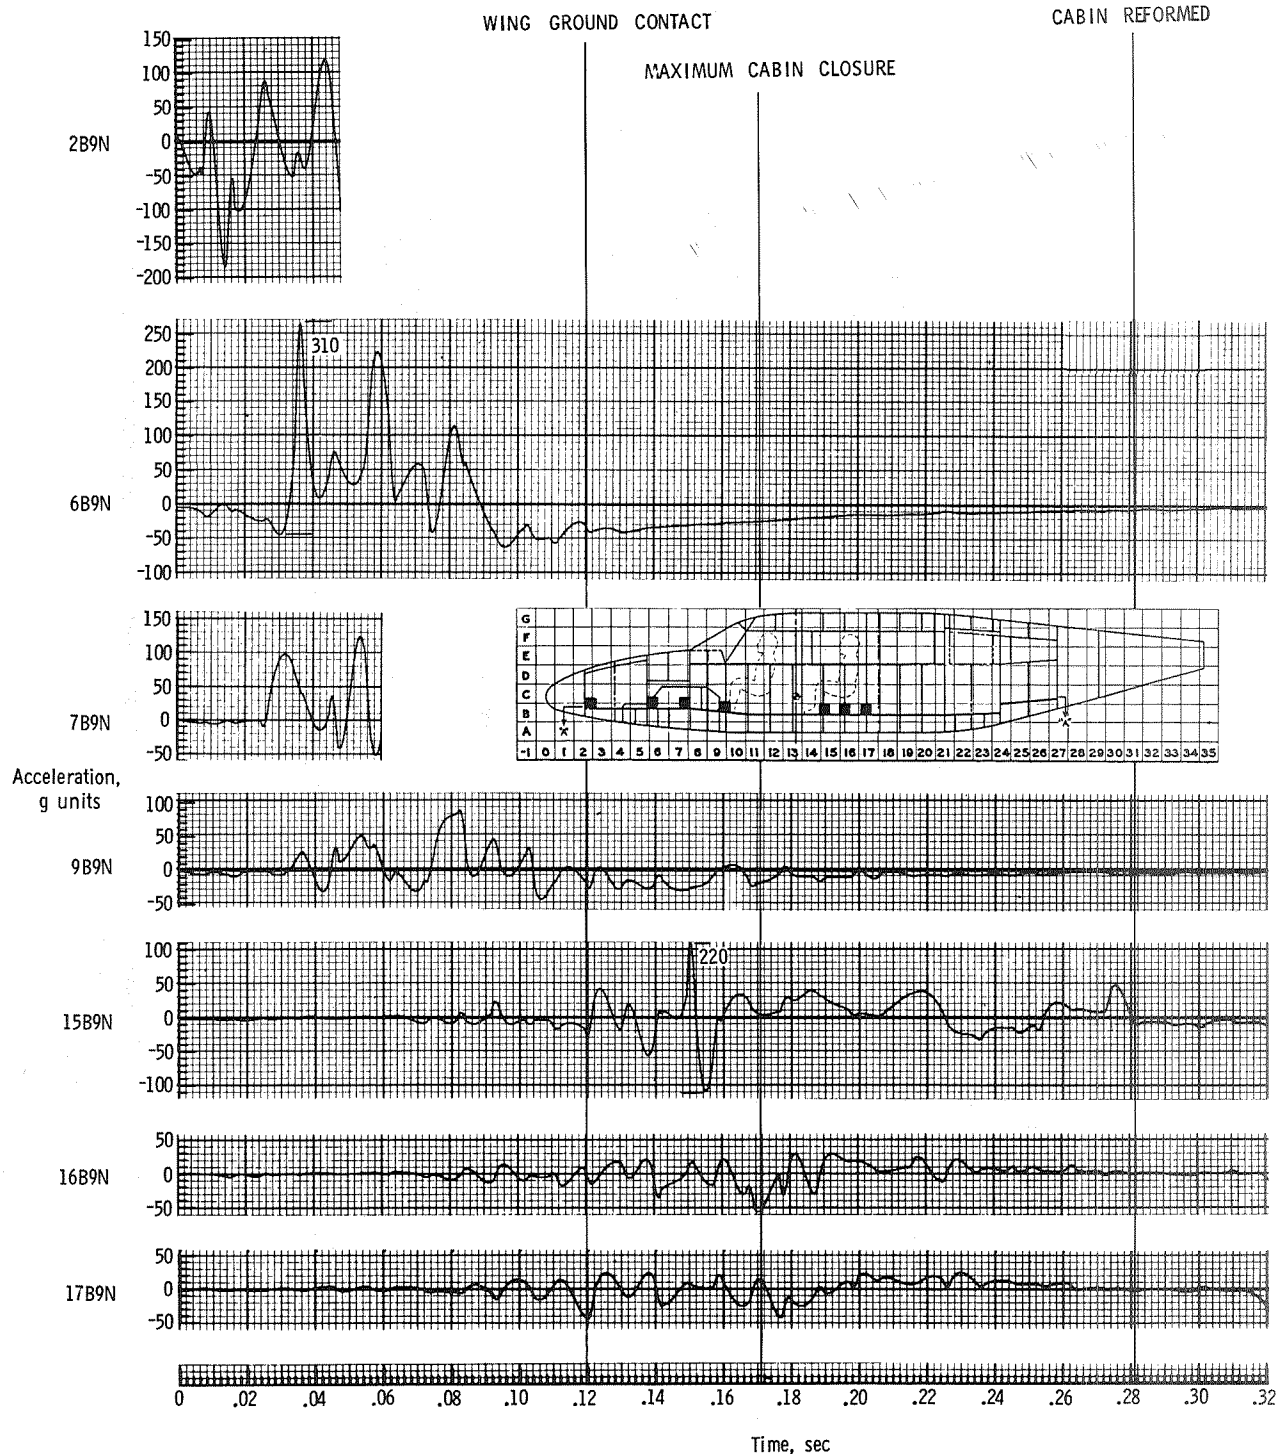
(c) -45° test specimen.

-45° test specimen.- Seven normal accelerations along the floor beam for the -45° impact are shown in figure 18(c). The accelerometer locations are similar to those of -30° impact (fig. 8). The response at initial ground contact in the nose of the airplane is most severe for the -45° impact; in fact, peak-to-peak accelerations as high as 310g are induced. On moving rearward after the progression of the impact pulse, the magnitudes of the acceleration decrease as some of the impact energy is absorbed by the nose structure and less difference in magnitude is evident between the -15°, -30°, and -45° acceleration traces in the cabin area of the three test specimens. Overall, the duration of accelerations is shorter and less severe in the -15° impact than in the -30° impact or in the -45° impact. (See figs. 18(a), 18(b), and 18(c).)

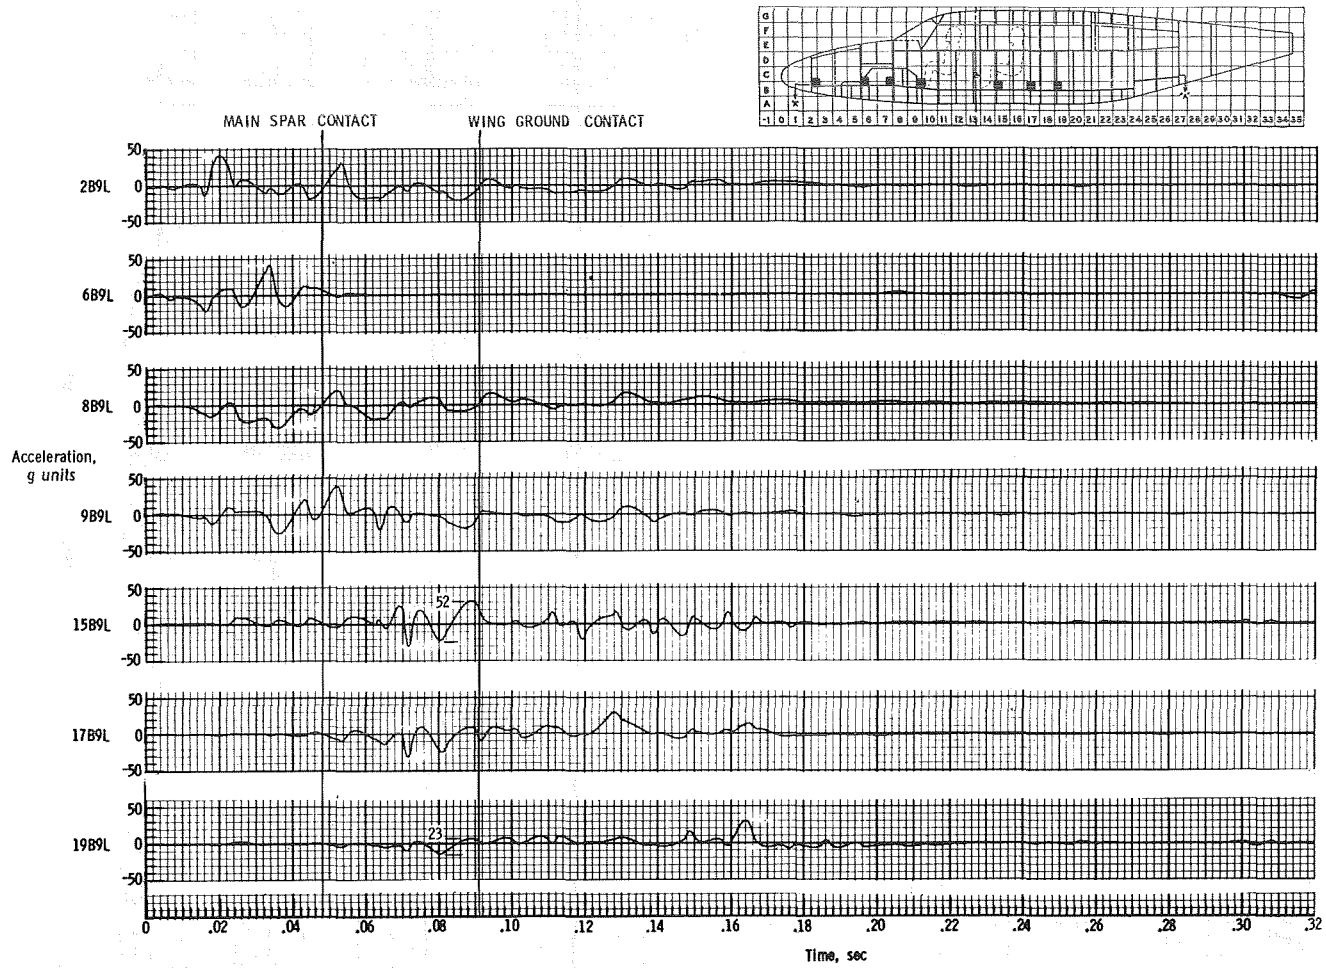
(a) -15° test specimen.

-15° test specimen.- Seven accelerometers (fig. 19(a)) are spaced along the floor beam of the airplane from the first nose frame (2B9L) to the rear of the passenger seat (19B9L). The response at initial ground contact is felt immediately at the first frame (2B9L), and contact progresses rearward to the instrument panel (9B9L) with diminishing intensity but with about half the acceleration magnitudes experienced in the normal direction. Similarly, a characteristic high-amplitude oscillatory behavior in the nose of the airplane in the vicinity of the main spar is again evident for the longitudinal accelerations as for the normal accelerations. Wing ground contact (second impact) is shown at 0.091 sec. The time at which fuselage separation occurred (across the cabin roof in the vicinity of the main spar) coincides with the positive acceleration peak in 17B9L and 19B9L at 0.164 sec.

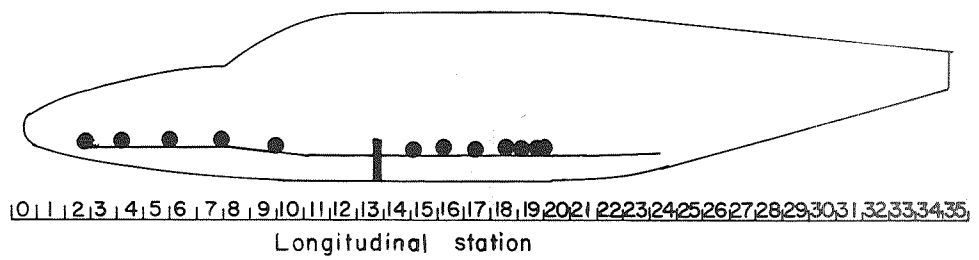
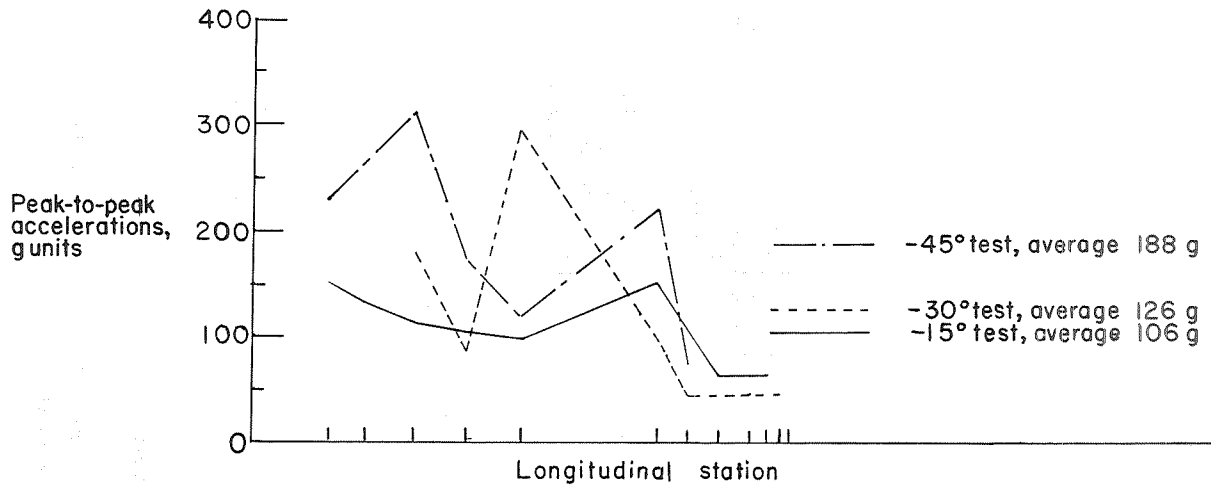
(a) Normal accelerations.

For the -15° test specimen, the normal peak-to-peak acceleration levels (fig. 20(a)) were more than twice the longitudinal acceleration levels (fig. 20(b)). This was due to higher decelerations in the normal direction when the airplane contacted the impact surface and abruptly stopped the motion in that direction. However, after initial impact in the longitudinal direction, the airplane skidded for some distance and then came to a stop; this long skid distance contributed to lower longitudinal deceleration forces. In figure 20(b) the longitudinal levels are shown to be nearly constant for the entire length of the floor beam, thus indicating little floor-beam deformation for the -15° test specimen but severe structural collapse and floor-beam deformations for the -30° and -45° test specimens. The effect of changes in flight-path angle

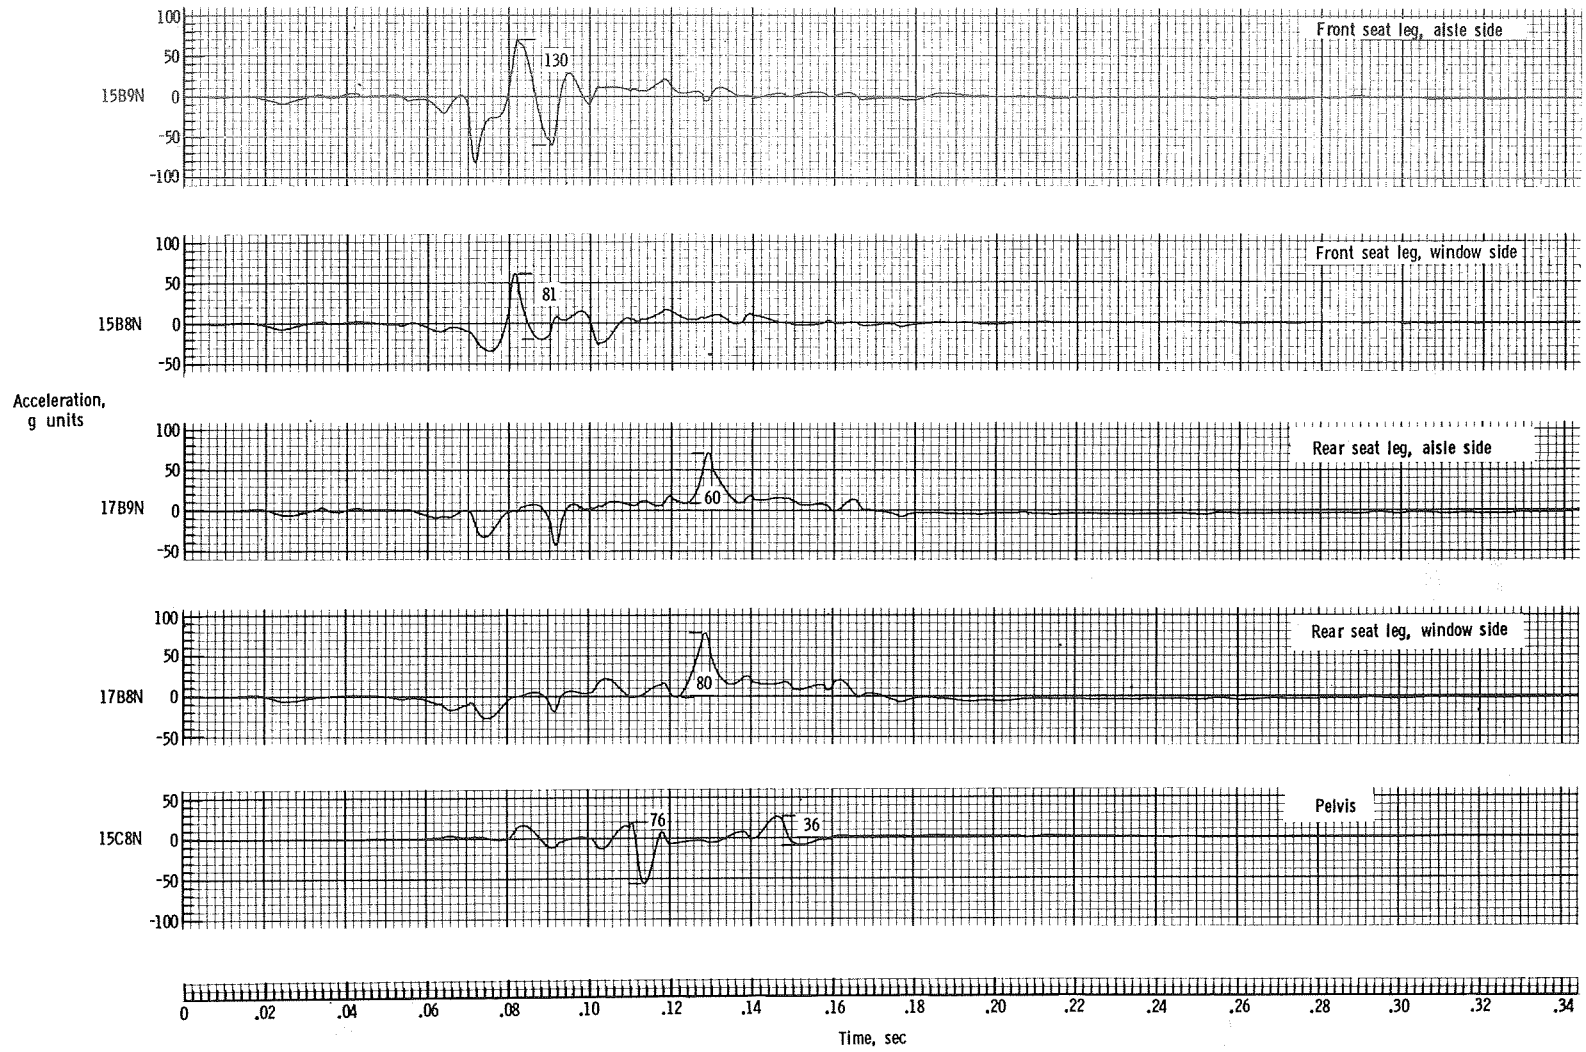
(a) -15° test specimen.

Normal accelerations at -15° .— Figure 21(a) shows the normal accelerations for the -15° test specimen. Peak-to-peak accelerations of 130g and 81g were recorded on the floor under the two front seat legs at the first-passenger location, and accelerations of 76g (58 percent of 130g) were recorded in the pelvis approximately 0.025 sec later. The peak-to-peak accelerations under the rear seat legs were 60g and 80g and corresponded to a 36g pulse (45 percent of 80g) on the pelvis — again with a delay of approximately 0.025 sec.

Effects of normal accelerations.— The pelvis peak-to-peak accelerations in the -15° , -30° , and -45° test specimens were 76g (fig. 21(a)), 40g (fig. 21(b)),

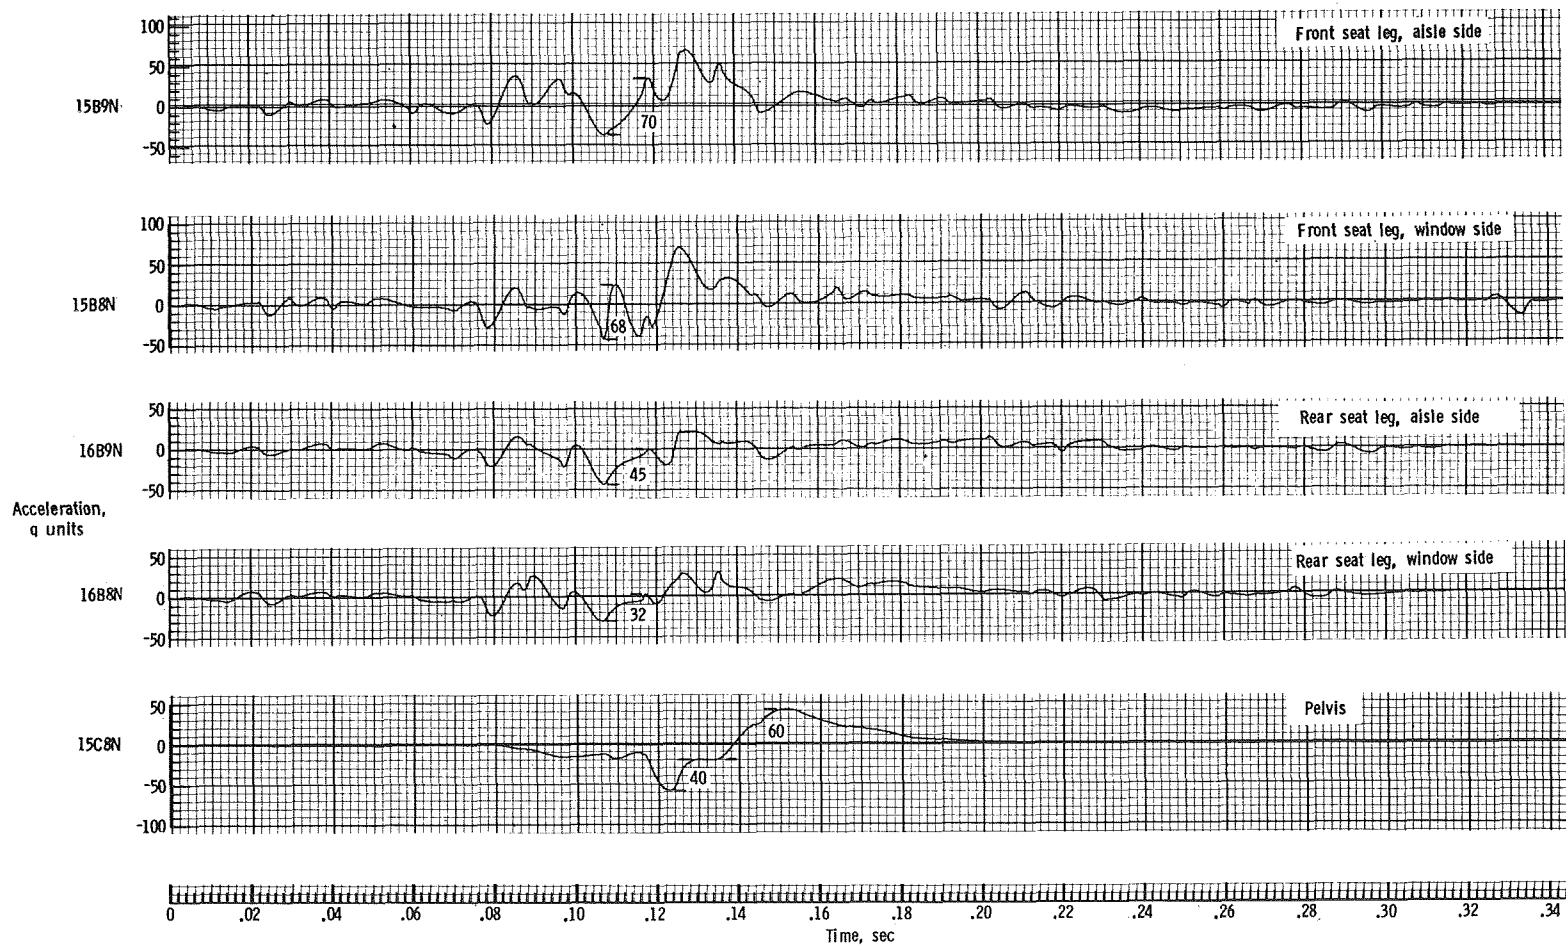
(b) -30° test specimen.

Normal accelerations at -30° .— Figure 21(b) shows the normal accelerations for the -30° test specimen. Peak-to-peak accelerations of 70g and 68g were recorded on the floor under the two front seat legs and 45g and 32g under the two rear seat legs. The acceleration on the pelvis was recorded at 40g (15 percent of 70g) approximately 0.02 sec later.

The -30° test specimen was the only one in which the restraint system of the first passenger was instrumented with load cells. The positive (downward) peak-to-peak accelerations of 60g (fig. 21(b)) in the pelvis corresponded to a 5.3-kN tensile force in the shoulder harness (see appendix fig. A3(f)) when the occupant's relative motion with respect to the seat was stopped by the restraint system.

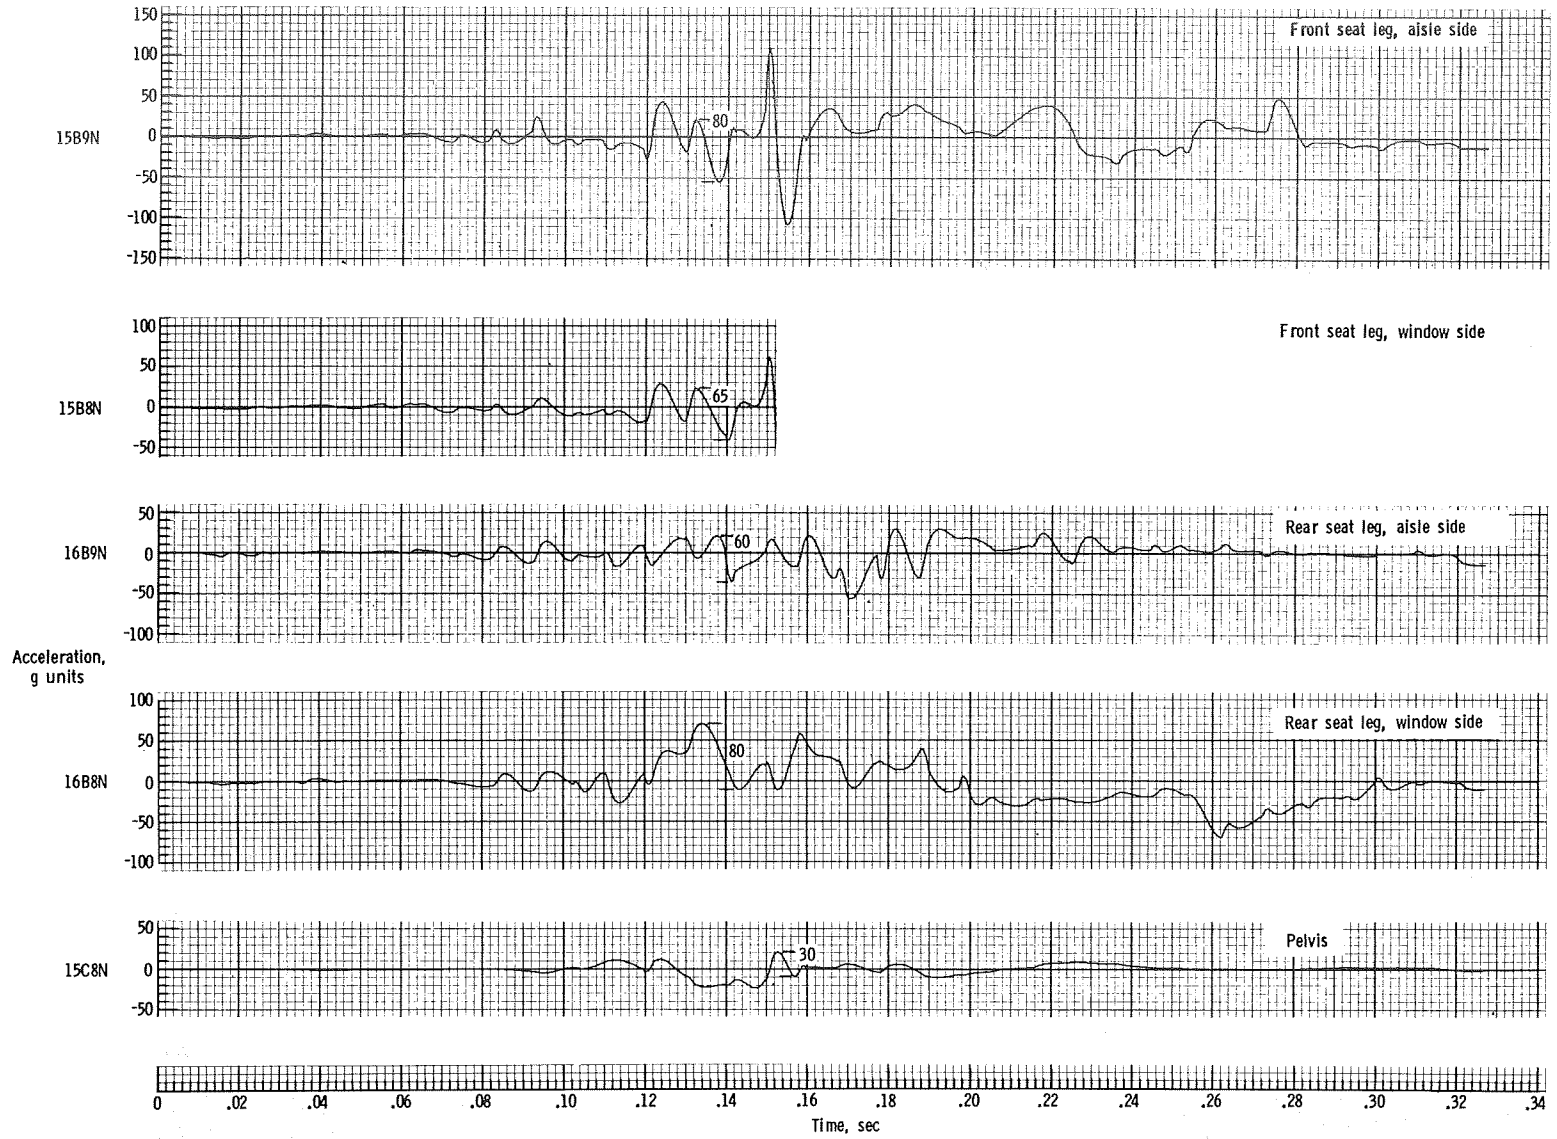
(c) -45° test specimen.

Normal accelerations at -45° .— Some unusual airplane crash behavior was exhibited by the -45° test specimen during impact. First, the nose of the airplane impacted and crushed progressively to the fire wall while the remaining portion of the fuselage maintained its -45° flight-path angle, thus eliminating the livable volume in the cabin. This behavior was followed by a downward rotation and a reforming of the fuselage immediately thereafter. The resulting accelerations (fig. 21(c)) on the floor and in the pelvis of the first passenger lacked the smoothness and well-defined pelvic pulse of the -15° and -30° test specimens. Nevertheless, peak-to-peak accelerations on the floor were 80g and 65g next to the front seat legs and 60g and 80g next to the rear seat legs. The peak-to-peak acceleration on the pelvis was 30g (38 percent of 80g), which occurred at about 0.015 sec later. The seat deformed, absorbing some of the impact energy and reducing the pelvic accelerations.

and 30g (fig. 21(c)), respectively. The 76g acceleration reflects the effect of cabin slapdown on the impact surface. A positive 60g peak-to-peak pulse was due to the effect produced by the dummy lifting off the seat against the restraint system. The 30g acceleration reflects the effect energy absorption plays in reducing load transmission. A greater total seat deformation was obtained in the -45° test specimen than was obtained in either the -15° or -30° test specimens. This situation suggests that accelerations experienced in aircraft crashes are limited by the eventual collapse of the surrounding structure. Unfortunately, this structural collapse may also be accompanied by the loss of a livable volume within the cabin area, affecting the survivability of the occupant. In a crashworthy design, the structural collapse would be controlled to produce maximum energy absorption and still maintain livable volume in the cabin.

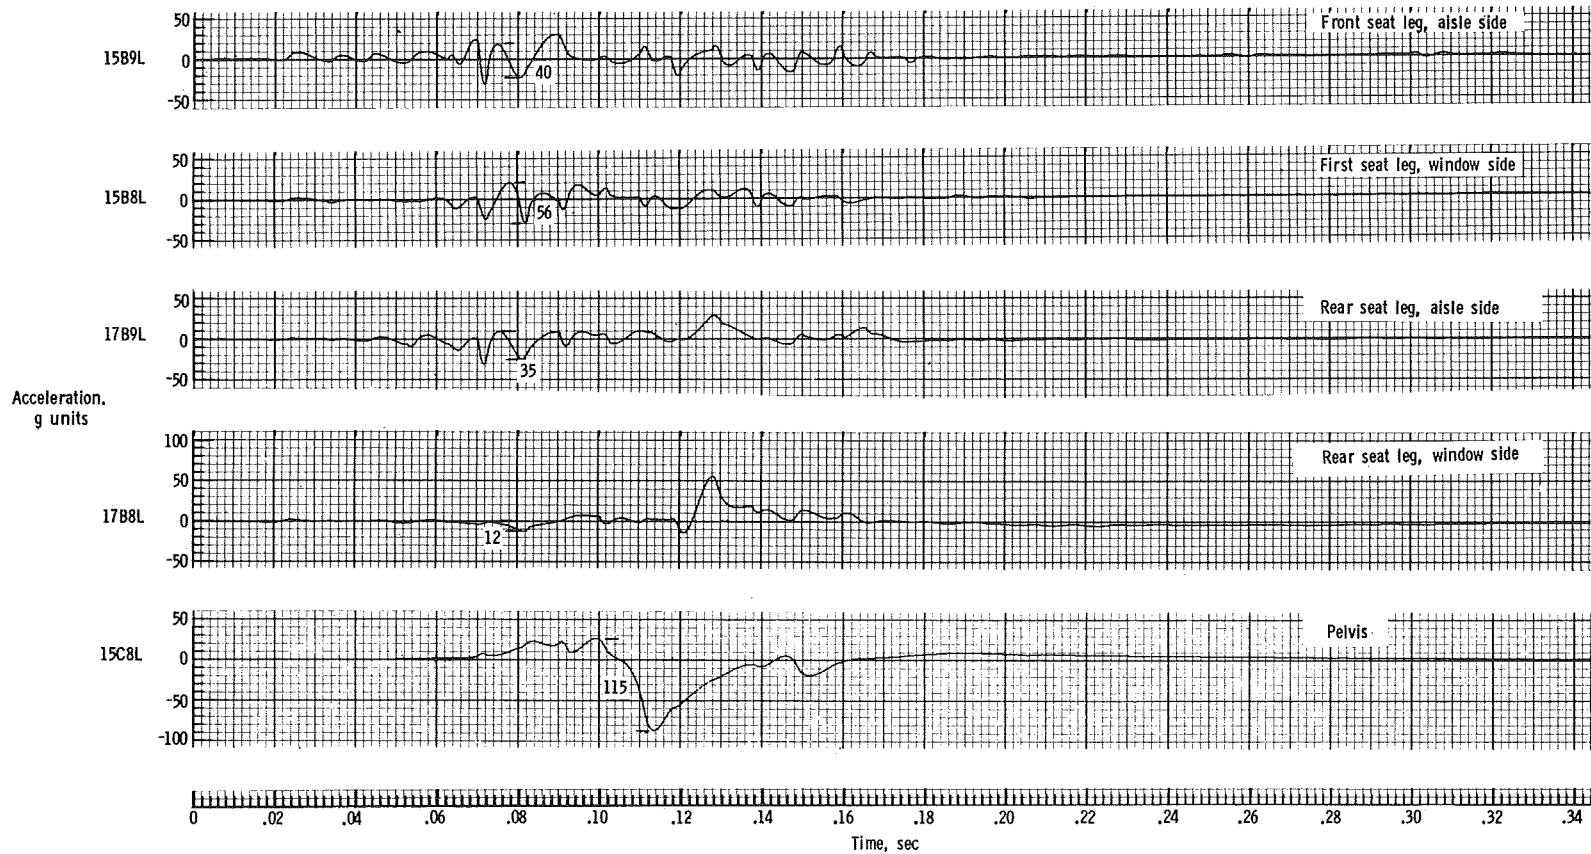
(a) -15° test specimen.

Longitudinal accelerations at -15° .— As shown for the -15° test specimen in figure 22(a), longitudinal peak-to-peak accelerations of 40g and 50g were recorded adjacent to the front seat legs and 35g and 12g adjacent to the rear seat legs. These acceleration pulses were recorded in the pelvis with a peak-to-peak value of 115g occurring 0.025 sec later.

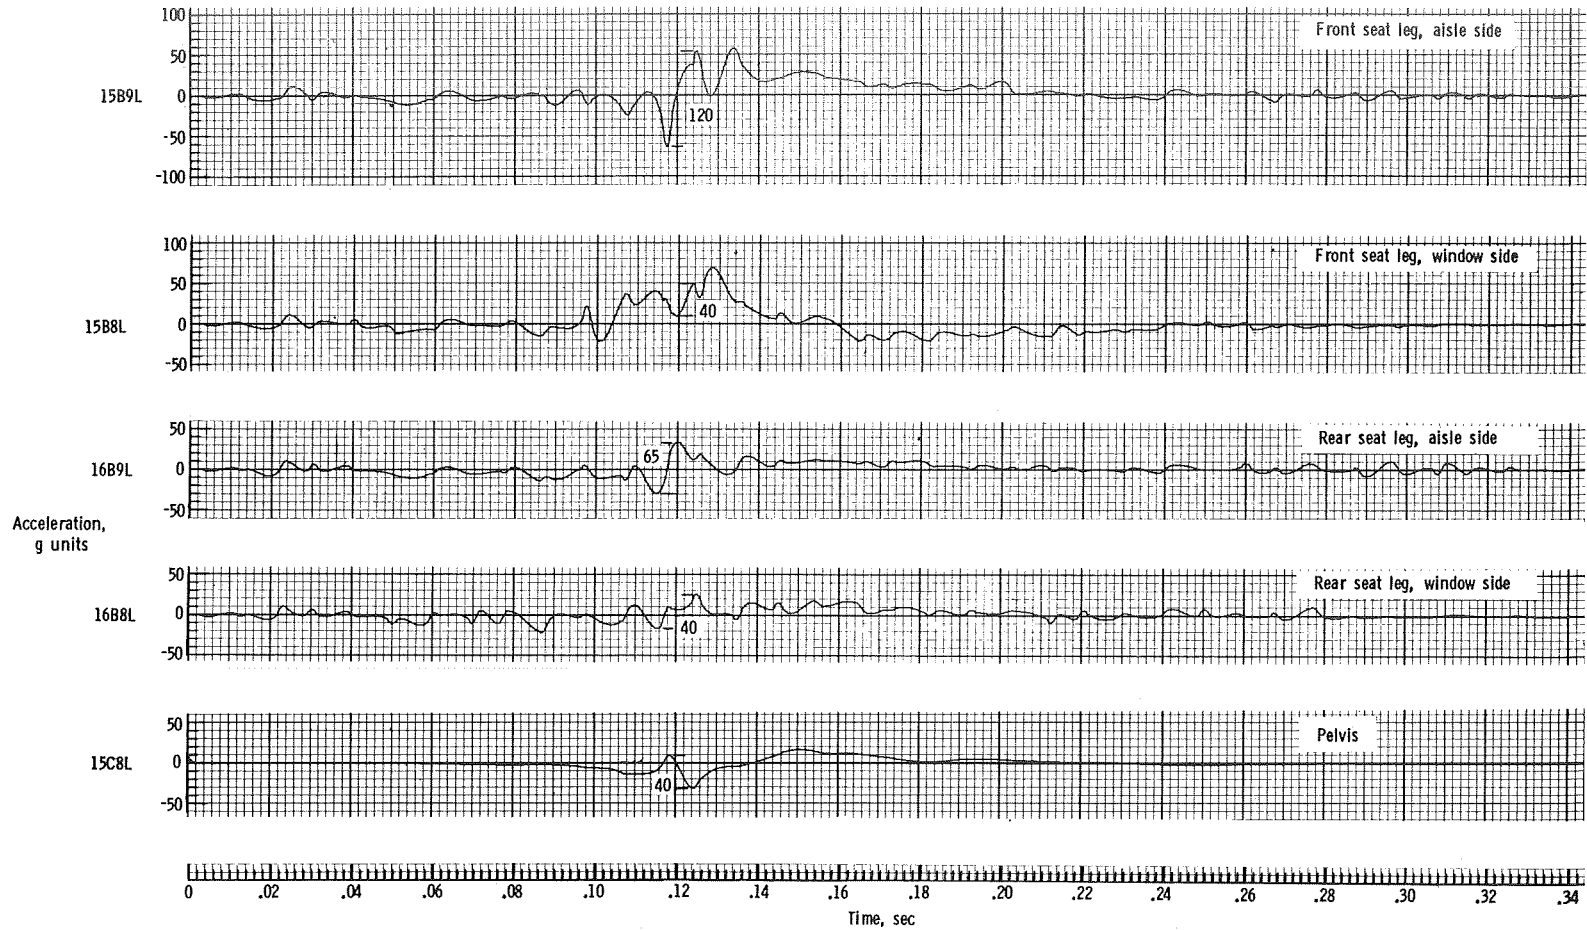
(b) -30° test specimen.

Longitudinal accelerations at -30° .— As shown for the -30° test specimen in figure 22(b), longitudinal peak-to-peak accelerations of 120g and 40g were recorded on the floor adjacent to the front seat legs and 65g and 40g adjacent to the rear seat legs. These peaks were recorded in the pelvis as a 40g peak-to-peak pulse occurring 0.025 sec later.

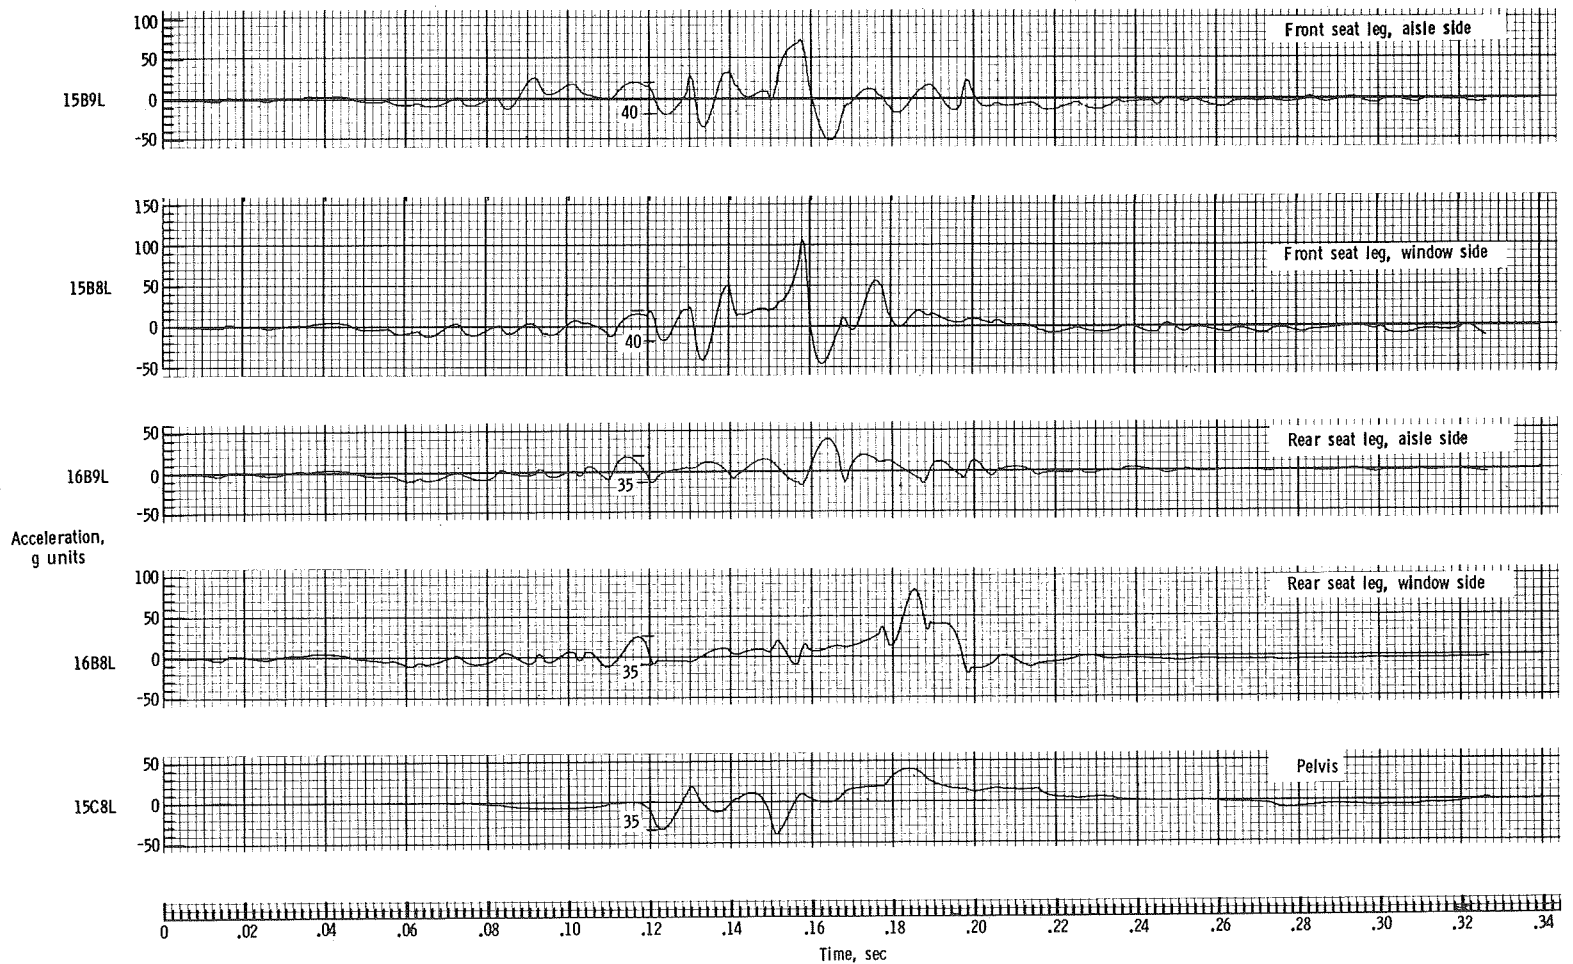
(c) -45° test specimen.

Longitudinal accelerations at -45° .— As shown for the -45° test specimen in figure 22(c), longitudinal peak-to-peak accelerations adjacent to each of the four seat legs were approximately the same: 40g for the two front legs and 35g for the two rear seat legs. The pelvis also experienced the same value as the two rear legs of 35g occurring 0.025 sec later.
