NASA CR-135381

LONG-TERM CF6 ENGINE PERFORMANCE DETERIORATION - EVALUATION  
OF ENGINE S/N 451-479

General Electric Company  
Aircraft Engine Group  
Cincinnati, Ohio 45215

February 1978

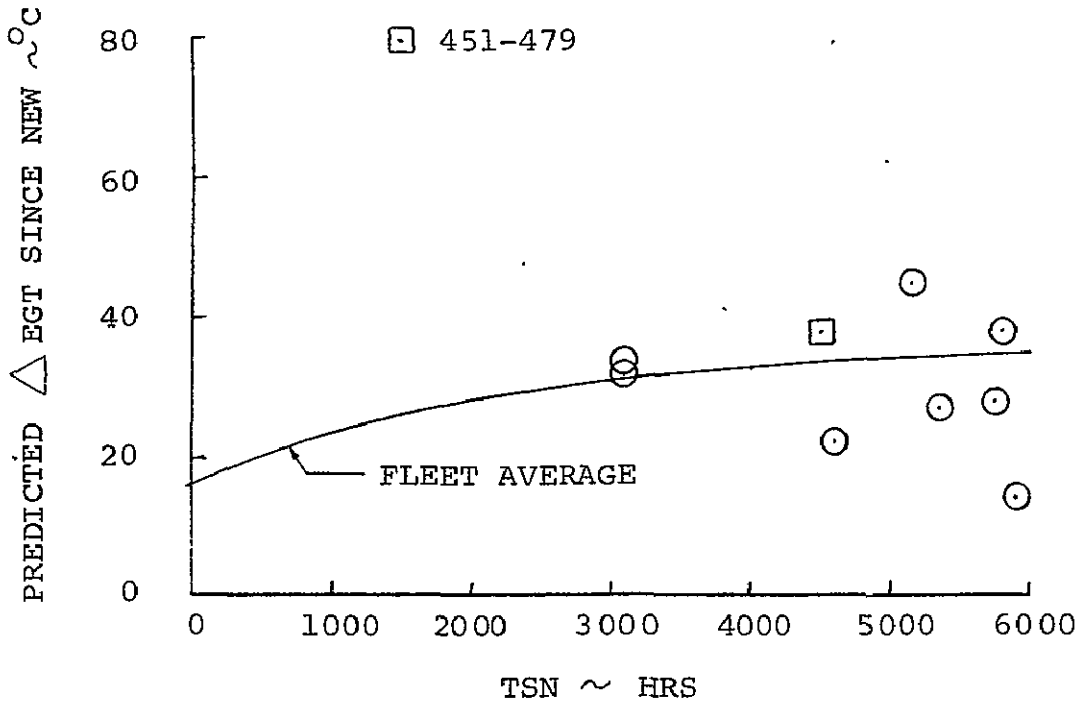
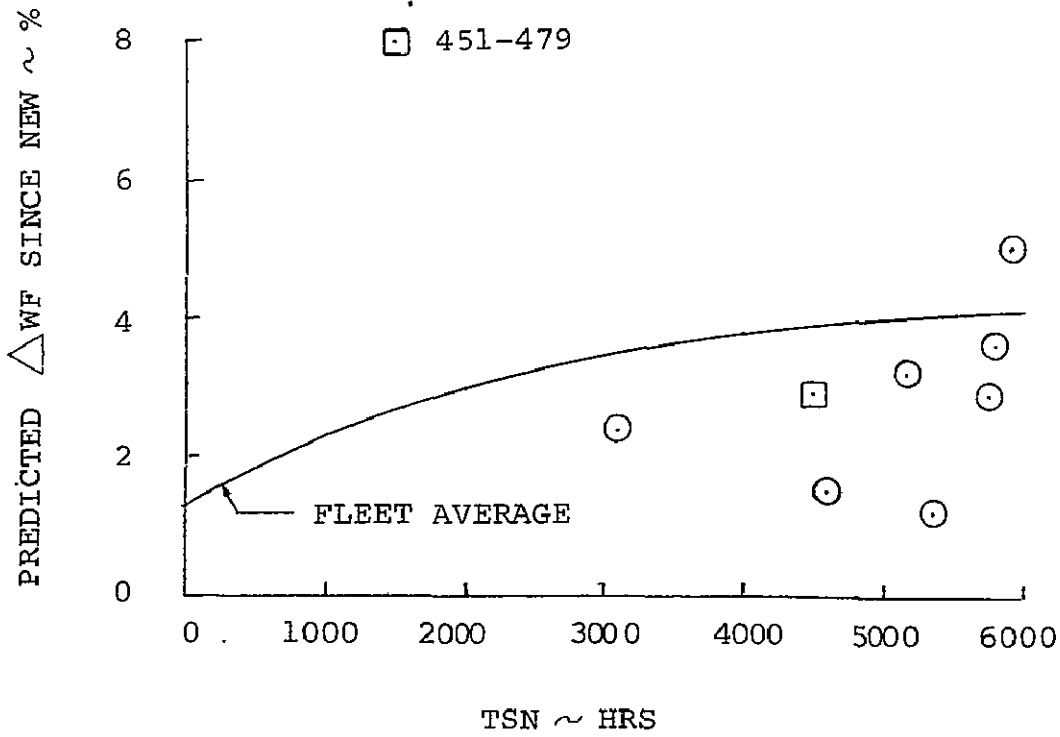
Figure 5-1. CF6-6D Cruise Deterioration.

The measured performance deterioration (production new to ASO/O inbound) was consistent with the level obtained for eight other inbound tests. Figure 5-1 presents aircraft cruise trend data as compared to these sample engines. Shown on these curves is a "fleet average" level which corresponds to the average cruise deterioration level of CF6-6D engines S/N 451-406 and up. Figures 5-2 and 5-3 present the inbound test cell deterioration levels for 451-479 and the other eight inbound engines. The "sea level fleet model" shown is based on sea level-to-altitude correlations of 0.7 for SFC, 0.8 for EGT, and 1.0 for WF (i.e.,  $\Delta EGT$  at cruise = 0.7 x  $\Delta EGT$  at sea level).

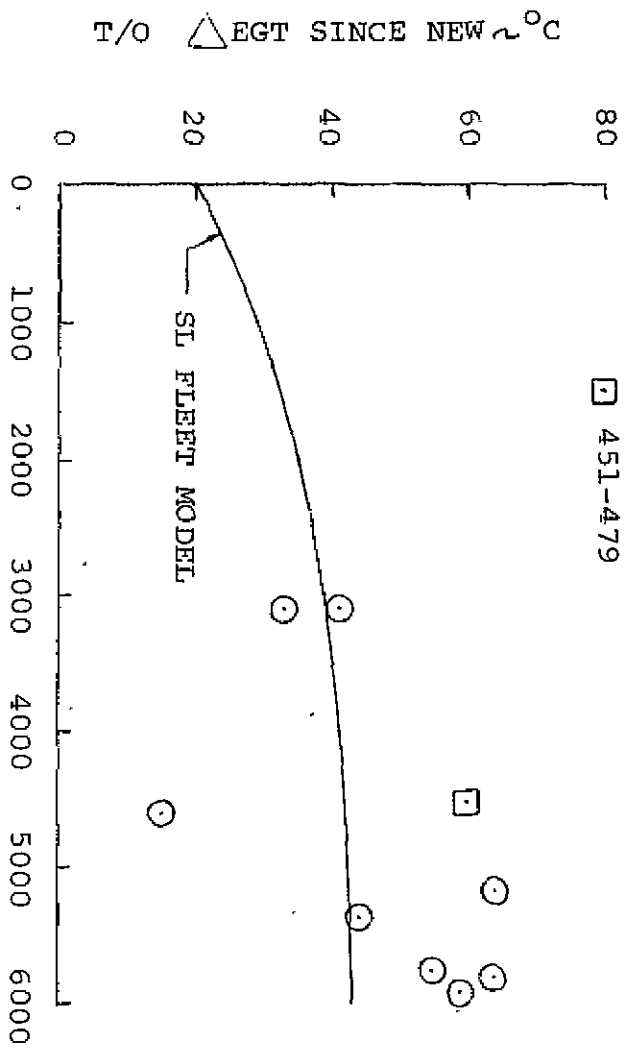
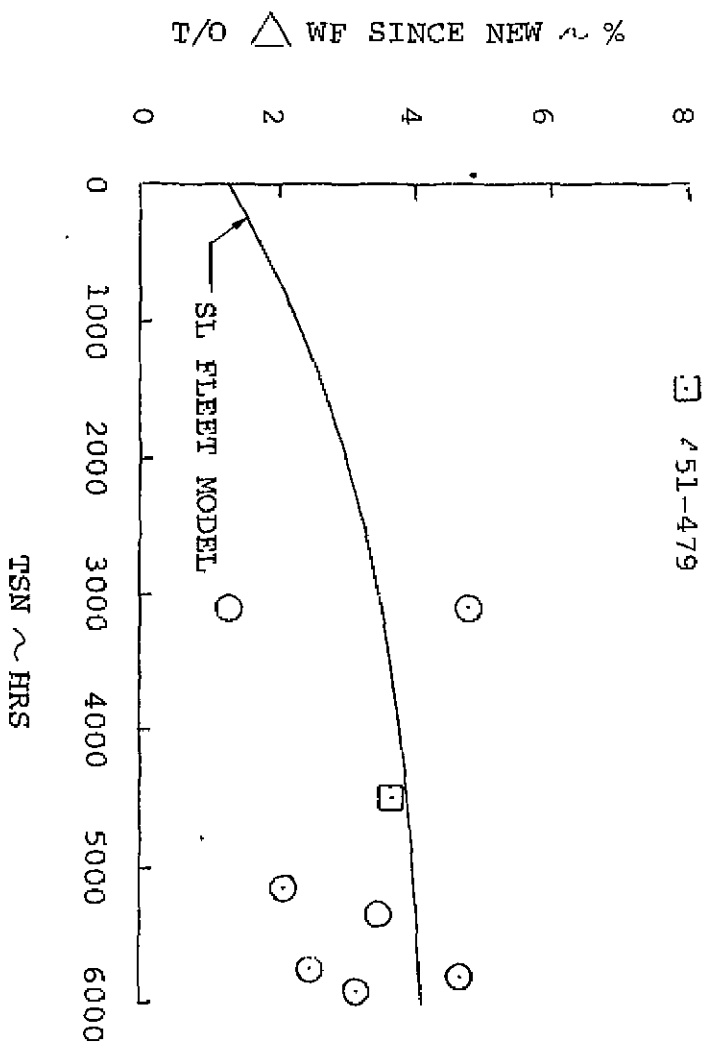
Figure 5-2. CF6-6D Inbound Sea Level Deterioration.

The inbound data are summarized in Tables 5-1 and 5-2. Almost all the measured component deterioration (inbound versus production acceptance) occurred in the HP turbine as presented below. Note that 1.3% of the 4.5% SFC deterioration is due to the "instant loss" at the aircraft manufacturer and not deterioration during revenue service.

-0.2%	$\Delta ETAC$	(HP Compressor Efficiency)
-4.3%	$\Delta ETAT$	(HP Turbine Efficiency)
0	$\Delta PARAS$	(Core Engine Internal Leakages and Cooling Flows)
-0.1%	$\Delta ETALPS$	(LP System Efficiency)
+0.6%	$FN@NI$	(Thrust at Fan Speed)

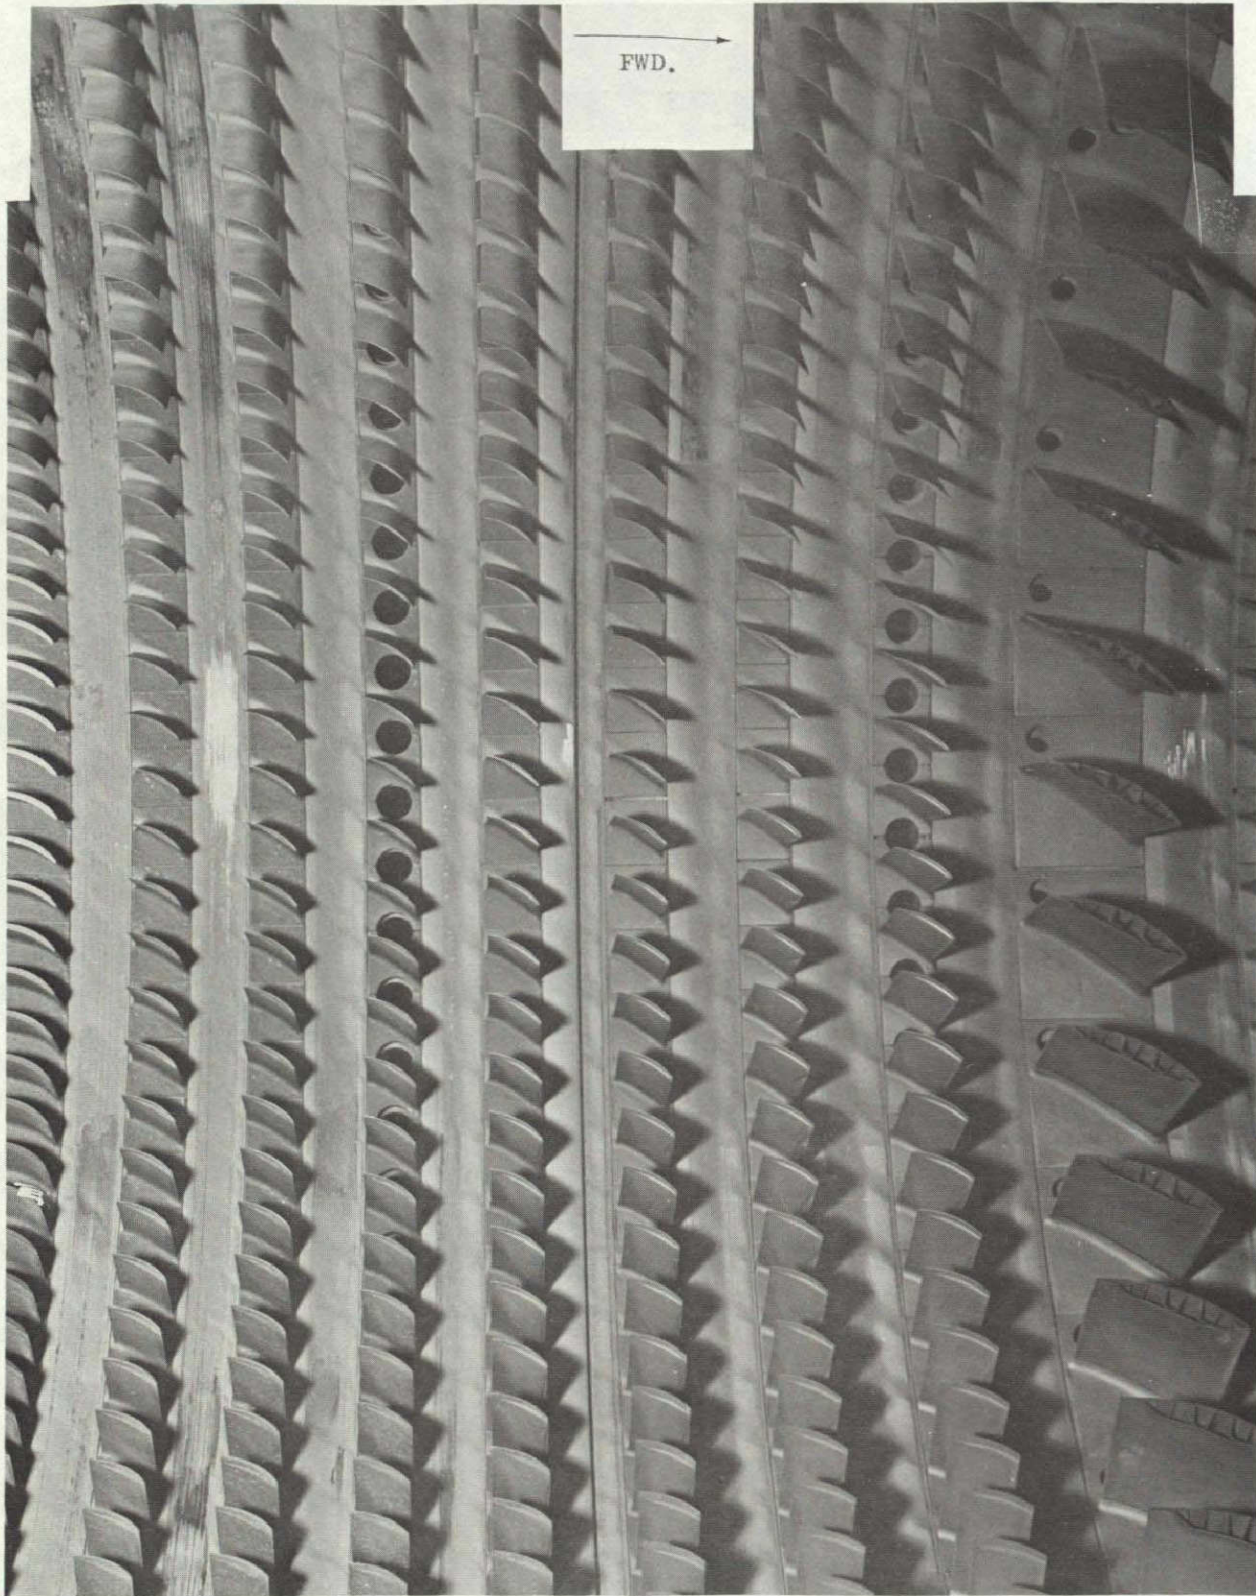
#### HP Compressor Casing Rubs - Upper (See Photo, Figure 8-4 in Appendix B)

Figure 8-4 . HP Compressor Stator, Upper Stage 7 to OGV - Rubs.

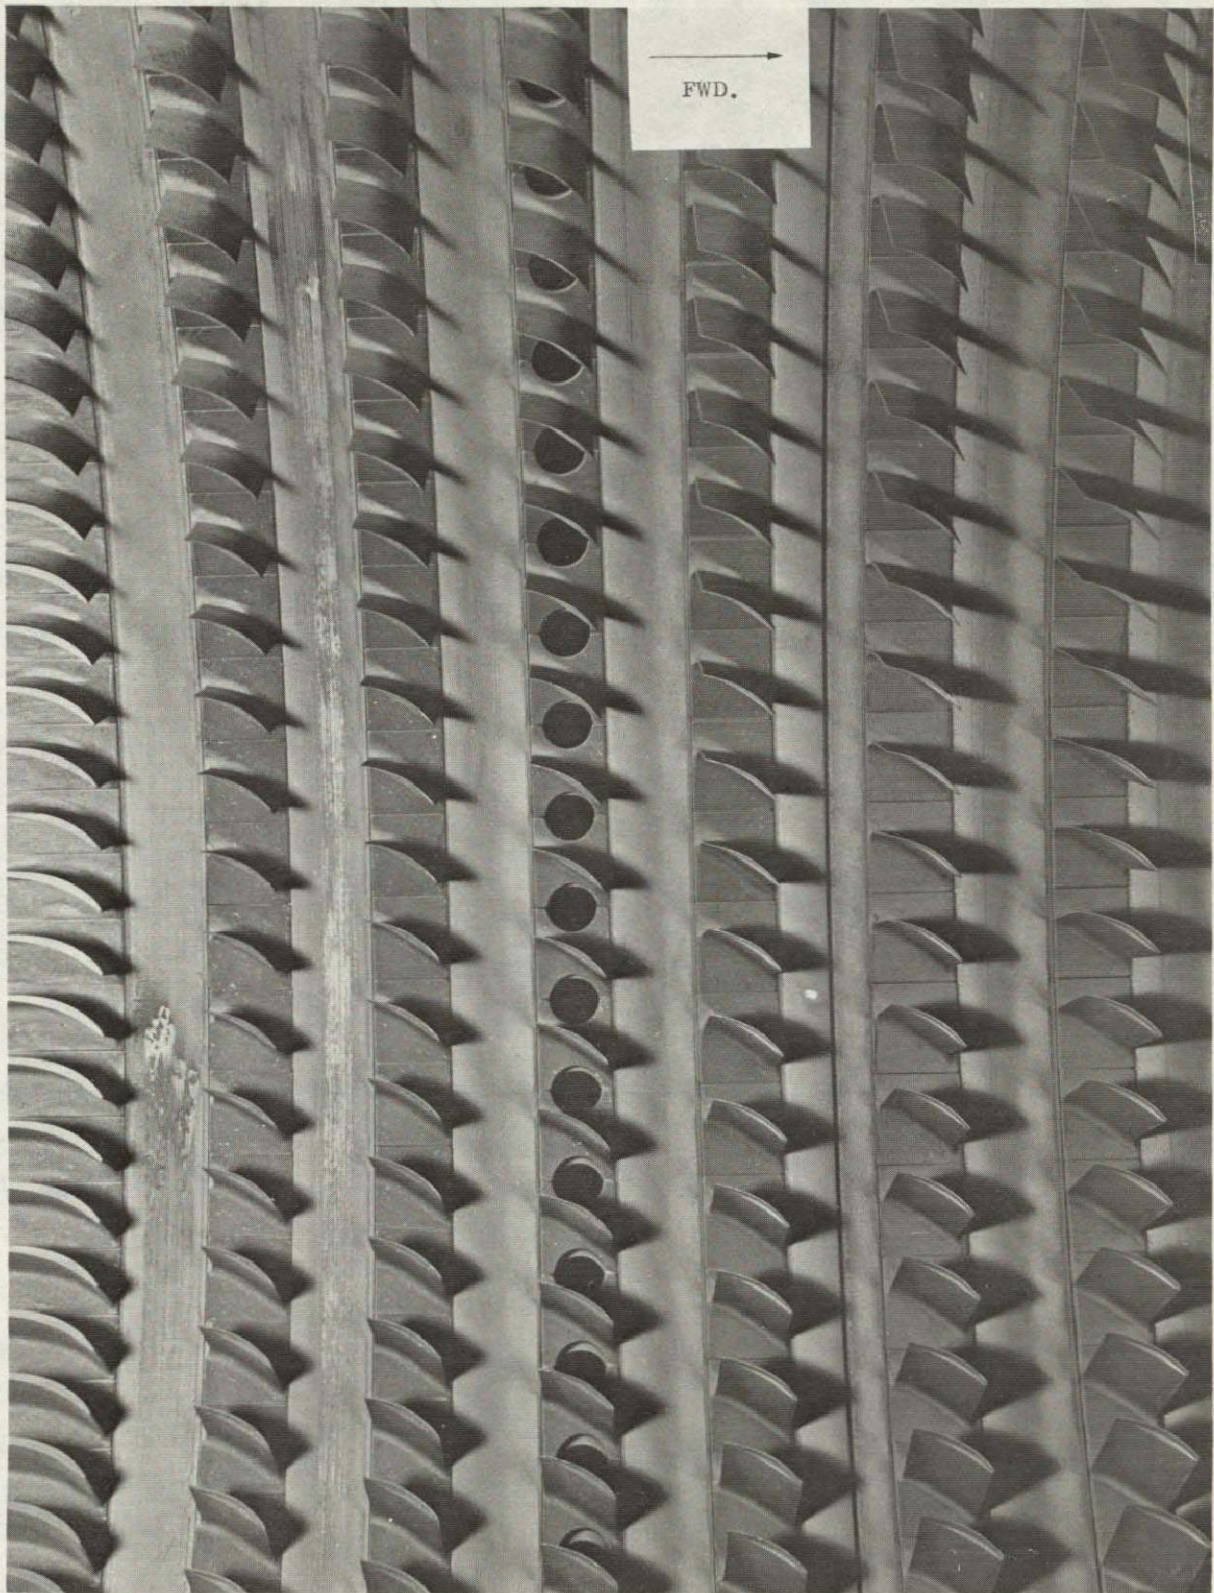
HP Compressor Casing Rubs - Lower  
(See Photo, Figure 8-5 in Appendix B)

Figure 8-5. HP Compressor Stator, Lower Stage 9 to OGV - Rubs.

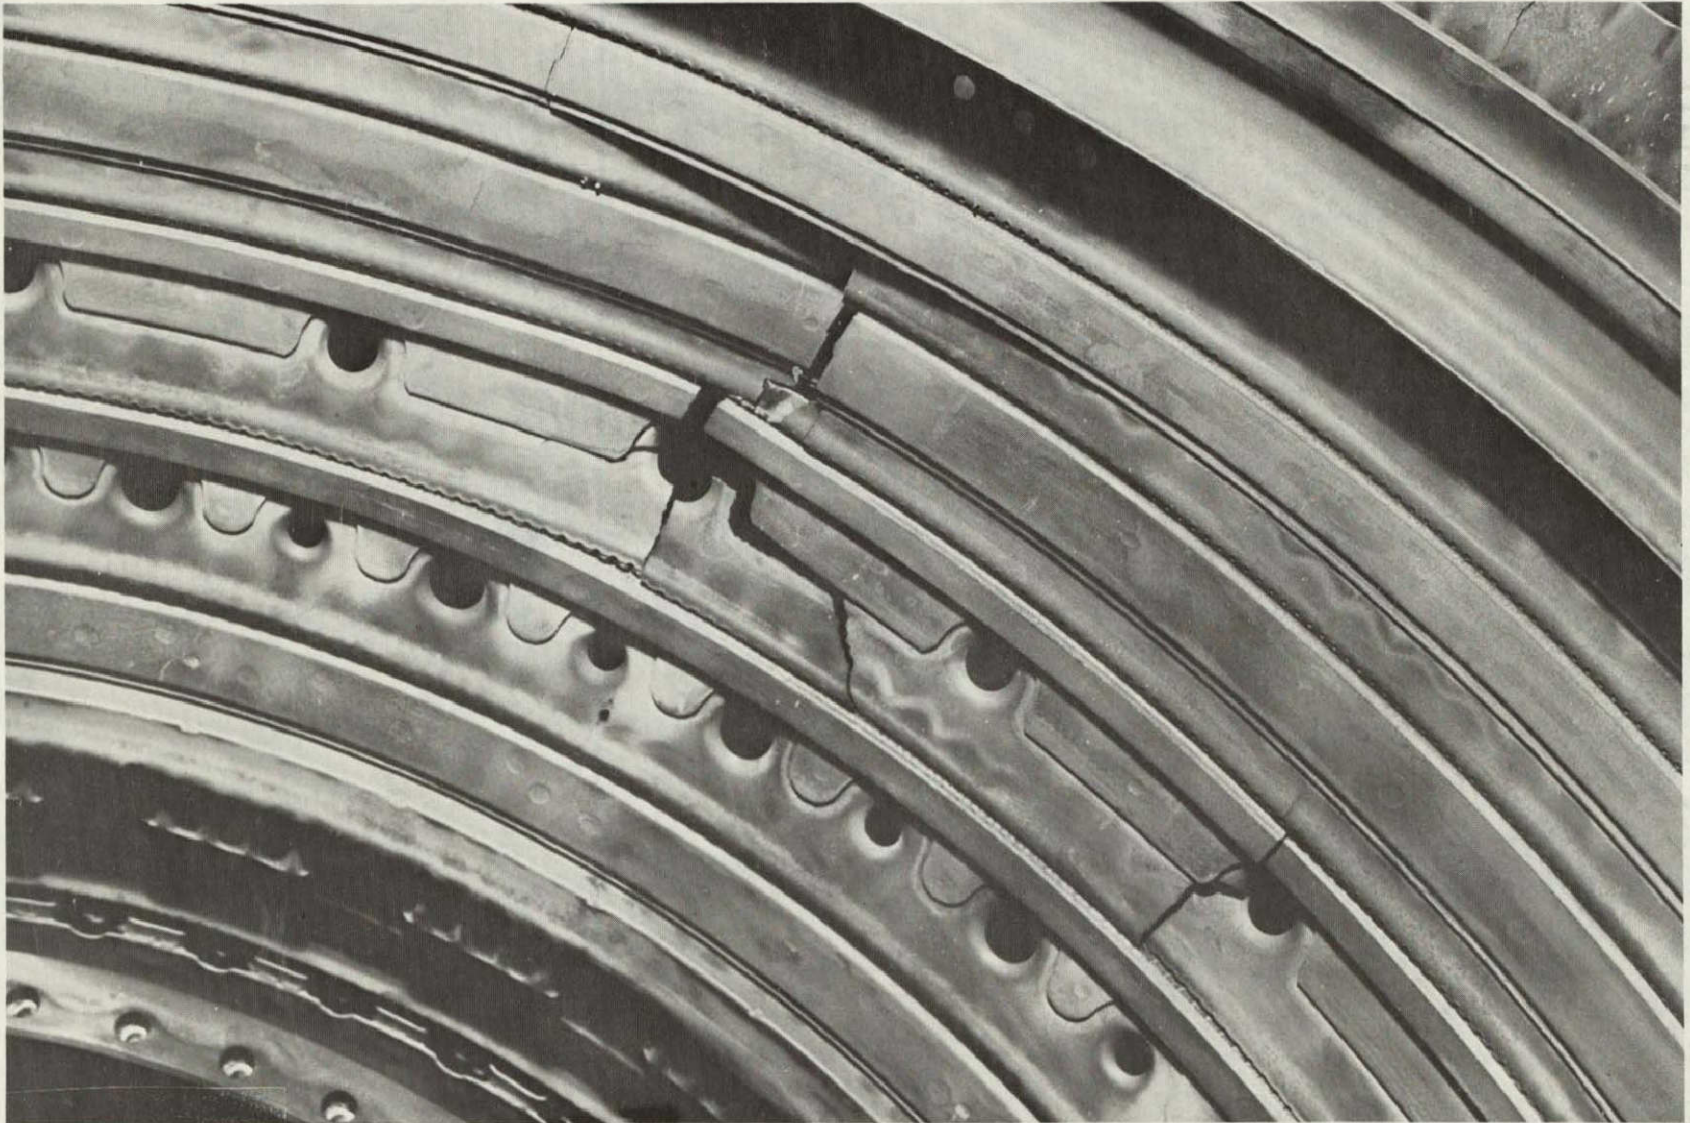
To expedite the work scope, the combustor was not removed from the rear frame, but rather visually inspected as installed. The combustor had its typical 1/4" to 1/2" cracks, inner and outer liners. The most noteworthy fault was the cracks originating at the inner liner's aft thimble louver at approximately the 7 o'clock location. This particular louver had cracked in four different directions of varying lengths (Figures 8-6 and 8-7 in Appendix B). The cracks were approximately 5/8", 1", and 2-1/2" in length and another about 2-1/4" long connecting with a 4-1/2" circumferential crack. The whole piece was bulged into the airstream approximately 5/8". There were six more of these thimble louvers with cracks ranging from 1/2" to 1-1/4" but these are considered insignificant with regard to performance.

Figure 8-7. Combustor, Closeup Crack at 7 o'clock.

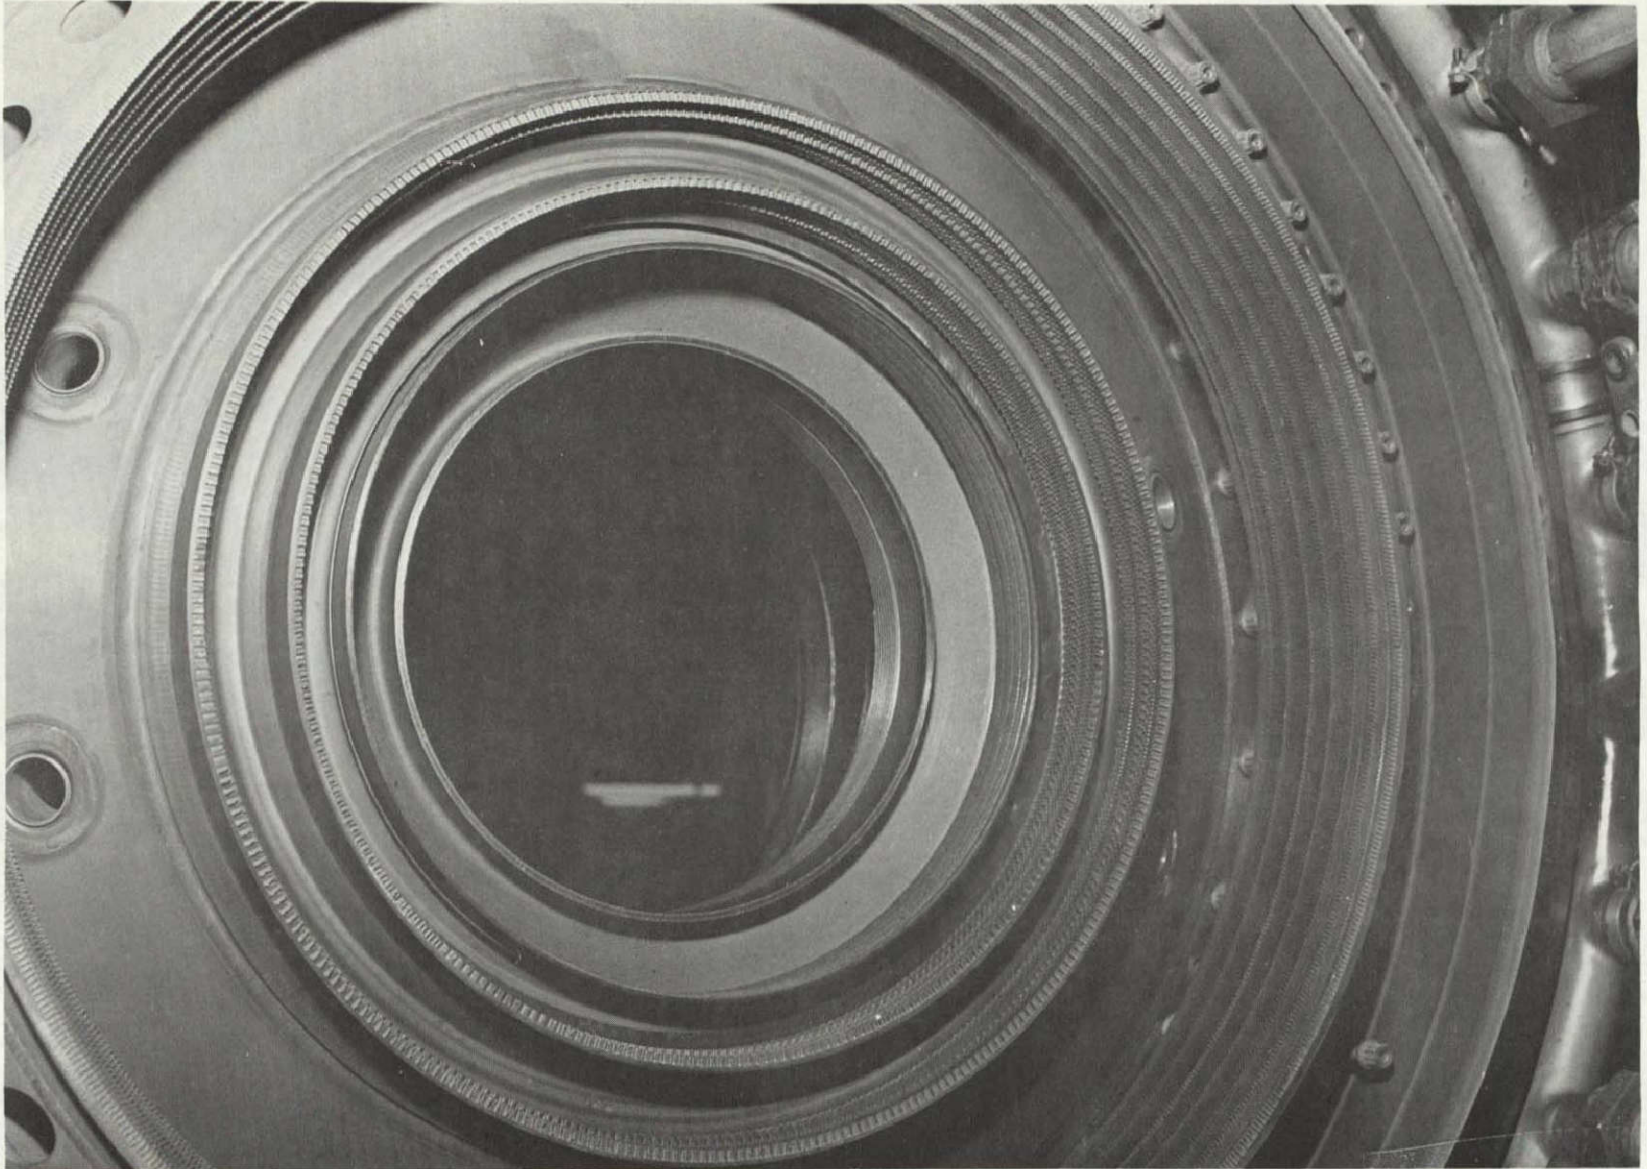
Measurements of each of the lands on the 4R CDP seal were taken and recorded. (A view of the forward CRF seals can be seen in Appendix B, Figure 8-8.) The results were as follows (all dimensions are in inches):

Figure 8-8. Compressor Rear Frame, Forward Seals - Overall View, Installed.

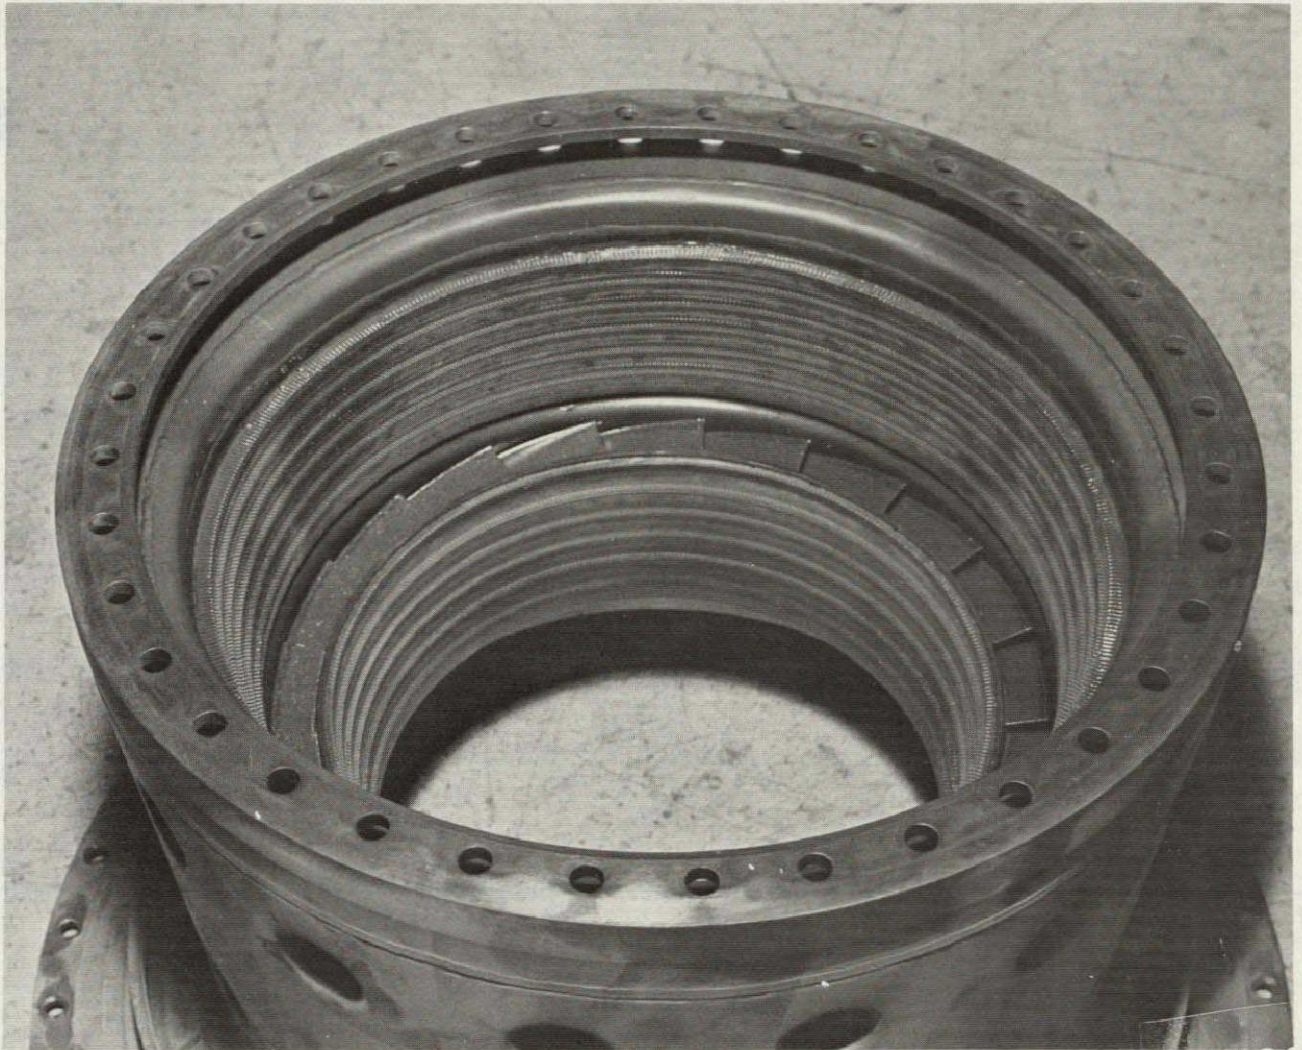
Diameter measurements of each land of each of the aft seals in the No. 4B pressure balance seal (mini-nozzle) were taken and are recorded below (dimensions are in inches). These are the seals that mate with the high pressure turbine rotor forward shaft seals. (A photograph of the mini-nozzle is contained in Appendix B, Figure 8-9.)

Figure 8-9. No. 4B Pressure Balance Seal, Overall View.

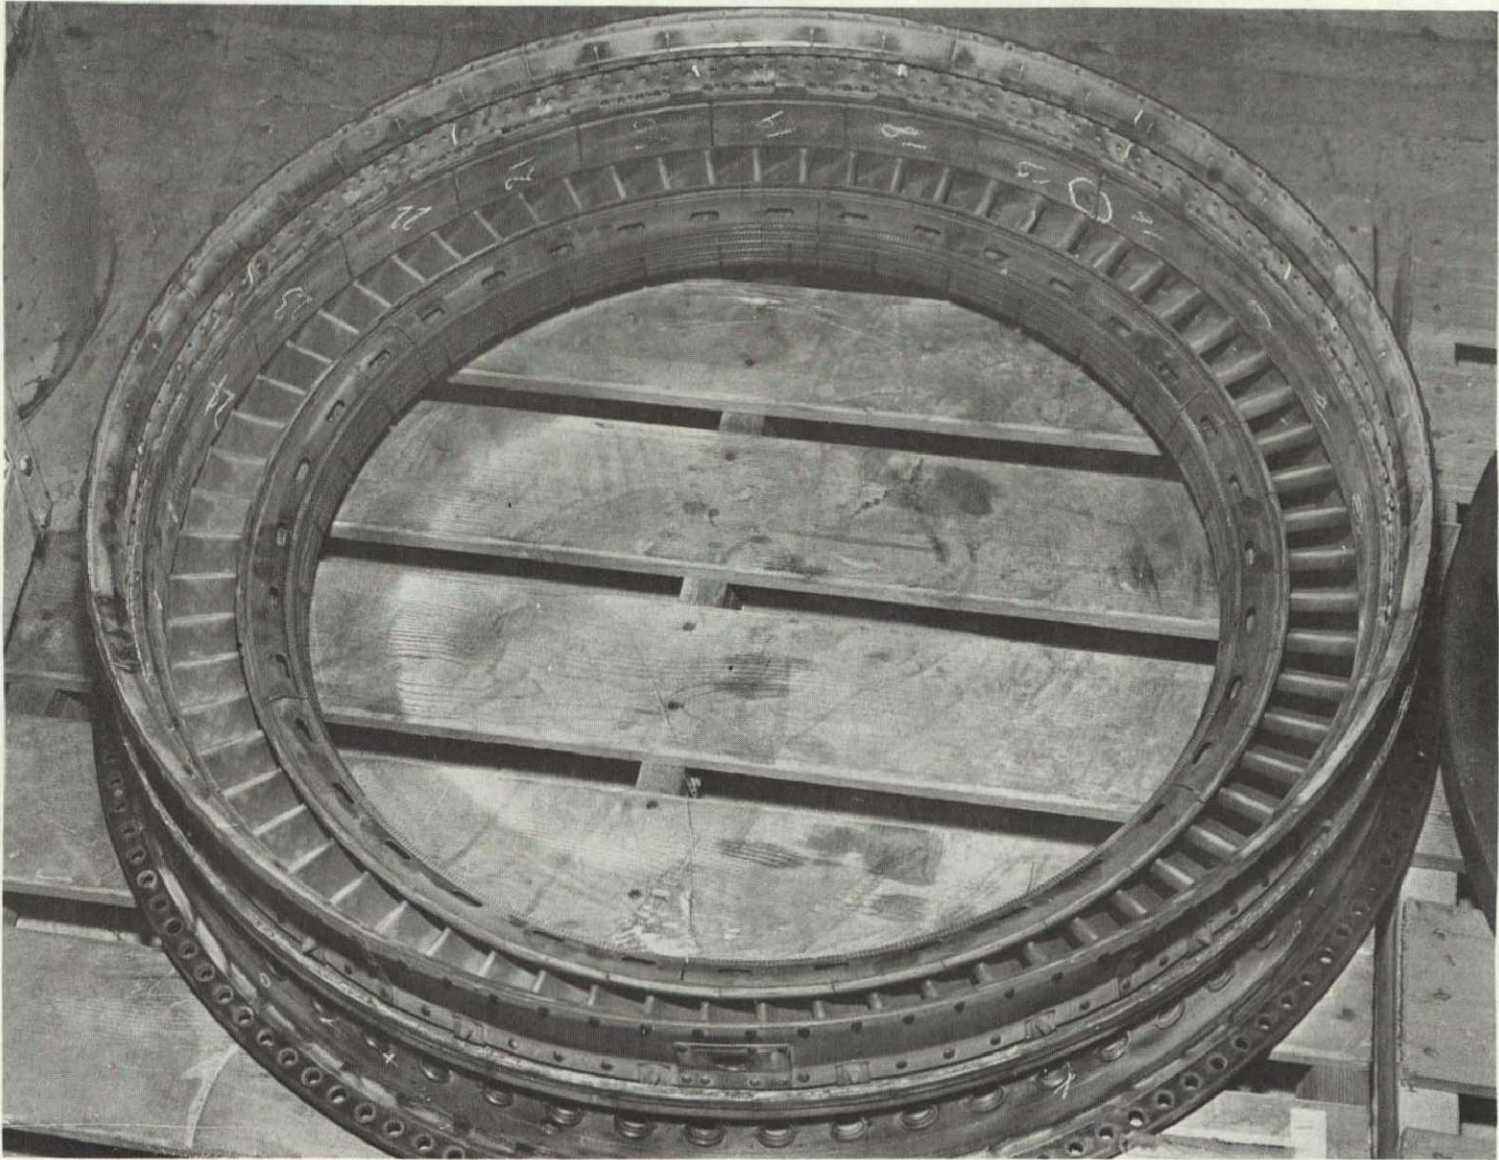
A visual inspection of the Stage 2 high pressure turbine nozzle, as assembled, produced no surprising results. It proved to be about as expected for an assembly with this amount of running time (see photograph, Figure 8-14, for an overall view of the assembly). The more noteworthy results of the inspections are covered in the following paragraphs.

Figure 8-14. HP Turbine Nozzle Assembly, Overall View, Forward End.

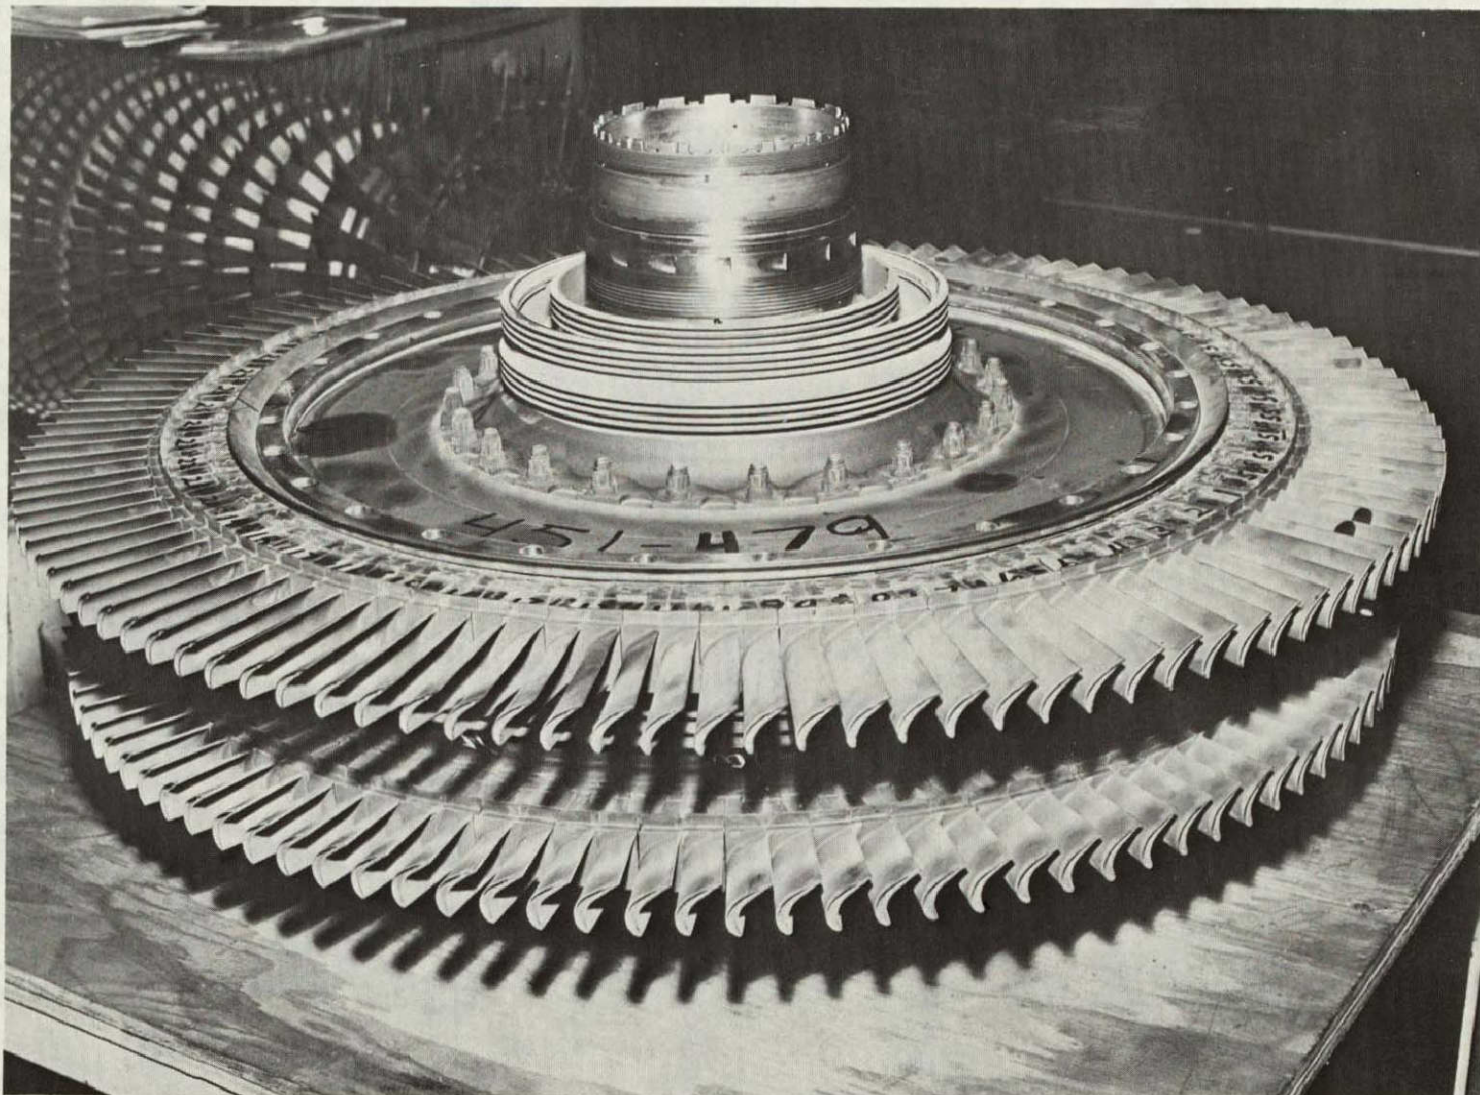
Photographs of the HTPR can be seen in Appendix B, Figures 8-17 and 8-18.

Figure 8-17. HP Turbine Rotor, Overall View of Blades.

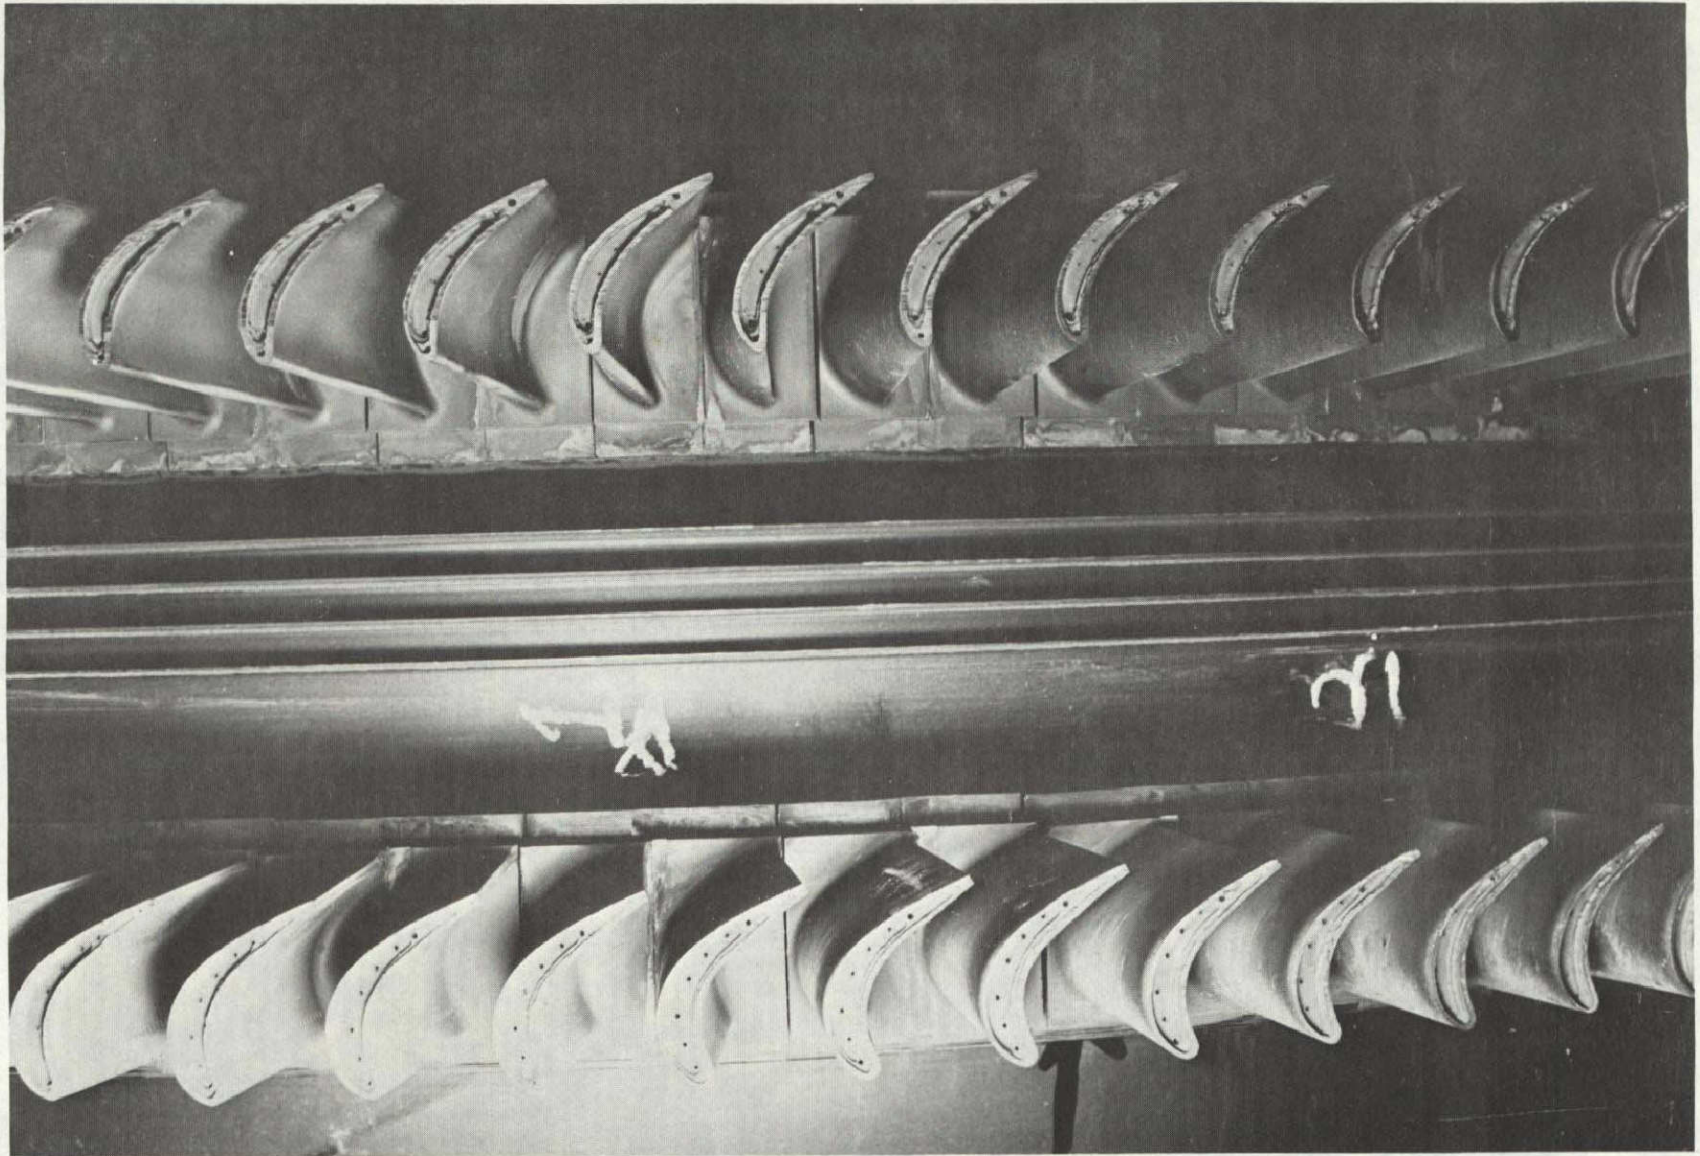
Figure 8-18. HP Turbine Rotor, Blade Tip Rubs.

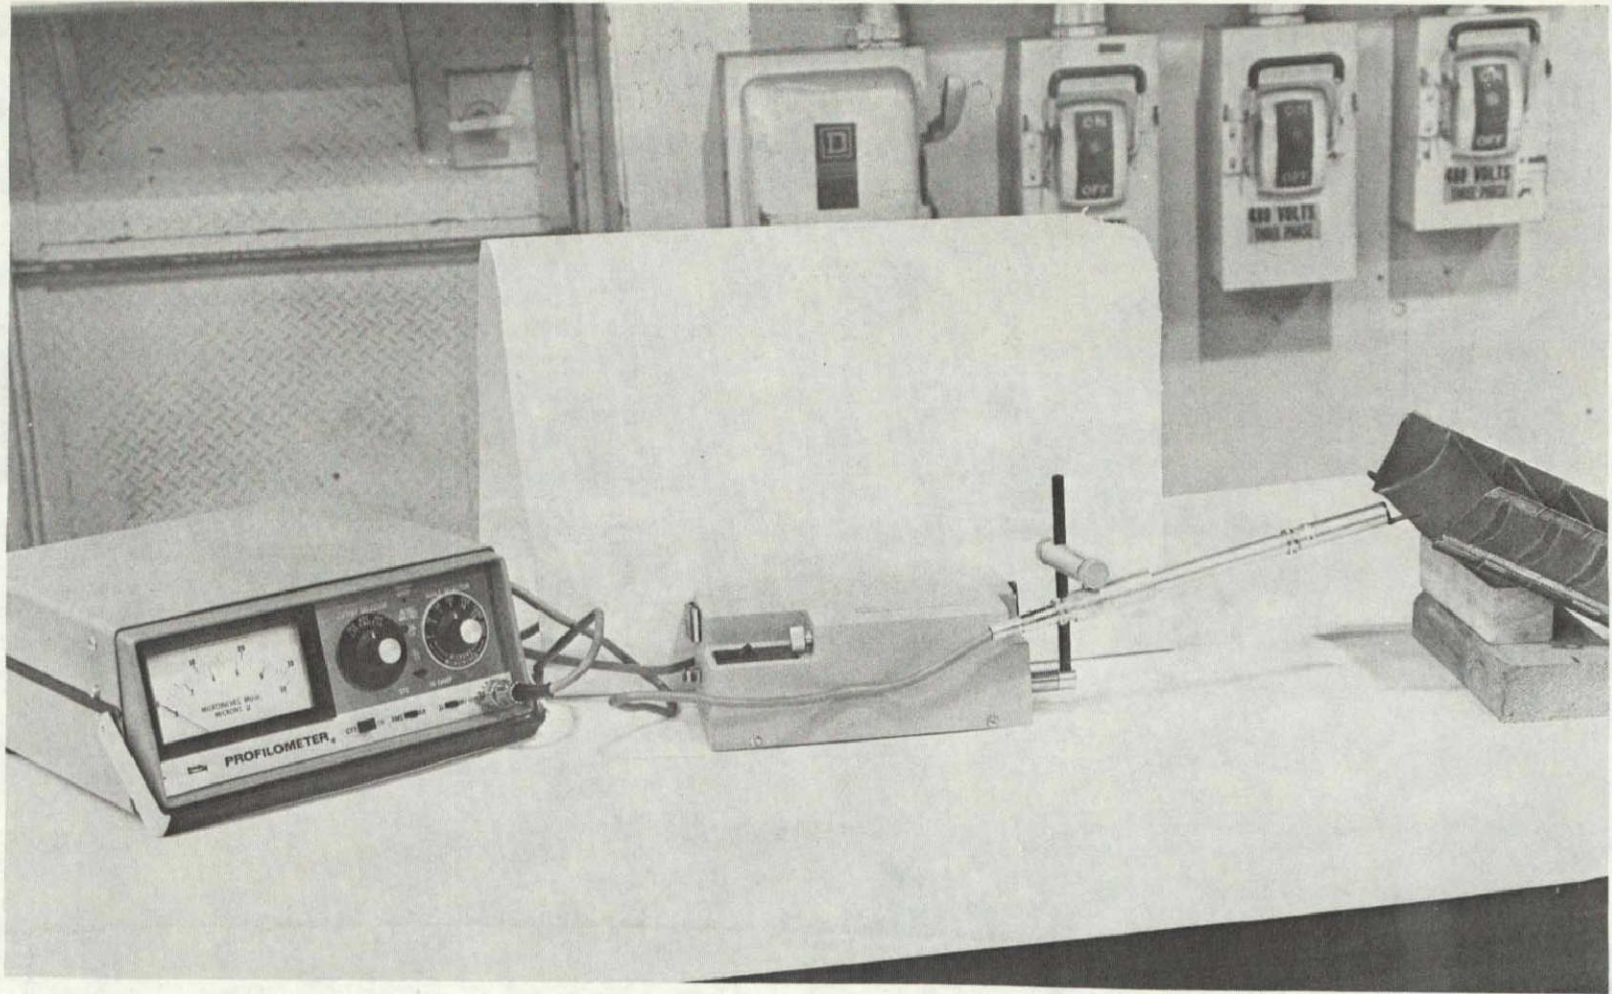
were inspected after removal from the TMF. The profilometer and associated hardware used for these surface-finish checks were supplied by Airline Support Engineering (ASE), Evendale. A typical setup of this equipment can be seen in Figures 8-20 and 8-21 in Appendix B.

Figure 8-20. Profilometer Setup, LP Turbine Nozzle Segment, Concave Side.

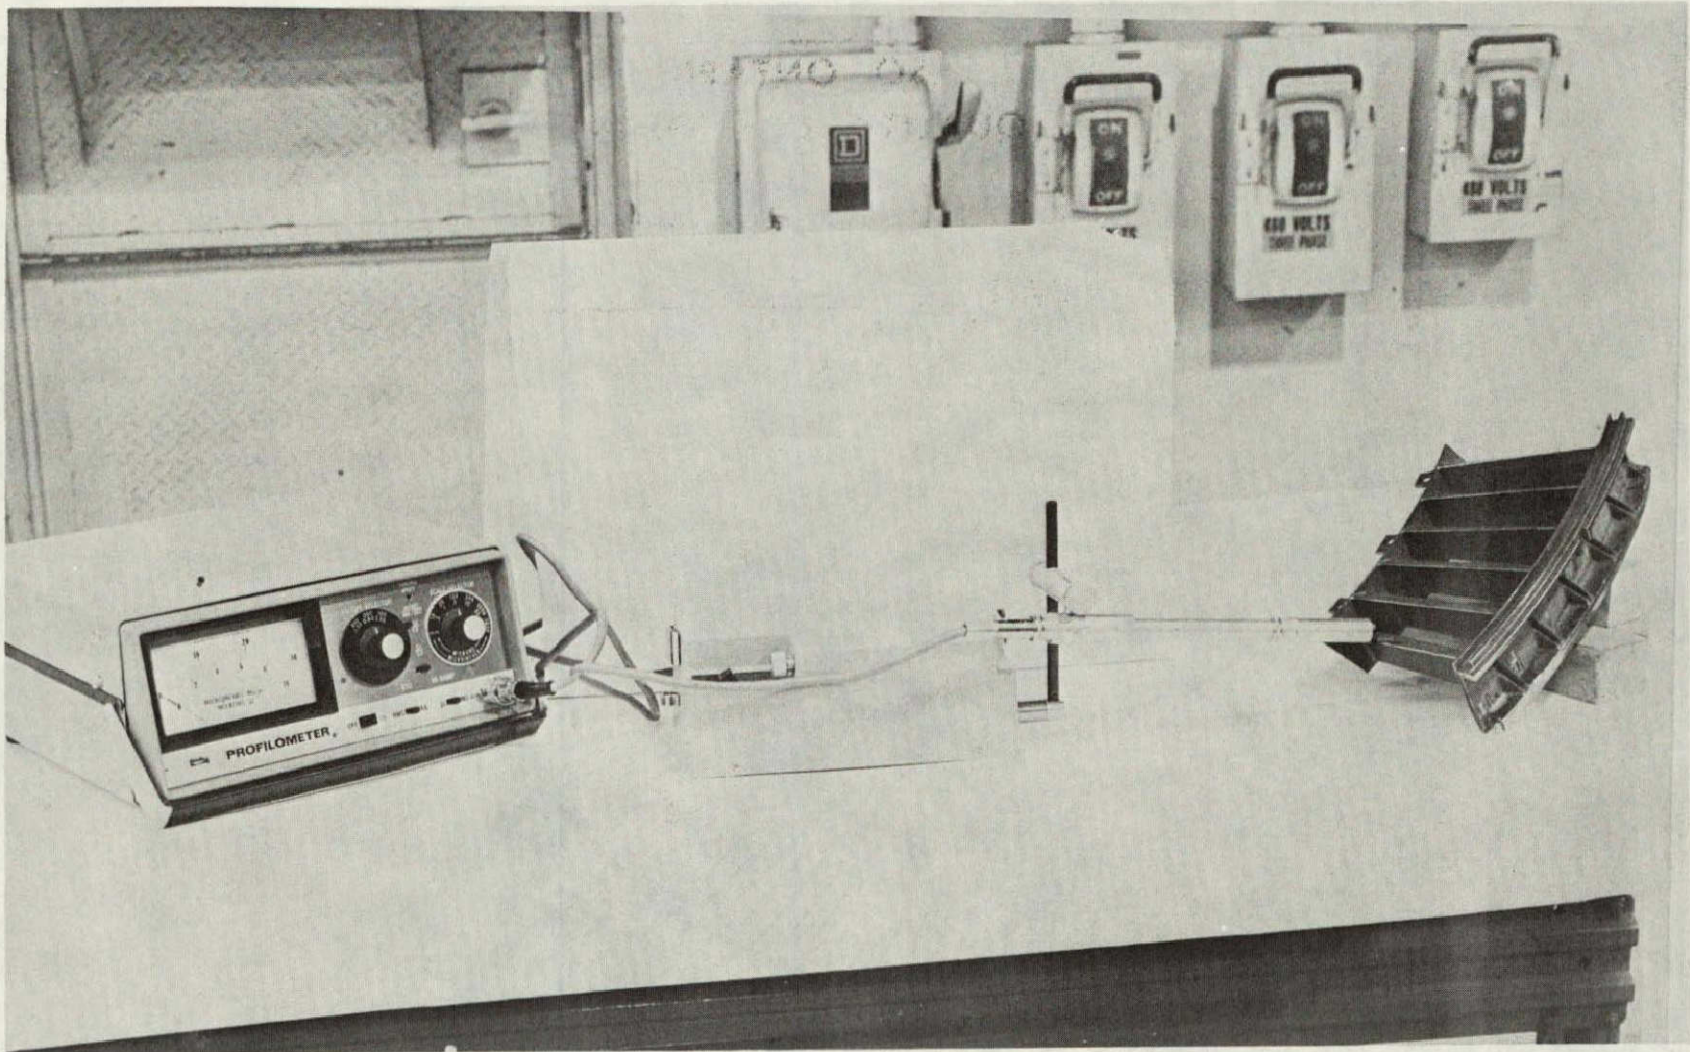
Figure 8-21. Profilometer Setup, LP Turbine Nozzle Segment, Convex Side.
