NASA CR-135381

LONG-TERM CF6 ENGINE PERFORMANCE DETERIORATION - EVALUATION  
OF ENGINE S/N 451-479

General Electric Company  
Aircraft Engine Group  
Cincinnati, Ohio 45215

February 1978

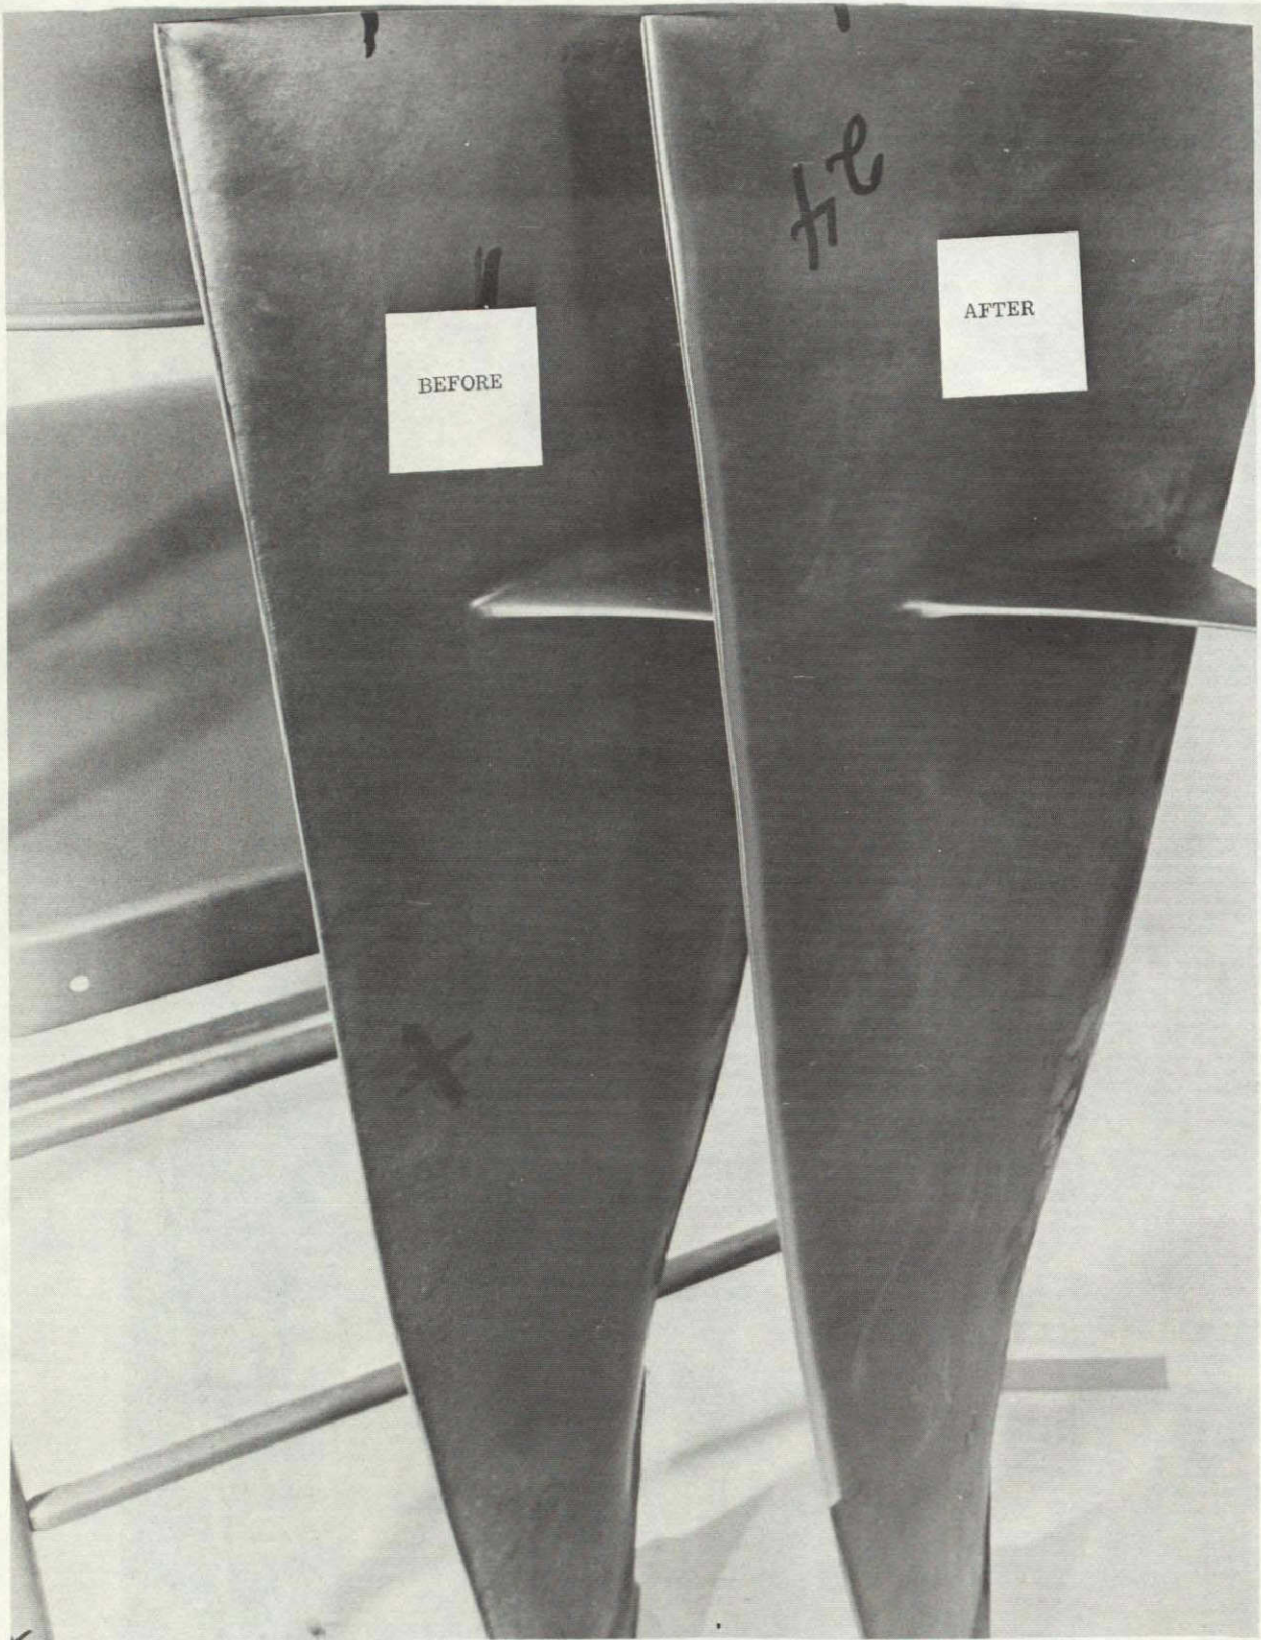
Leading edge contour was such that during the test plan, when the blades were reconditioned for test evaluation purposes, only minor rework using Tool 2C7546 was required to bring the contour into limits. See photograph, Figure 8-26, in Appendix B, depicting one blade before and another blade after recontour. The pressure side radius was already in limits, so no hand-blending was necessary on any of the blades.

Figure 8-26. Stage 1 Fan Blades Before/After Recontour.

To determine the performance effects for the fan section components, the following method was employed: The test cell run after the LPT blade and vane refurbishment served as a baseline for subsequent tests. Following this run, the Stage 1 blades were removed, cleaned, and the leading edges recontoured per Shop Manual. Another test cell run was then conducted. Since no other changes were made to the engine during this time period, the performance improvements achieved were attributed to the fan blade refurbishment. Figure 8-26 in Appendix B compares a recontoured blade with one that had not yet been reworked.
