FINAL REPORT

**DEVELOPMENT OF SPIRAL-GROOVE
SELF-ACTING FACE SEALS**

**AVCO LYCOMING DIVISION
550 South Main Street
Stratford, Connecticut 06497**

JUNE 1977

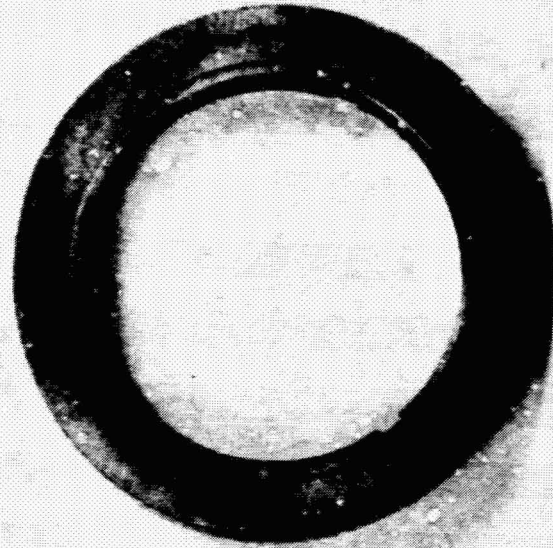
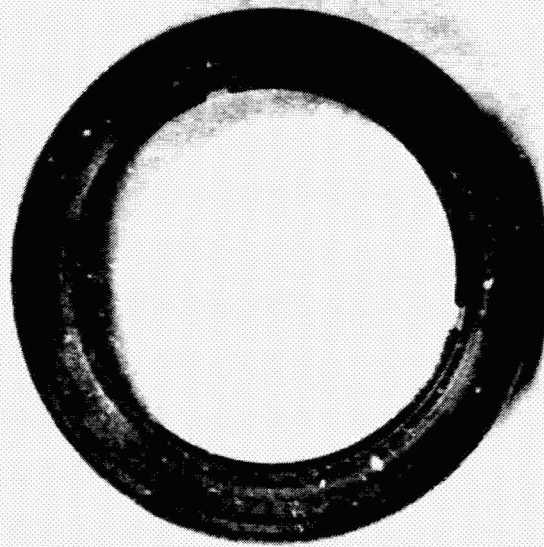
Figure 25. Back of Seal Seats After Build II Testing.

Figure 24 illustrates the forward and aft sealing elements after Build II testing. Figure 25 illustrated the back (normally nonsealing side) of seal seats with the forward seat illustrating contact marks from sealing element due to it being reversed. A wear ring on the aft seat, caused by unclamped operation can be seen. Figure 26 shows the opposite side (normally the sealing side) of the seats (contact side for aft seat). The forward sealing element, exhibiting heavy wear and shallow spiral-groove geometry, was replaced with a new part of Build III testing. Table IV illustrates changes in face dimensions after Build II testing.

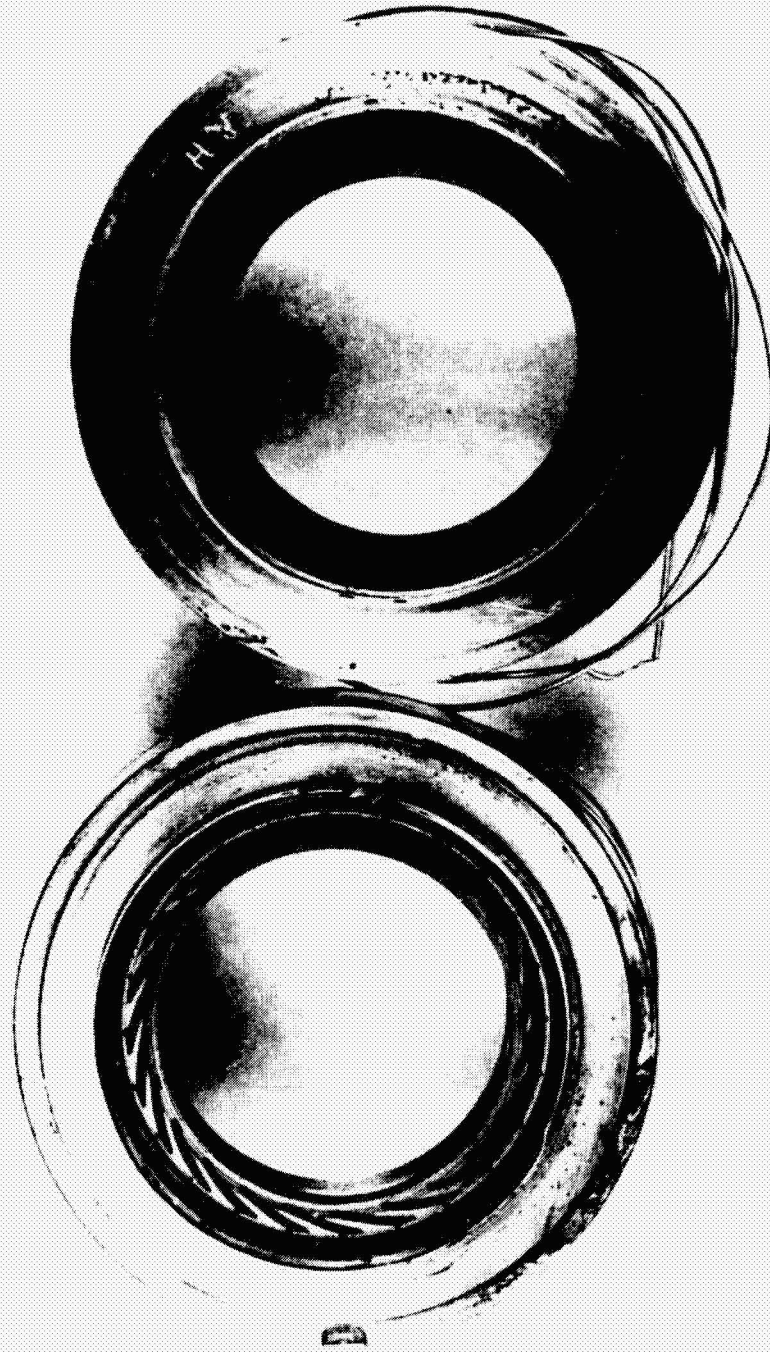
Figure 39. Forward and Aft Seal Assemblies After Endurance Test, Build II.

The test rig was rebuilt, and the endurance test was completed without problem. At the end of the endurance test, seal operation at 243 m/s (800 ft/sec) was accomplished. The condition of the seals at the completion of the endurance test is documented in Figures 39 through 52. Inspection revealed coking of the internal seal components had continued, and sufficient deposits had formed on the housing and piston ring carrier to prevent the seals from returning to their normal free height. Coke within the coil springs limited their action as did coke in the spring cavity (Figures 48 and 49). The effected forward seal components were less coked than the corresponding aft seal components. The piston rings of both seals were free from coke. (Figure 51)
