**NASA TM-73700**

**FRACTURE SURFACE CHARACTERISTICS OF OFF-AXIS COMPOSITES**

by J. H. Sinclair and C. C. Chamis  
Lewis Research Center  
Cleveland, Ohio 44135

TECHNICAL PAPER to be presented at the  
Fourteenth Annual Meeting of the Society of Engineering Science, Inc.  
Bethlehem, Pennsylvania, November 14-16, 1977

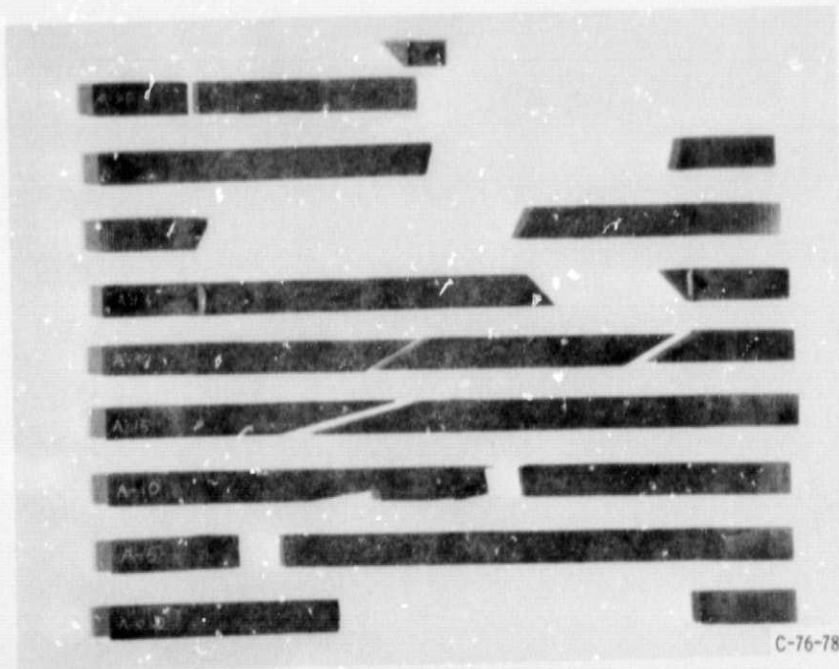
Figure 4. - Fractured tensile specimens.

Fractured surfaces from each tensile specimen shown in figure 4 were observed by scanning electron microscope, and typical photomicrographs were made to illustrate fracture modes.

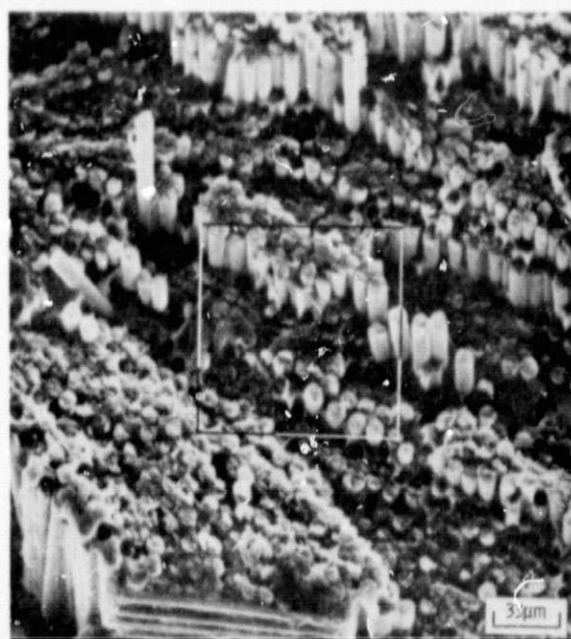
(b) DETAILED VIEW

fracture suggests poor bonding between matrix and fibers. The remaining areas of figure 6(a) show irregularly shaped tiered or stepped surfaces that are typical of the fracture surface of specimens tested in longitudinal tension. At some regions, fibers over relatively large areas fractured at approximately the same level, and they show little fiber pull-out. This is the type of fracture surface shown in figures 6(b) and (c). There was strong bonding between the fibers and matrix in these areas. The fracture mode of the resin was cleavage (fig. 6(c)). Lateral fiber surfaces of these stepped zones show some evidence of sheared resin lying between the fibers as seen in the upper left of figure 6(c).

Figure 6. - Scanning electron photomicrographs of fractured surface of MOD/Epoxy composite [D]g tested parallel to the fiber direction.

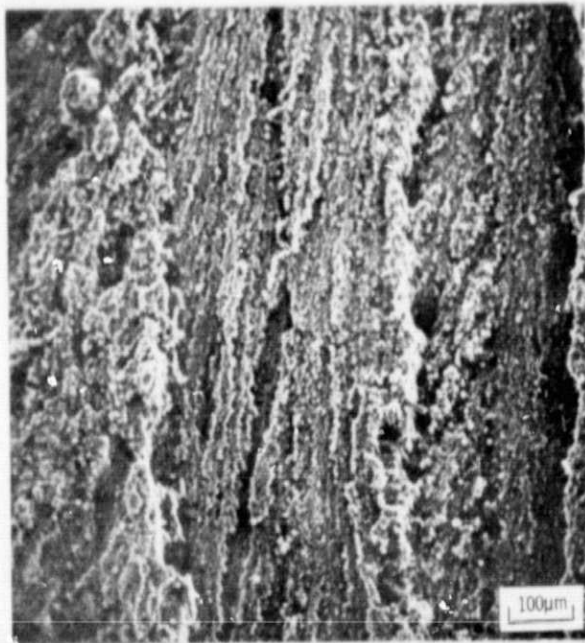
(a) GENERAL VIEW

The fracture surface of the 5° off-axis tensile specimen, figure 7, reveals the following features:
