NASA Technical Paper 1042

Light Airplane Crash Tests at Impact Velocities of 13 and 27 m/sec

Emilio Alfaro-Bou and Victor L. Vaughan, Jr.

NOVEMBER 1977

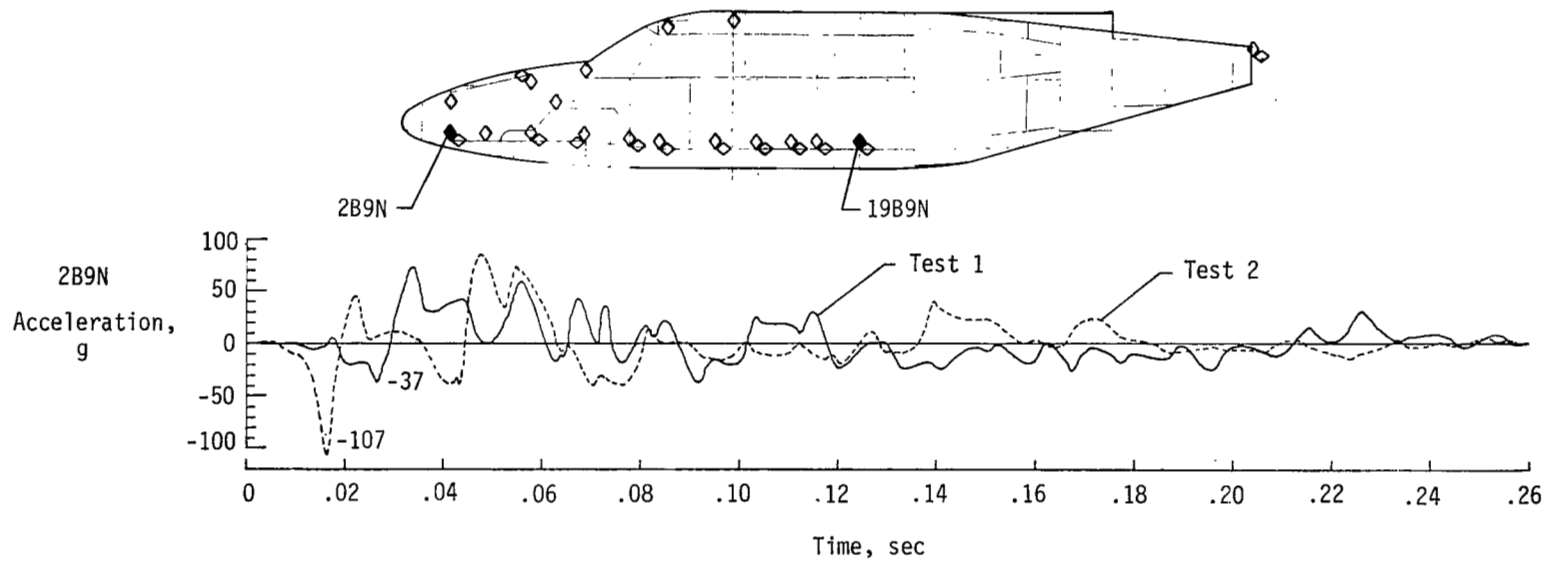
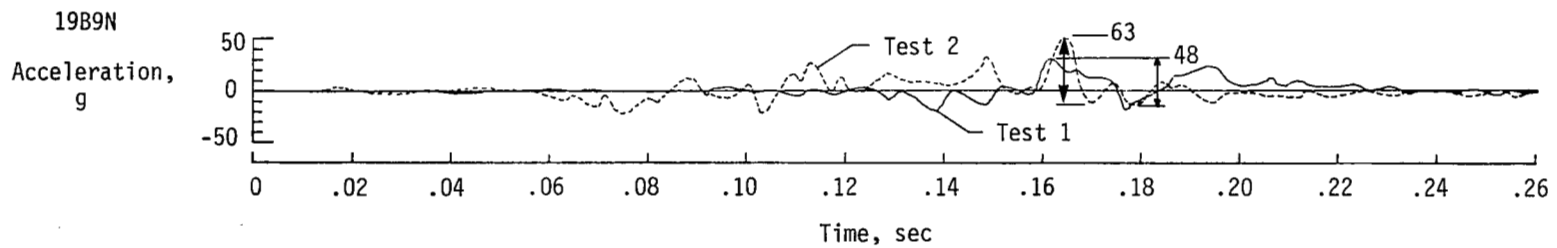
(a) Accelerations at two extreme points.

Acceleration traces in the normal (Z-axis) direction for two extreme points on the floor beam are shown in figure 9(a). The top traces are the acceleration time histories produced by the initial impact in the nose area at point 2B9N. The trace for test 1 (solid line) shows a peak of $-37g$ occurring 26 ms after initial ground contact whereas in test 2 (dashed line) a peak of $-107g$ was recorded 18 ms after contact. The minus signs signify accelerations in the upward direction. ($1g = 9.806 \text{ m/sec}^2$.) After initial impact, the

Figure 9.- Normal (Z-axis) LSF acceleration traces adjacent to floor beam.

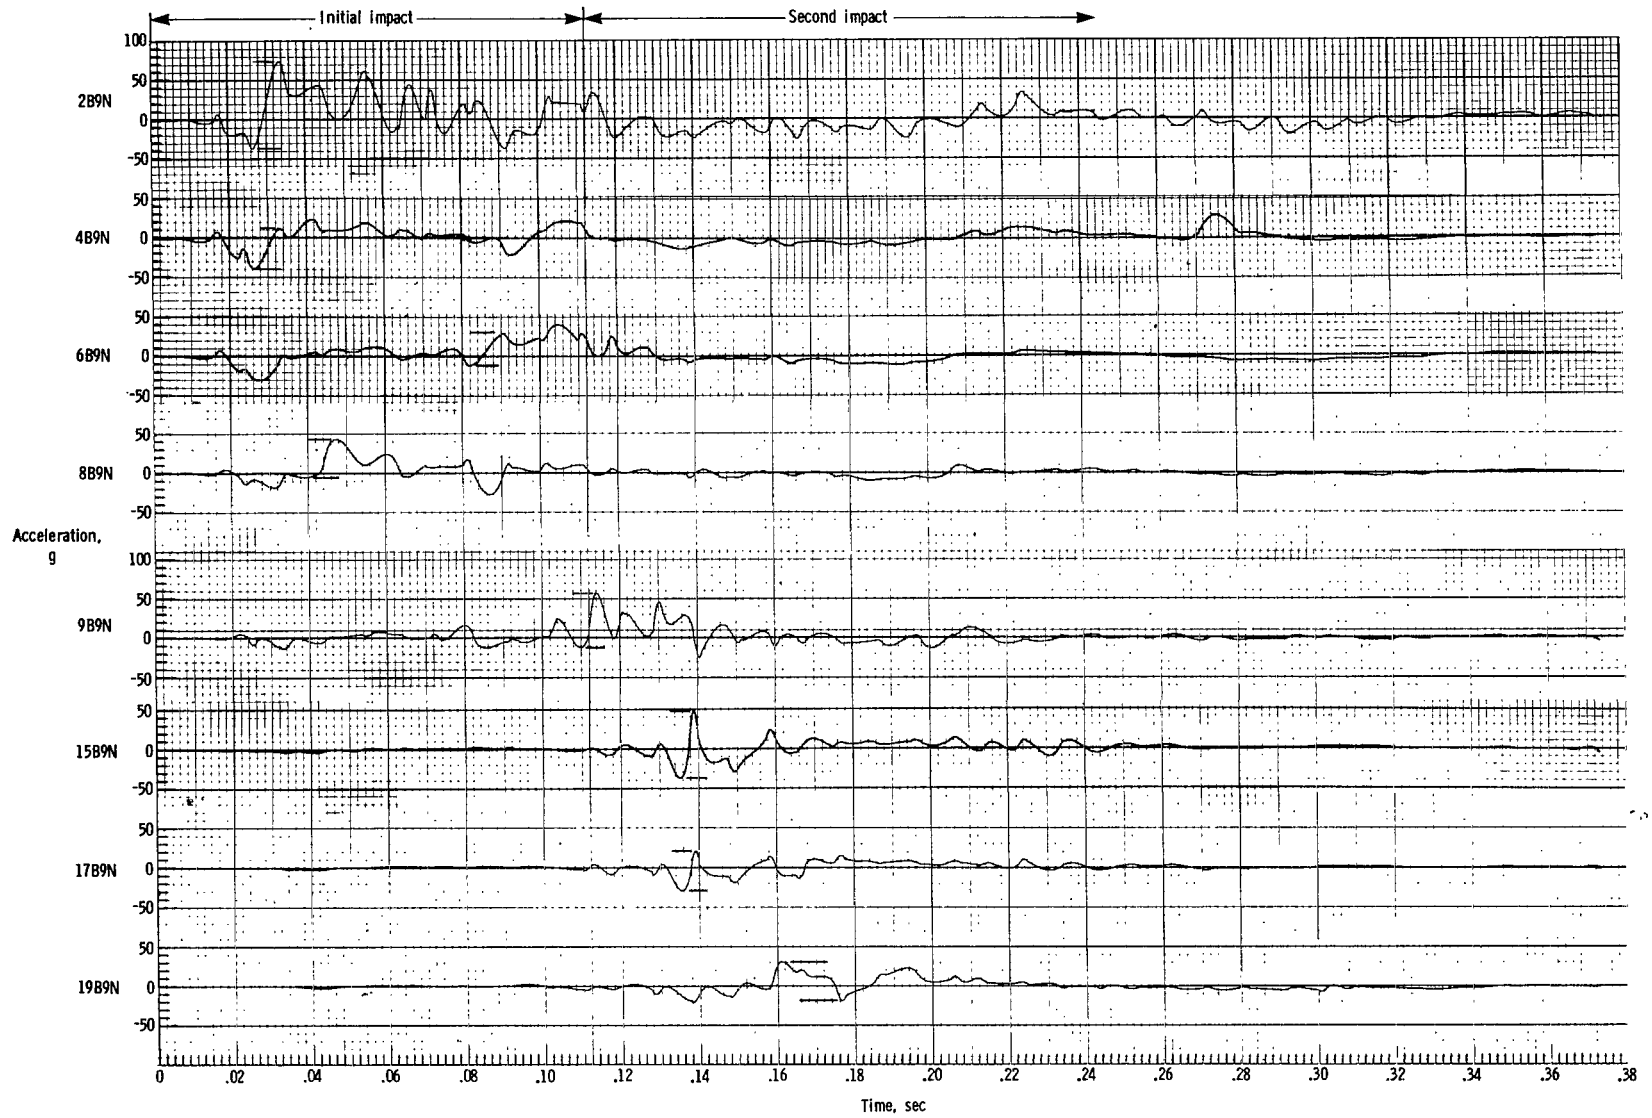
(b) Accelerations in sequence from fore to aft. Test 1.

Figure 9.- Continued.

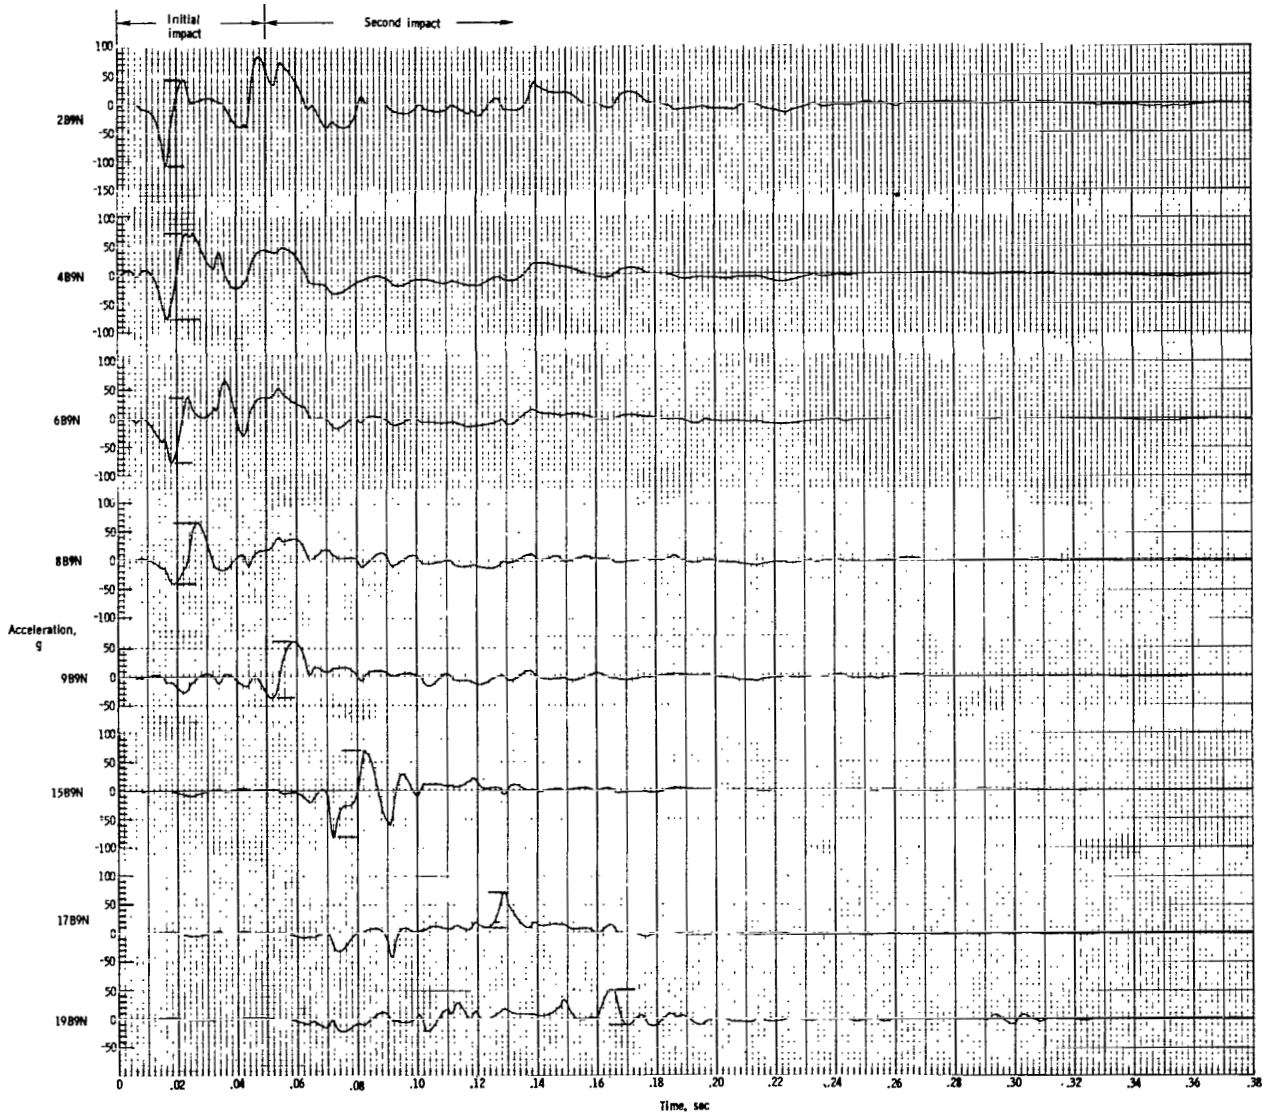
(c) Accelerations in sequence from fore to aft. Test 2.

Figure 9.- Concluded.

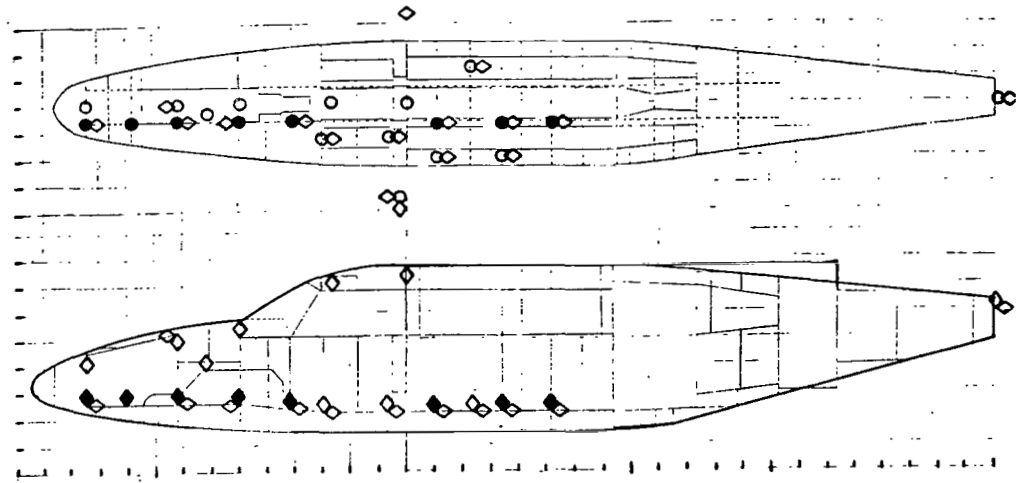
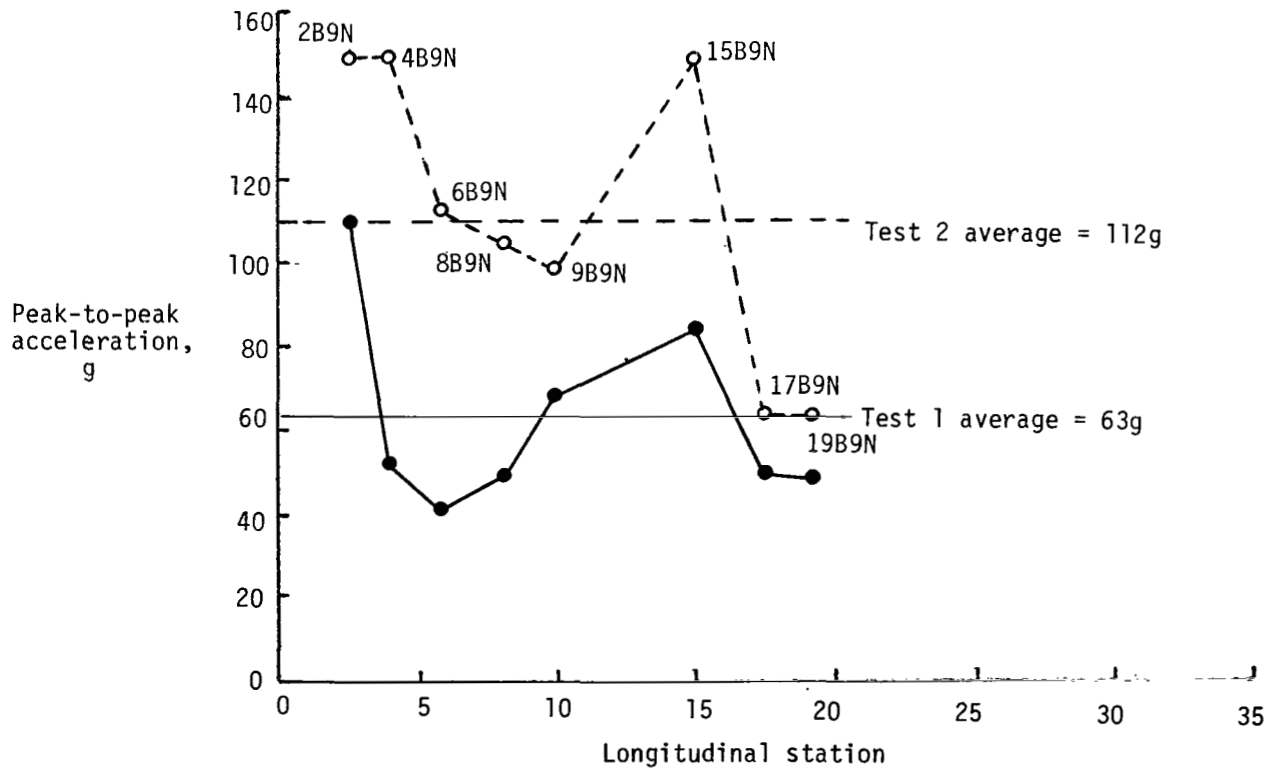
(a) Normal accelerations adjacent to floor beam.

Figure 12.- Peak-to-peak accelerations on structure.

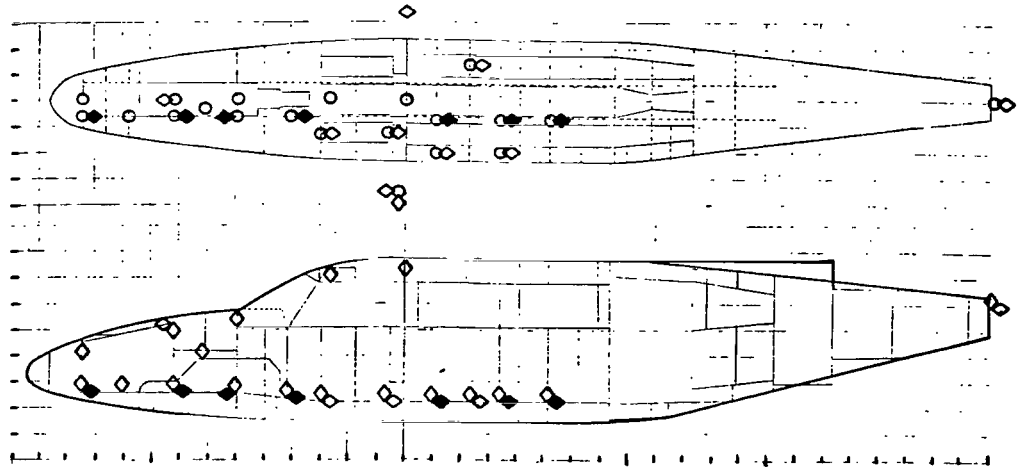
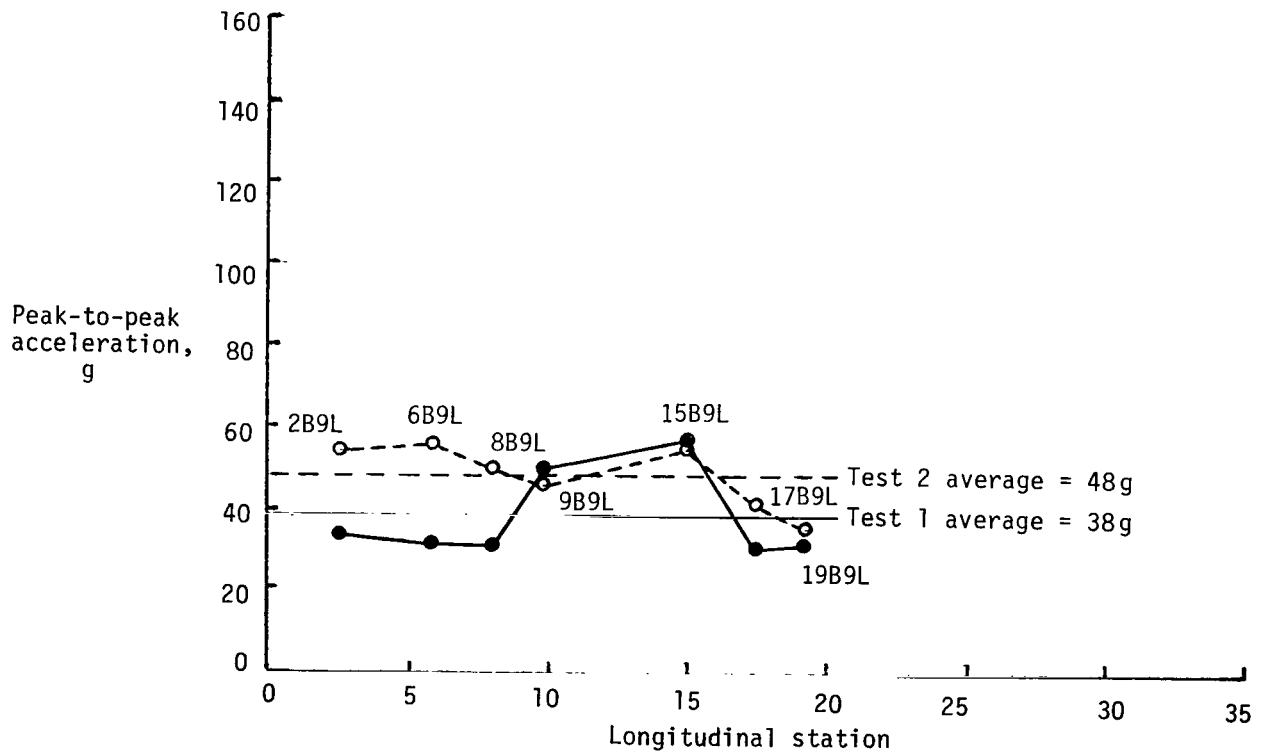
(b) Longitudinal accelerations adjacent to floor beam.

Figure 12.- Continued.

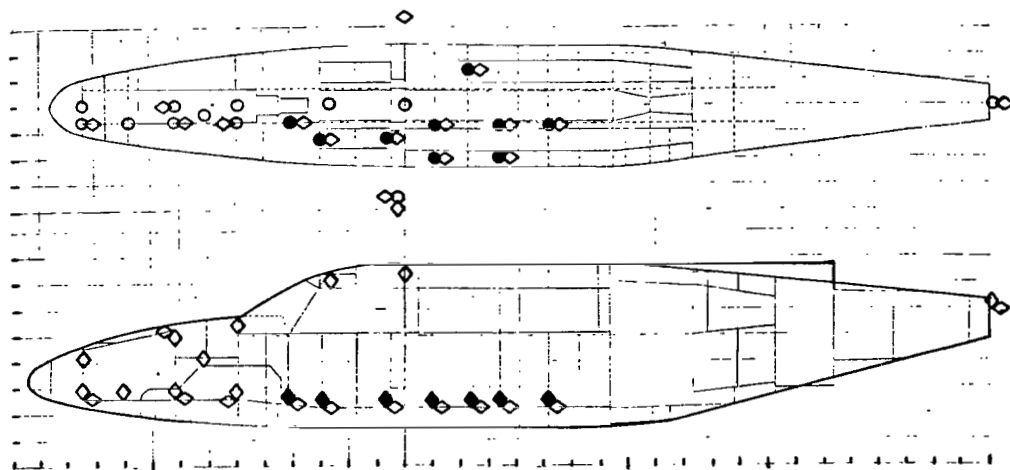
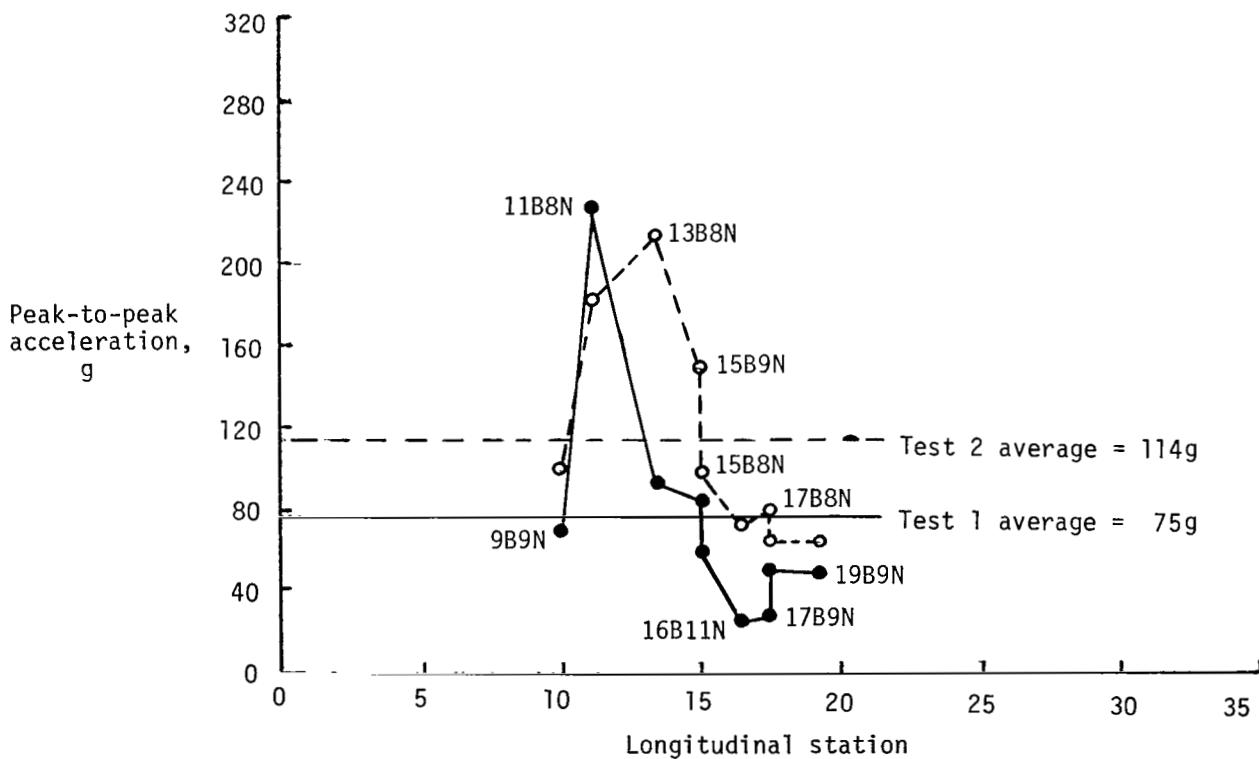
(c) Normal accelerations on roof.

The peak-to-peak accelerations normal to the roof were higher in the nose area. Average values were 43 percent higher in test 2 than in test 1 and are shown in figure 12(c). Figures 12(d) and 12(e) show the peak-to-peak accelerations on the cabin floor in the normal and longitudinal directions, respectively. In test 2 both the normal and longitudinal peak-to-peak accelerations were approximately 52 percent higher than in test 1.

The peak-to-peak normal accelerations on the roof (location 14G9N, fig. 12(c)) and adjacent to the floor beam (location 15B9N, fig. 12(a)) are 36g and 85g, respectively, for test 1 and 80g and 150g for test 2. In this comparison, the roof accelerations are 58 percent lower than those at the floor beam for test 1 and 47 percent lower for test 2. The lower roof accelerations reflect the effect of fuselage shell deformations and load alleviation as discussed for figure 11. After the impact was over, the cabin structure returned approximately to its original shape, but the floor beams remained deformed. In this test the apparent floor beam protrusion resulted in a slight rotation of the seats toward their respective side windows as shown in figure 11(d).

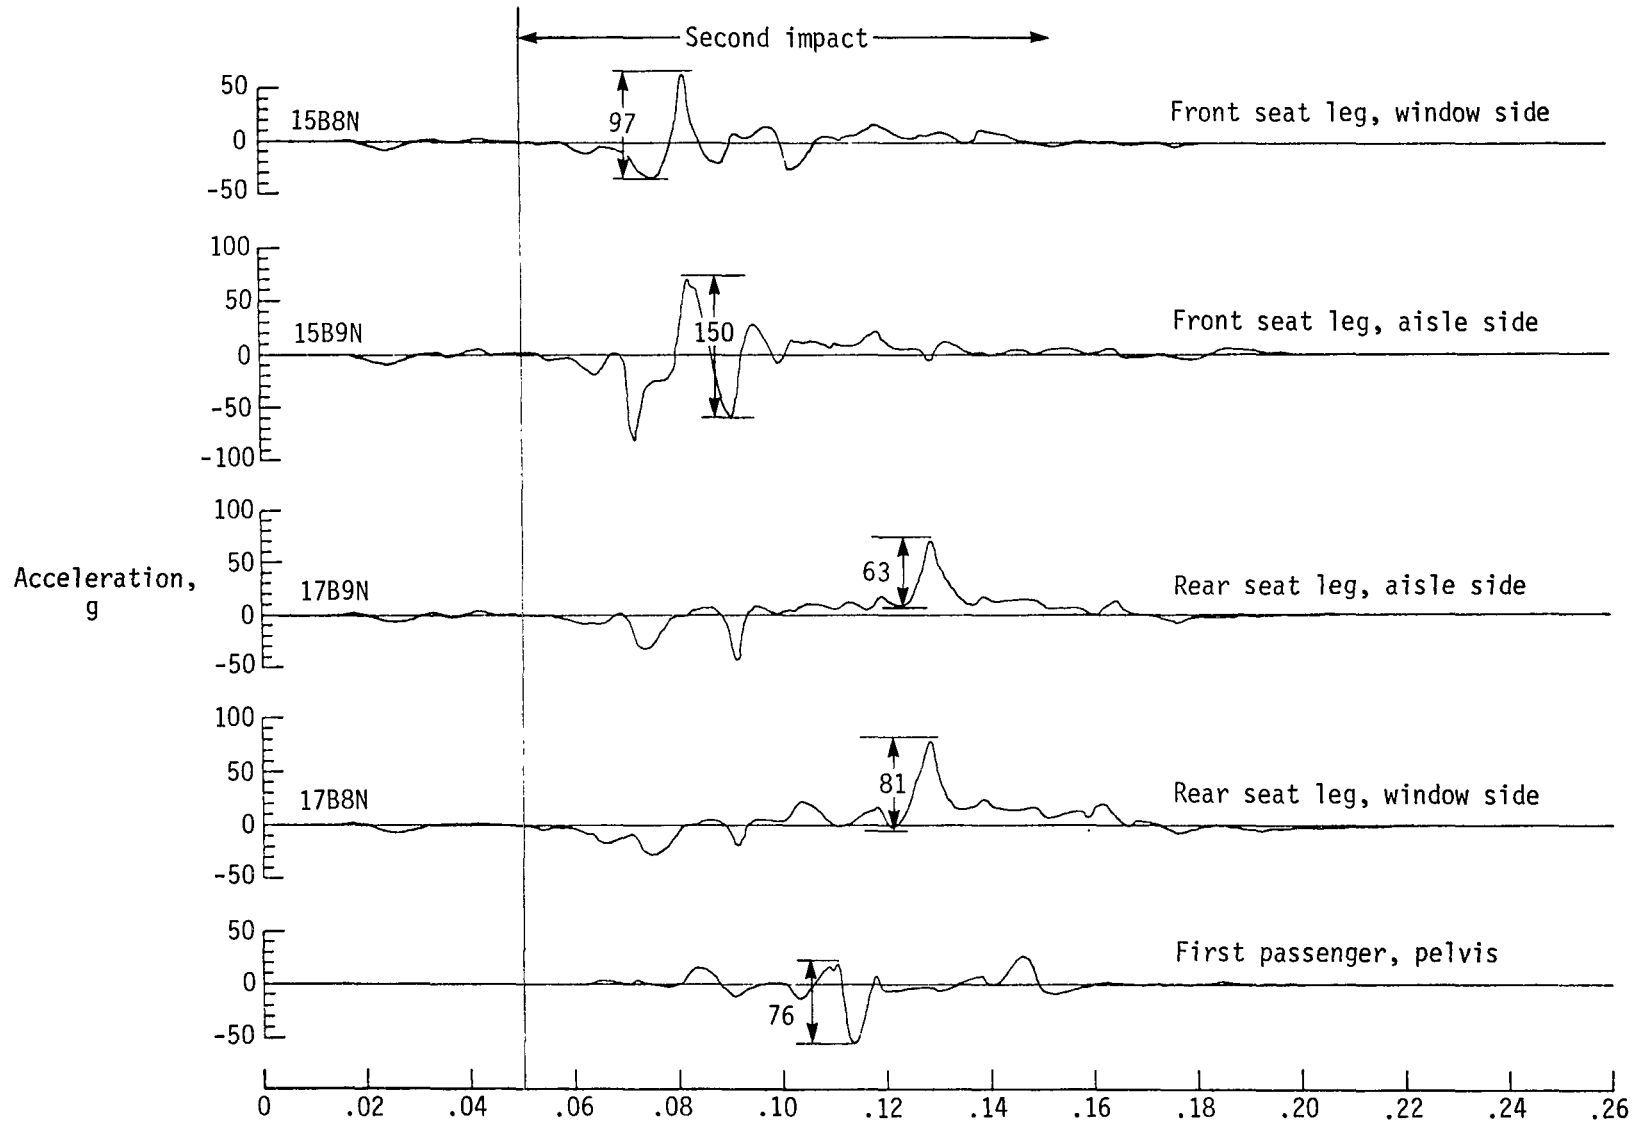
(b) Normal accelerations on floor and dummy pelvis along spine. Test 2.

Figure 13 is a plot of the normal accelerations on the floor at the base of the first passenger seat. The time of main spar contact with the ground was determined photographically and is superimposed on the traces for reference. In test 1 (fig. 13(a)) and in test 2 (fig. 13(b)) the combined effect of structural deformation, angular acceleration, and timing produces higher peak-to-peak accelerations on the cabin floor at the front seat legs compared with the accelerations at the rear seat legs. Also during second impact the peak-to-peak accelerations on the floor were higher on the aisle side than those on the

In test 2, the peak-to-peak acceleration at the dummy pelvis along the spine was 76g (fig. 13(b)). In test 1 the dummy pelvis was not instrumented. Although a direct comparison between normal peak-to-peak accelerations on the floor and on the dummy pelvis could not be made because the orientation of the accelerometer along the spine changed with dummy motions during the test, it appears that some energy dissipation or force alleviation has taken place due to seat deformation. The front seat legs are experiencing peak-to-peak normal accelerations of 97g and 105g. (The rear seat legs are averaging closer to normal peak-to-peak accelerations of 72g.)
