NASA TM X- 74039

HYPERVELOCITY IMPACT TESTS ON SPACE SHUTTLE ORBITER
THERMAL PROTECTION MATERIAL

Donald H. Humes
Langley Research Center

June 1977

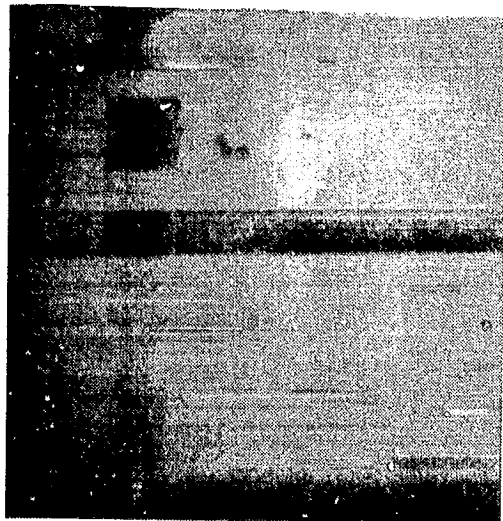
(b) projectiles launched at specimen 3-74

Only the front surface was cratered when the impact energy was 3 J, or less. Photographs of the front surface of the four specimens which were damaged only on the front surface are shown in figure 3. At 3 J a trace of the black carbon interior was exposed. At lesser energies only the exterior layers were penetrated. The exterior layers have good resistance to penetration but are brittle and spallation occurs around the impact point; see the front surface area damaged in table I. Information on how brittle the material is and how much resistance to penetration it has can be obtained by comparing the damage with that done to cold rolled steel under the same impact conditions. The test using specimen 3-74 provides an excellent comparison. In that test, three glass projectiles were launched (see figure 1(b)). The projectiles were all the same size and were accelerated to the same

Figure 1.- Photographs of the projectiles taken in flight to verify projectile integrity and to measure projectile velocity. Photographs do not have the same magnification.

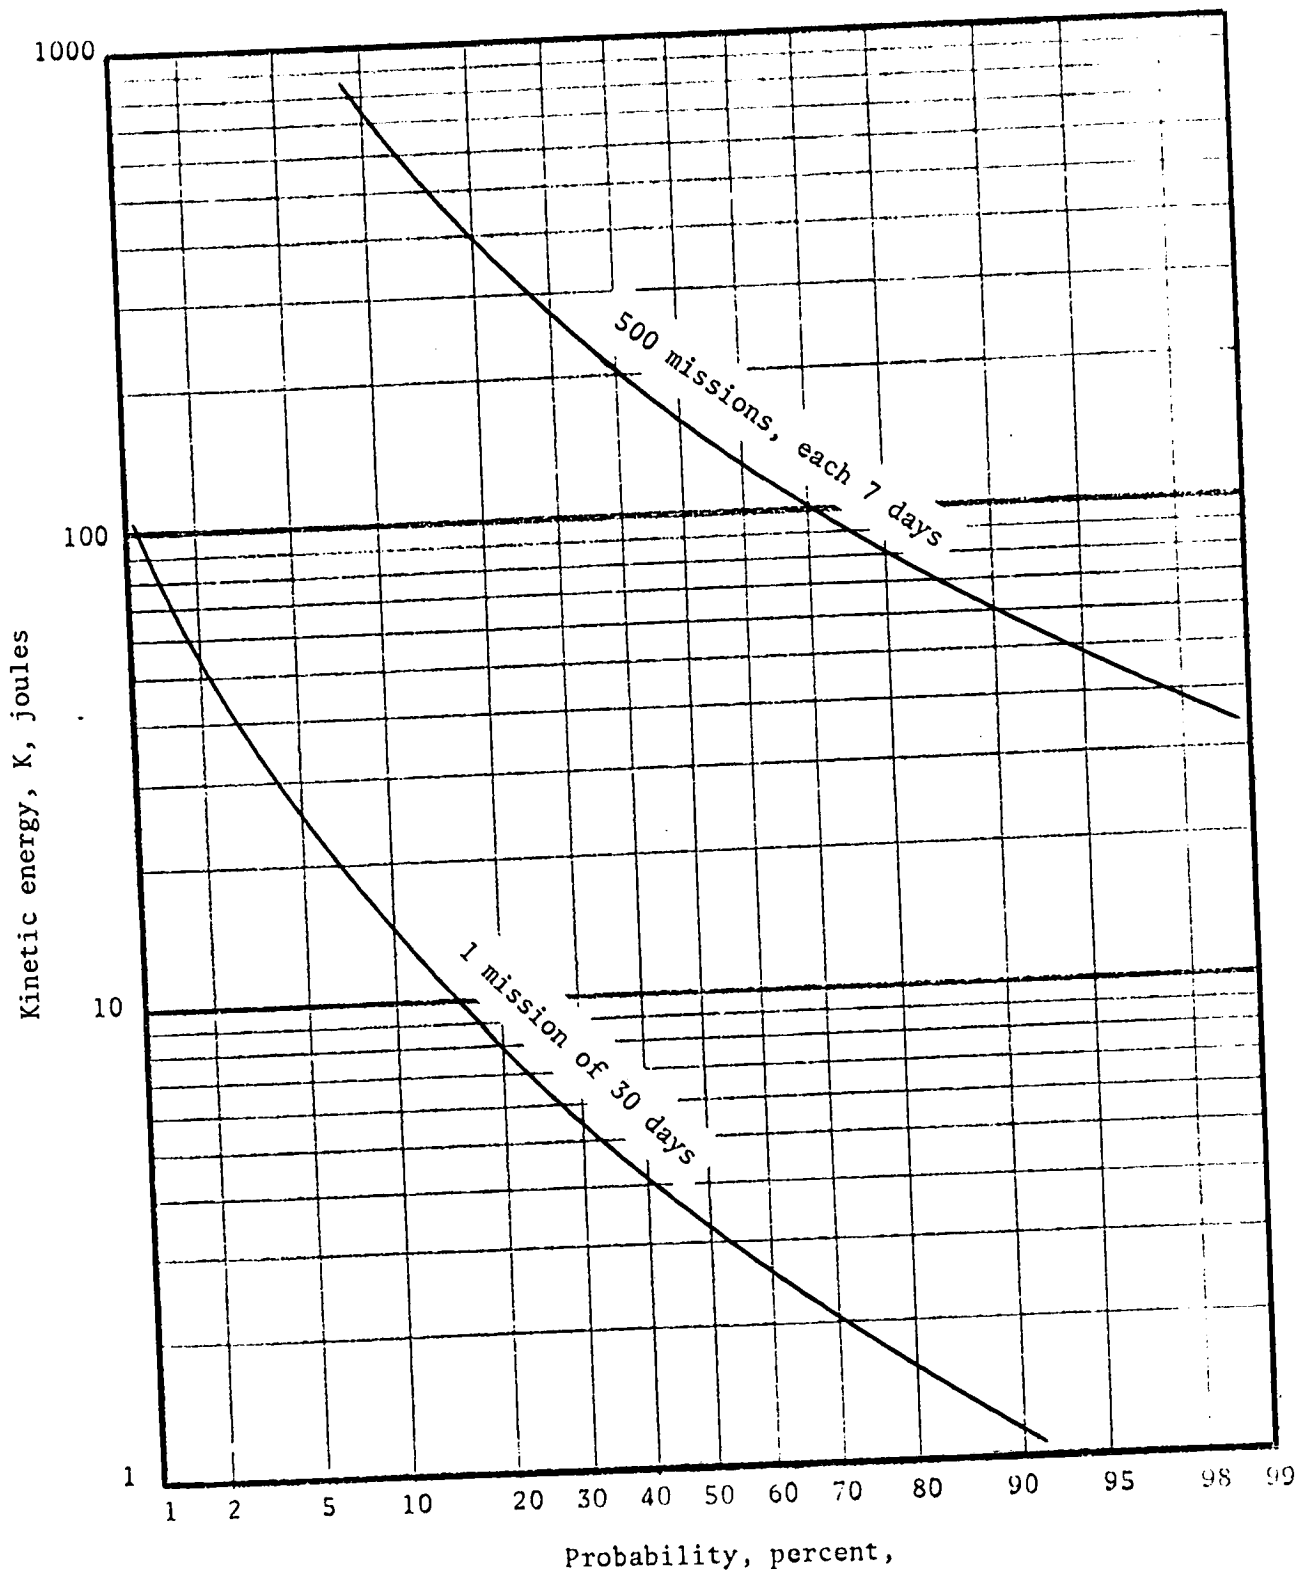
The impact energies that can be expected from meteoroids striking the LESS material on the Shuttle Orbiter are shown in figure 8. This calculation is based on the NASA meteoroid environment model (see ref. 3). The area of the nose and leading edge of the Shuttle Orbiter was taken to be 38 m^2 . It was assumed that the nose was pointed in the direction of motion of the spacecraft and, consequently, that the meteoroid flux was four times the average

that a meteoroid with kinetic energy exceeding K will strike the nose or leading edge of a shuttle orbiter.

Fig.8. The kinetic energy of meteoroids expected to strike the leading edge and nose of the Shuttle Orbiter.
