NASA TECHNICAL MEMORANDUM

NASA TM X-73390

INVESTIGATIONS FOR THE IMPROVEMENT OF SPACE SHUTTLE MAIN ENGINE ELECTRON BEAM WELDING EQUIPMENT

April 1977

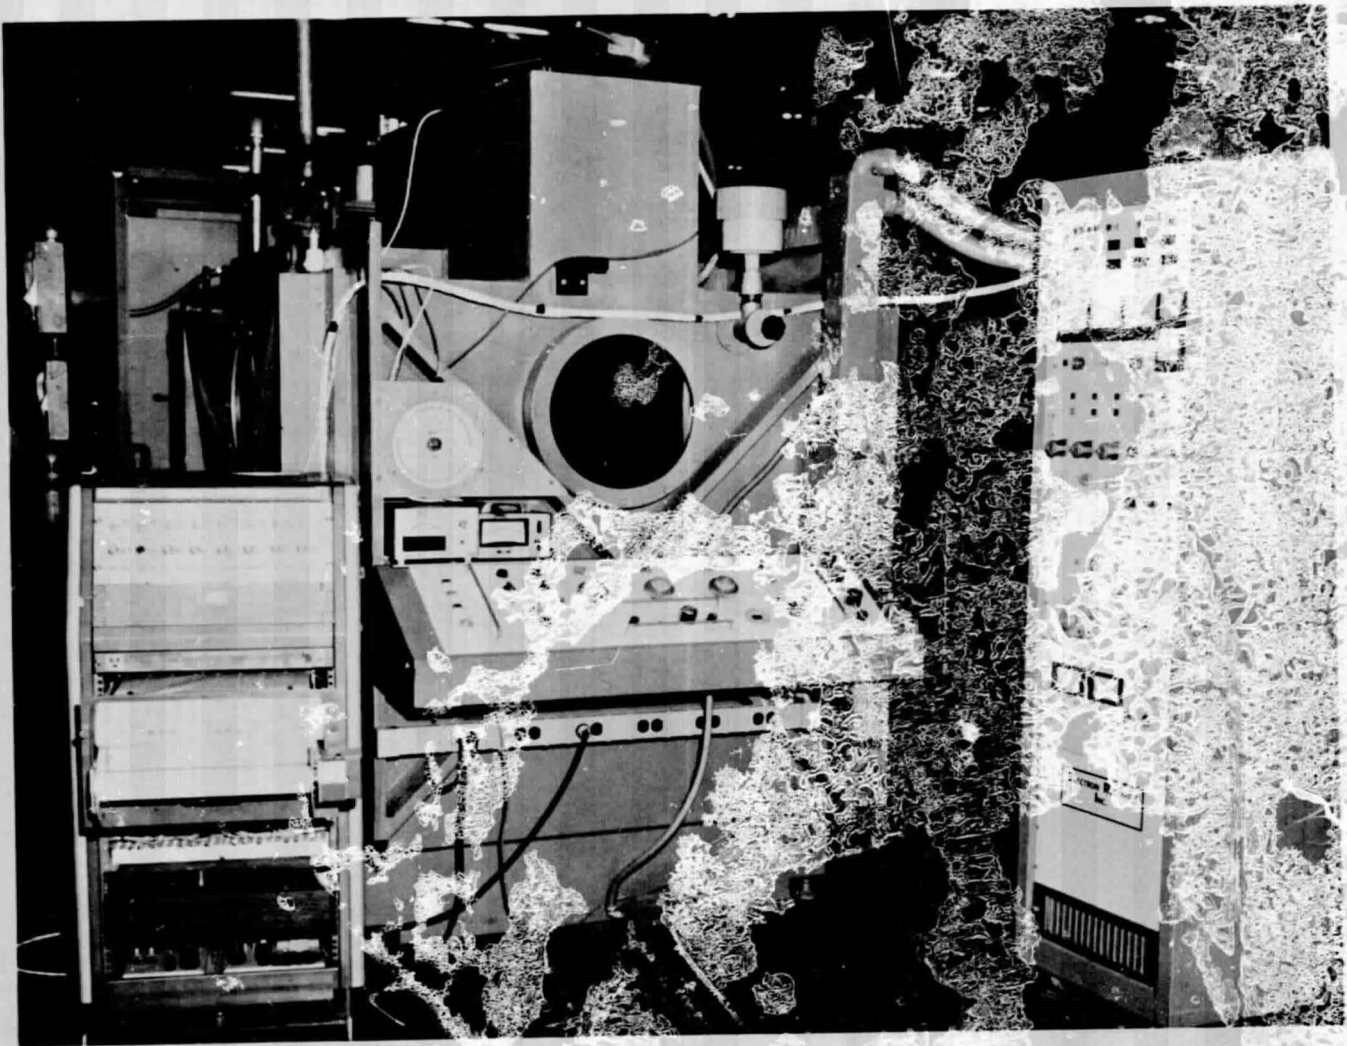
Figure 1. ERI DCC LP welder, shown instrumented.

In attempting to comply with this objective, it was found that the MSFC ERI EB welder was in extremely poor operational order. It was very hard to start. In fact, it often took from 3 to 4 h to raise the weld power level to 45 kV and 125 mA. Then, when reasonable power levels were attained, the nitrogen gas supply required almost constant adjustment to maintain that power output level. There were also very frequent automatic shutdowns of the equipment, due to flashovers, when attempting to operate at weld voltages greater than 45 kV.

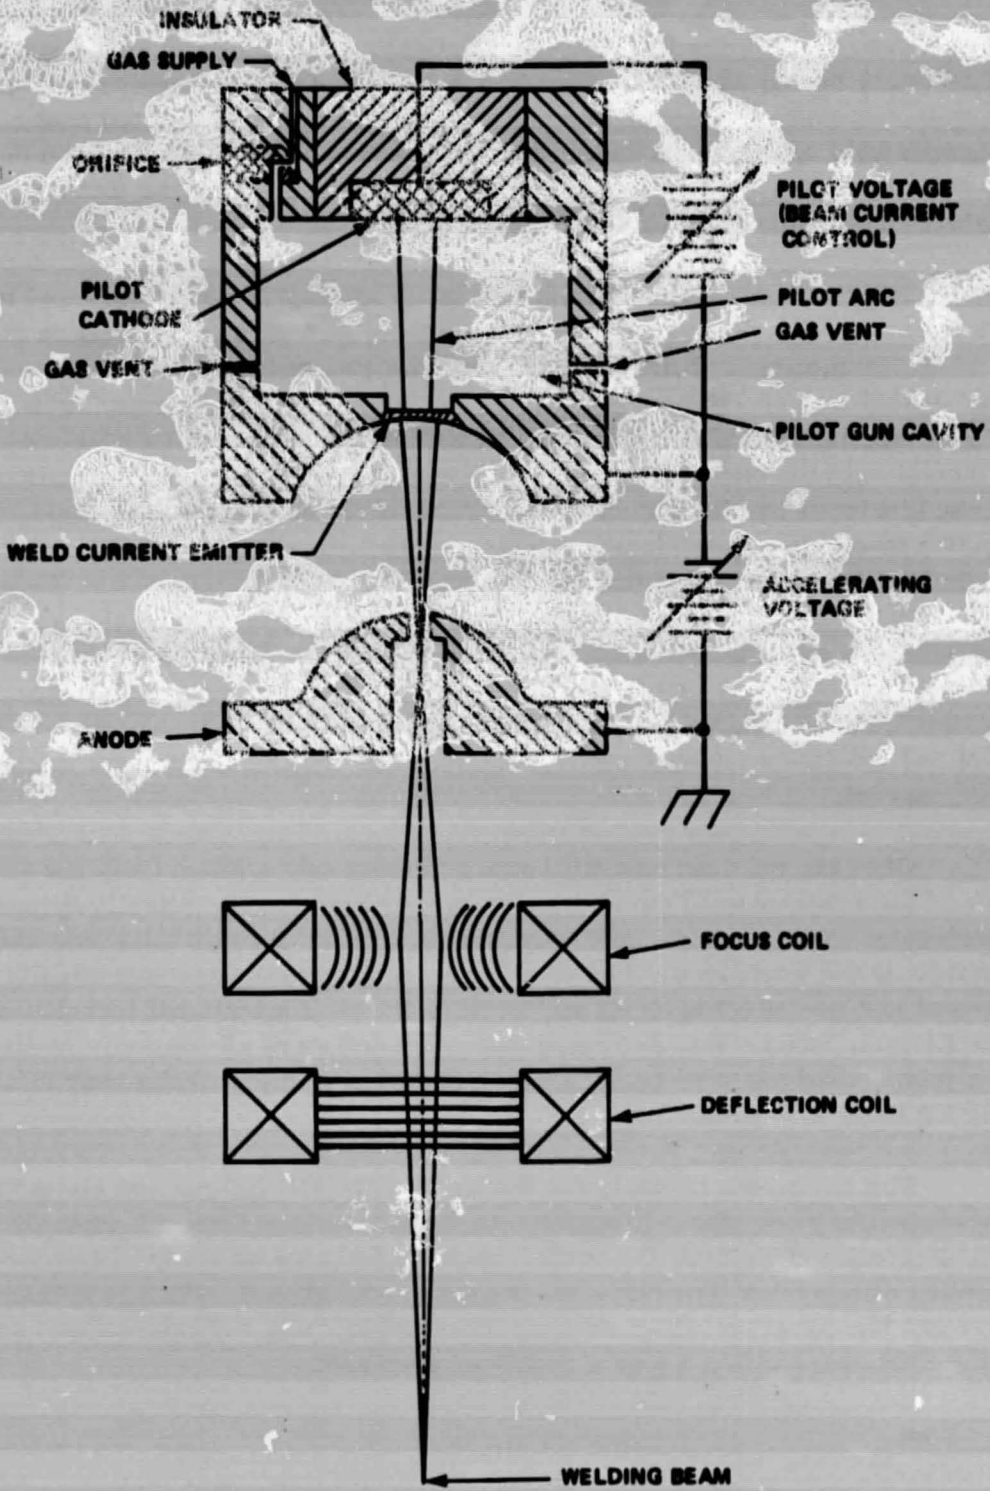
Figure 2. Electron beam gun, simplified diagram.

Indirect heating is accomplished by an ionization beam, referred to as the pilot arc (Fig. 2), which normally operates at a nitrogen ionization pressure of 50 to 150 microns. Nitrogen is fed from an external source through a replaceable 0.0127 mm (0.0005 in.) orifice in the EB gun and into the pilot gun cavity at a nominal rate of 0.5 to 5 SCCM. In the pilot gun cavity, the nitrogen gas interacts with the pilot voltage to create ions and electrons by field emission. These electrons bombard and heat a small spot in the center of the weld current emitter to electron thermionic emission temperature. The ionization gas then exits the pilot arc cavity through two adjustable vents and escapes to the workchamber. Gas flow, therefore, is a function of the source pressure, orifice leakage rate, and gas vent adjustment. Thus, the necessary weld current emitter heat is a function of the ionization gas pressure and the pilot arc voltage. Within the ionization gas pressure range in the pilot arc cavity, the pilot arc voltage is closed-loop, feedback controlled to maintain the required weld current.
