NASA CR-135169  
R76-189

# AEROSPIKE THRUST CHAMBER PROGRAM FINAL REPORT

ROCKETDYNE DIVISION  
ROCKWELL INTERNATIONAL

NASA Lewis Research Center  
Contract NAS3-20076

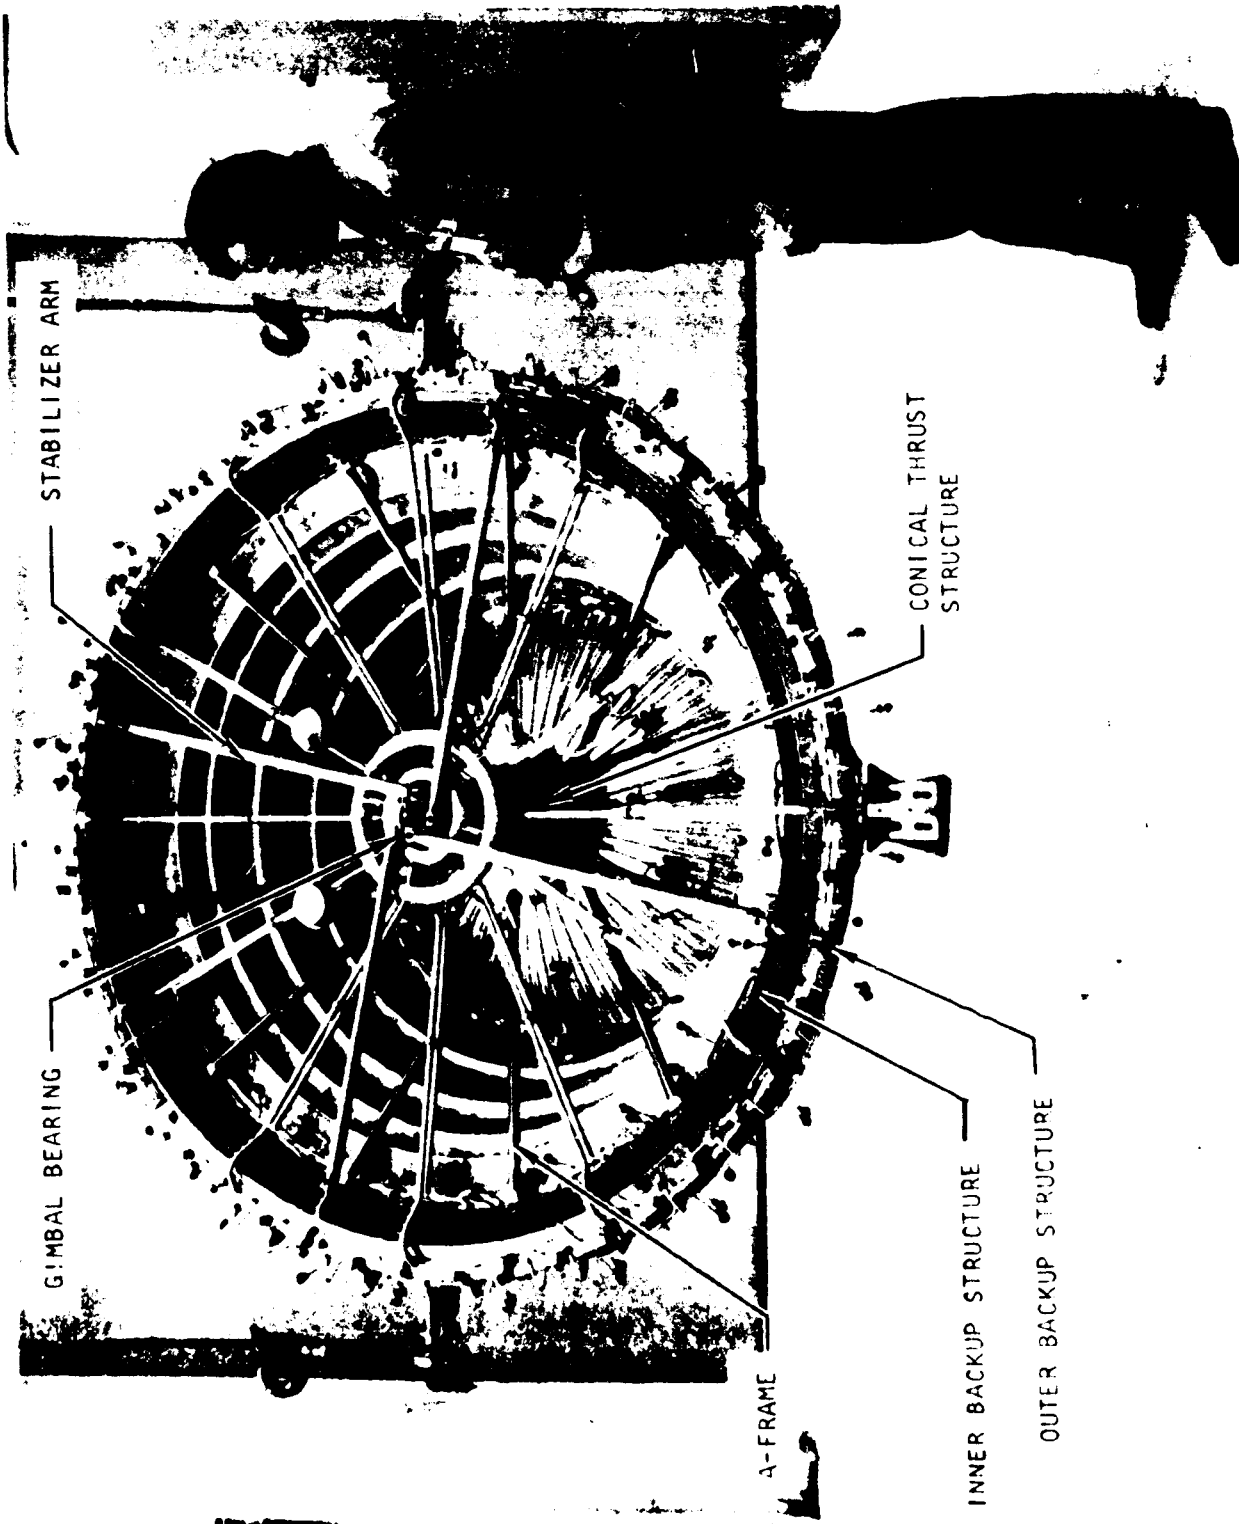
Figure 27. Thrust Chamber Assembly With Thrust Mount Components

The structure that carries the thrust from the inner backup ring to the gimbal bearing is illustrated in Fig. 27. As can be seen, a number of titanium struts carry the load in tension from the backup ring to the base of the thrust cone, and the cone carries the thrust in compression up to the gimbal bearing. All of these parts were somewhat affected by the fire that had occurred on the previous test. All parts were carefully cleaned and examined. Decisions were made on which parts could be refurbished and

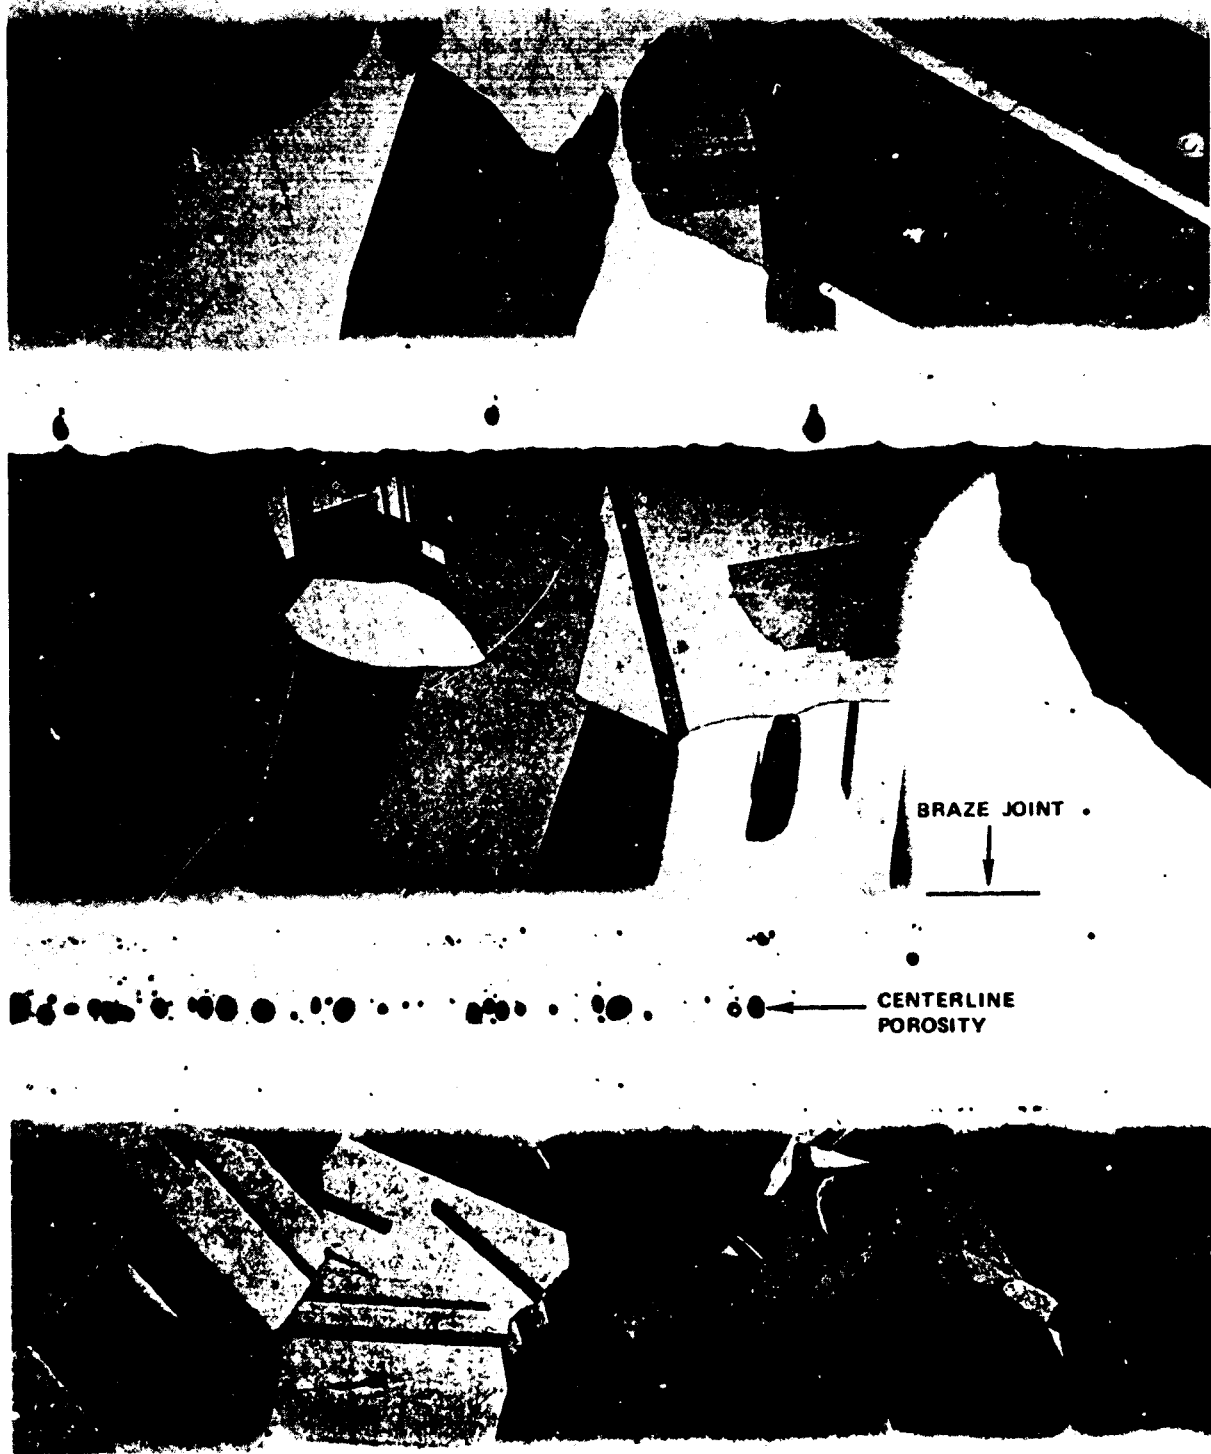
Figure 44. Test Specimen From NARloy-A Cover Sheet, Furnaced Brazed in Argon (No  $O_2-H_2$  Reaction Present; Centerline Porosity in Braze Joint) (.100X)

In most of the sections taken from both segments and experimental samples, porosity was noted in the braze joints. This is a common situation in braze joints due to shrinkage or entrapped gases. Where the braze porosity was oxygen from gases trapped in the joint surfaces at braze assembly, or oxides remaining in the gold-NARloy-A plating bond line, it might be assumed that these oxides could diffuse into the NARloy-A parent metal during thermal cycling and thus be the source of oxygen contamination. Several observations on the sections disproved this assumption. If the braze joint were the major source of oxygen, it would be expected that the  $H_2/O_2$  reaction in the NARloy would be worst near the braze joints, and this was not generally true. Again, combustor 514 (Fig. 41) is a good example. The worst grain boundary condition is in the liner some distance from the braze joint and very little  $H_2/O_2$  reaction occurred near the braze joint. In a section from combustor 516 (Fig. 42 and 43), isolated  $O_2/H_2$  reaction was found in an area remote from a braze joint. There is also evidence that at least part of the braze joint porosity is not the result of the  $O_2/H_2$  reaction. The section in Fig. 44 shows a centerline porosity and traces of bond line porosity in the braze joint, yet this specimen was never exposed to  $H_2$ , so the porosity cannot be steam bubbles from the  $O_2/H_2$  reaction. Additionally, a section from the inner half of segment 510 (Fig. 45) shows considerable bondline porosity in a braze joint with no associated  $O_2/H_2$  reaction in the NARloy. This segment was brazed in hydrogen. The same is true of the specimen shown in Fig. 40.

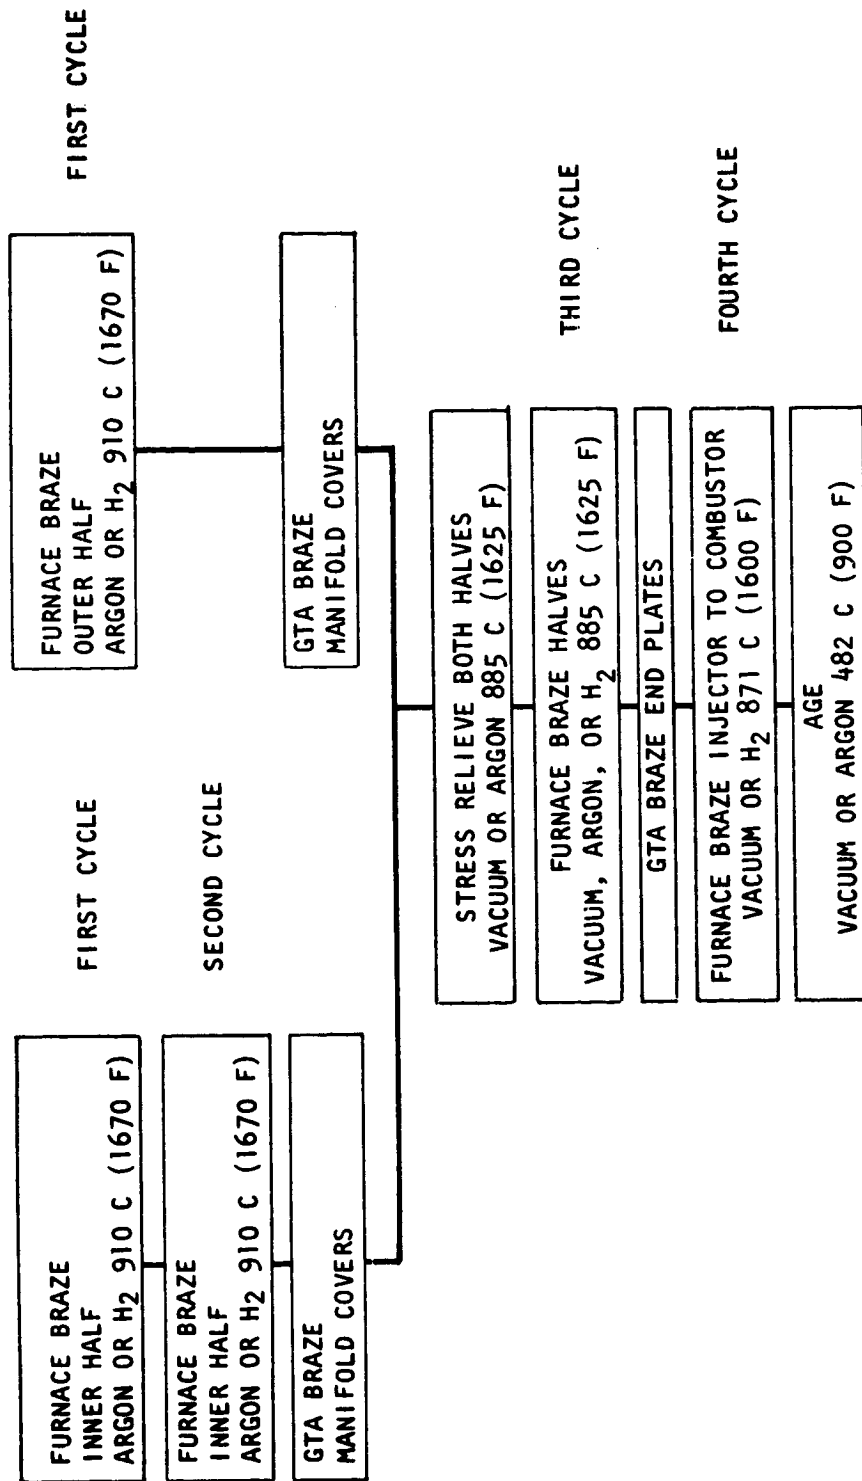
Figure 46. Segment Assembly Sequence

The third possibility, diffusion of surface oxides into the NARloy, was found to fit the observed facts. A review of the fabrication history of the segments brought out several significant points. The diagram in Fig. 46 shows the fabrication sequence in regard to furnace and torch brazing operations. GTA brazing (gas tungsten arc, with a heliarc torch used as a heat source for brazing) with Nicro (82Au, 18Ni), an alloy which brazes at 982.2 to 1010 C (1800 to 1850 F), was performed on all segments as a planned operation at two points in the sequence: the joining of manifold shells to coversheet strips prior to furnace brazing the segment halves together, and a reinforcement Nicro joint over the end plates after furnace brazing the halves together. Since the segments were small, GTA brazing temperatures were high, and NARloy is an excellent thermal conductor, elevated temperatures were experienced in the NARloy during GTA brazing.

With the mechanism established, it was now possible to reconstruct the fabrication situations which caused the NARloy cracking. Looking at the sequence in Fig. 46, it can be seen that there was no source of surface oxidation in the first two braze cycles, as all NARloy parts were chemically cleaned before the first braze cycle, and the operations between the first and second braze cycle consisted only of mechanical assembly in a clean area. There were no elevated temperature operations and thus no foreign materials introduced at that time. The first opportunity for surface oxidation and diffusion of oxygen into the NARloy-A was the GTA brazing of manifold covers, followed by a stress relief in vacuum or argon, which occurred immediately before the third braze cycle (the joining of the two combustor halves). The stress relief at 885 C (1625 F) provided ample opportunity to drive oxygen into the NARloy.

Either hydrogen or vacuum brazing was used for the third and fourth cycle depending on equipment availability. Subsequent repair cycles also used various atmospheres (hydrogen, argon, or vacuum) so the sequence of atmospheres was not the same for all segments. Regardless of the exact sequence; however, exposure to hydrogen on the third braze cycle or any cycle thereafter appears likely to have caused an H<sub>2</sub>/O<sub>2</sub> reaction in the NARloy-A. A review of the furnace records showed that all combustors except six were brazed in hydrogen at some time after the second braze cycle. Table 9 lists the furnace information by combustor segment number, together with an estimate of the probability of the presence of the H<sub>2</sub>/O<sub>2</sub> reaction.

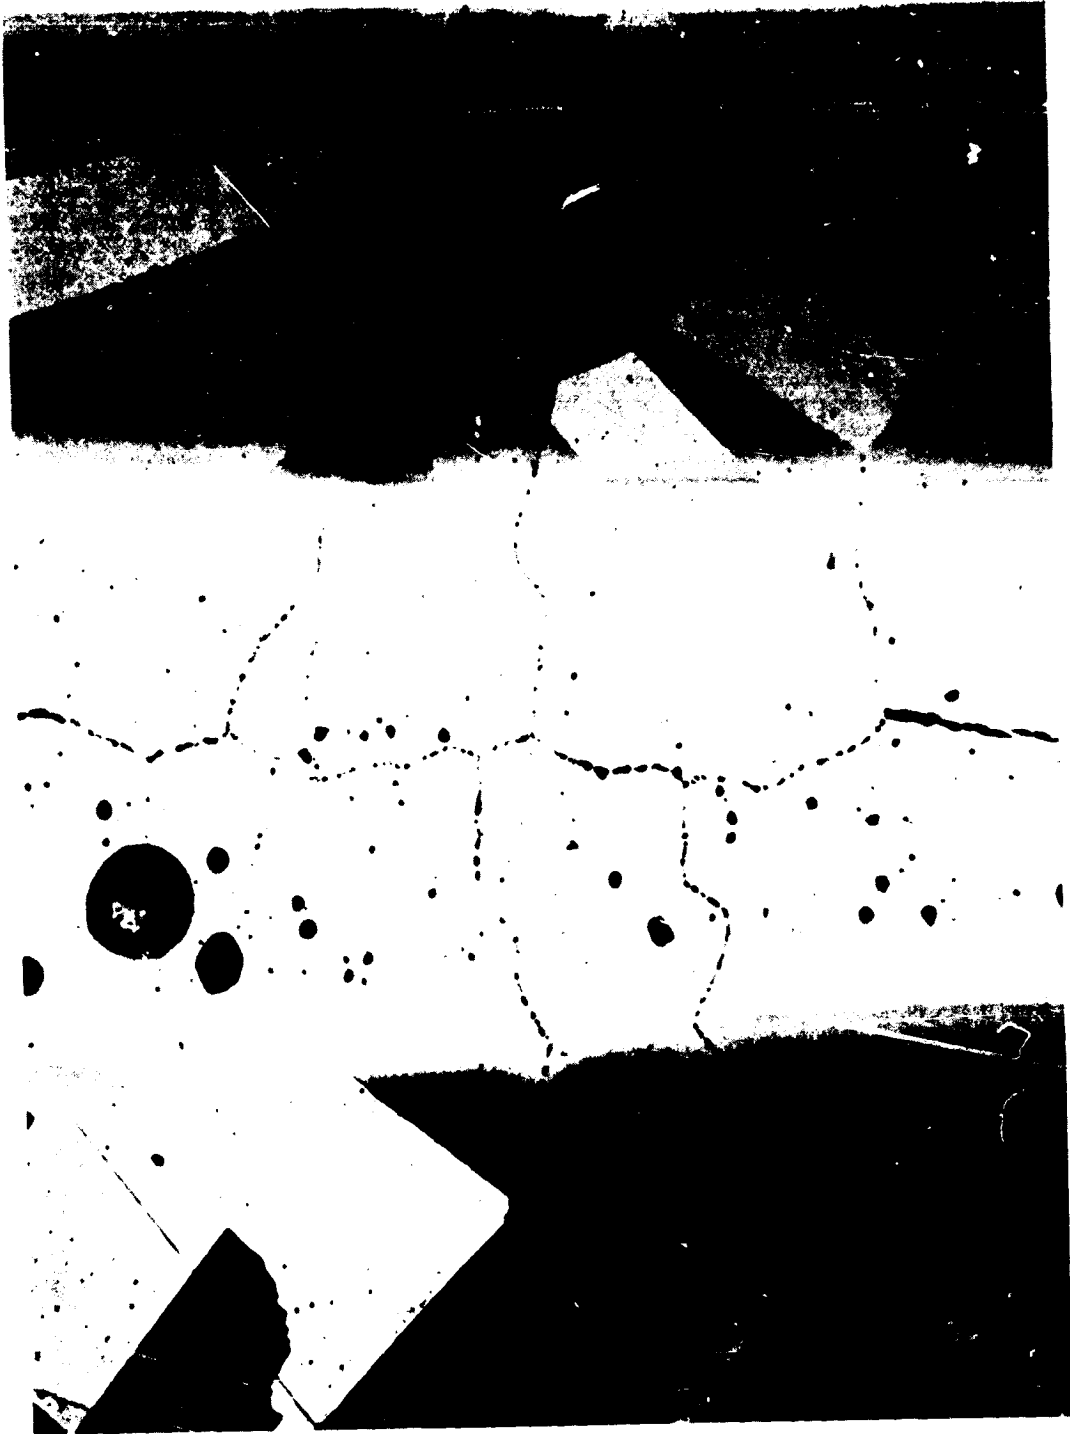
Figure 48. Test Specimen From NARloy-A Cover Sheet Furnace Brazed in Argon, Surface Oxidized With Torch, Reheated in Argon Furnace to 871 C (1600 F). Then H<sub>2</sub> at 871 C (1600 F) (Shows Severe O<sub>2</sub>-H<sub>2</sub> Reaction) (200X)

Experiments were then run to demonstrate that oxygen diffusion from an oxide-coated surface can occur in normal furnace operations. Figures 47 and 48 show the results. The section in Fig. 47 and 48 was taken from a specimen which was furnace brazed in argon for 30 minutes at 910 C (1670 F) and then held in argon for two hours at 871 C (1600 F). It was removed from the furnace and the surfaces were oxidized by heating in air with an oxyacetylene torch until the surfaces were black and slightly scaled. The specimen was then returned to the furnace, and held at 871 C (1600 F) in argon for 120 minutes followed by 30 minutes in hydrogen at 871 C (1600 F). The long hold time in argon approximated the multiple furnace cycles on combustors which were furnace repaired several times. Severe

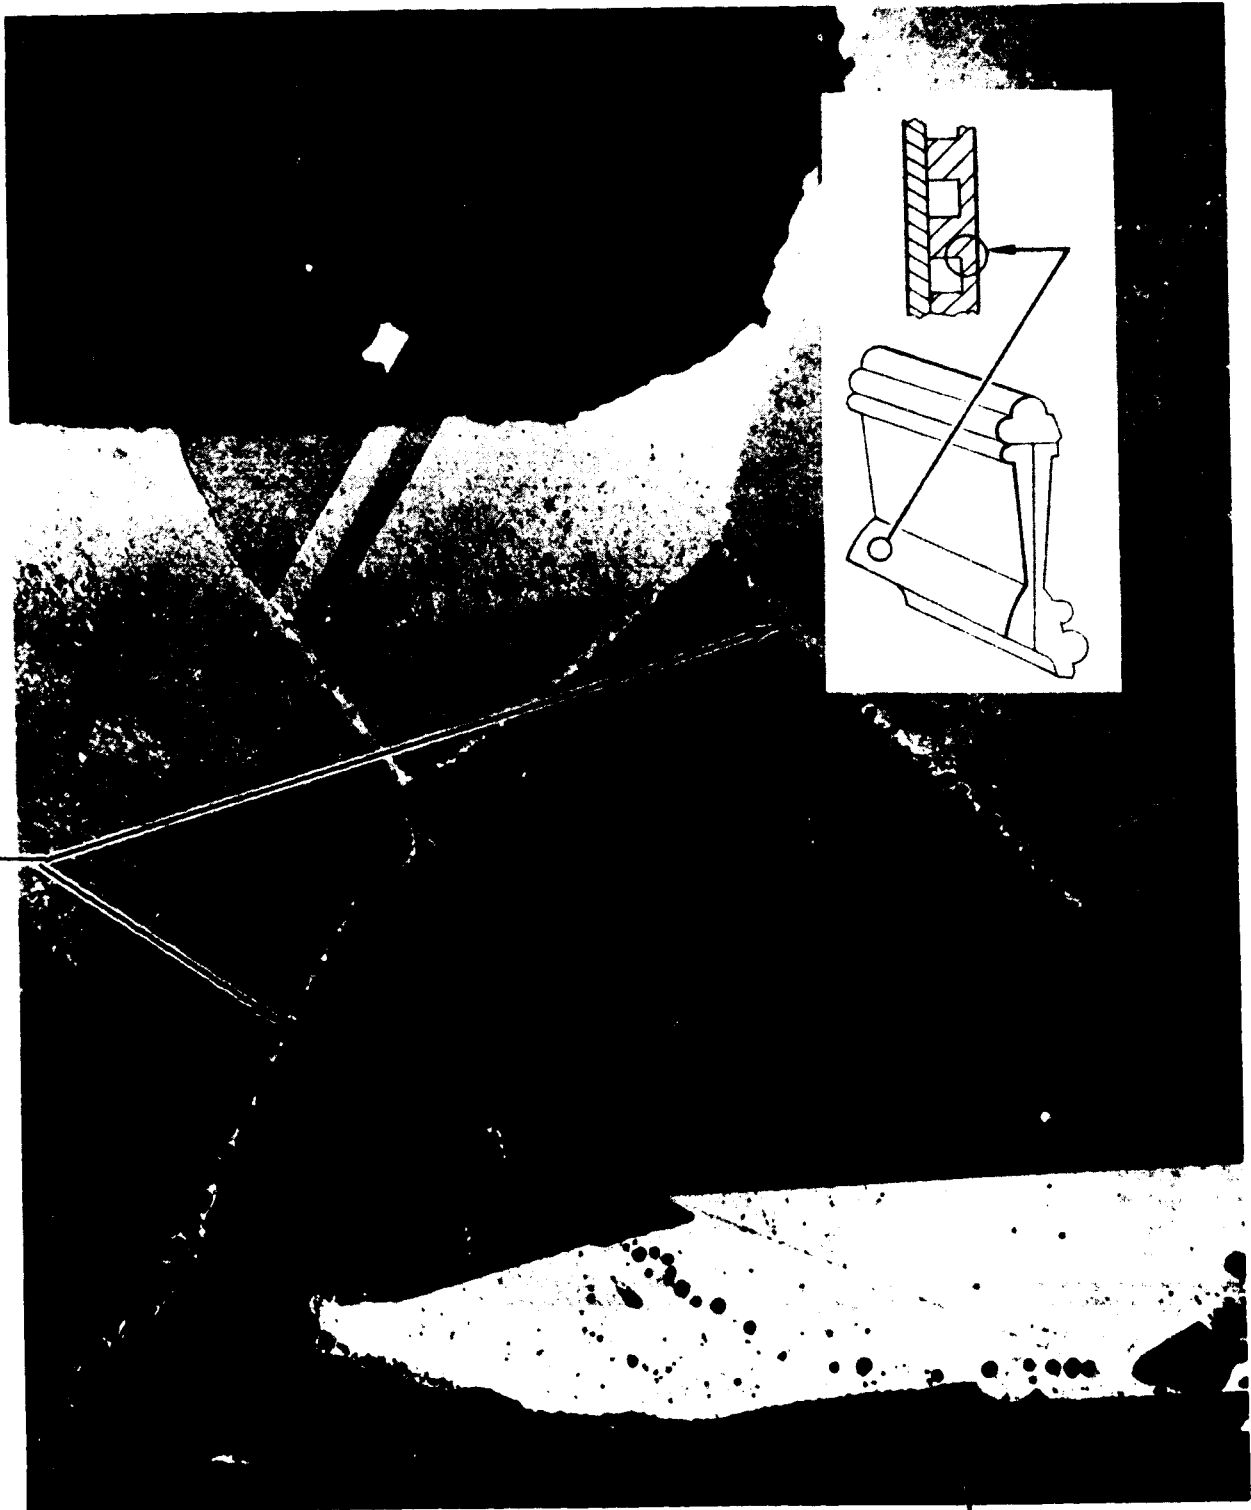
Figure 55. Section From Outer Half of Segment 514  
Showing Severe  $O_2-H_2$  Reaction (200X)

VOIDS  
FROM  
 $O_2-H_2$   
REACTION

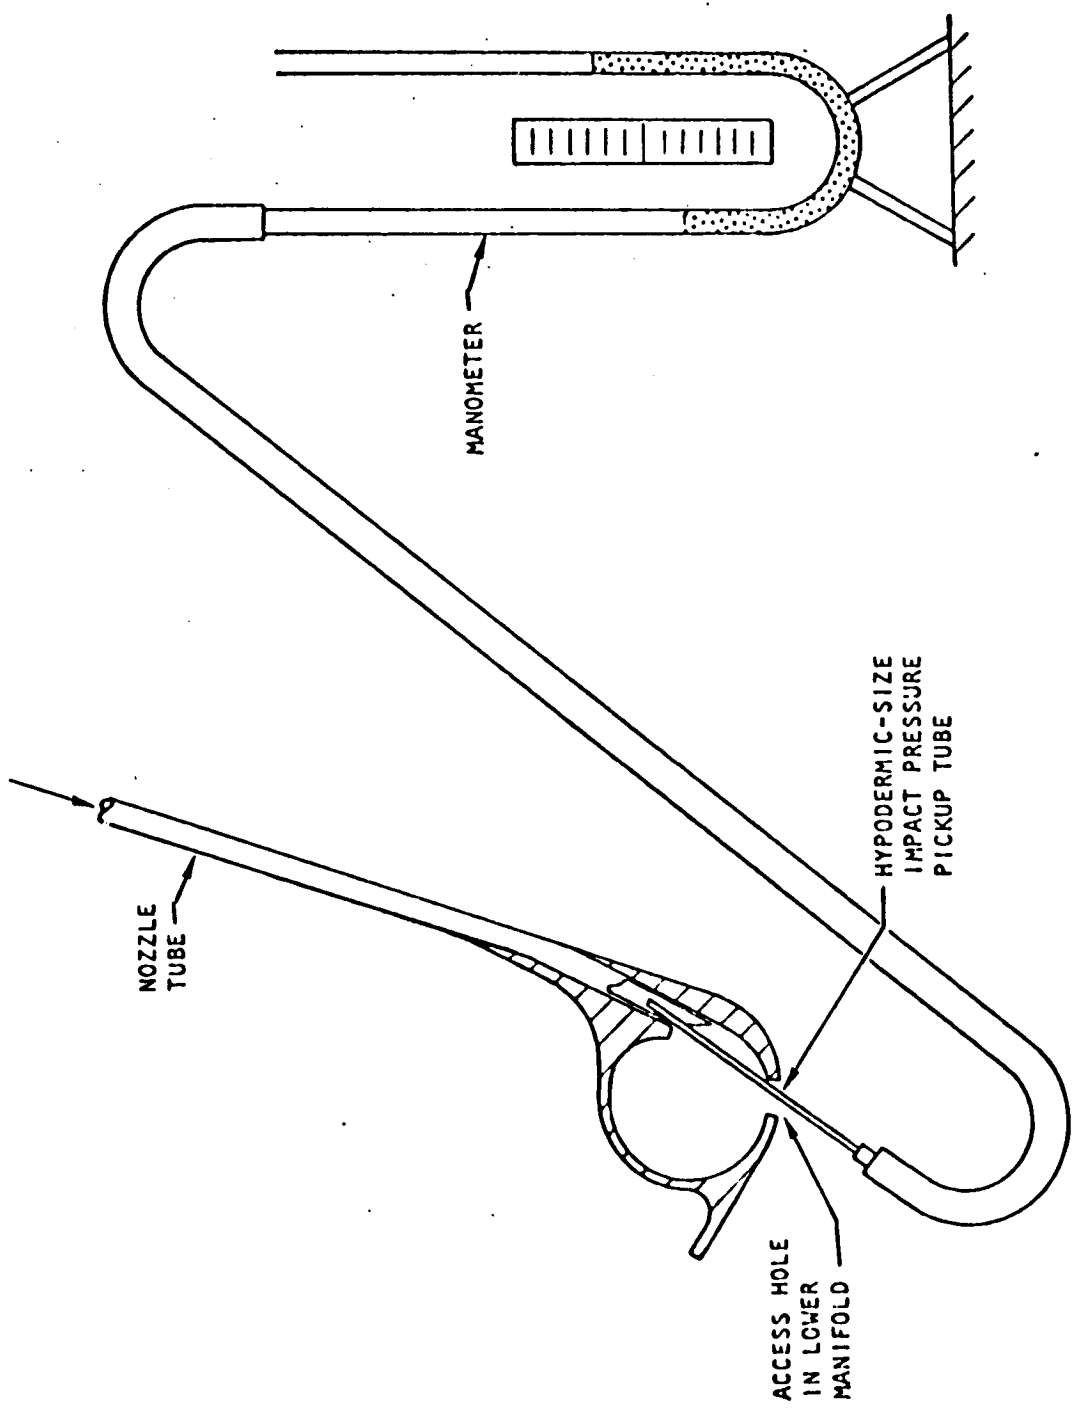
Figure 65. Air Flow Measurement to Detect Nozzle Tube Flow Restrictions

Both of the repair techniques under development involved the application of braze alloy to the tube and patch and, therefore, they present some risk that "droptrough" of the alloy will significantly increase the resistance of the tube to the cooling hydrogen flow. Because of this possible hazard, each of the repaired tubes was flow checked utilizing the technique illustrated in Fig. 65. Additionally, a representative sample of tubes that had not required repair were flow checked to establish a base condition. In utilizing this technique, one relies upon the condition that the static pressure at each tube exit is very close to atmospheric, and that all the tube exit areas are nearly equal. The square root of the total pressure measurement detected by the impact tube is therefore an indicator of the relative weight rate flow of air through the tube being probed. The air pressures throughout the nozzle system are all low, on the order of 14 kPa (2 psig), so that there is no possibility of choking in any location. In this respect, the flow conditions are consistent with those existing in a hydrogen-cooled nozzle, and the flow distribution in the test setup will closely simulate the firing condition. By the method described, it was possible to estimate the average flow through all the tubes in the nozzle and then, by comparison, to evaluate the reduction in the flow of those repaired tubes whose resistance had been affected by the repair activity. The results of this air flow check indicated that the tube repair techniques did not result generally in a gross reduction of flow in the repaired tubes as compared to the unrepaired tubes. This can be seen in the plot of Fig. 66 for the nozzle tubes in line with one of the 24 aerospike combustors. The unrepaired tubes are identified with a black dot. However, a number of repaired tubes did show a significant flow reduction so that it was necessary to establish a criterion for acceptability and to rework those tubes whose flow fell below this criterion. For this particular nozzle, it was possible to establish the criterion that no tube would be

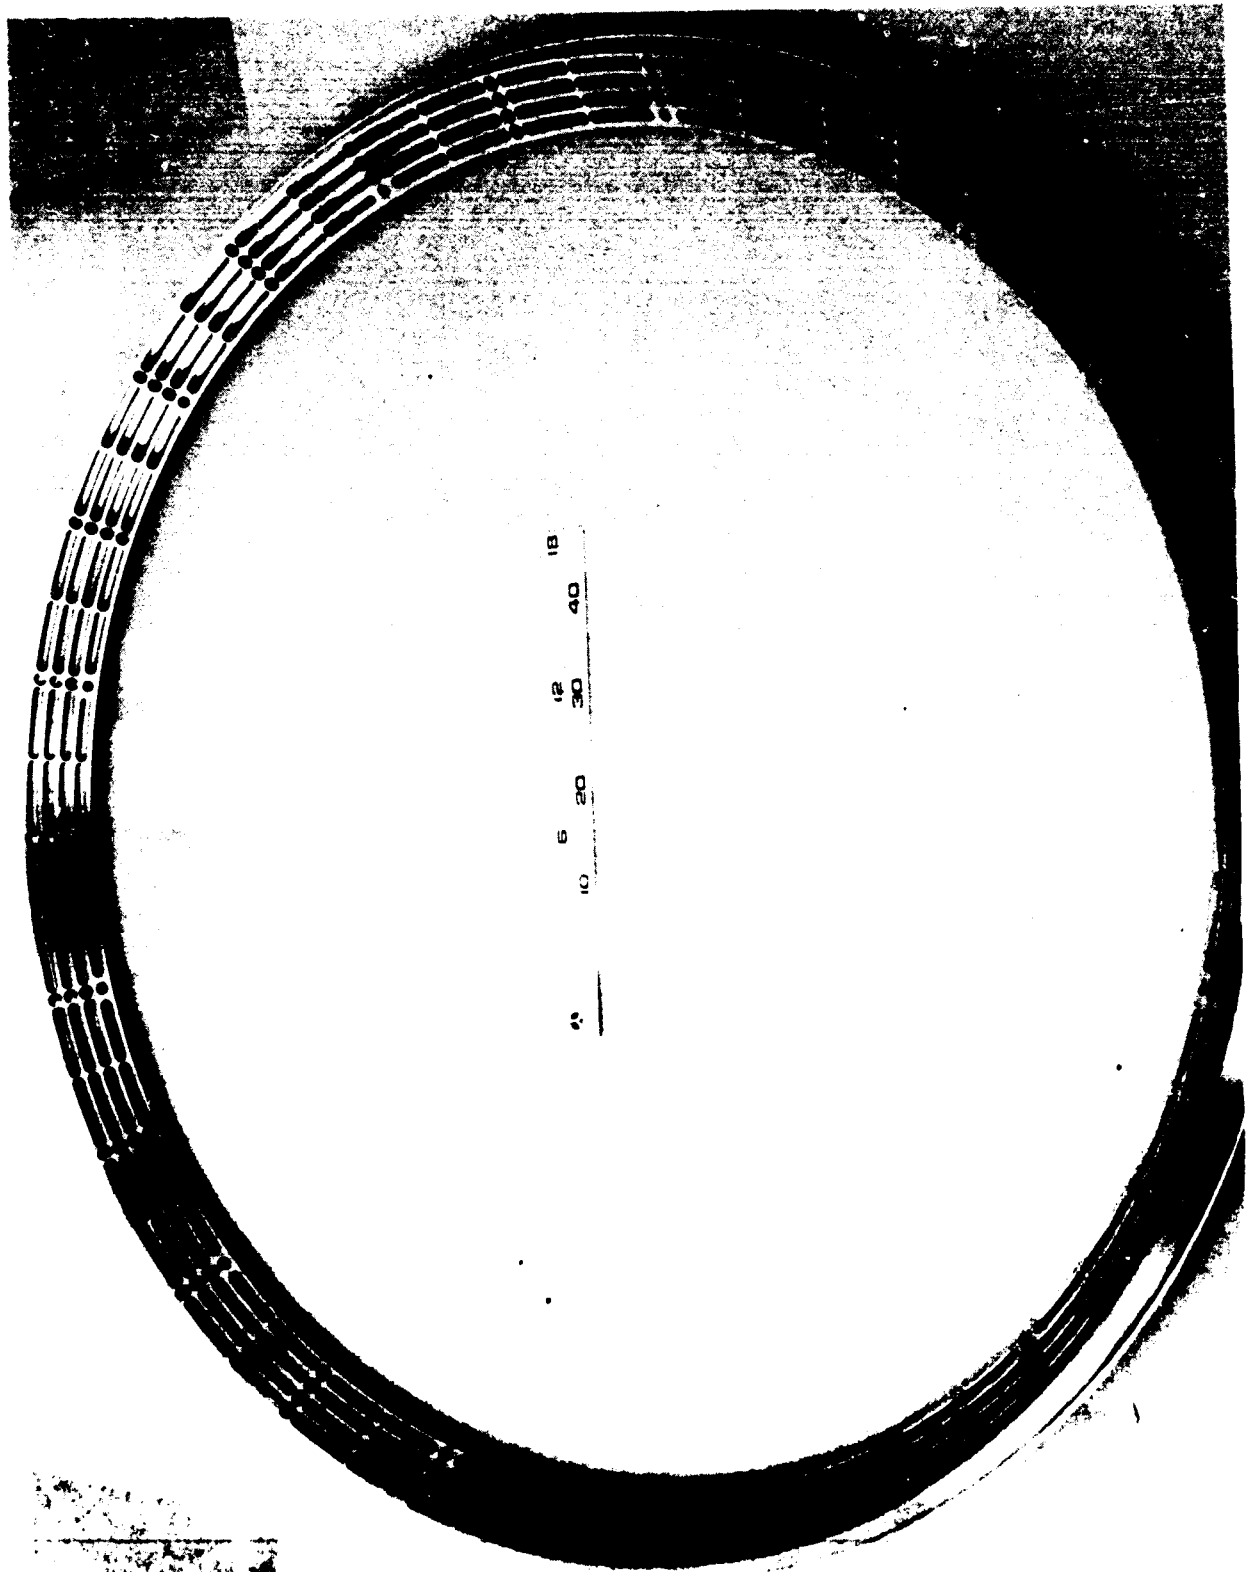
1EH92-7/14/76-CLA

The 24 combustors, and the aerospike nozzle to which they are attached, are supported by being sandwiched between titanium rings that serve to position the combustors correctly on the nozzle. The rings accept the thrust generated by the combustors and the nozzle and transmit that thrust to a central gimbal bearing. The inner ring of this two-ring assembly was so seriously damaged during the fire that had terminated the previous test program that the ring had to be replaced rather than repaired. It had already been demonstrated on the previous contract that a sufficiently lightweight construction for this ring could be designed and fabricated, so it was decided on this contract that the replacement ring would not exactly duplicate the previous design. It omitted some of the intricate but weight-saving machining that tends to add materially to cost and schedule time. A new design, No. RS003737X, was made to define the configuration of the new inner backup ring. A copy of the drawing is incorporated in Fig. 67 of this report. A titanium forging from which this ring could be machined was available from the previous program. A five-axis, numerically controlled milling machine was utilized for machining the lightening holes, and a VTL tracer lathe was used for the external contour. A photo of the completed ring is shown in Fig. 68.

Figure 68. Completed Inner Backup Structure Ring

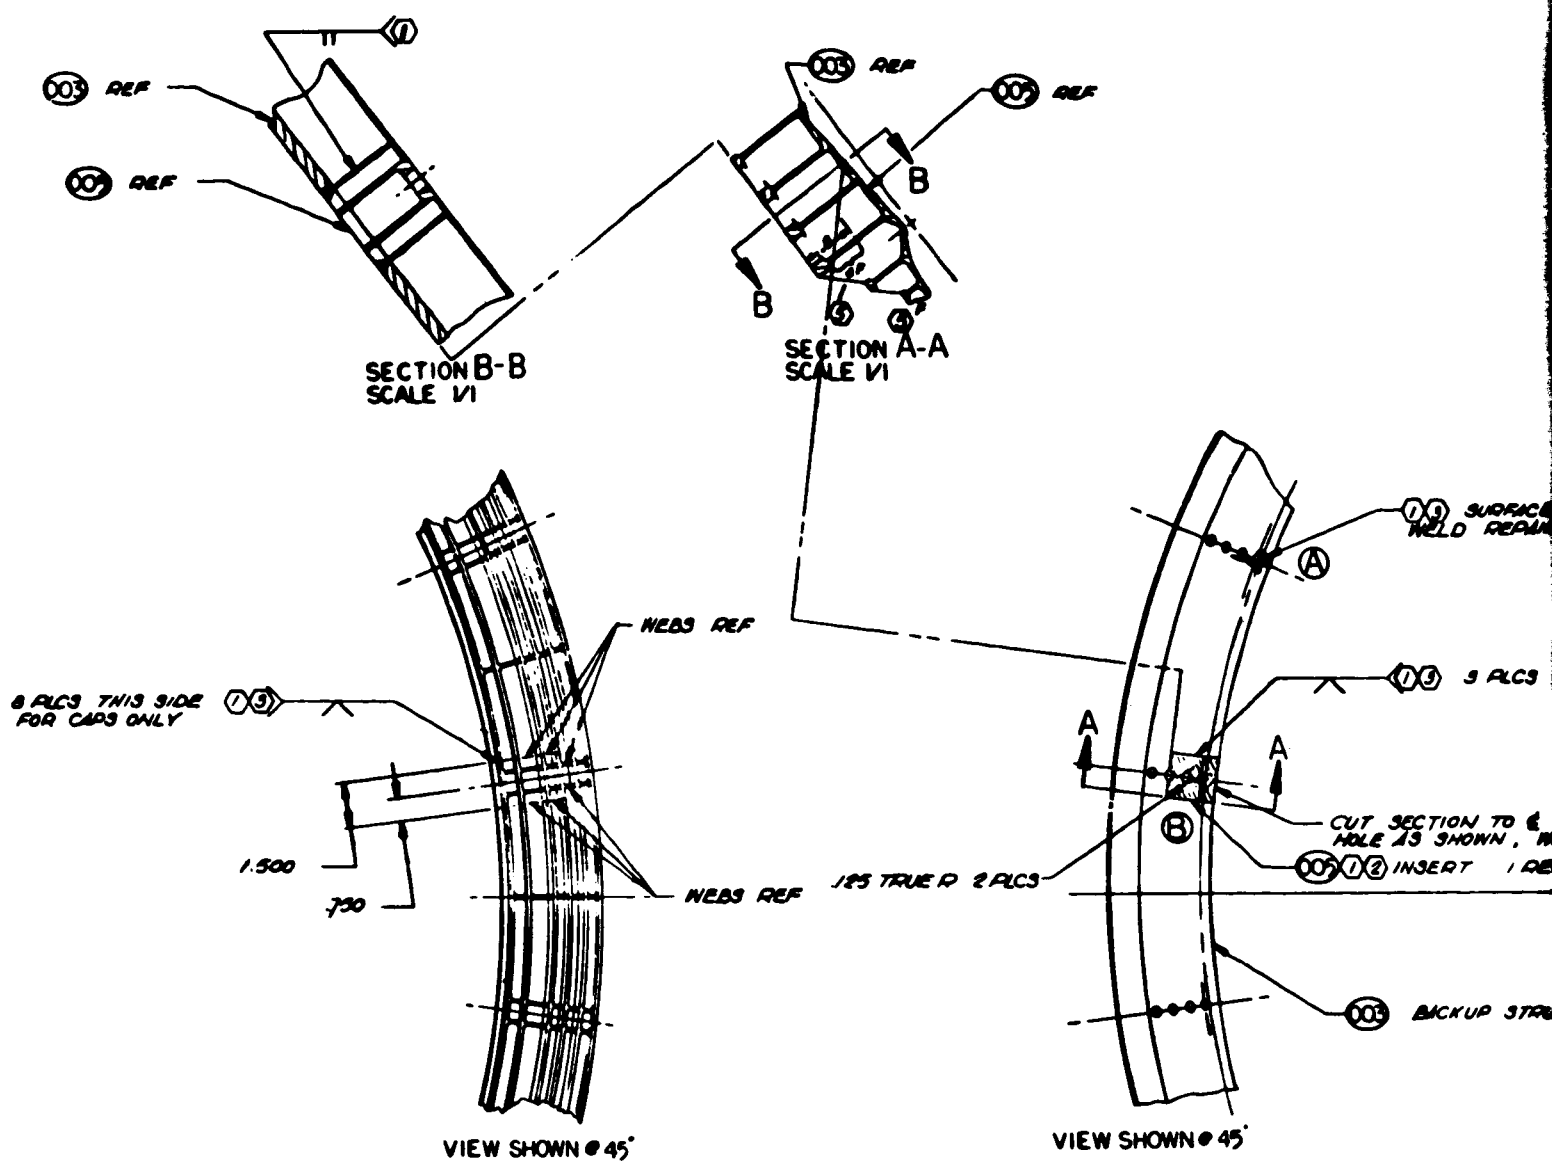
ASR 76-169

①③ SURFACE & HOLE  
WELD REPAIR REQD

- ADD TITANIUM FILLER MATERIAL 6-2-N-2 TO WEB LENGTHS 48" TO 7" AND CAPS,
- MACHINE PER RADIO9-002
- AFTER WELDING ALL WELDS TO BE GROUND FLUSH WITH EXISTING M
- INSERT TO BE MADE FROM EXISTING SECTION THEN WELDED IN PLAC
- WELD PER RADIO7-016 CLASS 1 USE ARGON ATM BOP, 6 WELD DEP
