NASA CR-145043

PROGRAM FOR ESTABLISHING LONG-TIME FLIGHT SERVICE
PERFORMANCE OF COMPOSITE MATERIALS IN THE
CENTER WING STRUCTURE OF C-130 AIRCRAFT
PHASE IV - GROUND/FLIGHT ACCEPTANCE TESTS

September 1976

by W. E. Harvill and J. A. Kizer

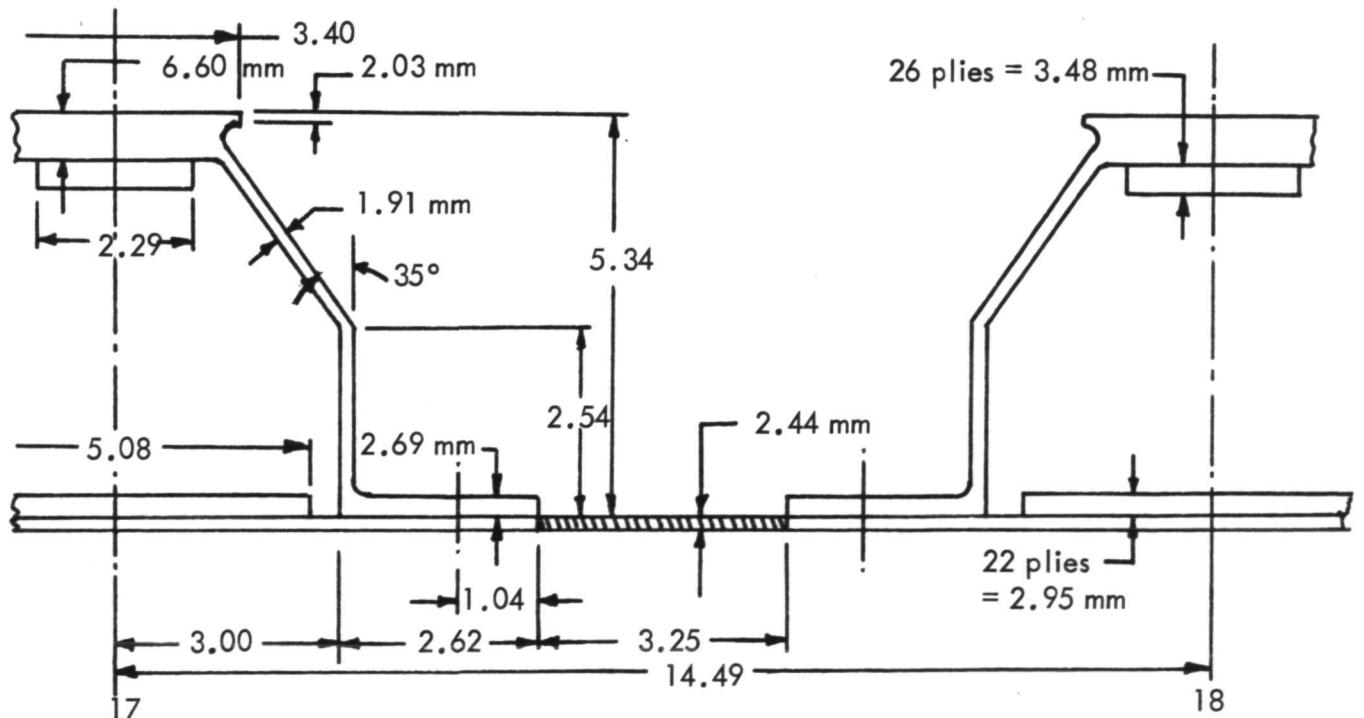
FIGURE 39. - W.S. 180 LOWER SURFACE CRACK

The sketch in Figure 39 depicts the lower surface panel in the region of W.S. 180 along with pertinent geometry. The crack location was chosen to be between Stringers 17 and 18 rather than emanating from a fastener hole in deference to the ability to inflict initial damage in the crack growth test without disassembling the structure. Furthermore, this choice isolates the crack so that only hat-section stringer and laminate effects need to be considered.

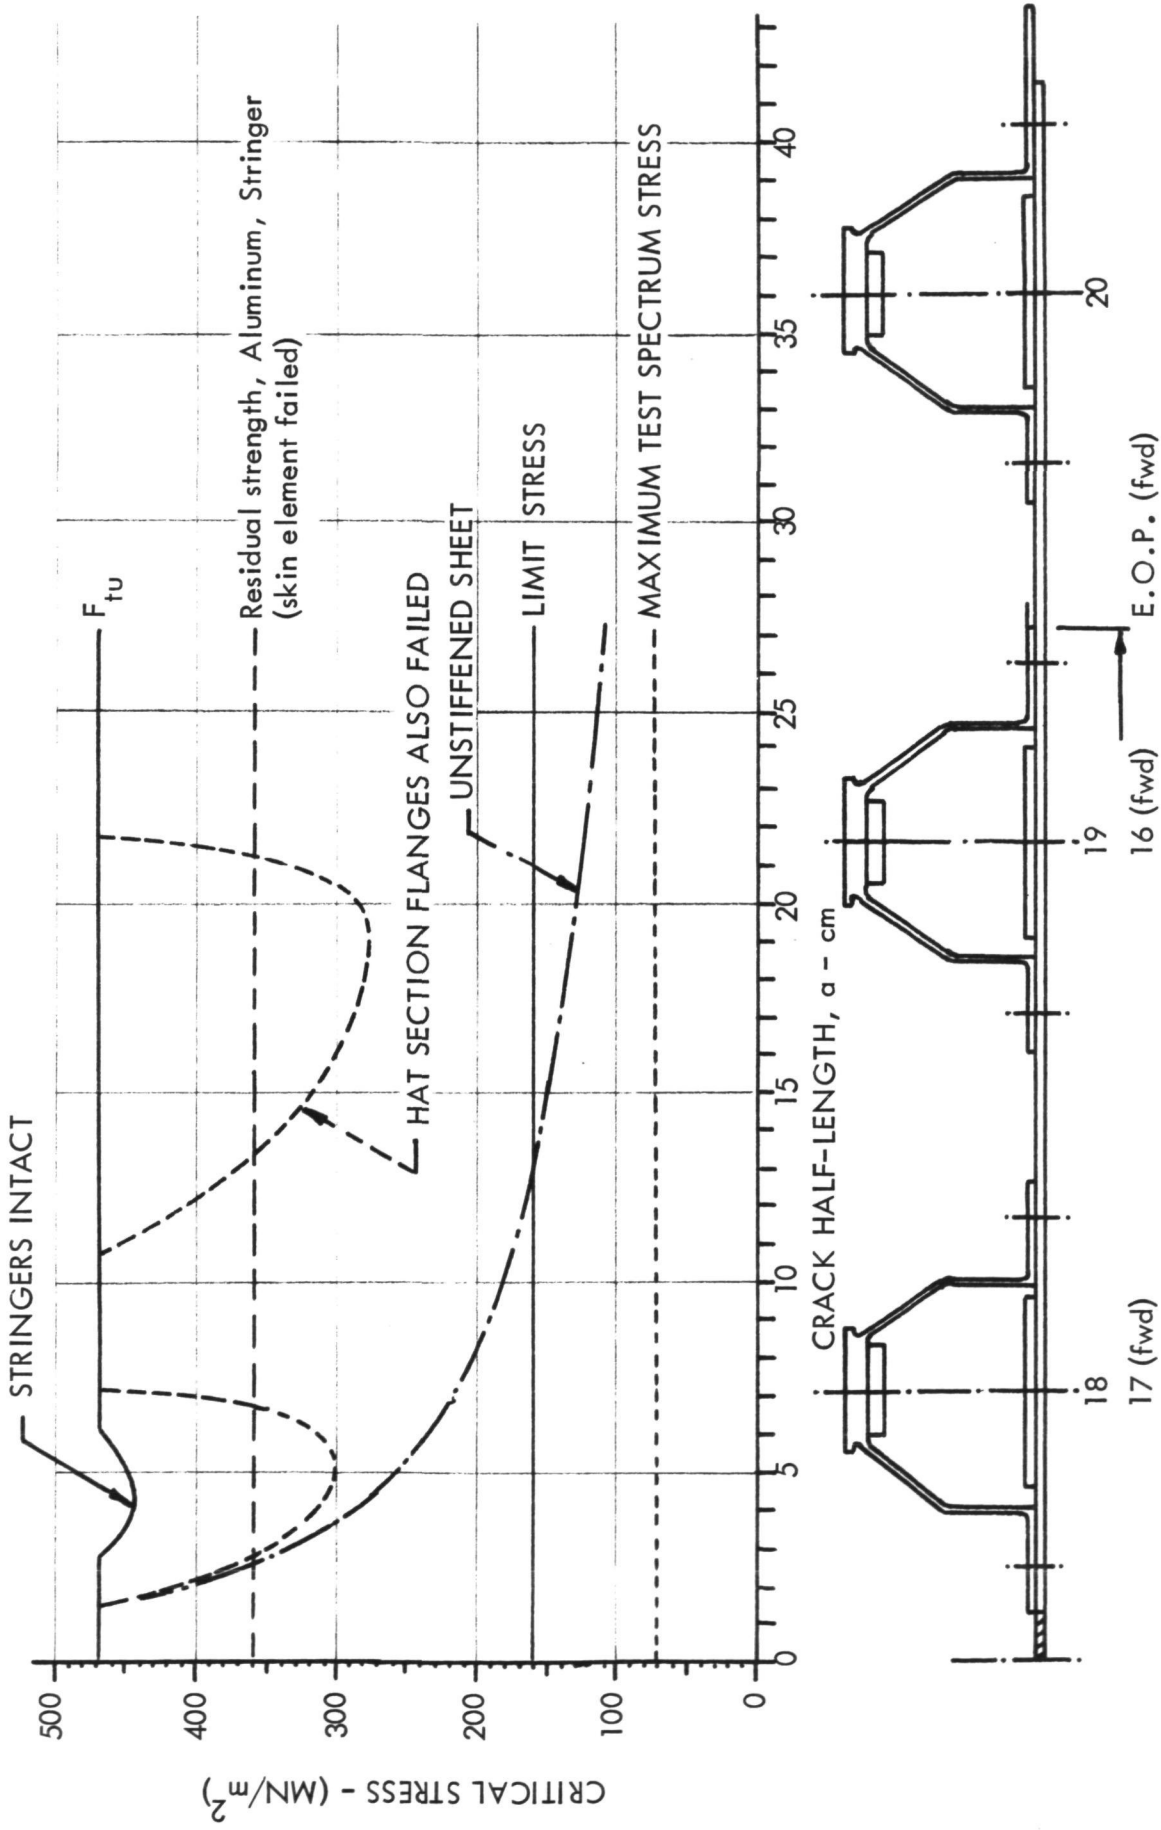
FIGURE 41. - CRITICAL STRESS, W.S. 180 LOWER

Critical Stress - Using $K_c = 101.2 \text{ MN/m}^2 \cdot \sqrt{\text{m}}$ (92 ksi $\sqrt{\text{in.}}$) from Reference 8 and the correction factors from Figure 40, Equation 3.9.1 was solved for critical stress as a function of the crack size parameter, a . Results are shown in Figure 41. For comparison, results for an unstiffened sheet, i.e., $\lambda = 1$, are also shown. The critical stress was cut off at $F_{tu} = 469 \text{ MN/m}^2$ (68 ksi). Stress levels for residual strength, limit stress, and maximum test spectrum stress are superimposed.

In Figure 41 it is observed that the crack does not become critical for limit load as long as the boron-epoxy laminates remain effective. However, if both stringer and laminates were ineffective, the crack would become critical for limit load at $a_c = 12.7$ cm (5.0 in.); that is, when the crack is 25.4 cm (10.0 in.) long.

Thermal stresses, assuming the laminates intact, would raise the applied stress by 22 MN/m^2 (3.2 ksi) for normal operations or by 43.5 MN/m^2 (6.3 ksi) for the low temperature condition (218°K, -67°F). The conclusions remain the same except the critical crack length for the unstiffened sheet case does not apply.

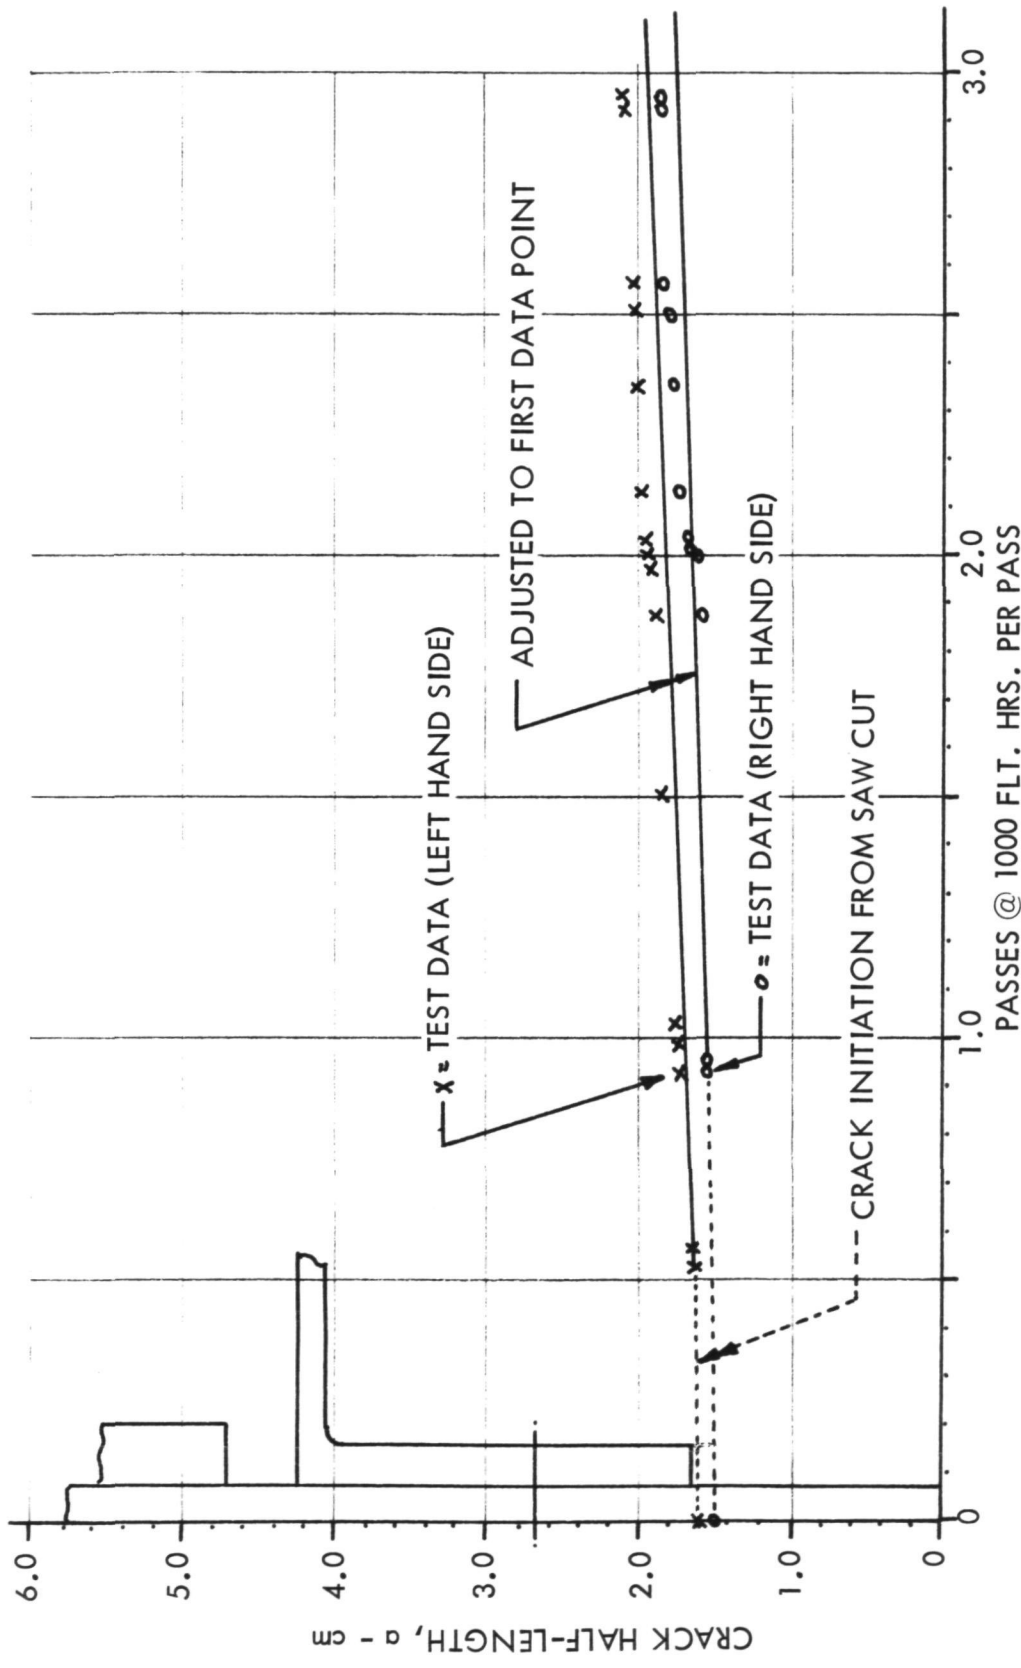
FIGURE 43. - CRACK PROPAGATION IN CRACK GROWTH TEST (SECTION 3.10), W.S. 180 LOWER

Crack Propagation - The crack propagation characteristic from integrating Equation 3.9.2 for the test spectrum is shown in Figure 42, and is correlated with crack growth test observations in Figure 43. In Figure 42, results showing the effect of 22 MN/m^2 (3.2 ksi) thermally induced stress are also shown.

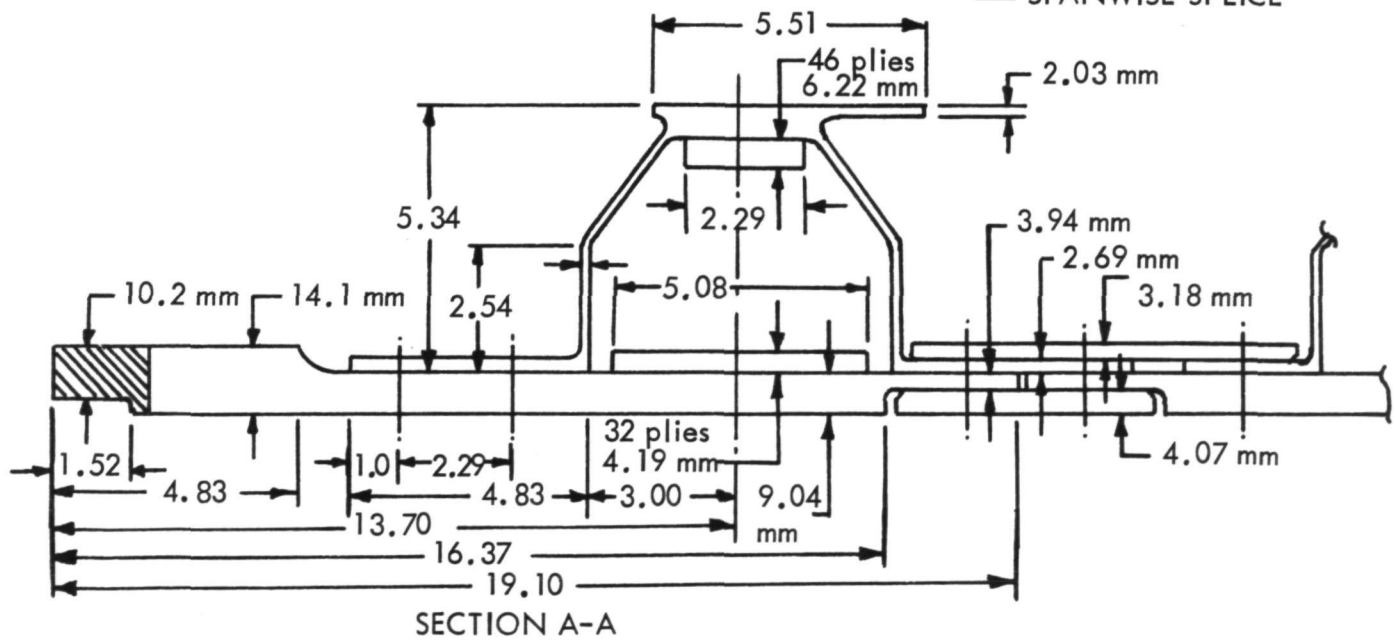
FIGURE 44. - W.S. 120 LOWER ACCESS DOOR AREA CRACK

The sketch shown in Figure 44 depicts the lower surface panel in the region of the W.S. 120 lower access door cutout. Cracking of the skin element from the aft side of the door cutout was investigated.

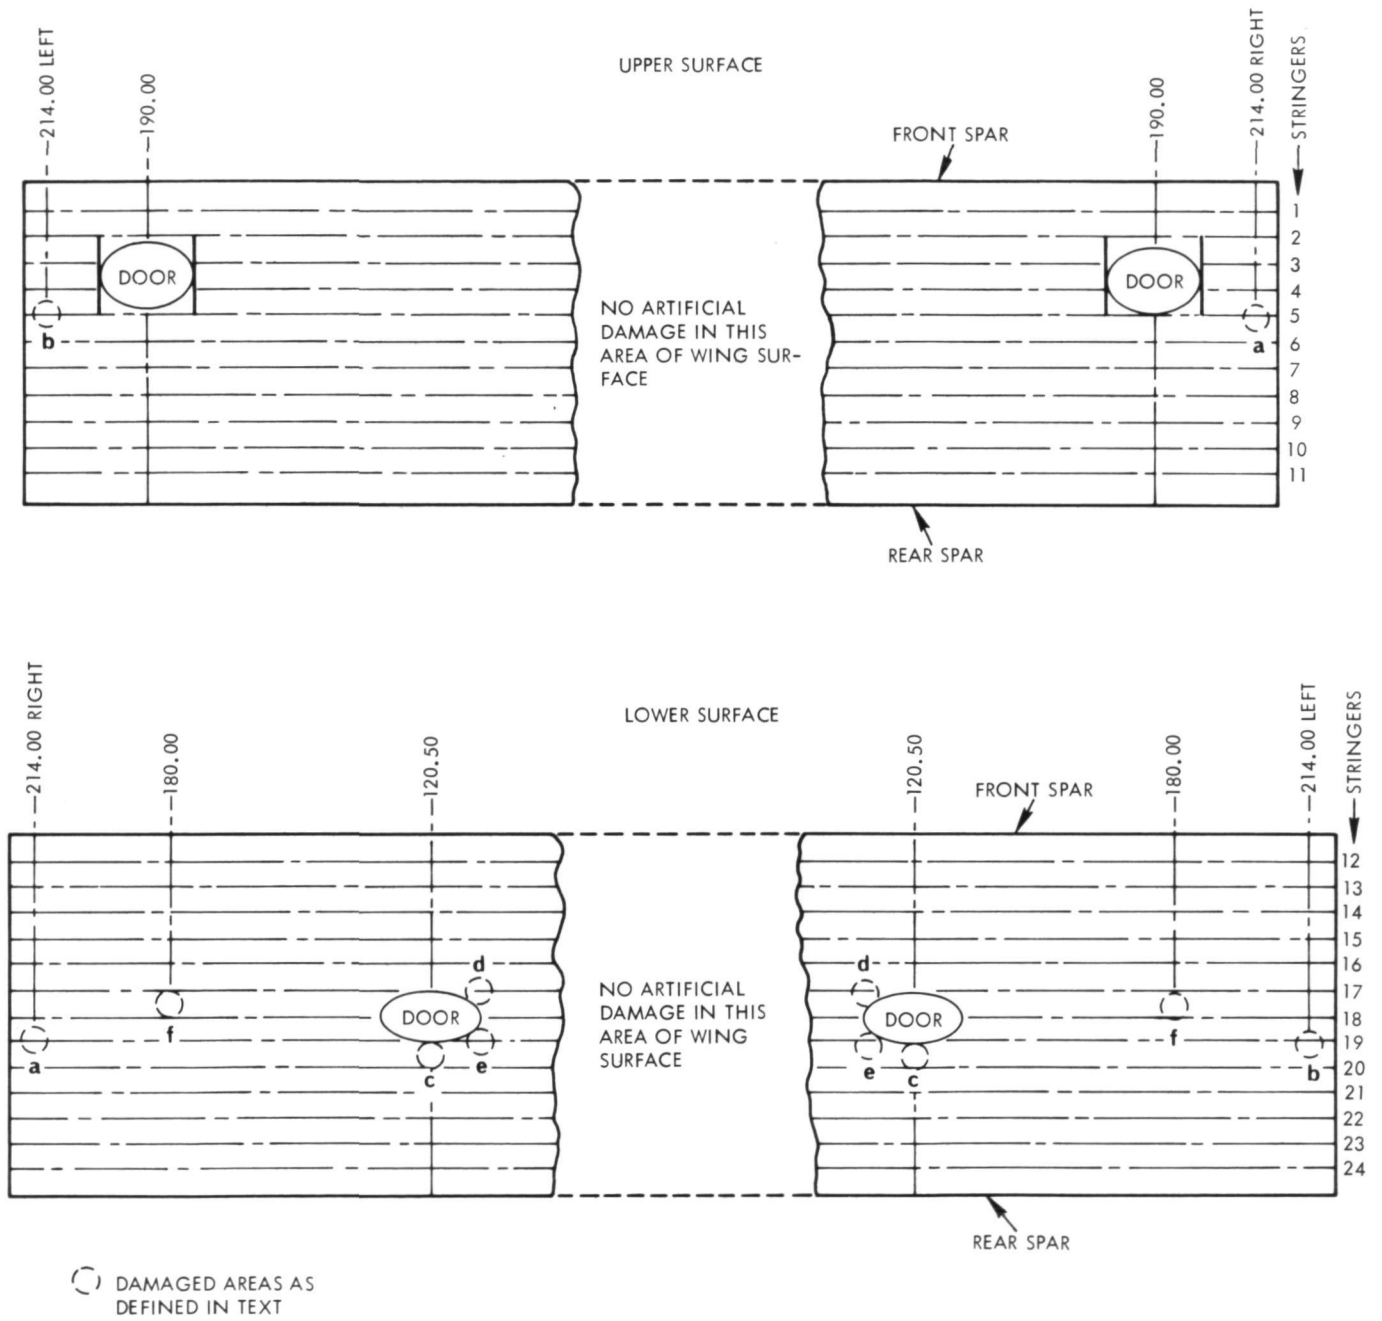
A crack growth test was conducted on the fatigue test article after completing the second upbending proof load test. The fatigue test article was intentionally damaged at twelve locations with ten locations in the lower surface and two locations in the upper surface. The damaged areas for both wing surfaces are depicted in Figure 65 and a detailed description of each area follows.

FIGURE 65 - DAMAGE AREA LOCATIONS ON UPPER AND LOWER SURFACES OF C-130 CENTER WING TEST ARTICLE

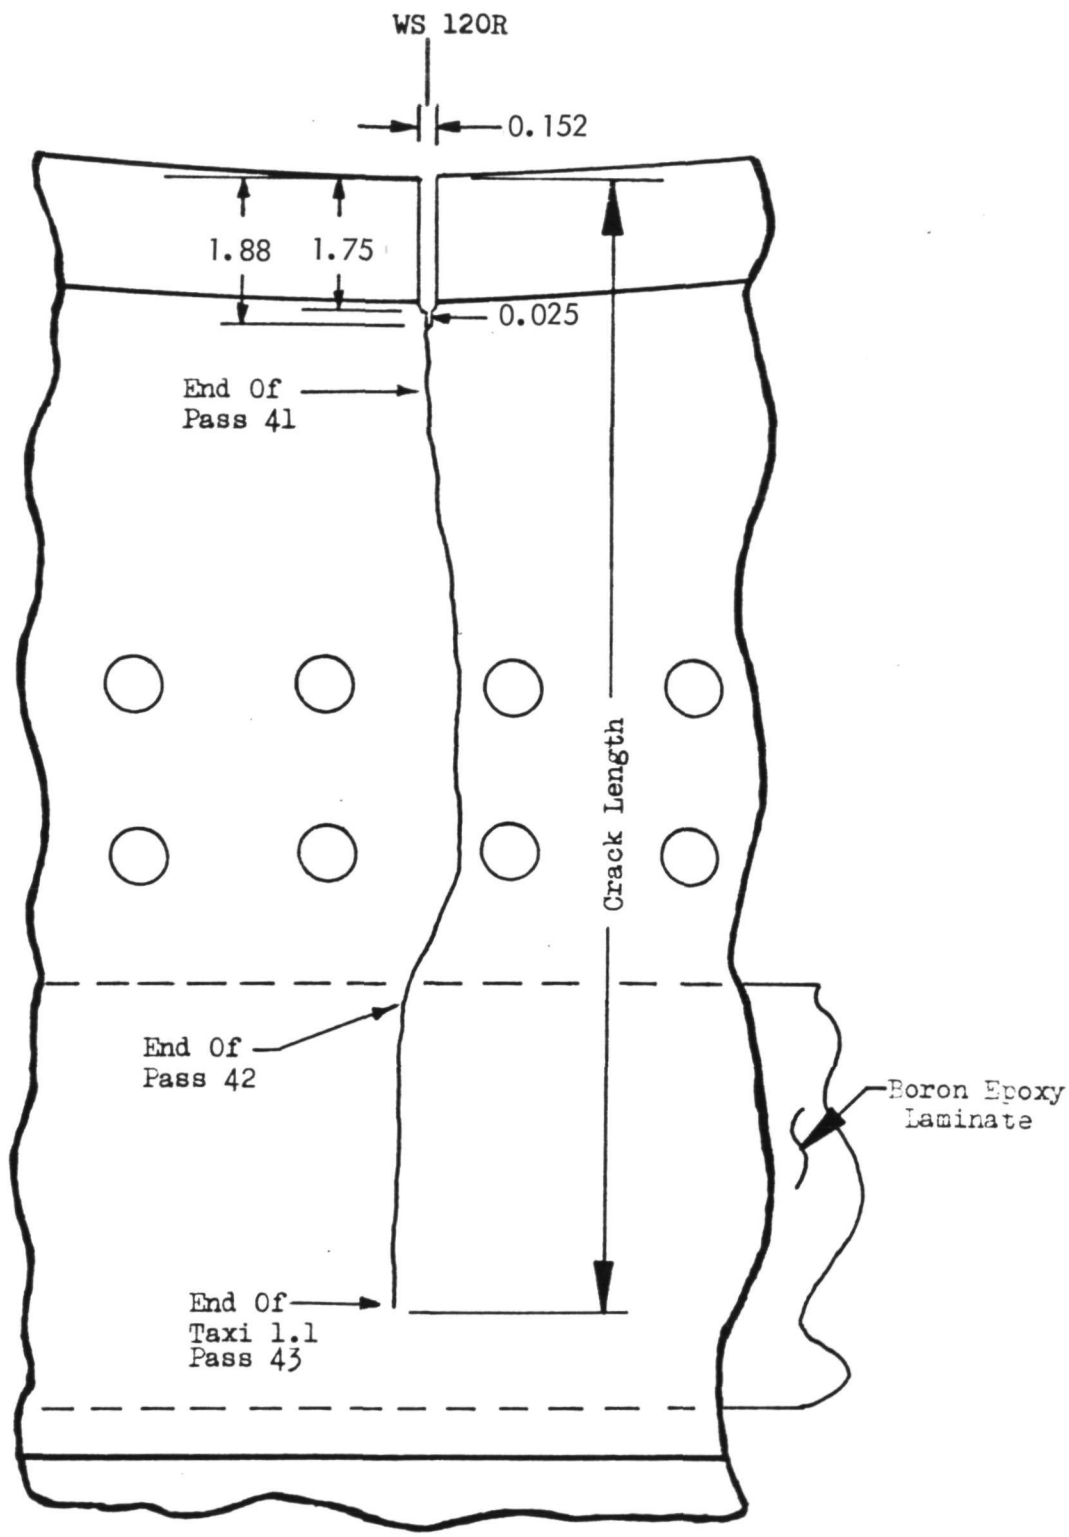
A summary of crack length measurements for both upper and lower wing surface planks is presented in Table VI. The crack lengths in this table are the sum of the artificial damage lengths plus the fatigue crack lengths. As shown in the table, natural crack growths occurred only in the lower surface wing plank at W.S. 120 and W.S. 180. The highest growth rate occurred at W.S. 120, left and right, and the growth histories are charted on Figures 72 and 73, respectively.

FIGURE 73 - CRACK GROWTH HISTORY IN LOWER WING SURFACE PLANK AT W.S. 120 RIGHT

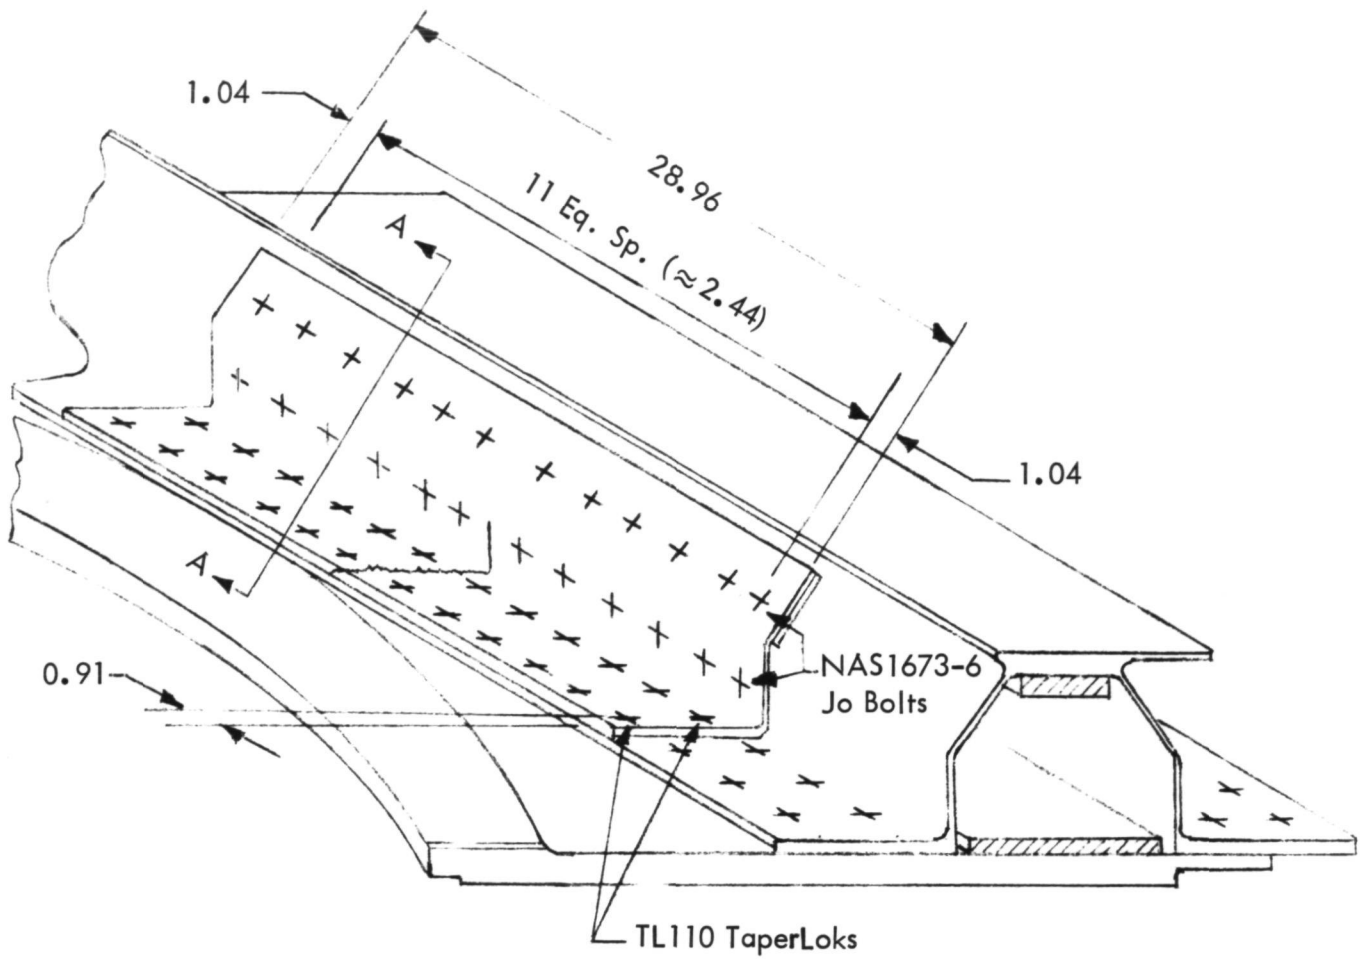
Upon suspension of the crack growth test, a limit load upbending test was conducted on the fatigue test article. This test was conducted in a similar manner to previous upbending proof load tests. Prior to conducting the limit load upbending test, the cracked hat-section stringer at Wing Station 120, left and right, was repaired by adding a portion of a hat-section stringer to the damaged area. Each repair member was 28.96 cm (11.4 inches) in length and was attached to the cracked stiffener as shown in Figure 74. A filler shim was required to be located between the oblique leg of the repair member and the oblique leg of the cracked stringer. Necessary tapered interference fasteners in the stringer flange-to-wing skin plank were removed and replaced by tapered interference fasteners installed in the original members plus the repair member flange. Also, two rows of blind Jo-bolts were installed in the vertical and oblique legs of the repair member and the cracked hat-section stringer.

FIGURE 74 - REPAIR FOR HAT-SECTION STRINGER AT W.S. 120 IN FATIGUE TEST ARTICLE

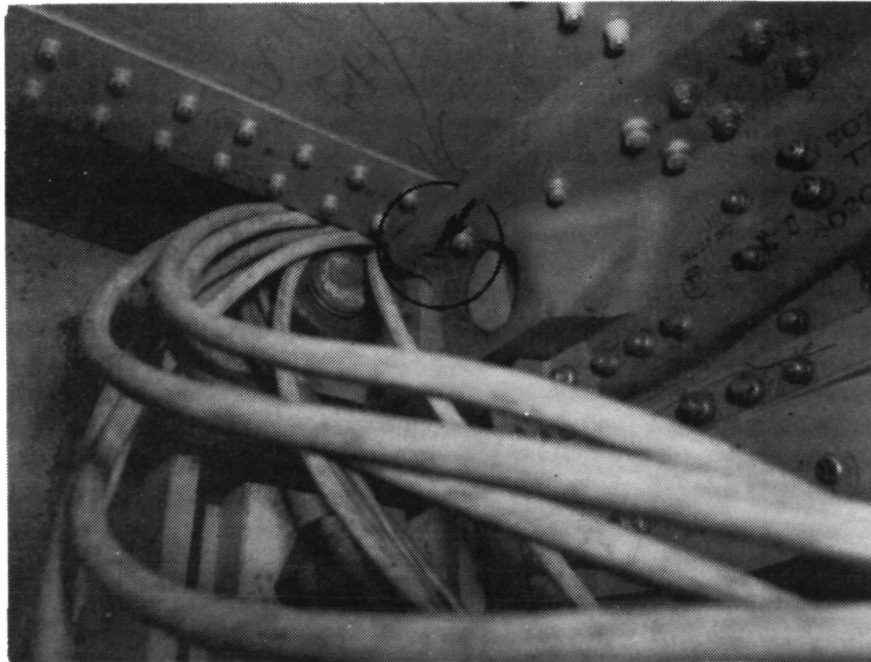
A $\frac{1}{4}$ -inch diameter Huk-bolt in the 390619-5 Fitting had broken head. Fracture surface had fatigue markings. Eddy current inspection of fastener hole wall revealed no cracks. Hole was reamed to accept HL-56 fastener which was installed wet with STM 40-111 sealant.

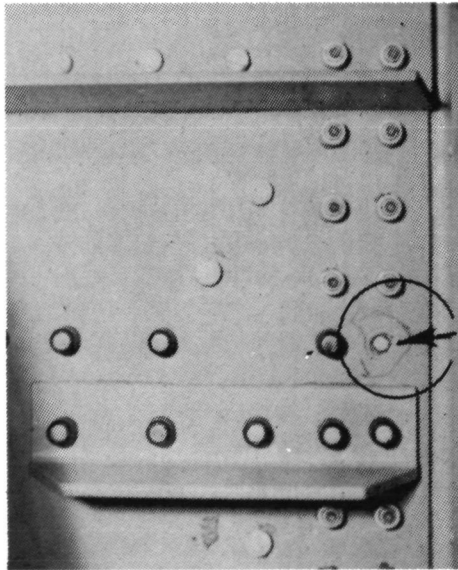
A 3/16-inch diameter Huk-bolt in the 371231-1L, Rib Installation, had failed at the collar. Fracture surface had fatigue markings. Eddy current inspection of fastener hole wall revealed no cracks. Failed fastener was replaced with an HL-18 fastener installed wet with STM 40-111 Sealant.

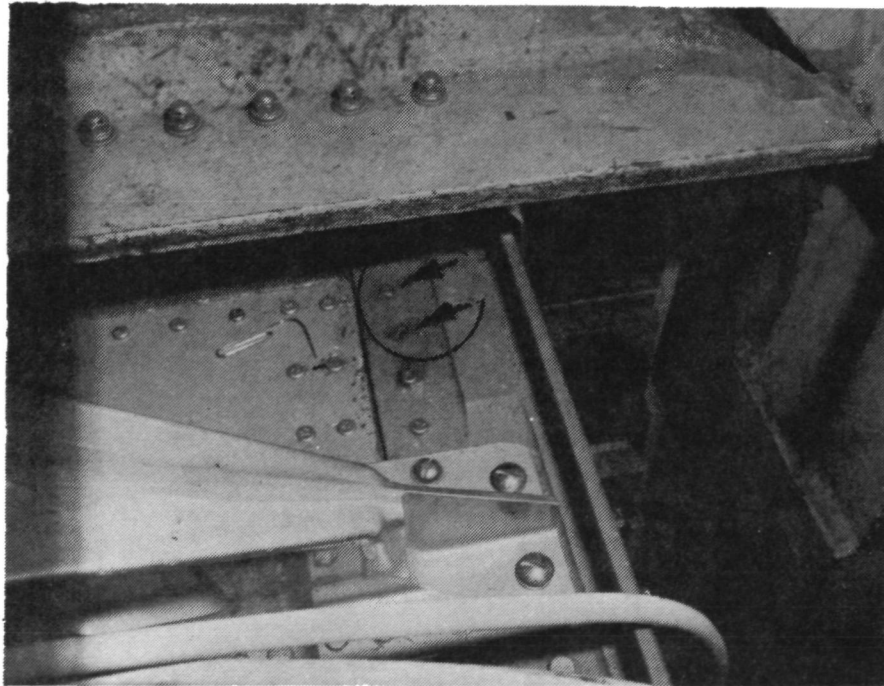
Two Huk-bolts in 388196-48 Strap had broken heads. Fracture surfaces had fatigue markings. Eddy current inspection of hole walls revealed no cracks. Holes were reamed to accept HL-56 fasteners which were installed wet with STM 40-111 Sealant.

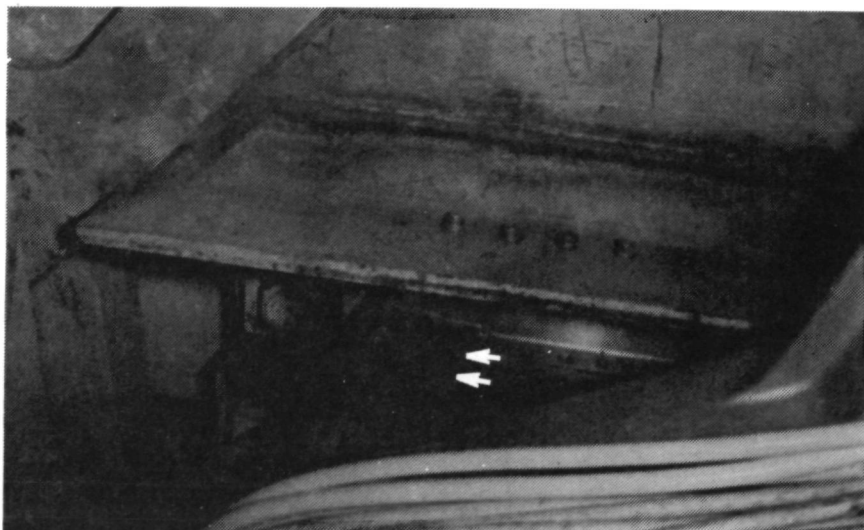
Two 3/16-inch diameter Hi-Loks, which replaced broken Huk-bolts per Discrepancy Report Number 060066, in the 388196-47 strap had broken at collars. All fixture bolts shearing P_z load into the front and rear beam webs at CWS 220 left and right were checked for looseness and were retorqued as required. Several bolts required some retorquing. Failed fasteners were replaced with HL-36 fasteners with TLN 1000 nuts installed wet with STM 40-111 sealant. Also, one previously installed Hi-Lok was found to be loose and was replaced with fastener equivalent to HL-36.

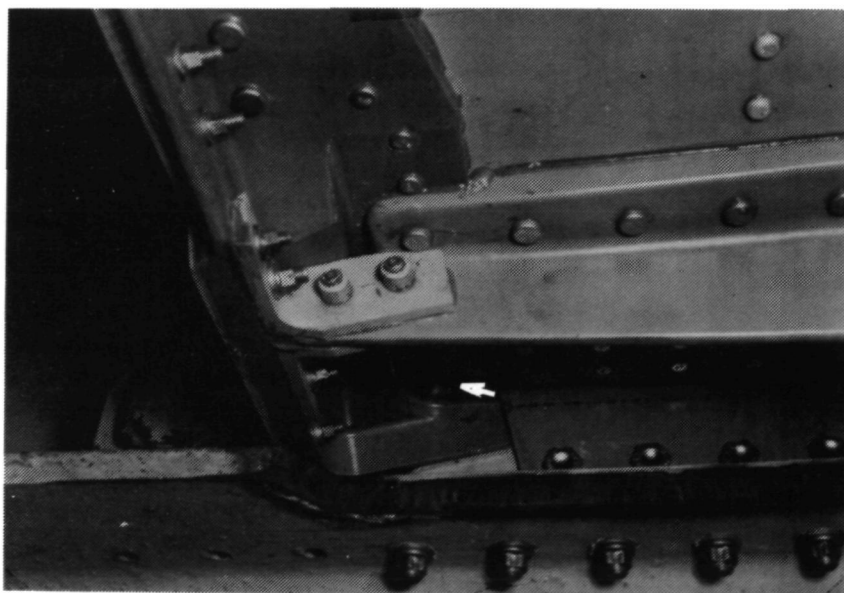
One 3/16-inch diameter Huk-bolt in the 370521-3 Fitting and one 3/16-inch diameter Huk-bolt in the 370521-4 Fitting had broken heads. Fracture surfaces had fatigue markings. In conjunction with Discrepancy Report No. 060256 all fixture bolts shearing P_z load into the front and rear beam webs at CWS 220 left and right were checked for looseness and were retorqued as required. Several bolts required a small amount of retorquing. Fastener holes were reamed to accept HL-56 fasteners which were installed wet with STM 40-111 sealant.

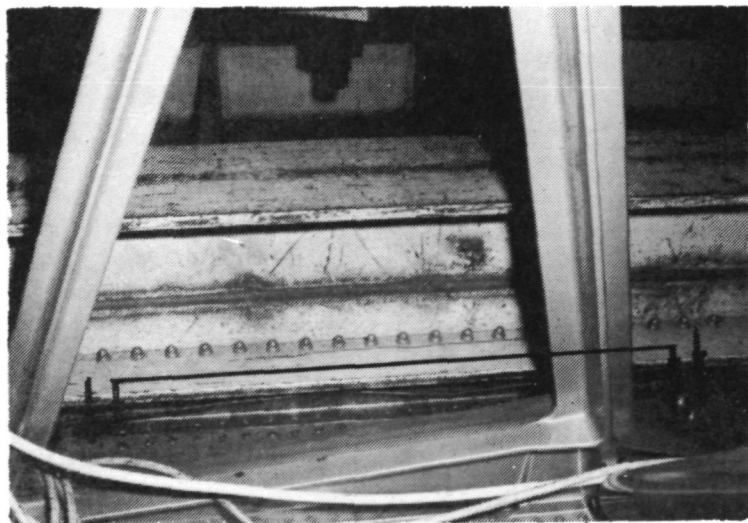
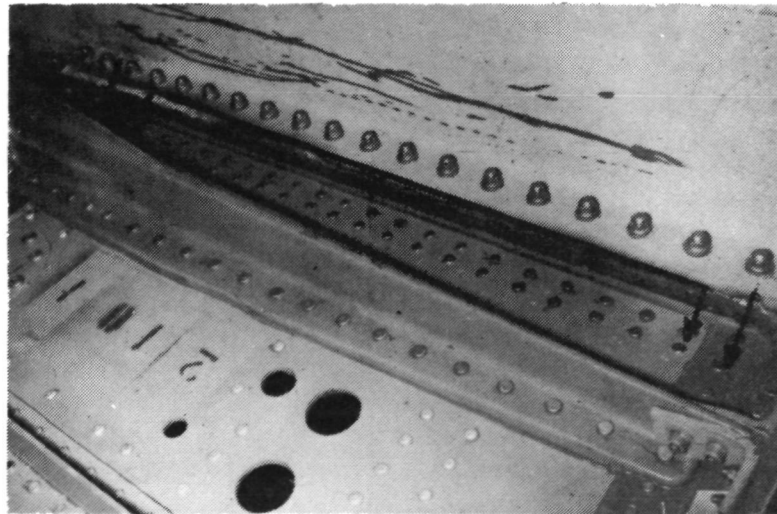
One 3/16-inch diameter Hi-Lok in the 388196-47 strap had broken at the collar and one 3/16-inch Hi-Lok in the 388196-47 strap had broken at the nut. (Reference Damage Item Number 5).

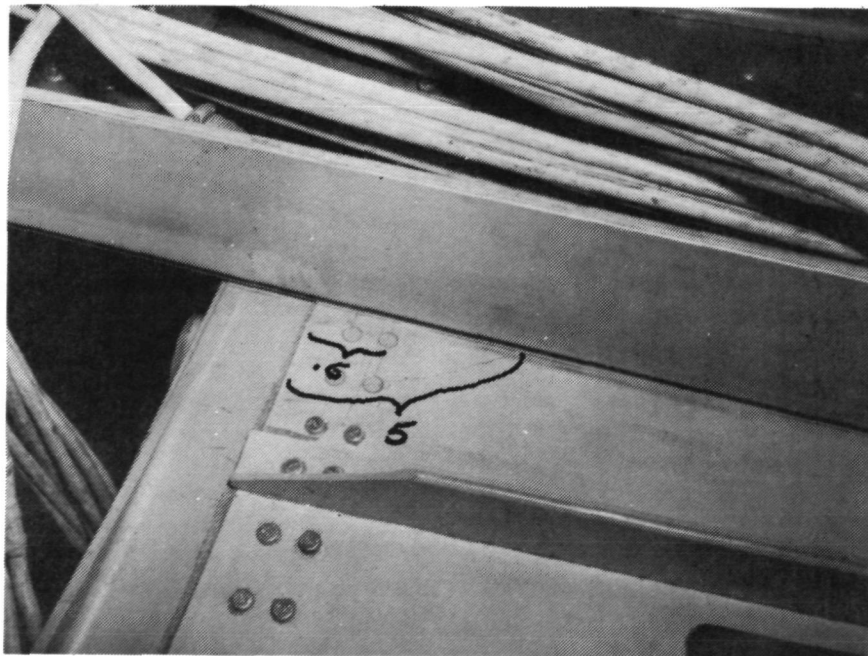
The 370532-5 Web had two cracks. One 0.6-inch long at WS 73L running through two fasteners to the edge of the web. The other was 5.0-inches long at WS 74L running through two fasteners to edge of the web. Cycling was continued until completion of fourth lifetime with periodic inspections revealing no crack growth. The area was repaired per S-5420 which specified web reinforcement with steel doublers.

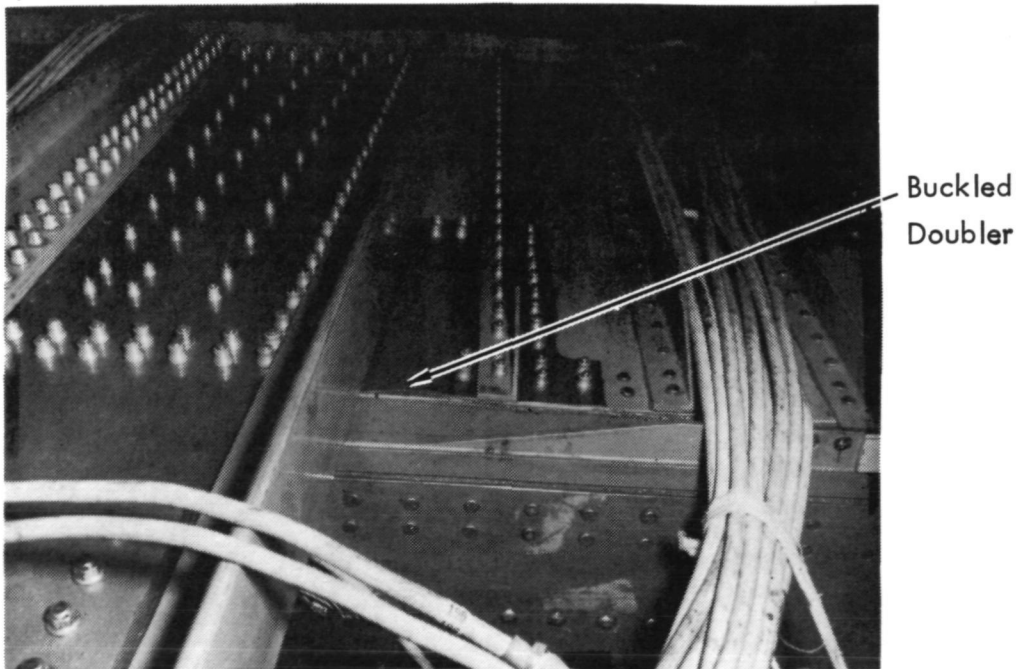
The S-5420 Repair doublers buckled at WS 73L during Limit Load Test (Upbending Strain Survey, Case 1102, Limit Load). The double row of fasteners in the top edge of the repair was extended parallel to the buckle. The fasteners common to the web and the beam cap in this double row were omitted.
