**NASA TN D-8301**

**APOLLO EXPERIENCE REPORT -  
COMMAND AND SERVICE MODULE  
CONTROLS AND DISPLAYS SUBSYSTEM**

*Aaron B. Olsen and Robert J. Swint*

*Lyndon B. Johnson Space Center*

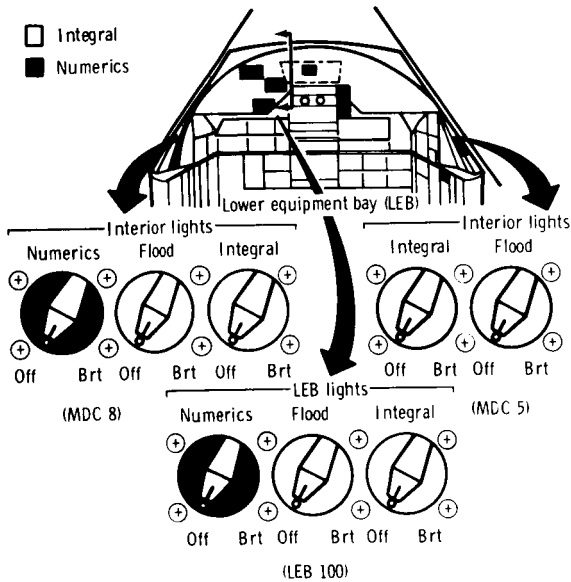
Figure 3.- The command module integral and numerics illumination system.

Triggers. - Most floodlight failures were attributed to the overloading of a semiconductor diode. Because of excessive current, the unit overheated the encapsulated circuitry and caused emission of smoke and noxious odors. The failure was traced to the thermal sensitivity of the three-layered semiconductor diode used as a trigger. The supplier confirmed that the three-layered diode could not be manufactured with adequate parameter controls.

Transient susceptibility. - In July and August 1966, floodlight failures were attributed to transient susceptibility of the lamp circuitry, which created conditions that allowed the lamp assembly to draw excessive current that, in turn, opened the fuse. The circuitry was redesigned to limit the current flow by the addition of an input filter, a time-delay network, and a zener diode.

**Lamp tube.** - Other than problems caused by poor handling, the greatest cause of tube failure was an inadequate amount of mercury injected into the tube. Manufacturing procedures were changed to prevent recurrence of this discrepancy.

**Lamp moisture absorption.** - To prevent failures caused by moisture absorption, improved procedures were implemented for the application of the potting sealant to tube ends and epoxy surfaces.

The three-layered diode trigger was replaced with a four-layered one that could be manufactured with adequate controls. The new trigger maintained the required switching speed over the required environmental range of vibration, temperature, pressure, and humidity. An improved parts screening procedure was implemented on the new triggers. A summary of the screening tests includes the following.

Circuit protection. - The power distribution circuit was examined to determine the feasibility of improving the overcurrent protection by reducing circuit breaker ratings. It was determined that the existing breakers were sized to protect the power distribution wiring and that the reduction of these ratings to provide protection for each light assembly would result in the loss of other lights or system elements on that same circuit breaker. The final corrective action adopted was to add a fuse in each power input circuit of each light assembly.

Transient protection. - To protect against the effects of switch contact bounce, the input filter chokes were replaced with 0.25-ohm resistors, and the 6.8-microfarad input filter capacitance was increased to 68 microfarads. Also, a 102-millisecond time-constant delay network and a zener diode were added to limit the maximum voltage that could be applied to the trigger circuit.

To make the CM interior more fireproof, the high-impact plastic lens was replaced by a lens of laminated glass. Because the glass lens could splinter on hard impact, it was overlaid with a thin (approximately 0.008 centimeter (0.003 inch)) coating of fluorinated ethylene propylene Teflon to prevent injury to any crewmember should splintering occur.

Fluorescent tube protection. - To prevent leakage of mercury vapor in case of fluorescent tube failure (crack or break), a protective coating of Teflon was added to the tube, and the tube ends were encapsulated to provide a seal.

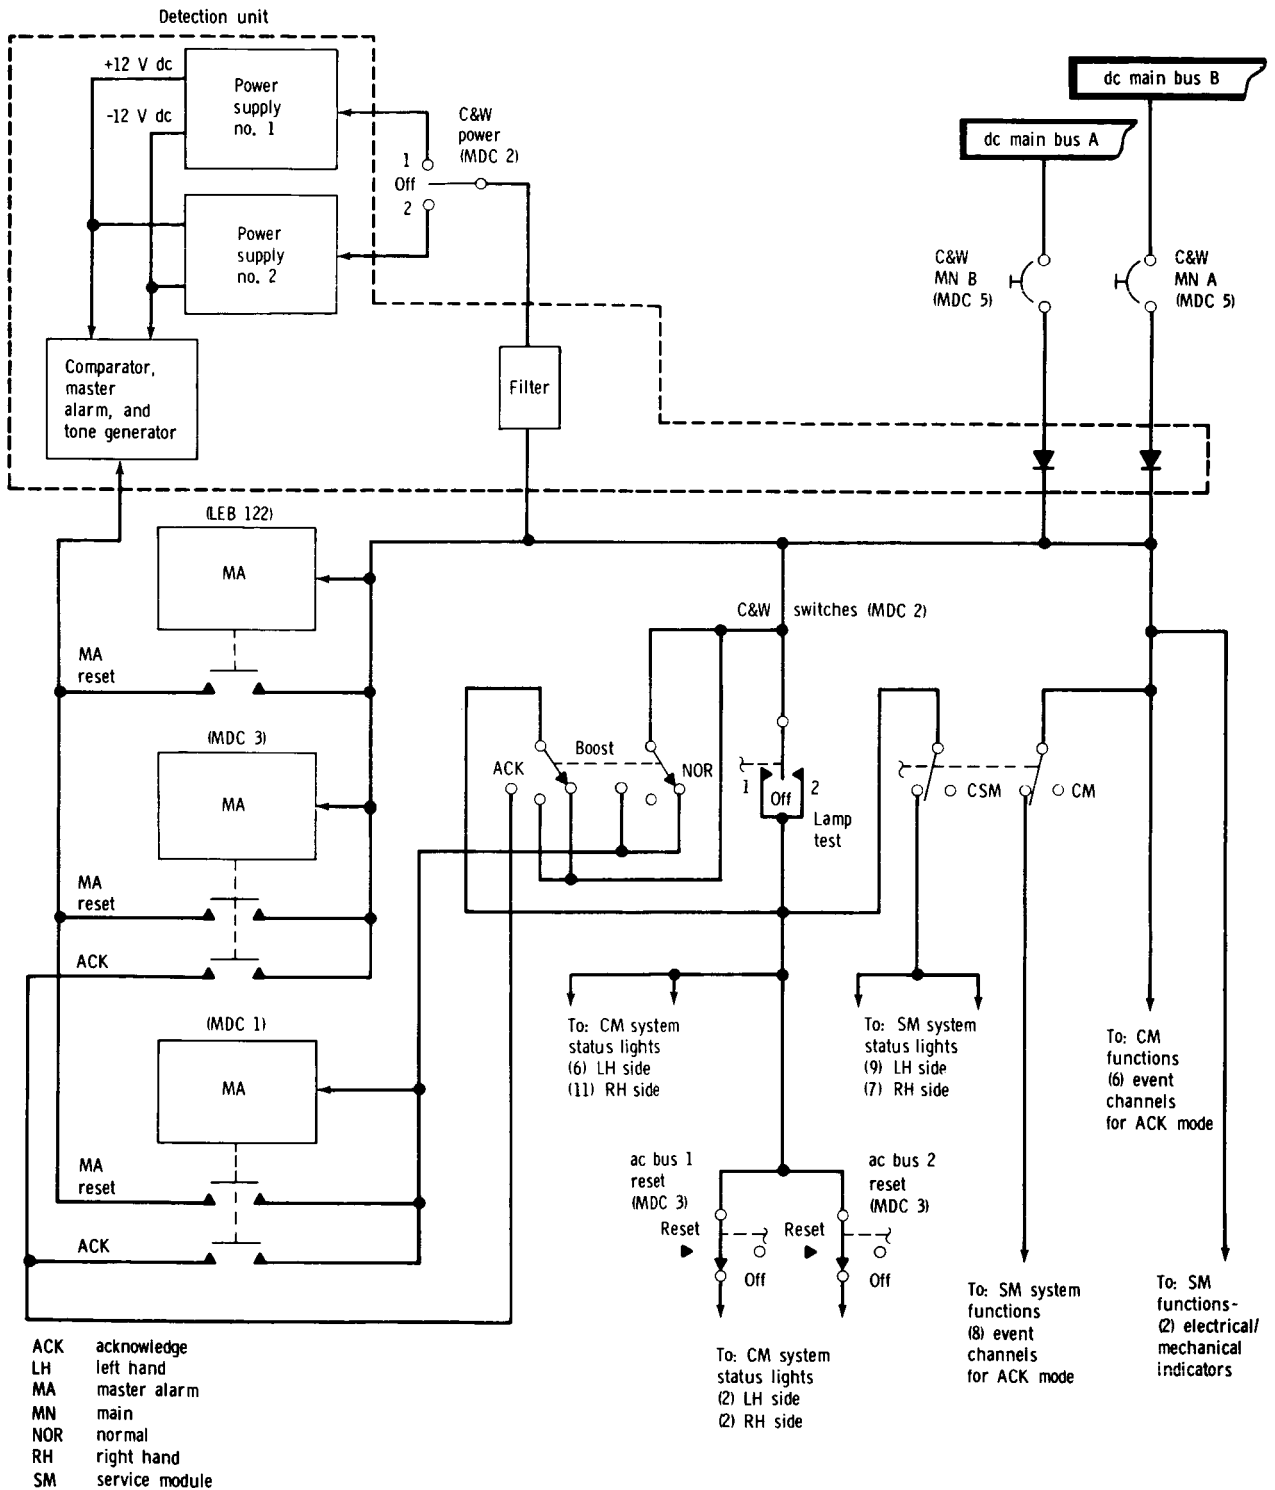
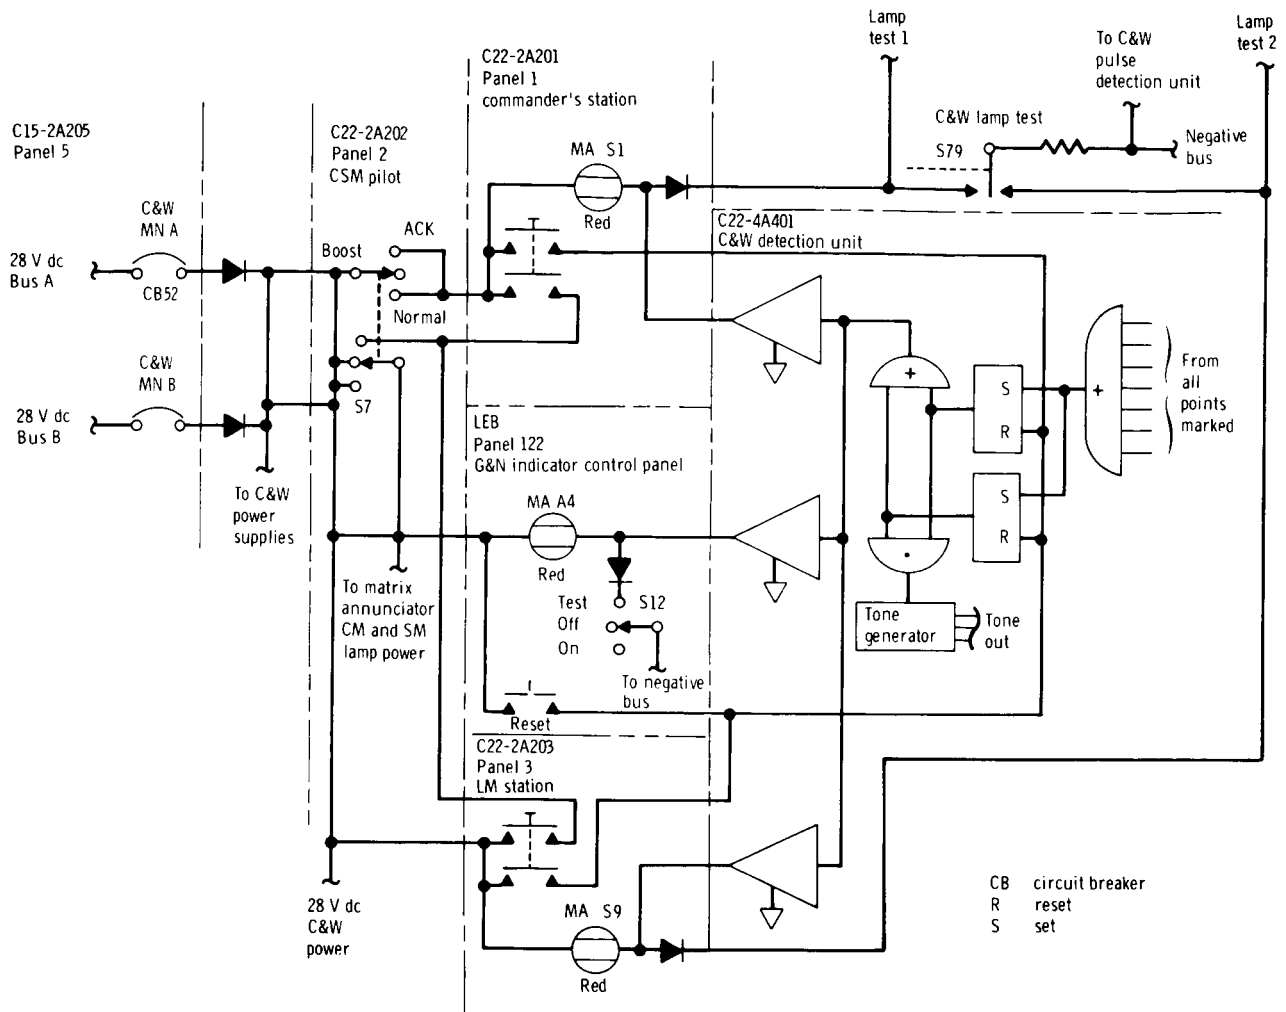
Figure 6. - Schematic of C&WS power distribution.

No known vehicle test failures and only one reported flight anomaly occurred in the C&WS. The reported anomaly occurred approximately 0.45 second after final ring-latch closure during the initial transposition and docking maneuver of the Apollo 9 (CSM 104) mission. Analog and bilevel data did not indicate any out-of-tolerance condition at the time. The fact that the alarm occurred during the hard docking rather than at physical contact ruled out static discharge between the two vehicles and indicated a shock-sensitive condition. The C&WS MA circuit was a latching system that could respond to transients of 10 microseconds in duration, and a transient on any of the 69 inputs could trigger the alarm. Analysis of CSM 104 flight data revealed no system anomaly; thus, the specific cause remains unknown.

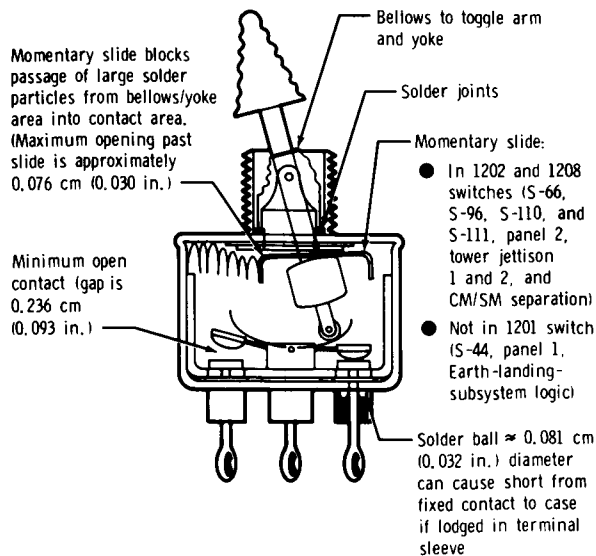
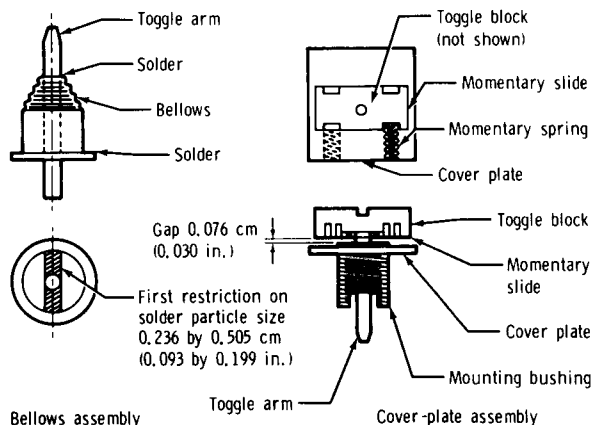
Figure 14.- Toggle switch.

Toggle switches, used as manual control elements on the CM, were configured in one to four poles and in two or three positions and were of a maintained, momentary, or lock type, depending on the use. The block I toggle switch was an environmentally sealed unit with a low failure rate. After the block II requirements were established for a hermetically sealed switch, it was determined that the block I vendor did not manufacture one and did not choose to manufacture one. Consequently, the initial block II toggle switch was a hermetically sealed plunger-type unit with an unsealed toggle mechanism for switch actuation. Early in the block II program, switch problems became apparent. Failures caused by high contact resistance, by mechanical lockup, and by nonfunction at high or low pressure resulted in a change to the present completely hermetically sealed switch. This switch had many serious problems (figs. 12 to 14), such as internal solder balls, extra parts and pieces inside switches, contact buttons welded to a terminal post in an inverted position, defective contact-button welds, auxiliary contact-plate welds, momentary shorting of contact arm with spring, cracked toggle block assembly and bellows, annealing and displacement
