O A L S BULLETIN 11

AN ASSESSMENT OF THE IMPACT OF  
WATER IMPOUNDMENT AND DIVERSION STRUCTURES  
ON VEGETATION IN SOUTHERN ARIZONA

OFFICE OF ARID LANDS STUDIES  
University of Arizona  
Tucson, Arizona

December 1975

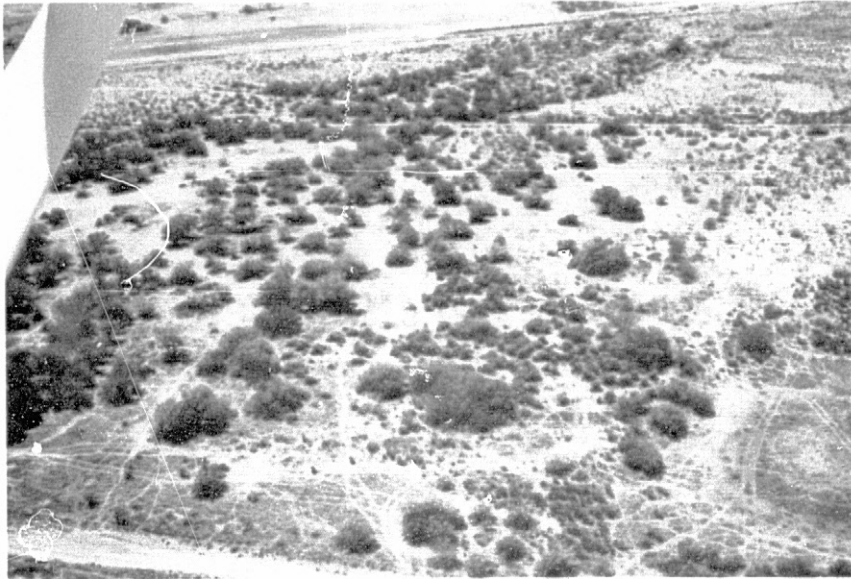
Figure 12. Infrared low-altitude photo of upslope vegetation (Structure #4).

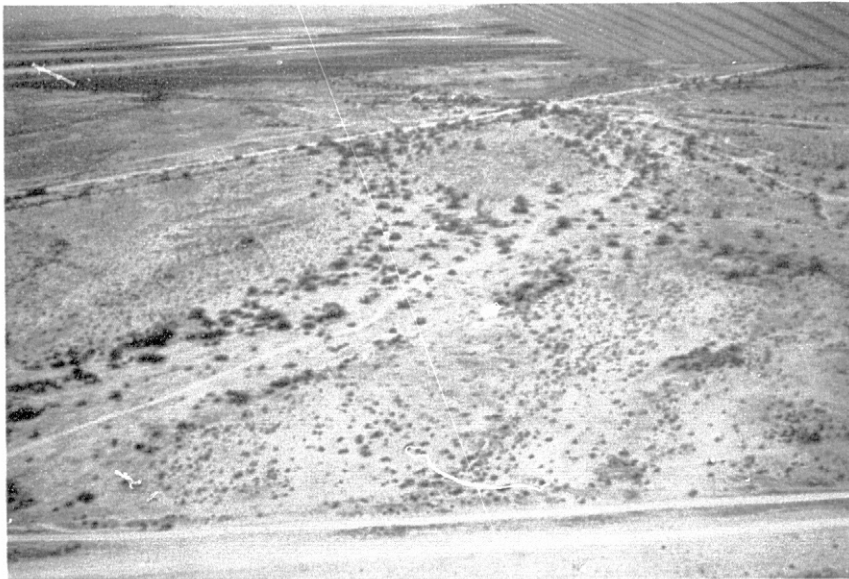
Figure 13. Infrared low-altitude photo of upslope vegetation (Structure #4).

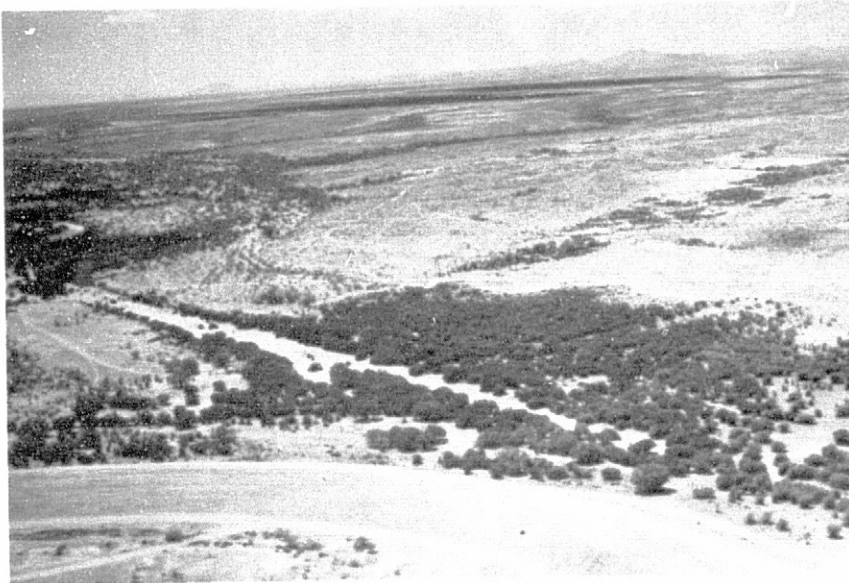
Upslope, in the areas of deepest seasonal standing water, there occurs a very dense stand of seep-willow (shown in Figure 15). Further upstream, wash vegetation is primarily the Mesquite/Blue Paloverde type as shown in Figure 16. Interfluvial vegetation is the Triangle-Leaf Bursage/Creosote Bush type.

Figure 15. Dense stand of vegetation immediately upslope of structure (#5).

Cover, density, and vigor of upstream vegetation are much greater upslope than downslope as is shown by Figures 15 and 18. Blue paloverde seems to be the most severely stressed plant downstream.

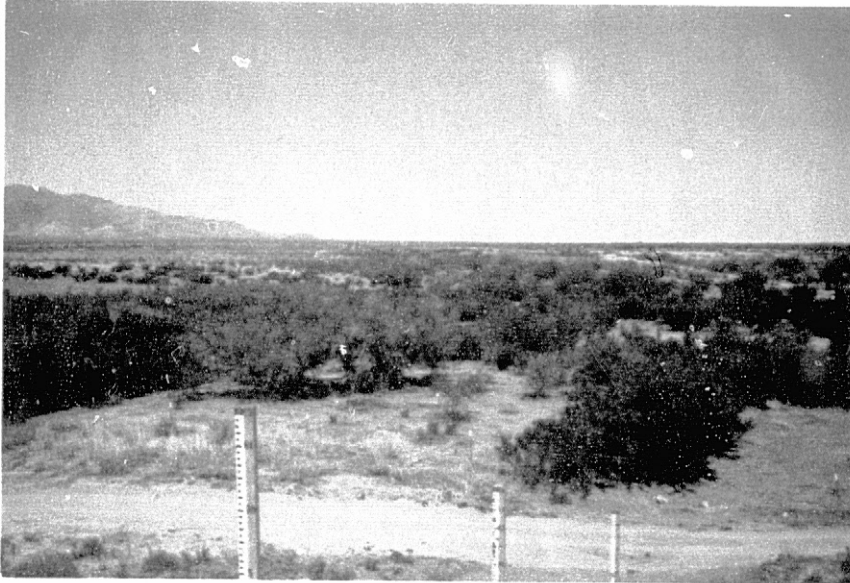
Figure 16. Mesquite/Blue Paloverde type upslope from the structure (#5).

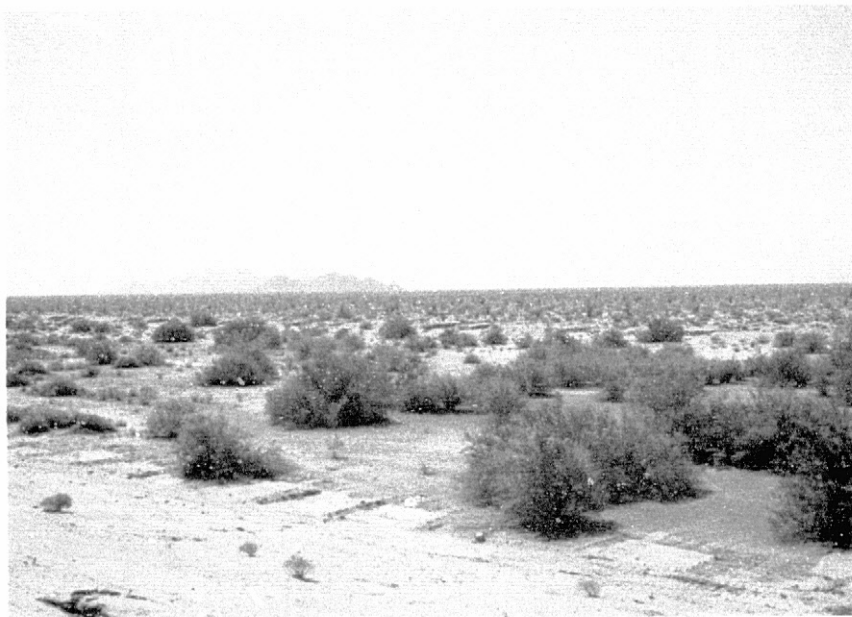
In general, downslope and upslope vegetation is the same in species composition, density, cover, and vigor. Upslope, however, there is an increase in the before-mentioned vegetation parameters immediately adjacent to the highway. Downslope, at culverts, the vegetation is locally luxuriant and vigorous. Figures 20 and 21 (photos of upslope and downslope vegetation) and Figure 22 (an aerial infrared photo of the highway and areas upslope and downslope) show the differences in vegetation

Figure 20. Ground truth photo of upslope vegetation (Structure #6).

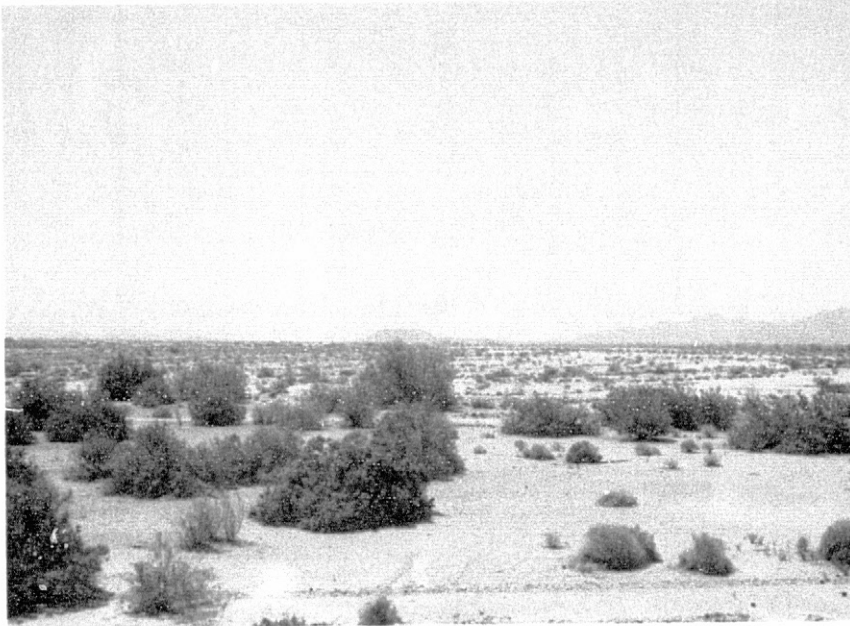
Figure 21. Ground truth photo of downslope vegetation (Structure #6).

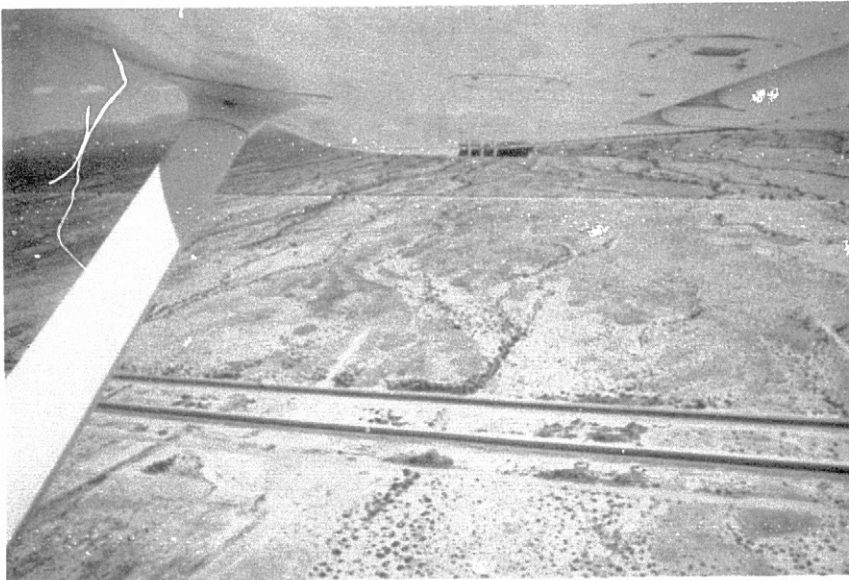
Figure 22. Infrared low-altitude photo of I-10 and areas upslope and downslope. (Structure #6).

As can be seen from Figure 22, the vegetation patterns are essentially the same both upslope and downslope, although vegetation densities are somewhat locally higher upslope along the diversion.

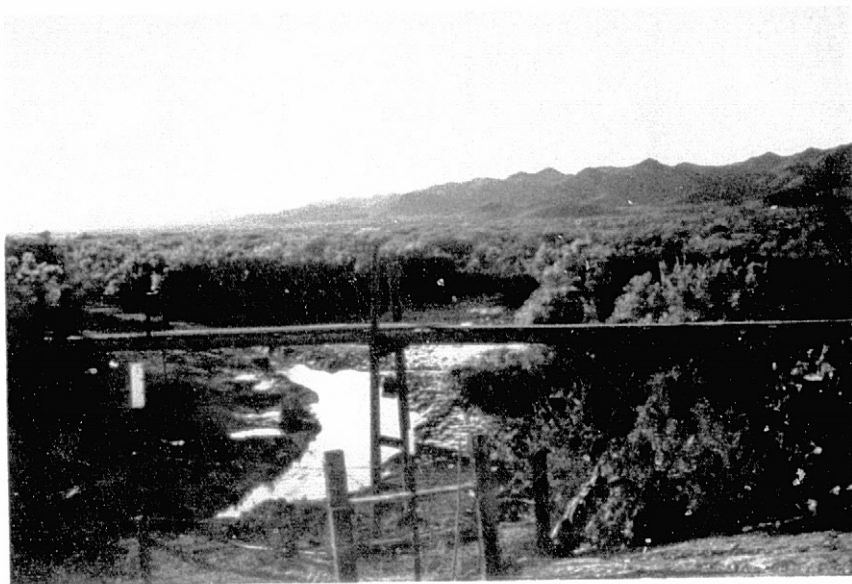
Associated with the standing water upstream is a very dense and vigorous stand of tamarisk. Further upstream tamarisk grades into Mesquite Desert-scrub Associations also of high density and vigor. Figure 27, a ground photo of upslope vegetation, and Figure 28, an infrared aerial photo of upslope vegetation, document the nature of upslope vegetation.

Figure 27. Ground truth photo of upslope vegetation (Structure #8).

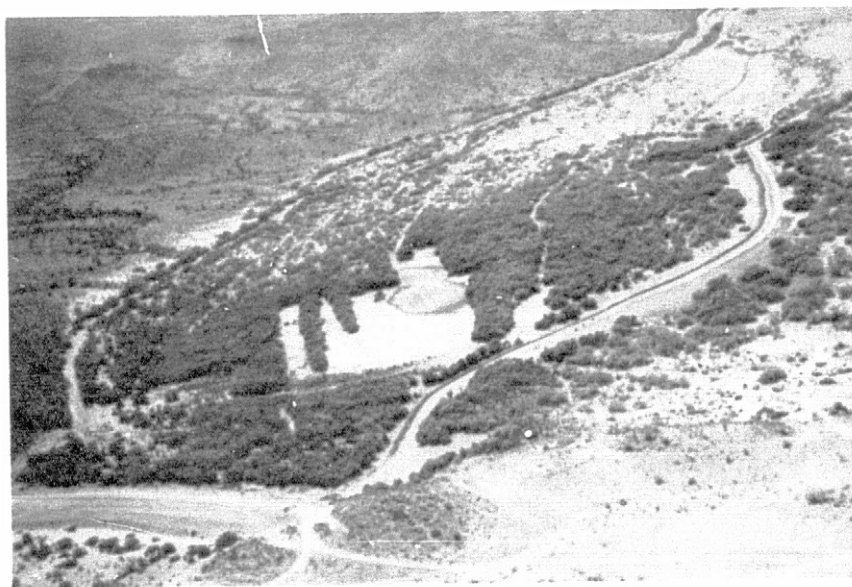
Figure 28. Infrared low-altitude photo of upslope vegetation.(Structure #8).

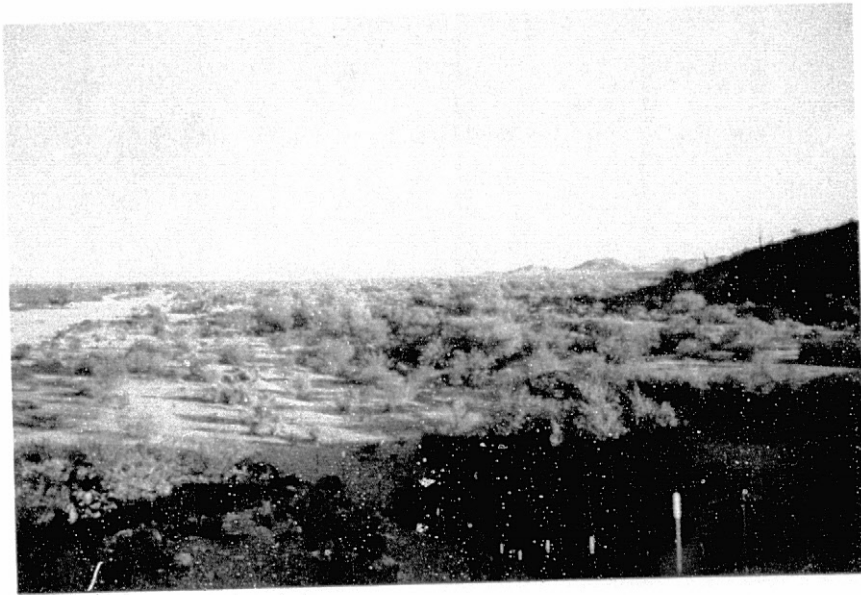
Downslope, vegetation along the stream channel consists of the Mesquite/Blue Paloverde type with scattered cottonwoods. A vegetation type consisting of foothill paloverde, creosote bush, and triangle-leaf bursage occupies the non-riparian areas both downslope and upslope from the structure. This vegetation type does not appear to be stressed. Figures 29 and 30 illustrate the vegetation downslope from the structure.

Figure 29. Ground truth photo of downslope vegetation (Structure #8).

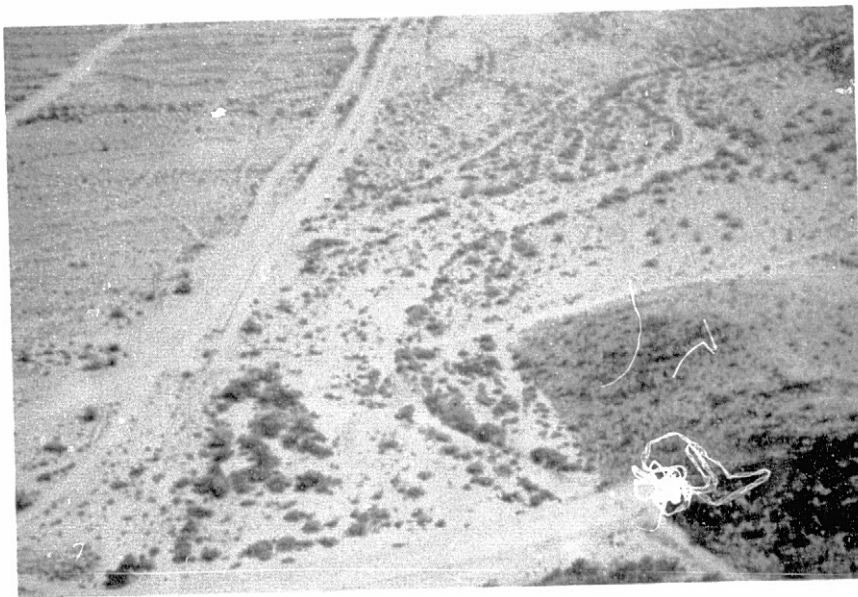
Figure 30. Infrared aerial photo of downslope vegetation (Structure #8).

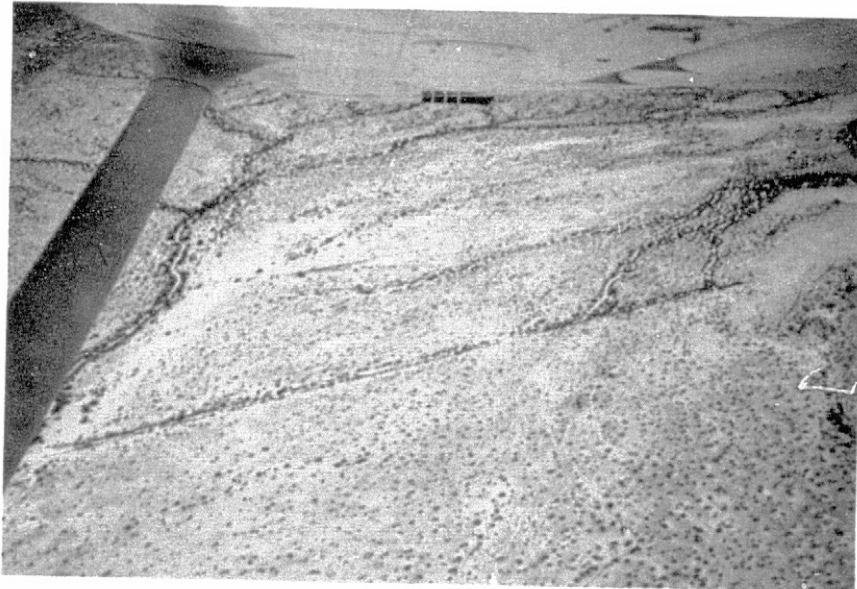
Vegetation both upslope and downslope from the structures consists of the Creosote Bush type with scattered mesquite and cholla. Mesquite is abundant along the upslope edge of the diversions. Cover and vigor of vegetation upslope and downslope from the structures has been little affected. Figure 33, an aerial photo of one of the structures, shows how it has possibly affected the alteration of water courses.

Figure 33. Infrared aerial photo of one of the structures (#10).

The alteration of stream courses and enhancement of vegetation cover immediately upslope appears to be the main effects of the structures.

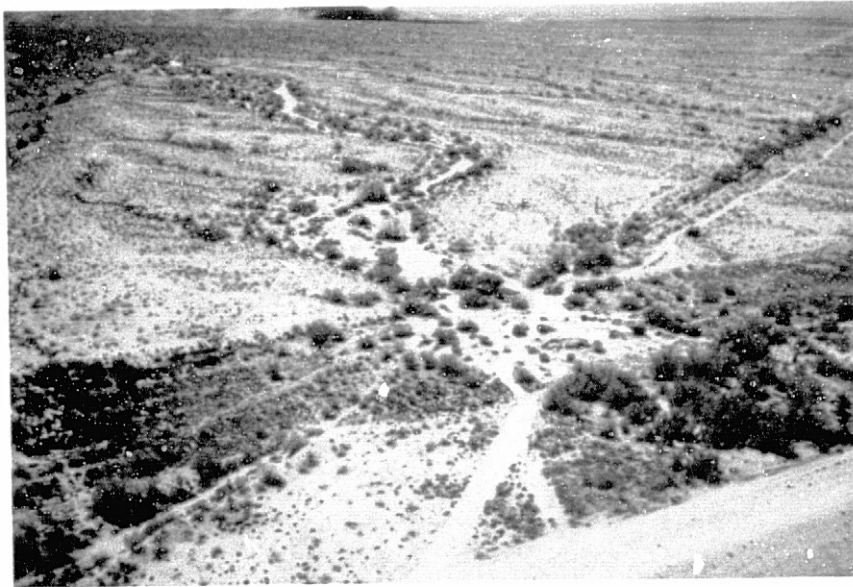
As is shown by Figure 34 (an aerial photo of the site) and Figure 35 (the vegetation map of the site) vegetation patterns are similar upslope and downslope, except for a narrow band of dense vegetation immediately upslope from the structure.

Figure 34. Infrared low-altitude photo of the diversion structure and upslope-downslope vegetation (Structure #11).

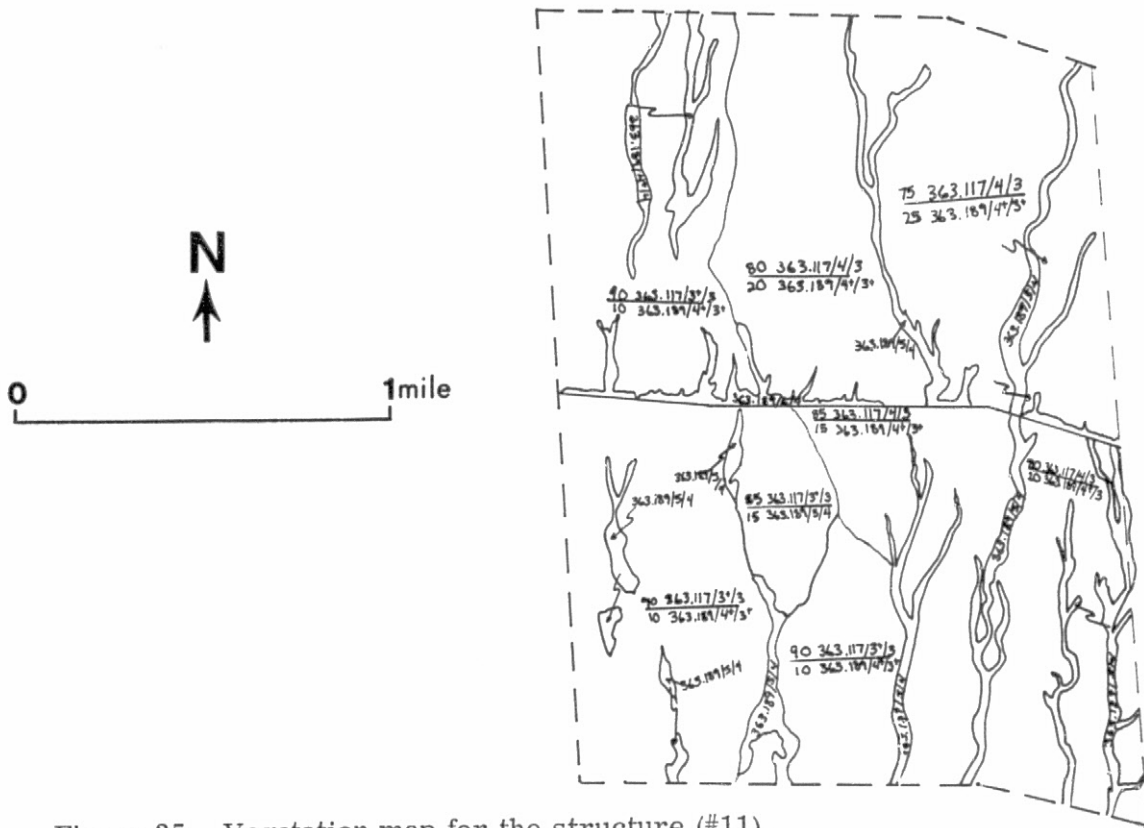
Figure 35. Vegetation map for the structure (#11).

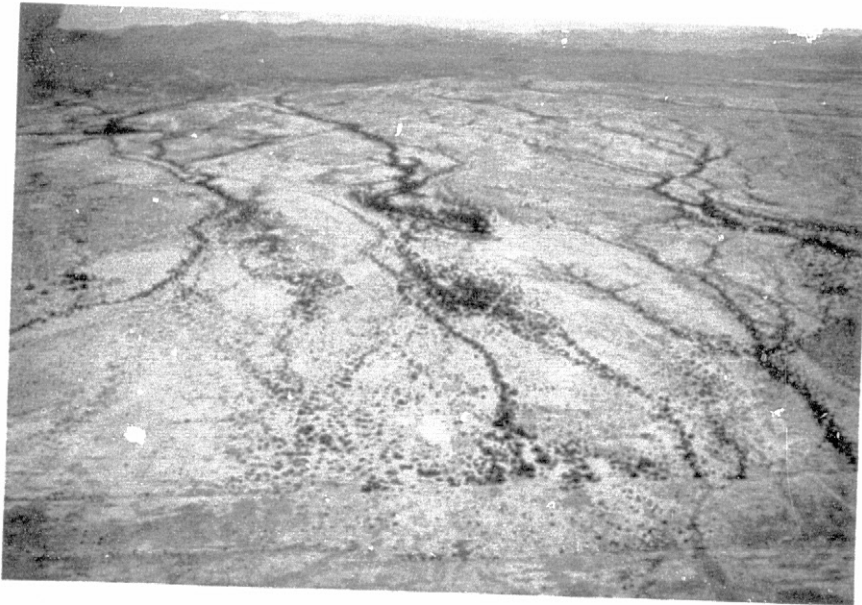
Figure 36. Low-altitude infrared photo of upstream vegetation showing high vegetation cover along washes (Structure #12).

As can be seen in Figure 36, the vegetation cover along the major washes is quite high. Interfluvial vegetative cover is intermediate. Vegetation vigor is average on the interfluvies, and from moderately high to very high along the washes.

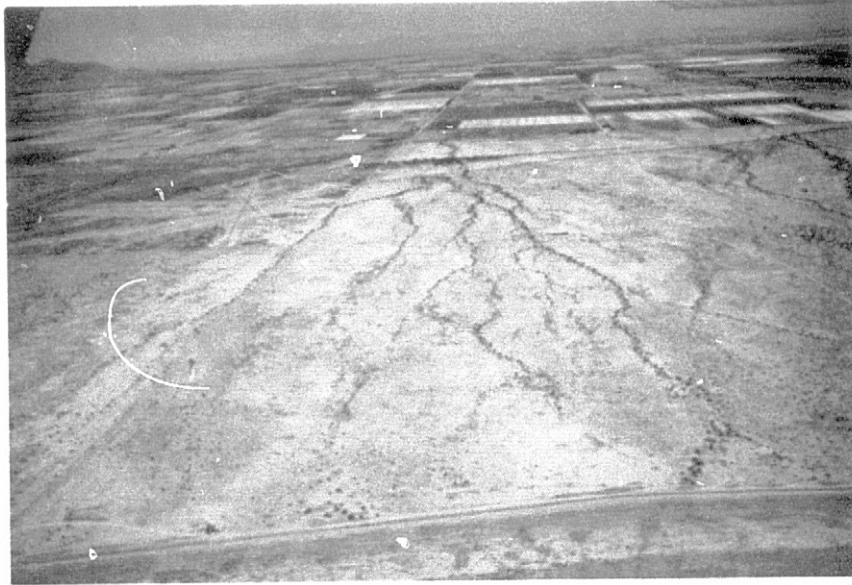
Downslope vegetation is the same as upslope vegetation with respect to species composition and distribution. Cover and vigor are much decreased downslope, however. Wash vegetation is especially affected, as is illustrated by the comparison of aerial photos of downslope and upslope vegetation (Figures 37 and 36, respectively).

Figure 37. Low-altitude infrared photo showing downslope vegetation.

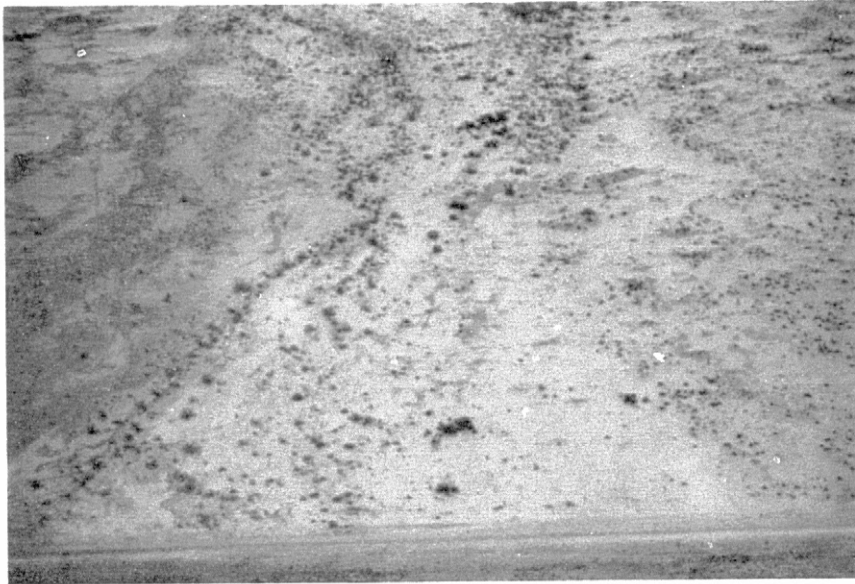
The vegetation upslope and downslope from the structure consists of the Creosote Bush type on the interfluves and the Mesquite type along the washes. Generally, the vegetation upslope is more vigorous and has higher cover than the vegetation downslope. As is illustrated by the comparison of Figure 40 (infrared aerial photo of downslope vegetation) to Figure 41 (infrared aerial photo of upslope vegetation), riparian vegetation upslope is much more dense and vigorous than downslope vegetation. Some of the riparian stands upstream are bosque-like in character while most riparian vegetation downstream is sparse and impoverished. Interfluve vegetation exhibits a smaller upslope-downslope difference in the aforementioned parameters than does riparian vegetation.

Figure 40. Infrared aerial photo of downslope vegetation (Structure #13).

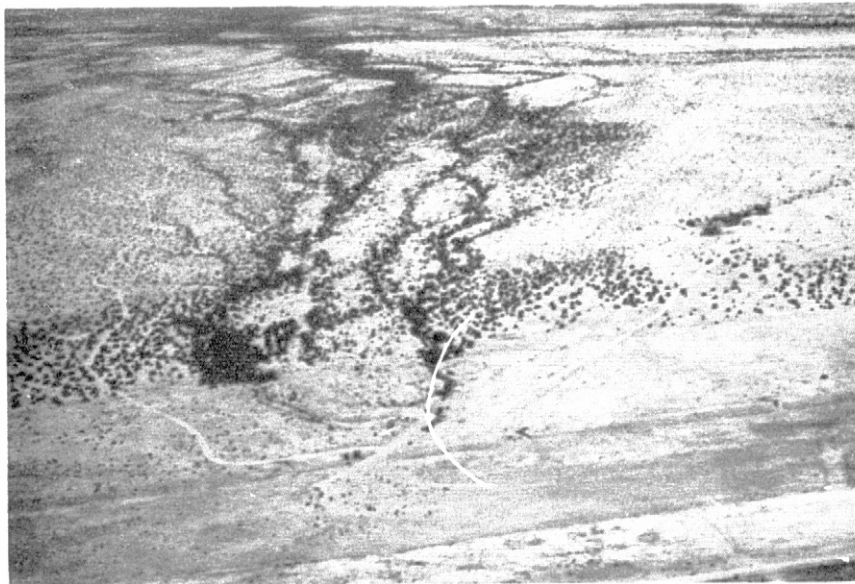
Figure 41. Infrared aerial photo of upslope vegetation (Structure #13).

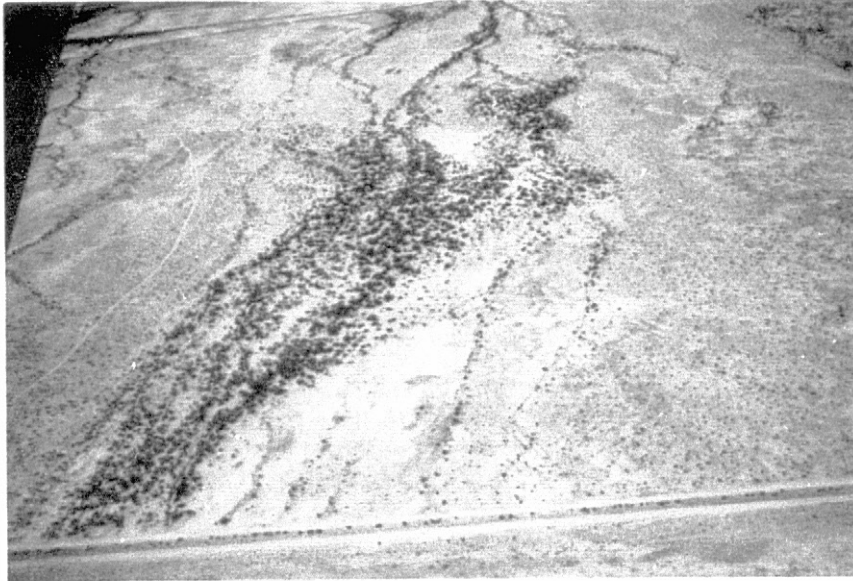
The vegetation upslope and downslope from the structure consists of the Creosote Bush type on interfluves and the Mesquite or Mesquite/Ironwood type along watercourses. The cover and vigor of the upslope vegetation is higher than that of downslope vegetation. Riparian vegetation downslope is severely stressed, while upslope it is quite vigorous. Figures 43 and 44 (color-infrared aerial photos of upslope and downslope vegetation, respectively) show the difference between upslope and downslope vegetation.

Figure 43. Infrared low-altitude photos of upslope vegetation (Structure #14).

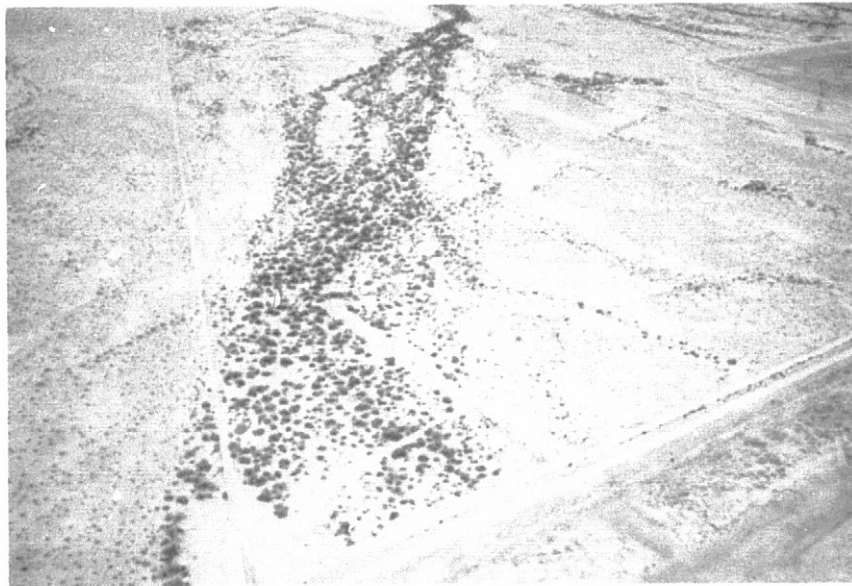
Figure 44. Infrared low-altitude photo of downslope vegetation (Structure #14).

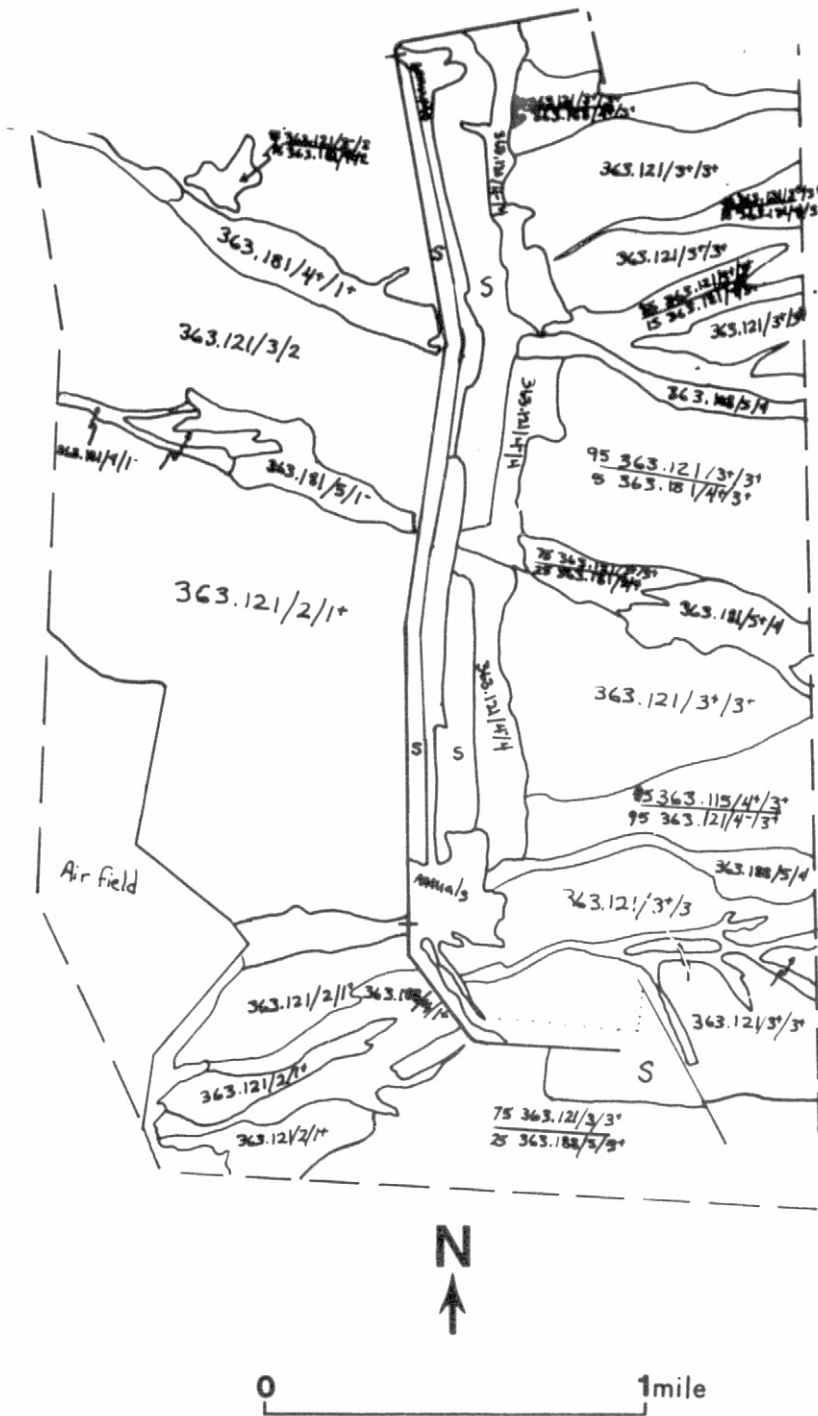
Figure 45, a vegetation map of the site, shows vegetation patterns upslope and downslope from the structure. There is a general buildup of riparian vegetation behind the structure and along incoming watercourses, although the overall patterns are the same on both sides of the structure.

Riparian vegetation, downstream from the only flow-through point, appears to be faring quite well when compared to other riparian vegetation downslope from the structure.

Figure 45. Vegetation map for Rittenhouse Dam (#14).

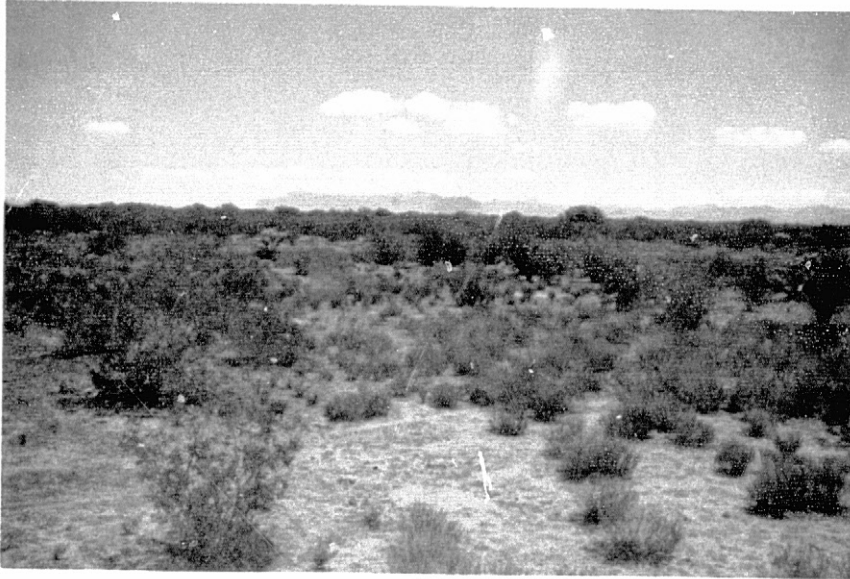
Downslope, interfluvial vegetation also consists of the Creosote Bush with cholla type; however, vegetation cover and vigor are much reduced. In some areas creosote bush appears to be almost dead. Downslope riparian vegetation consists of the Mesquite type or the Ironwood/Foothill Paloverde type. Vigor and cover of downslope wash vegetation is much lower than that of upslope wash vegetation. Figures 46, 47, and 48 (ground photos of upslope and downslope vegetation, and an aerial photo of the structure and upslope-downslope vegetation, respectively) illustrate the differences between upslope and downslope vegetation.

Figure 46. Ground truth photo of upslope vegetation (Structure #15).

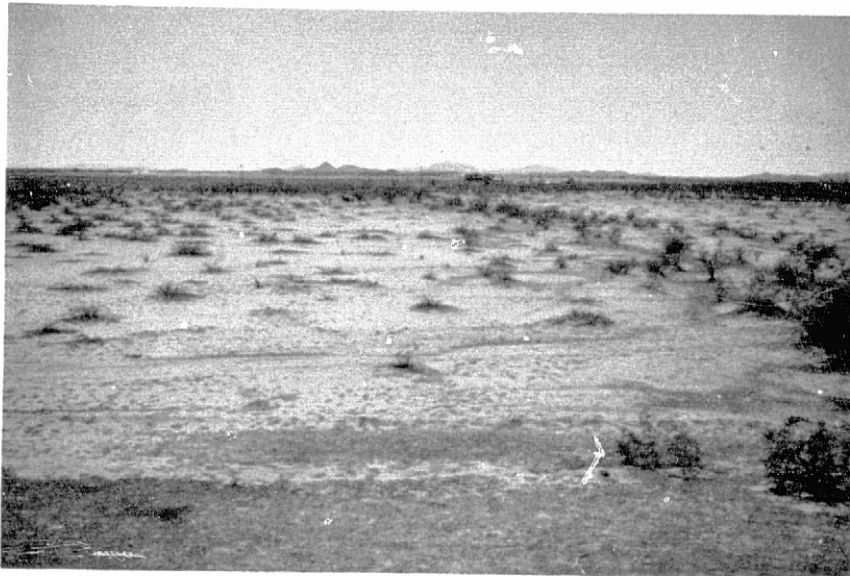
Figure 47. Ground truth photo of downslope vegetation (Structure #15).

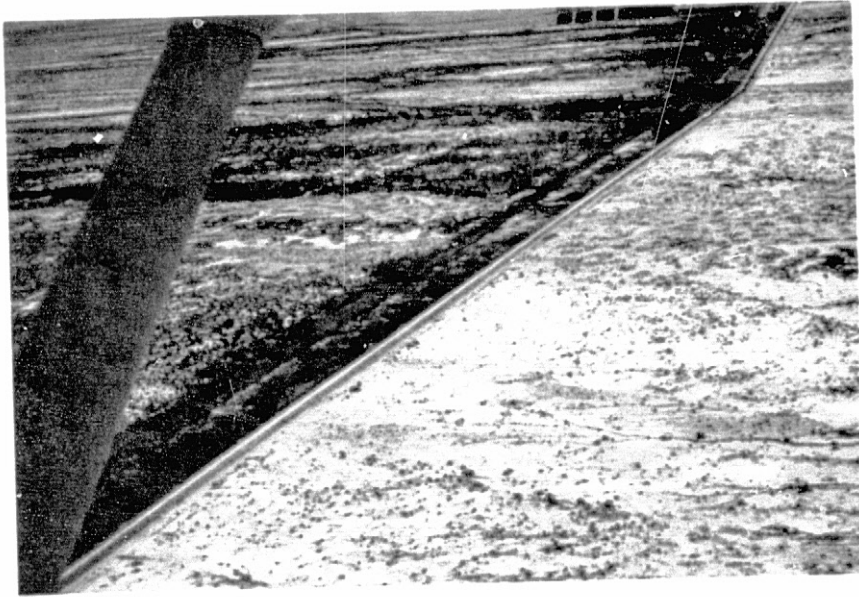
Figure 48. Infrared aerial photo of the structure and upslope-downslope vegetation (Structure #15).

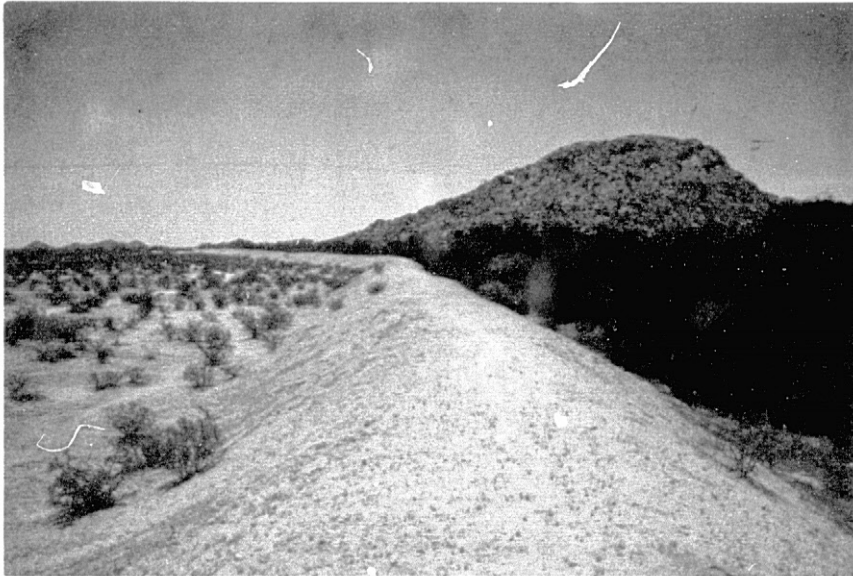
Vegetation upslope and downslope from the structure consists of the Foothill Paloverde/Ironwood type along the washes and the Creosote Bush type on the inter-fluves. Adjacent and upslope from the structure, the vegetation consists of the Ironwood/Mesquite/Blue Paloverde type as is shown in Figure 53. The vegetation adjacent and upslope from the diversion and in the canal consists of the Tamarisk/Mesquite type.

Figure 53. Ironwood/Mesquite/Blue Palo Verde type adjacent and upslope from the structure (#10).

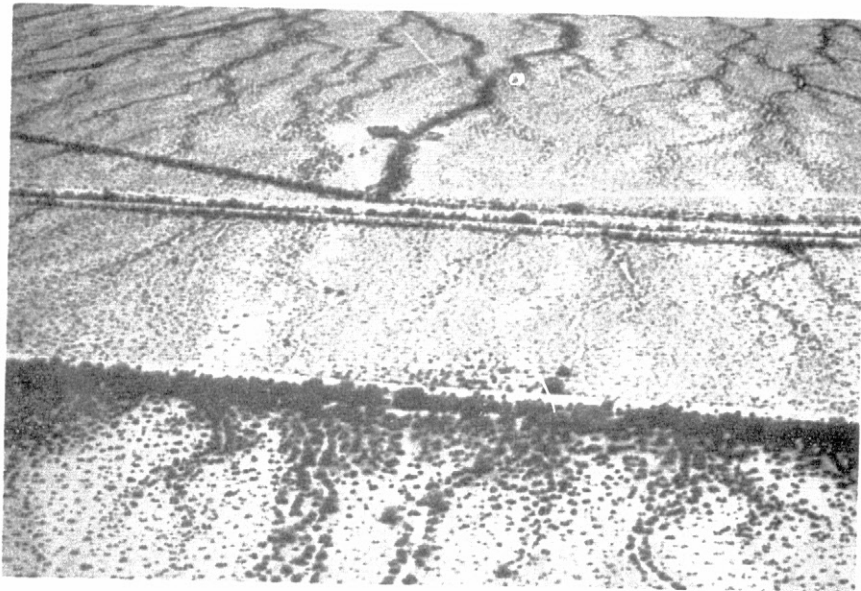
Except for the areas just upslope from the diversion structure and canal, upslope and downslope vegetation have similar cover and vigor. The vegetation in the canal, upslope from the canal, and immediately upslope from the diversion structure, is quite dense and vigorous. Figure 54, an aerial color-infrared photo of the site, illustrates the differences in vegetation vigor and cover.

Figure 54. Aerial infrared photo of the structure and associated vegetation (Structure #18).

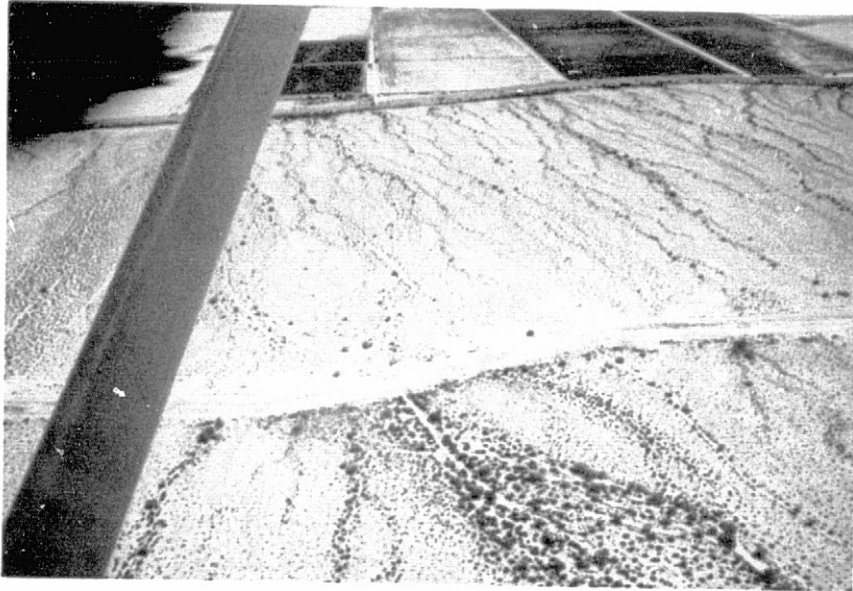
In general, vegetation upslope has more cover and vigor than vegetation downslope. Riparian vegetation adjacent and upslope from the structure is quite luxuriant and vigorous. Downslope vegetation, when compared to similar vegetation not in the immediate vicinity of the structure, is of lower cover and vigor. Figure 56, an aerial infrared photo of the site, shows the differences in upslope-downslope vigor and cover.

Figure 56. Aerial infrared photo of the structure and upslope-downslope vegetation (#18B).

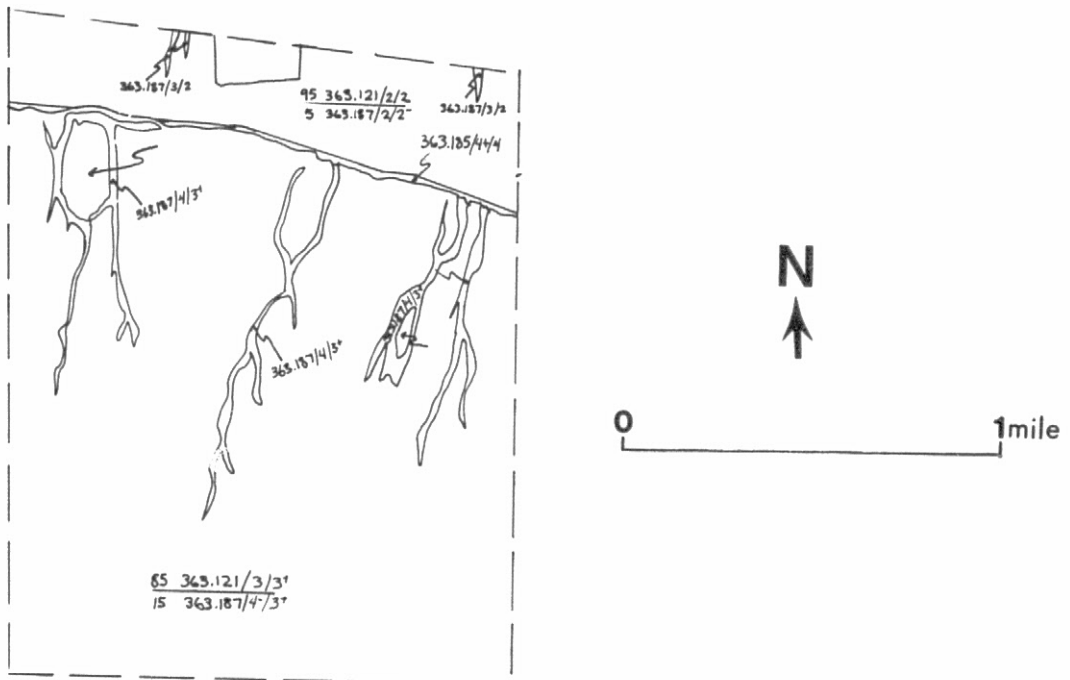
Due to the presence of agricultural fields a short distance downstream from the diversion, more upslope vegetation was mapped than downslope vegetation, as is shown by Figure 57, the vegetation map of the site. Because of the paucity of downslope vegetation data, conclusions regarding the differences in vegetation patterns upslope and downslope from the diversion are tenuous. The map does suggest however, that riparian vegetation patterns are interrupted by the structure.

Figure 57. Vegetation map for I-10 Site (#18B)

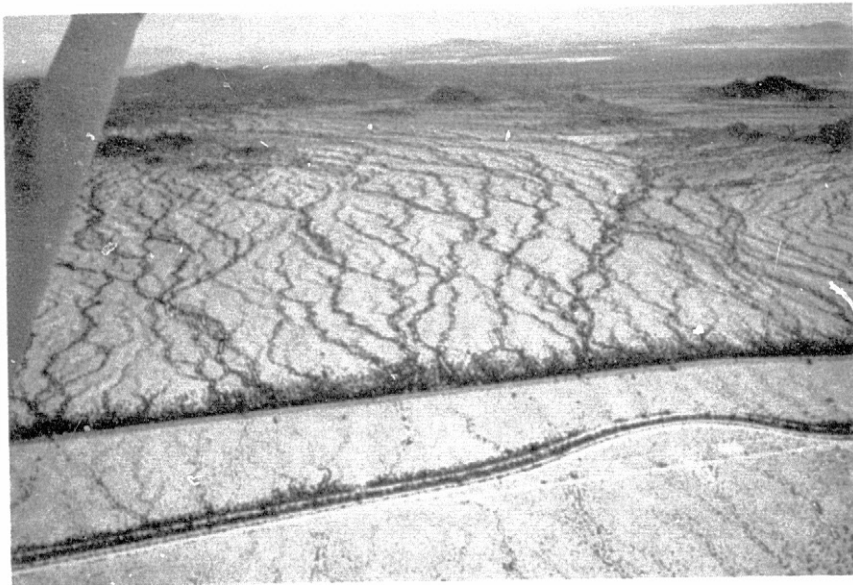
With the exception of some dense vigorous riparian vegetation along washes upslope from the diversion, upslope and downslope vegetation is quite similar with respect to cover and vigor. Figure 58, an aerial infrared photo of the site, shows the upslope-downslope vegetation.

Figure 58. Infrared low altitude photo of the structure and associated vegetation (#18C).

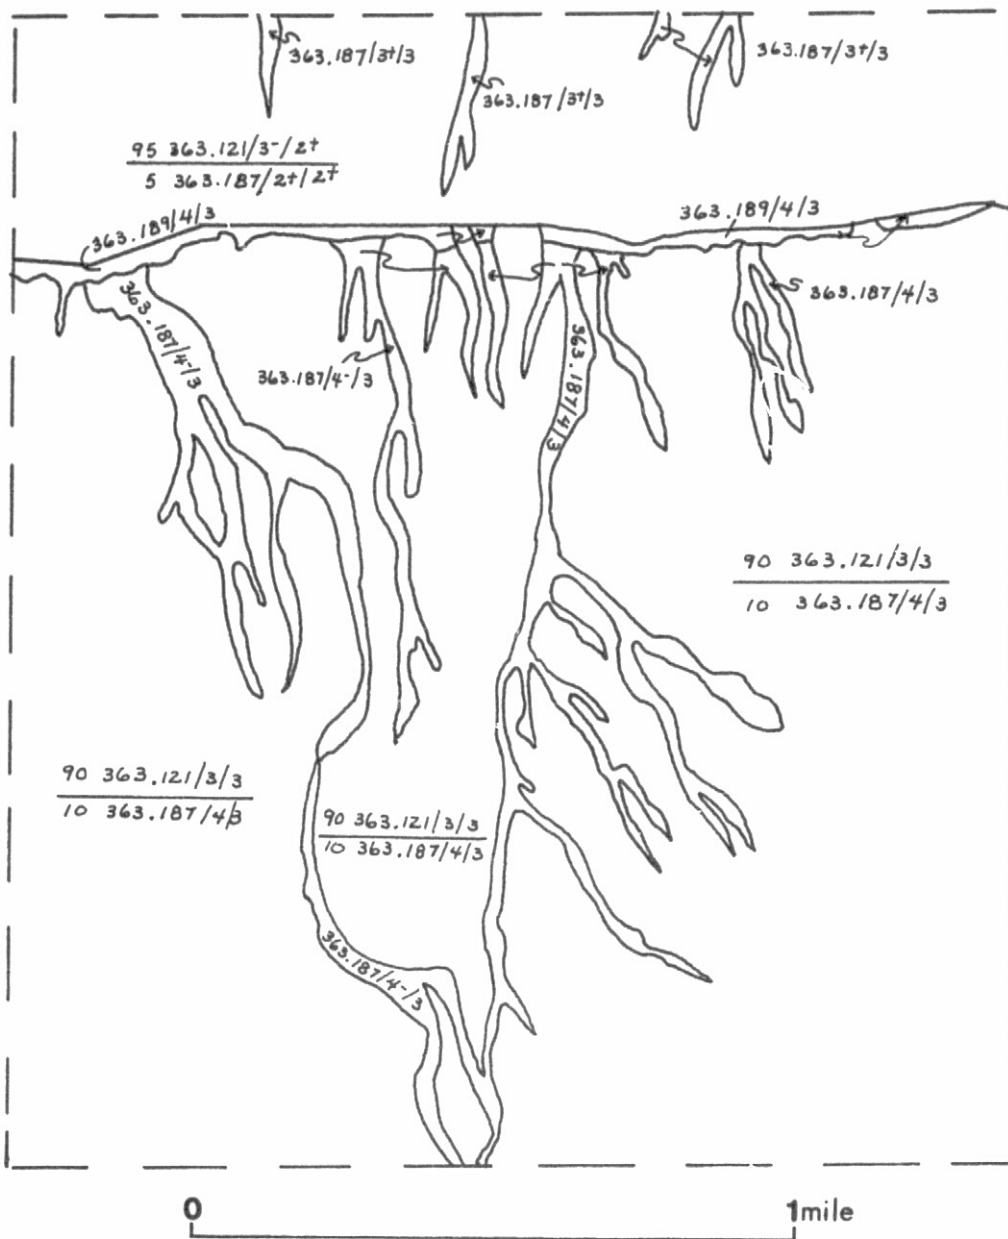
Figure 59. Vegetation map for Agency Peak Site (#18C).

As is shown by the vegetation map of the site, Figure 59, comparison of upstream-downstream vegetation patterns is made more difficult by the presence of agricultural fields downslope. The map suggests, however, that the riparian patterns are interrupted by the diversion structure.
