OH-58 HELICOPTER TRANSMISSION FAILURE ANALYSIS

by D. P. Townsend, J. J. Coy,* and B. R. Hatvani
Lewis Research Center
Cleveland, Ohio 44135
January, 1976

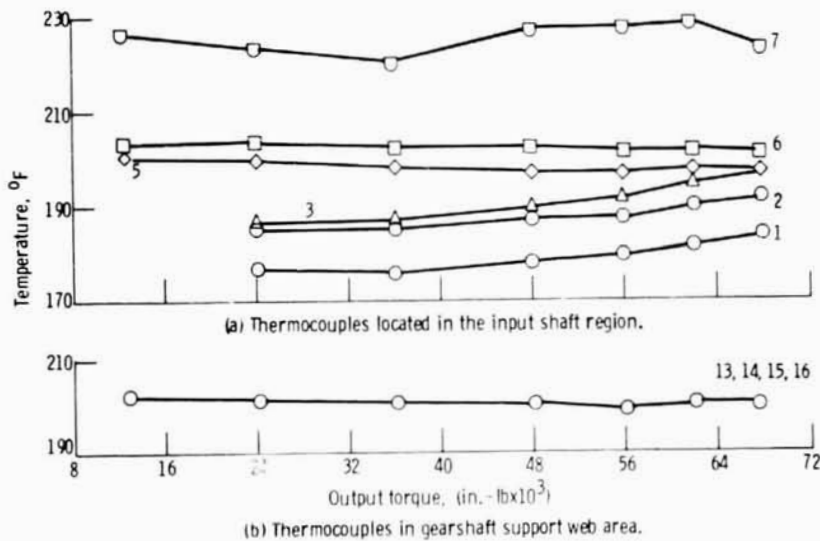
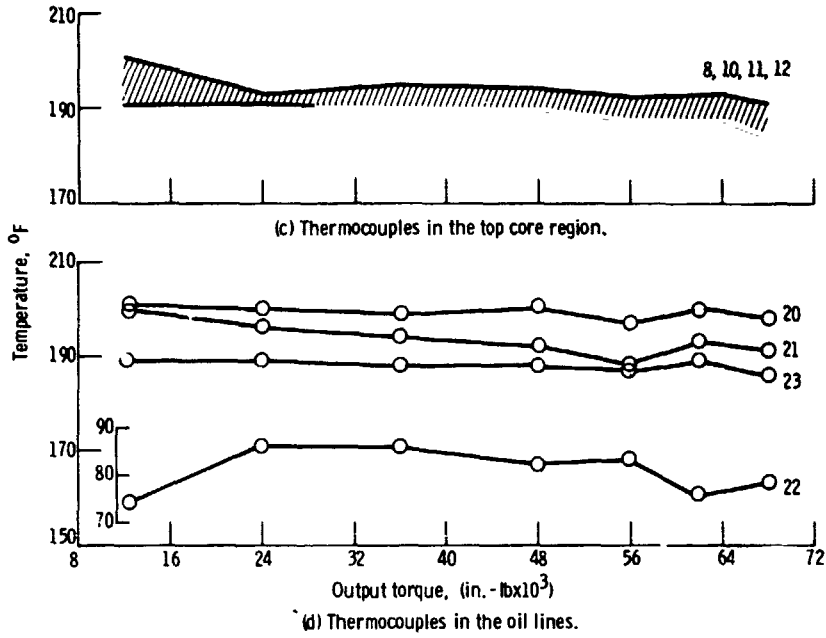
Figure 6 contains the temperatures of the various transmission components as a function of output torque. The respective numbers in the figure indicate the location of the thermocouples in figure 2(a). The oil-out temperature was maintained at 200° F and the input speed was 6200 rpm. The temperature recorded for the 67 000 inch-pound torque (140 percent power rating) was not stabilized due to the short time at which this overload condition (140 percent torque) was maintained. The highest temperature was recorded for the pinion seal which was 228° F at an output torque of 62 400 inch-pounds (130 percent power rating).

Figure 6. - OH-58 transmission stabilized temperatures as a function of output torque. Input speed, 6200 rpm; oil-out temperature, 200^o F.

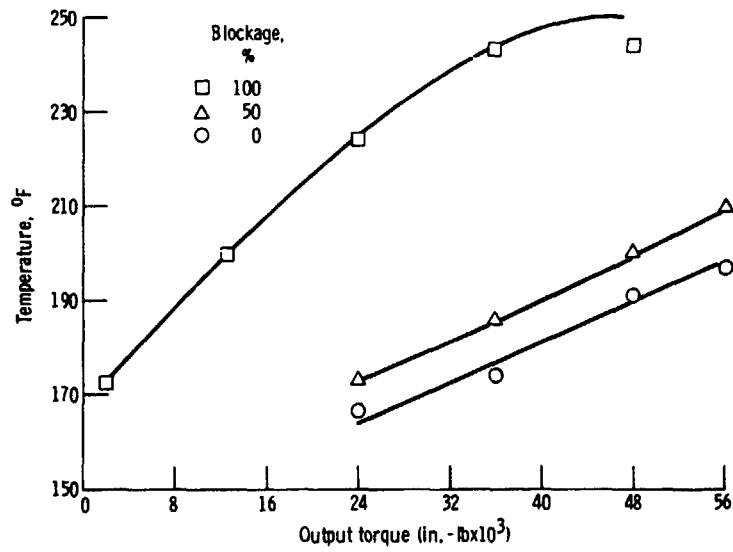
In order to determine the transmission oil-out stabilization temperature, the transmission was run with different output torque conditions while the oil cooler was either completely blocked, partially blocked or completely open. The results of these tests are summarized in table I and shown in figure 7. The maximum oil-out temperature obtained for zero percent and 50 percent oil cooler

Figure 7. - Stabilized oil-out temperatures as a function of output torque for different amounts of oil cooler blockage. Input speed, 6200 rpm.

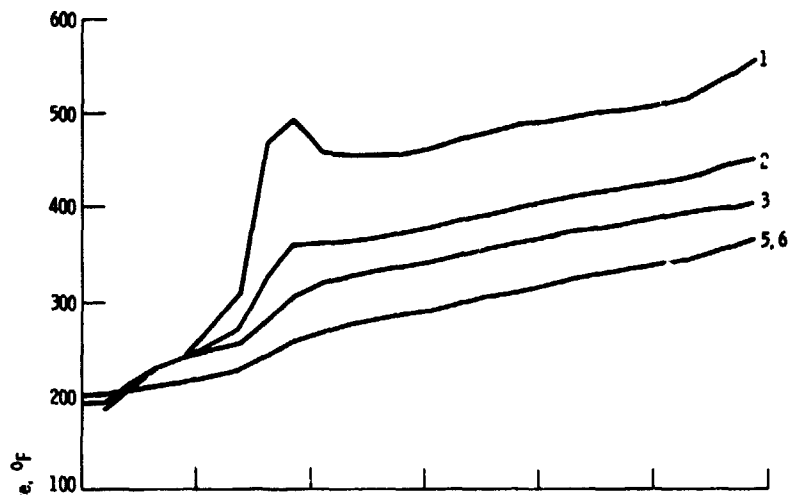
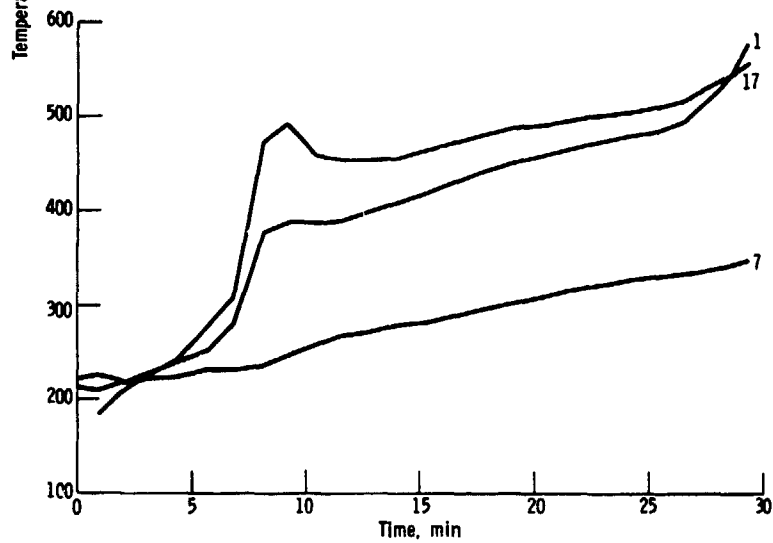
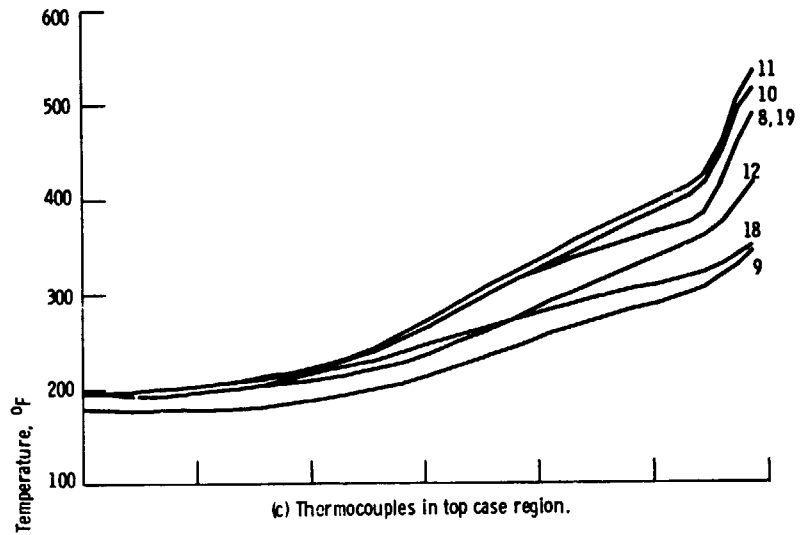
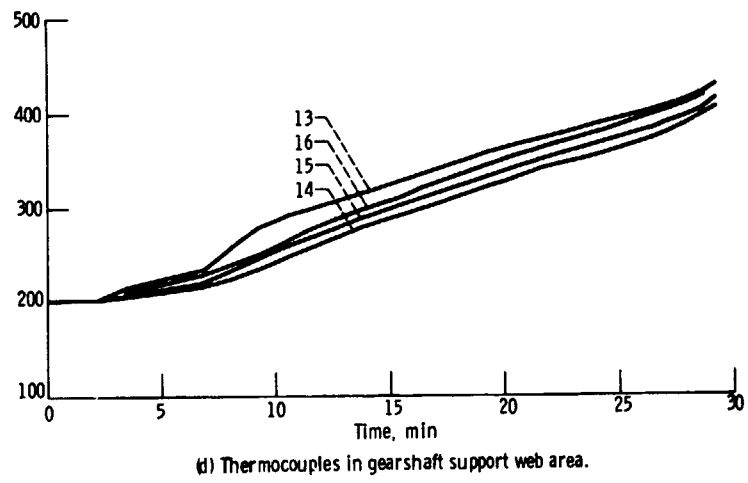
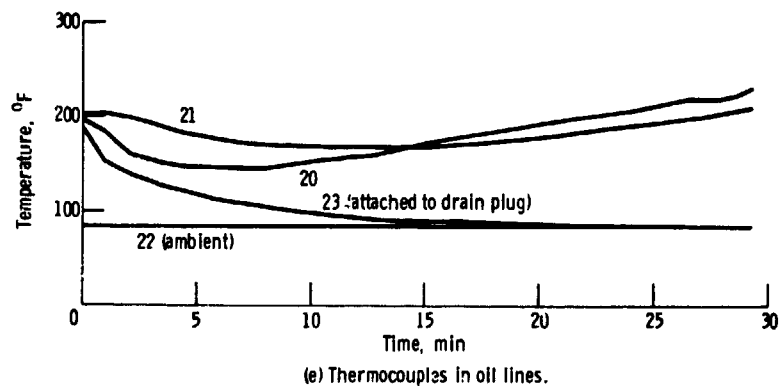
At a torque level of 36 000 inch-pounds and a speed of 6200 rpm the drain plug at the bottom of the transmission housing was removed and the oil in the transmission was allowed to drain out. The results of this test are shown in figure 8 wherein the component temperatures are shown as a function of time. Time zero is the time at which the oil drain plug was removed.

Figure 8(c) shows an increase in temperature in the planet gear area at approximately 13 minutes.

The rate of increase of the pinion temperatures slowed until at approximately 14 minutes the rate began to increase again (figs. 8(a) and (b)). These increases in temperature were caused by additional planet bearing cages melting which allowed the spherical rollers in the planet gear bearings to tumble and slide within the bearings (fig. 11).

At approximately 27 minutes there is an additional increase in the rate of temperature rise as seen in the planet and (fig. 8(c)), the pinion area (figs. 8(a) and (b)) and to a lesser extent in the bevel gear bearing area (fig. 8(d)). At this point in time the gearbox is approaching complete failure. At these temperatures, the planet gears have very little strength. The lock nut on the planet bearing was being machined by the bevel gear bolt heads (fig. 12). The pinion

Figure 8. - Temperature as a function of time for survivability test of OH-58 transmission. Input speed, 6200 rpm; output torque, 36 000 in.-lb.

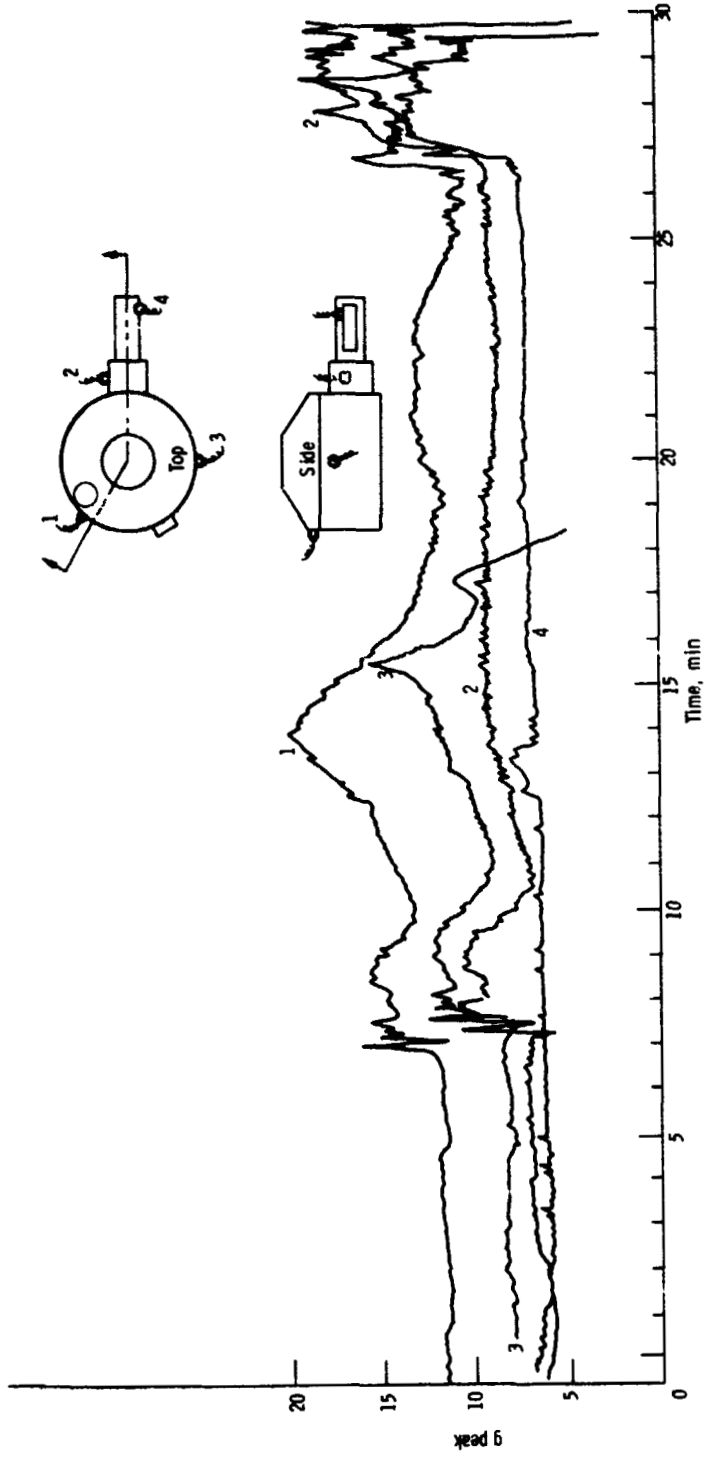
Figure 13. - Time history of acceleration measured on transmission during survivability test. Input speed, 6200 rpm; output torque, 36 000 in.-lb.

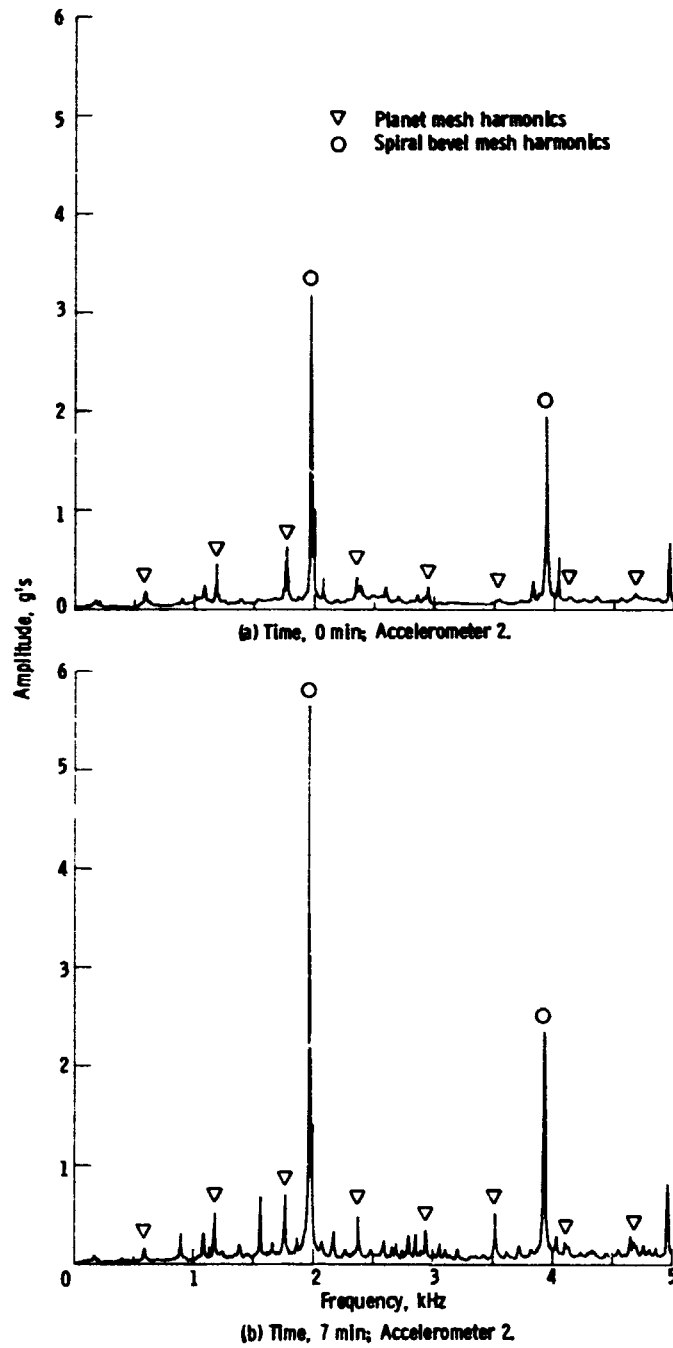
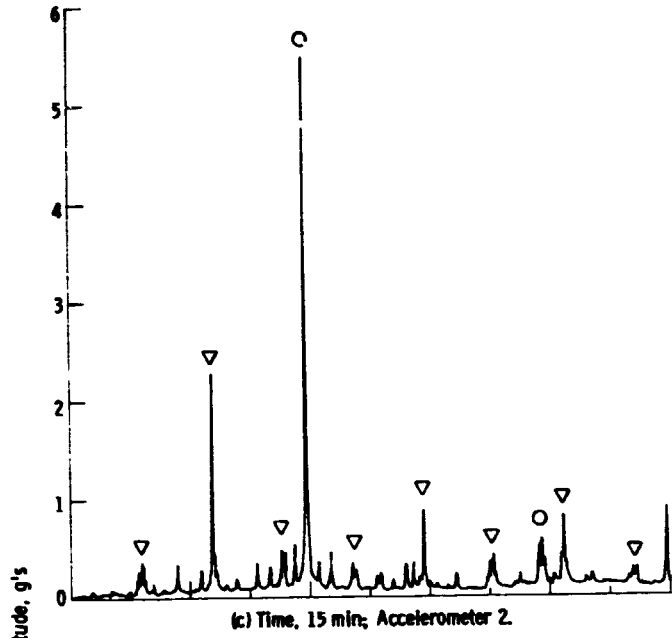
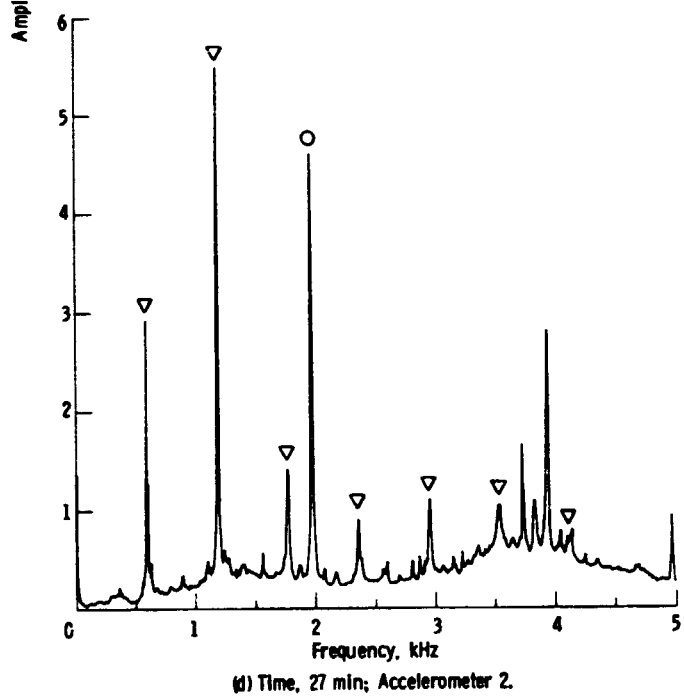
Figure 14. - Input pinion amplitude spectrum for survivability test. Input speed, 6200 rpm; output torque, 36 000 in.-lb.

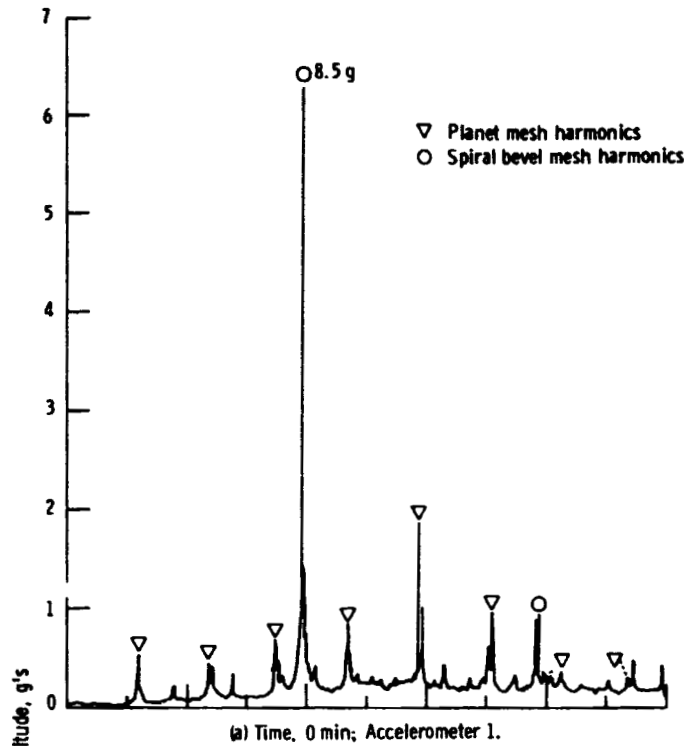
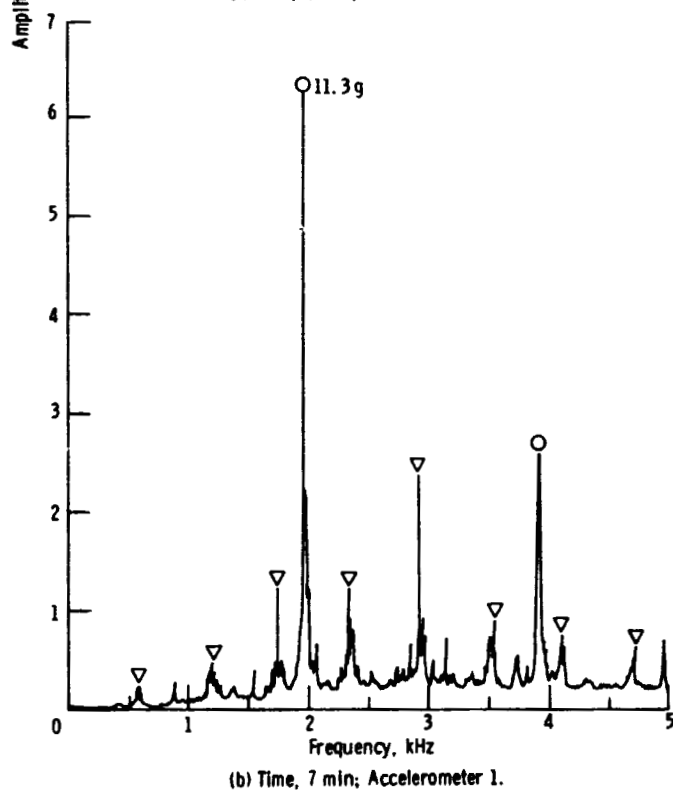
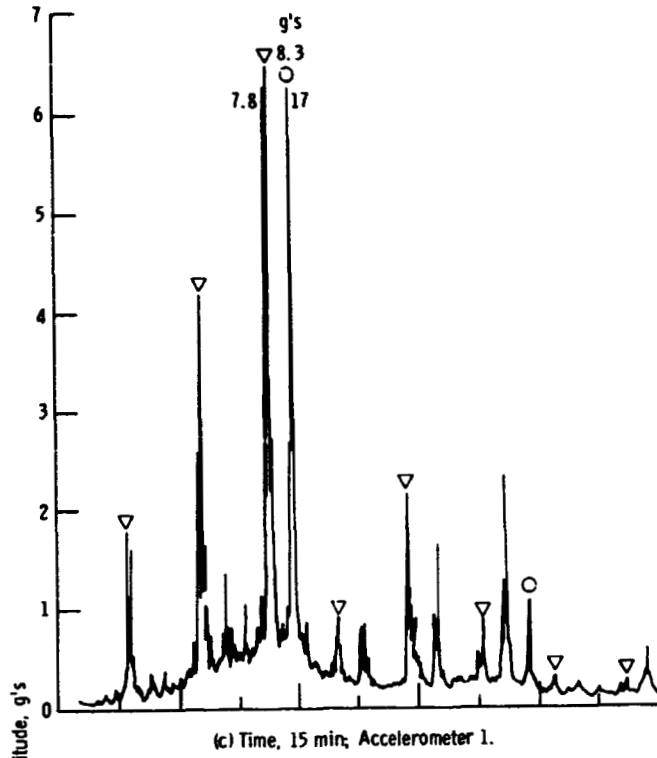
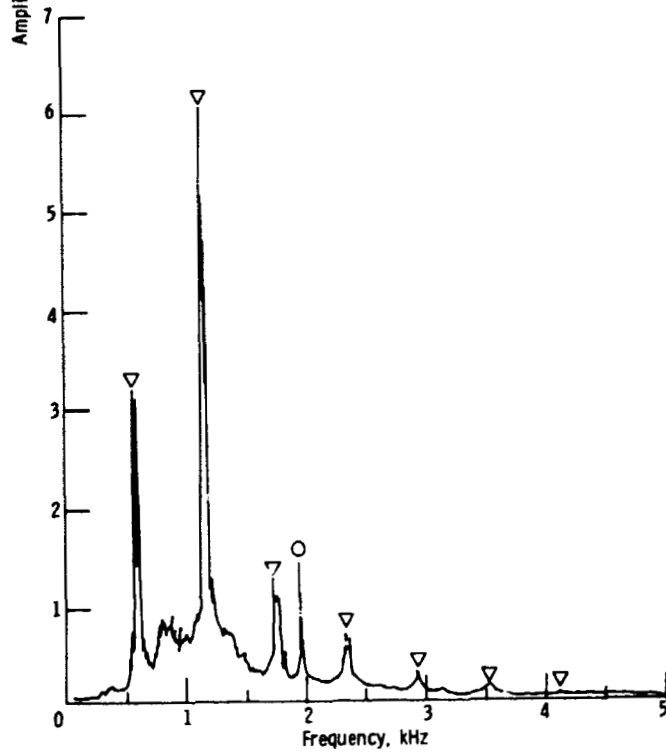
Figure 15. - Ring gear amplitude spectrum for survivability test. Input speed, 6200 rpm; output torque, 36 000 in. - lb.
