NASA TM X- 72797

EVALUATION OF HIGH PRESSURE WATER BLAST WITH ROTATING SPRAY BAR
FOR REMOVING PAINT AND RUBBER DEPOSITS FROM AIRPORT RUNWAYS,
AND REVIEW OF RUNWAY SLIPPERINESS PROBLEMS CREATED BY RUBBER
CONTAMINATION

Walter B. Horne, Langley Research Center and
Captain Guy D. Griswold, Base Civil Engineers
Langley Air Force Base

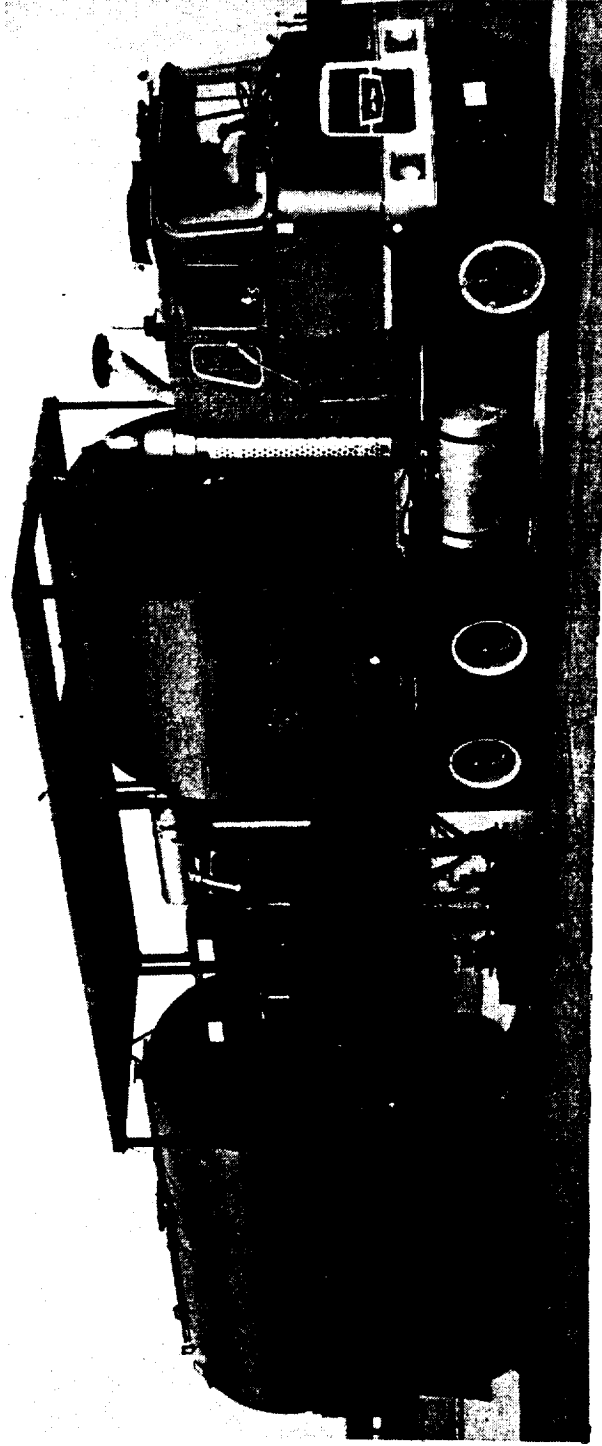
a) Overall View of Equipment

b) Close-up View of High Pressure Water Rotating Spray Bar

4- FIGURE I. - HIGH PRESSURE WATER PAINT AND RUBBER REMOVAL EQUIPMENT
REMOVING PAINT STRIPE ON LAFB RUNWAY 25.

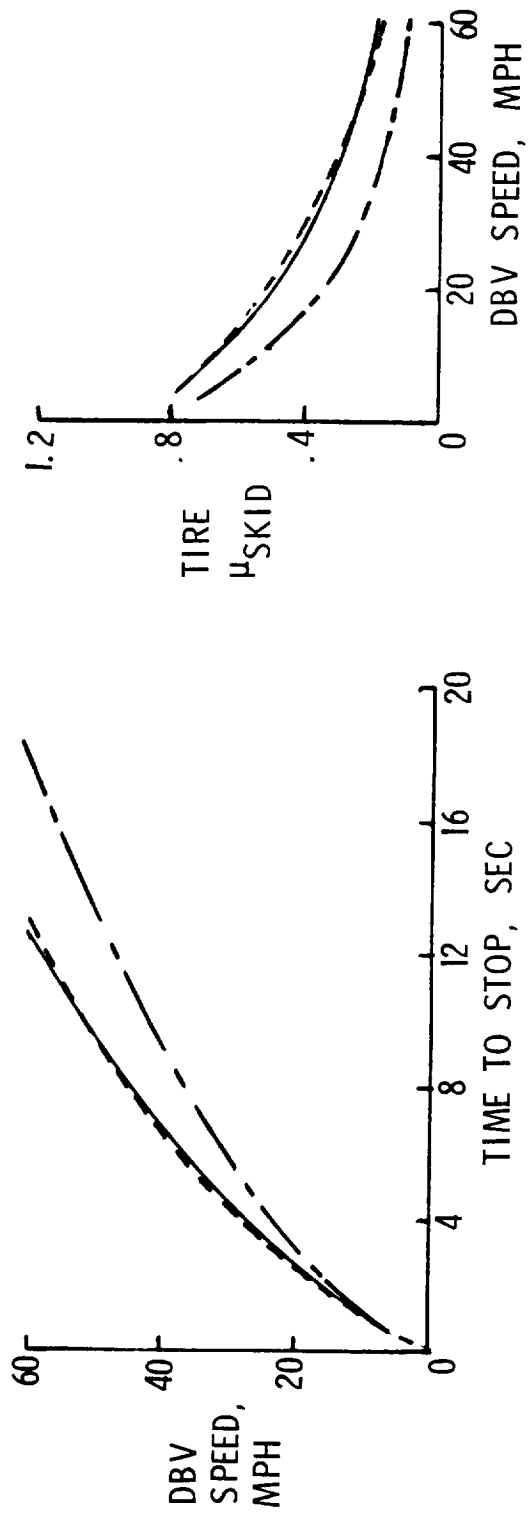
FIGURE 13. - COMPARATIVE DBV STOPPING AND TIRE FRICTION PERFORMANCE ON LAFB RUNWAY 25 UNDER ARTIFICIALLY WET CONDITIONS; 0.02 - 0.03 in. WATER DEPTH

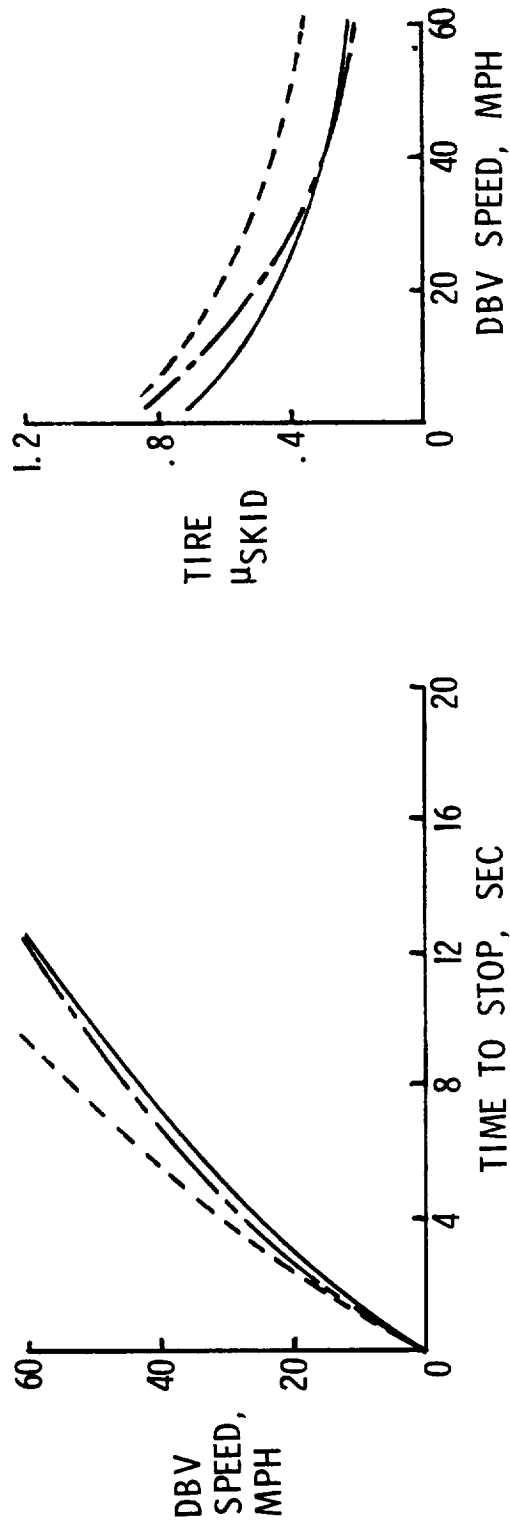
Runway marking paints are used to make runways more visible and recognizable to pilots during approach and landing. However, runway paints are viscous fluids that have reflective glass beads added during application to enhance the paint's reflectivity. This paint and glass bead combination when applied to a runway pavement hardens into a smooth surface that usually has a reduced microtexture over the surface that it coats. The result is painted surfaces are usually more slippery when wet than unpainted adjacent runway surfaces. Such a result obtained during the present investigation as shown in figure 14 which compares DBV and tire μ_{skid} braking performance on painted and unpainted surfaces of runway 7.

FIGURE 14. - COMPARATIVE DBV STOPPING AND TIRE FRICTION PERFORMANCE ON PAINTED AND CLEAN (NO RUBBER) SURFACES OF LAFB RUNWAY 7 UNDER ARTIFICIALLY WET CONDITIONS; 0.02 - 0.03 IN. WATER DEPTH

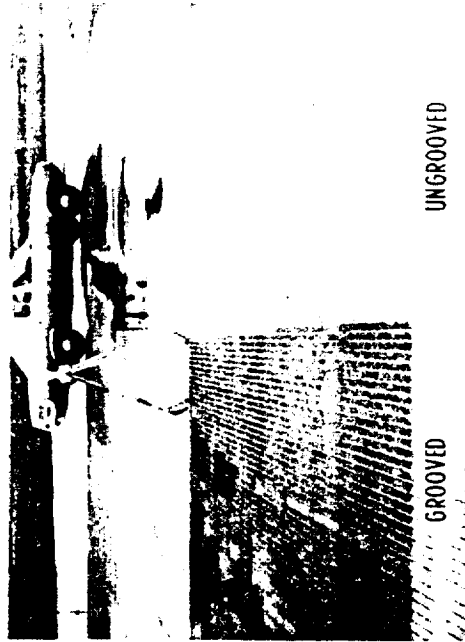
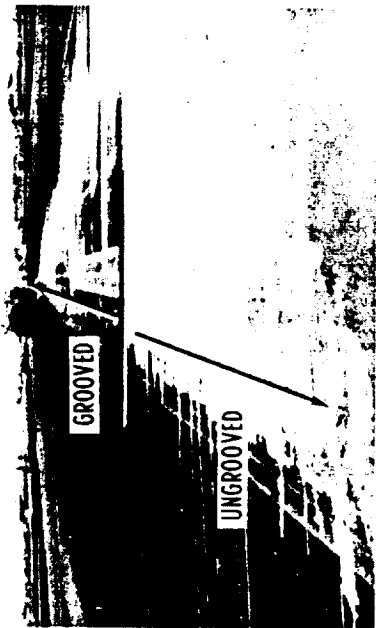
FIGURE 15. - WATER DRAINAGE FOLLOWING WATER TRUCK WETTING FROM GROOVED AND UNGROOVED SURFACES OF A SMOOTH ASPHALTIC CONCRETE RUNWAY.

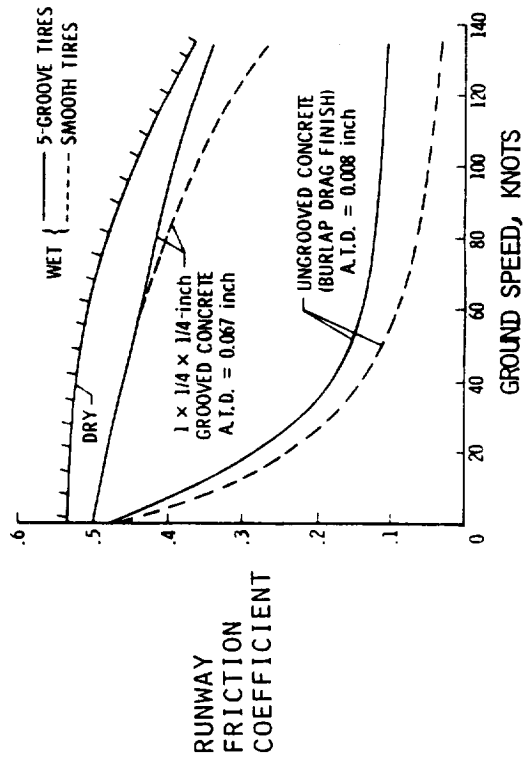
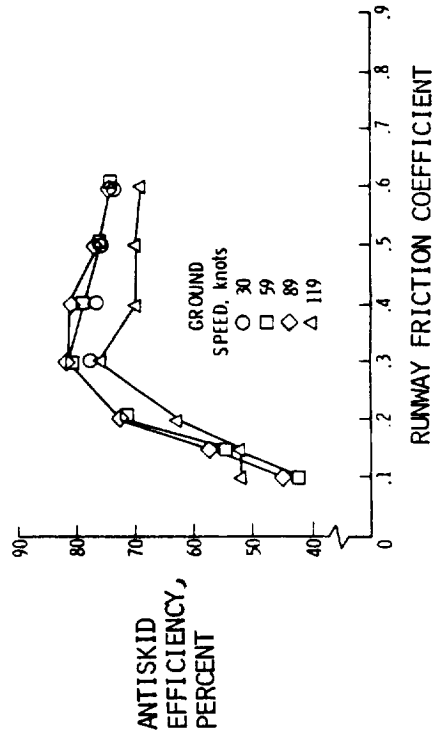
The data in figure 17 (obtained from reference 3) illustrate the powerful effect a close groove spacing (1 x 1/4 x 1/4 inch) has on recovering tire traction lost by a conventional concrete surface treatment (Burlap drag) due to poor ability to drain water from the tire-pavement contact zone. These data also indicate that aircraft stopping capability is further increased by grooving because the high traction levels developed on a grooved runway allow the aircraft antiskid braking system to operate at a higher efficiency. The low DBV SDR values obtained on non-rubber contaminated grooved pavements and shown in tables VII, and VII, and IX, and X further substantiate the effectiveness of grooving treatments in restoring or maintaining good pavement skid resistance during wet runway conditions. These data also confirm the expected trend for grooving effectiveness to decrease as the groove spacing is increased.

FIGURE 17. - WET RUNWAY SURFACE TEXTURE EFFECTS ON TIRE/ AIRCRAFT BRAKING TRACTION.

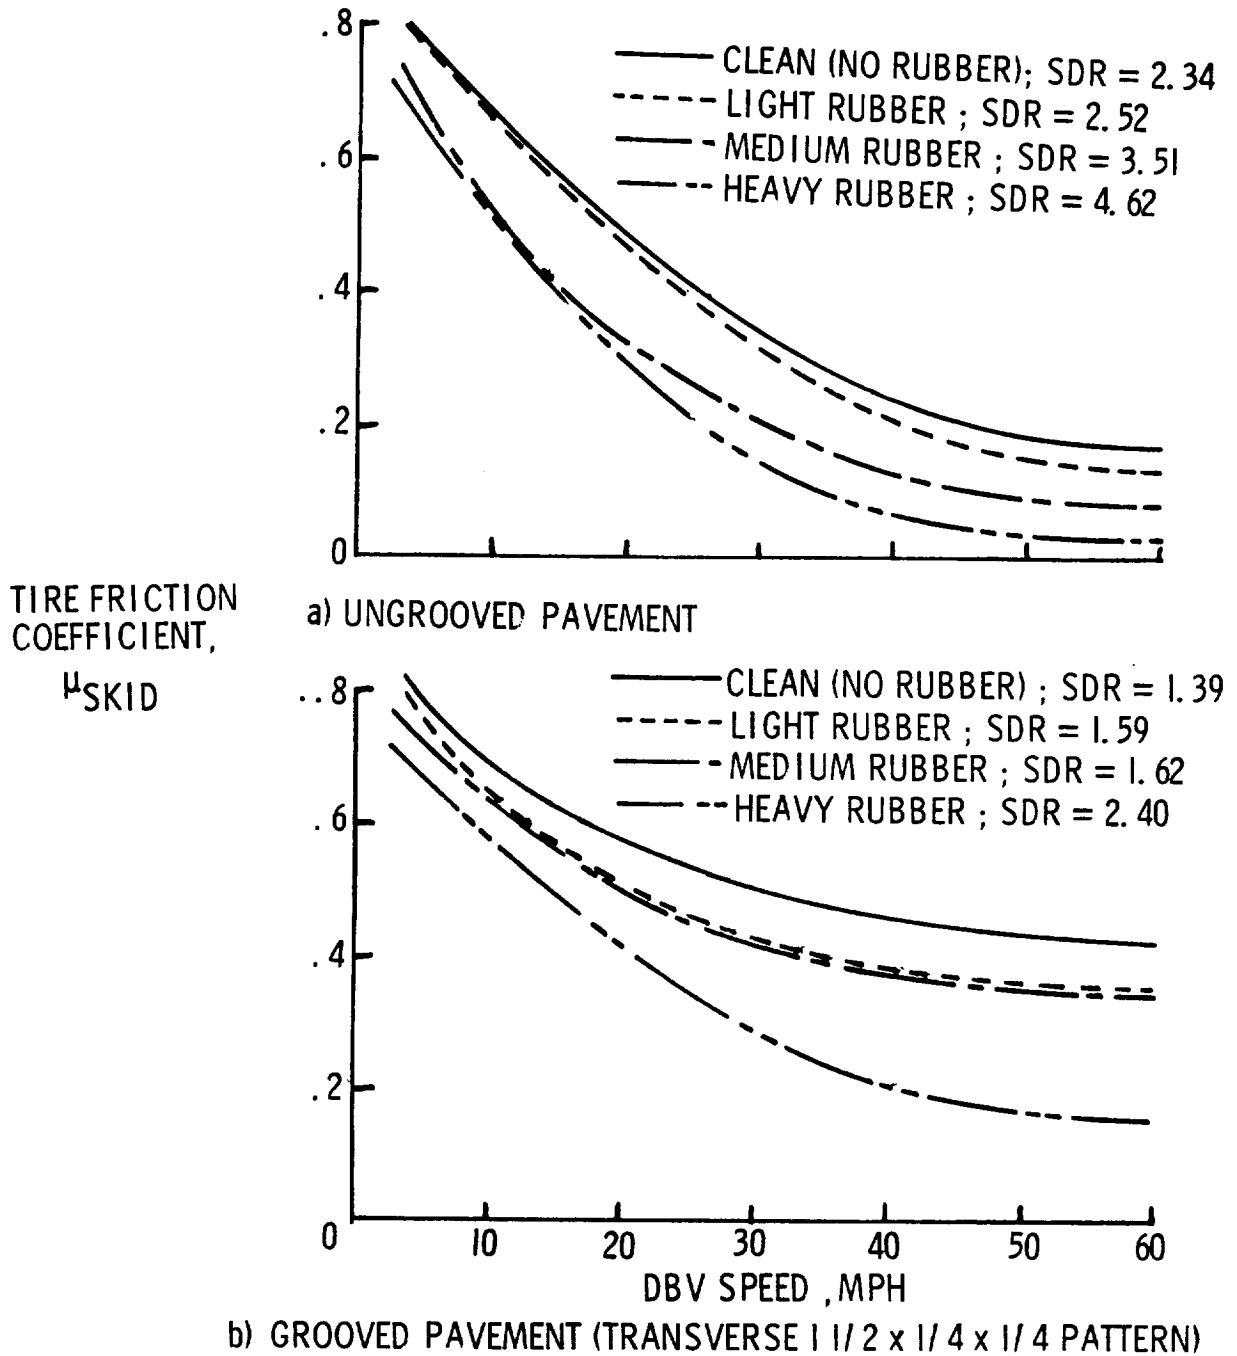
DBV braking tests were made at Miami International Airport (M.I.A.) while runways 9R/27L and 9L/27R were being grooved to a 1 1/2 x 1/4 x 1/4 inch pattern (LWP-1114). These tests were conducted in grooved and ungrooved areas of the runway where rubber deposits ranged from heavy to light. Also included were tests areas free of rubber contamination. These data are presented in figure 19 and show a large reduction in DBV SDR due to improved pavement skid resistance as a result of grooving.

FIGURE 19. - EFFECT OF RUBBER DEPOSIT ACCRETION ON DBV SDR AND TIRE μ_{SKID} OBTAINED ON WET GROOVED AND UNGROOVED SMOOTH ASPHALTIC CONCRETE SURFACES AT MIAMI INTERNATIONAL AIRPORT
