**NASA TECHNICAL
MEMORANDUM**

NASA TM X- 62,471

**FIRE SAFETY EVALUATION OF AIRCRAFT LAVATORY AND
CARGO COMPARTMENTS**

August 1975

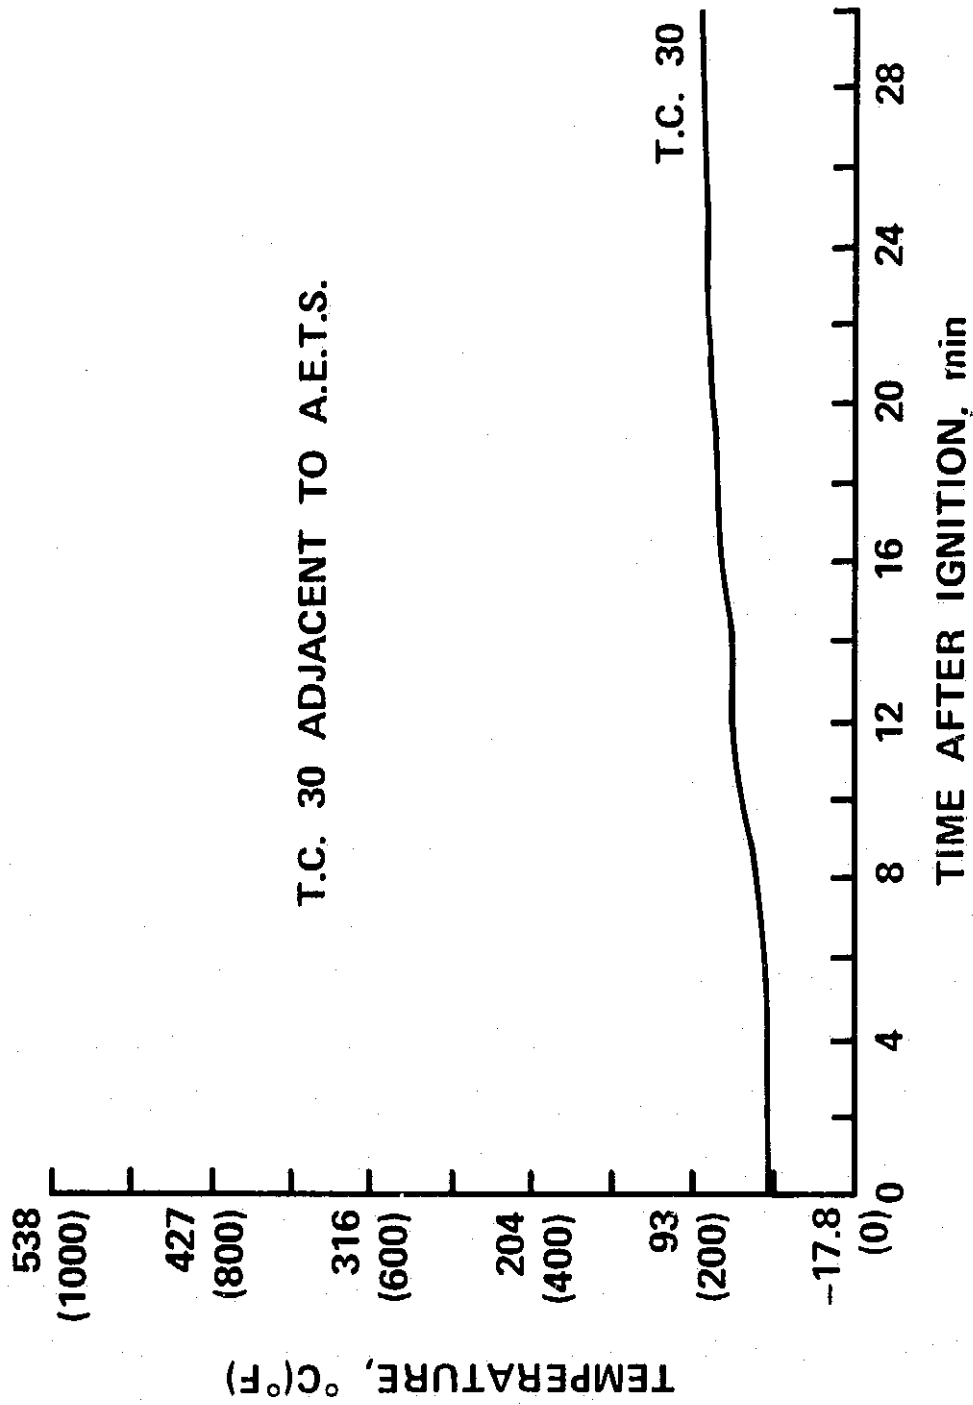
Figure 10.—Air temperature in enclosure.

The temperature recorded adjacent to the AETS cage is shown in figure 10. The mice died approximately 18 minutes after test initiation.

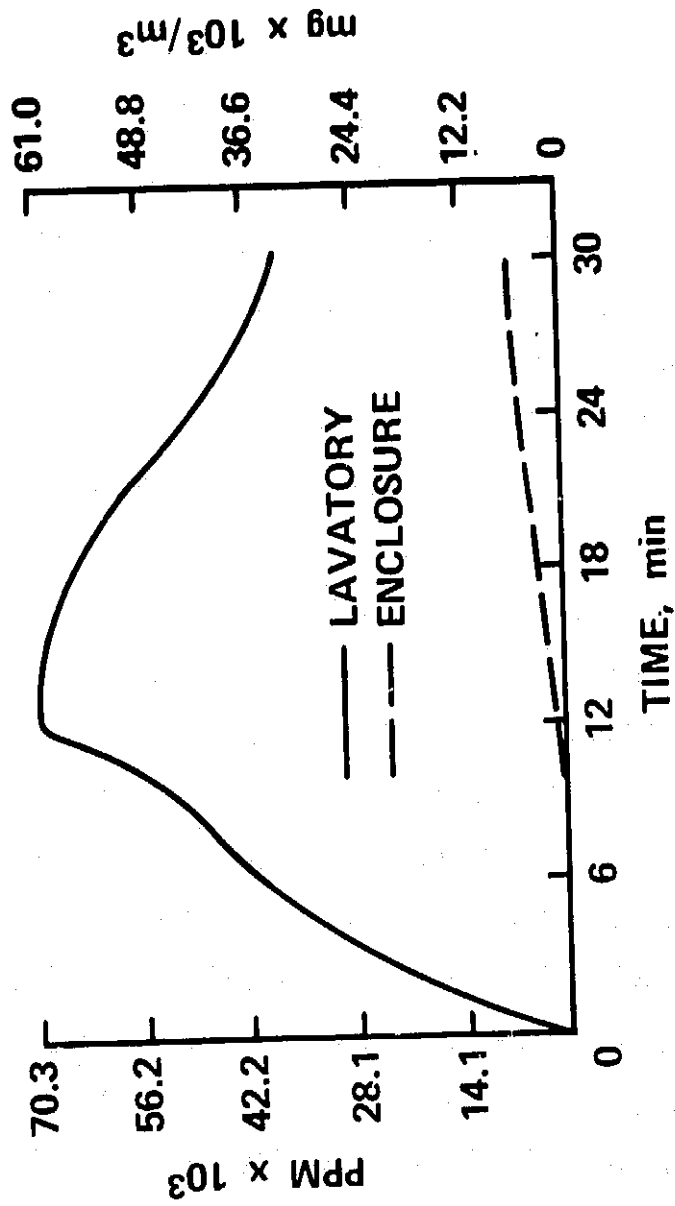
Figure 11.—Concentration of CO.

Graphs of the concentrations of the atmospheric gases and toxicants in the lavatory and test enclosure against time are shown in figures 11 - 17. Two episodes of toxicant production are indicated. Large amounts of HF, HCl, and CO, and severe oxygen depletion were observed at the beginning of the fire during the first episode. Very little HCN was produced. Probably during this period rapid burning of the waste fuel was occurring, with HCl and HF forming respectively through pyrolysis of the polyvinyl chloride floor mat and the polyvinyl fluoride surface of the lavatory interior.

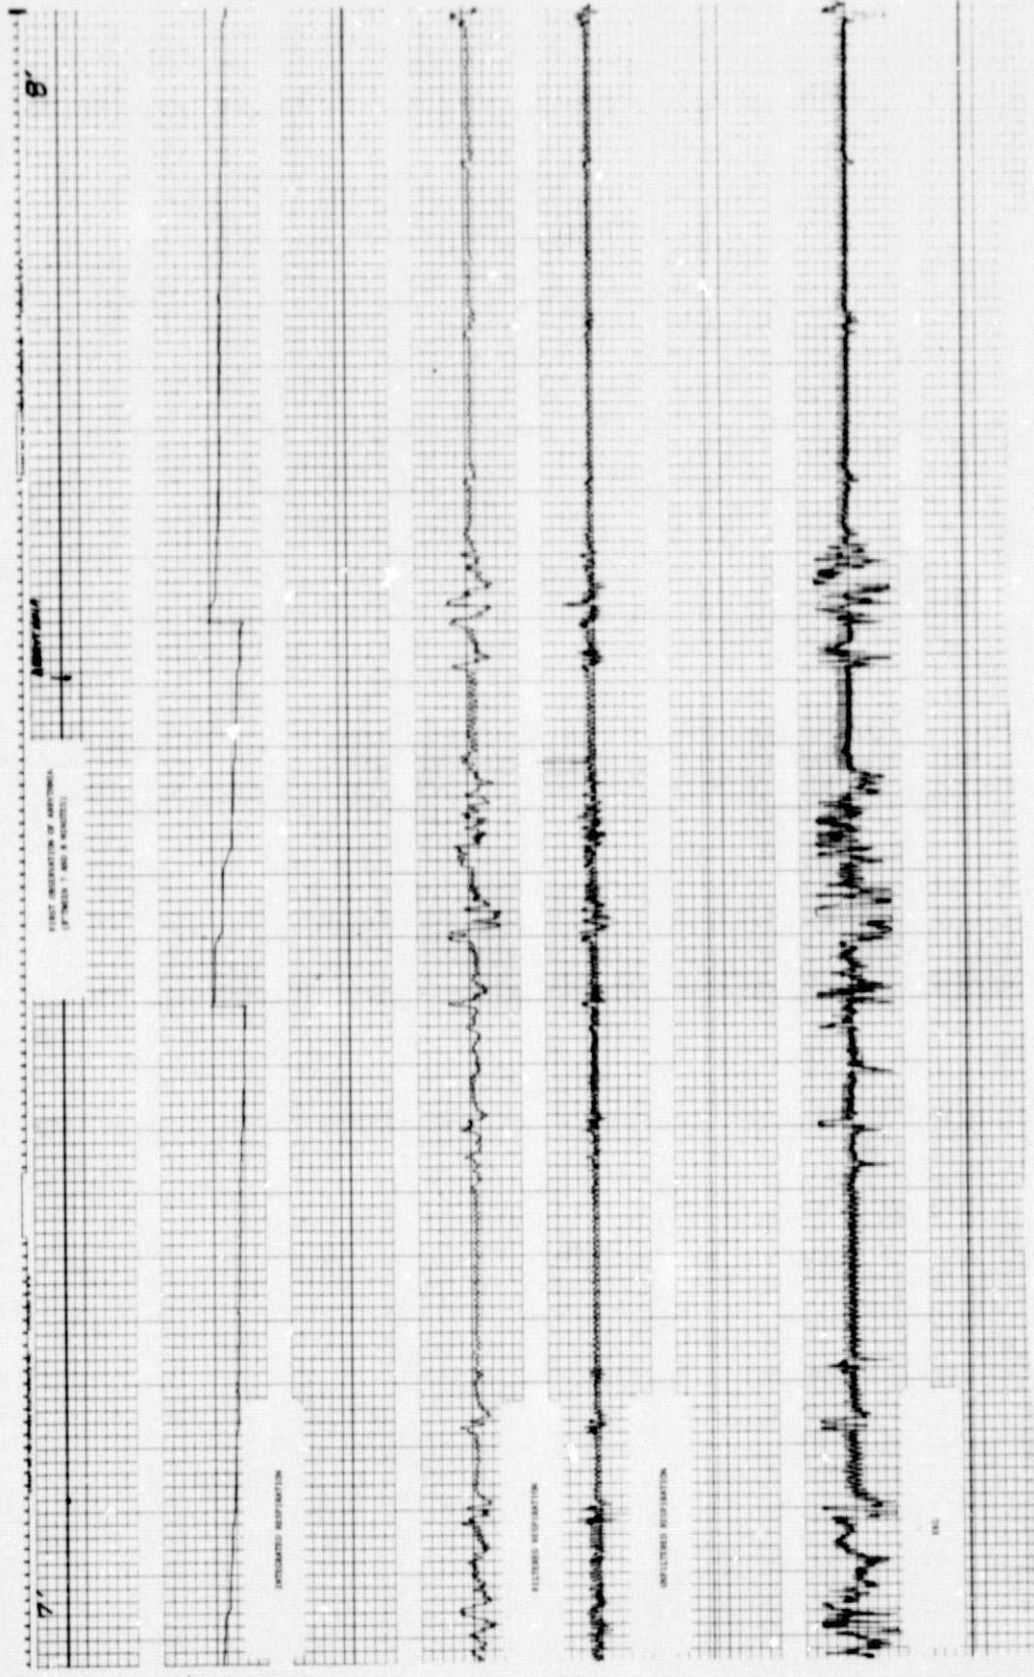
Figure 19.—First observation of arrhythmia (between 7 and 8 min).

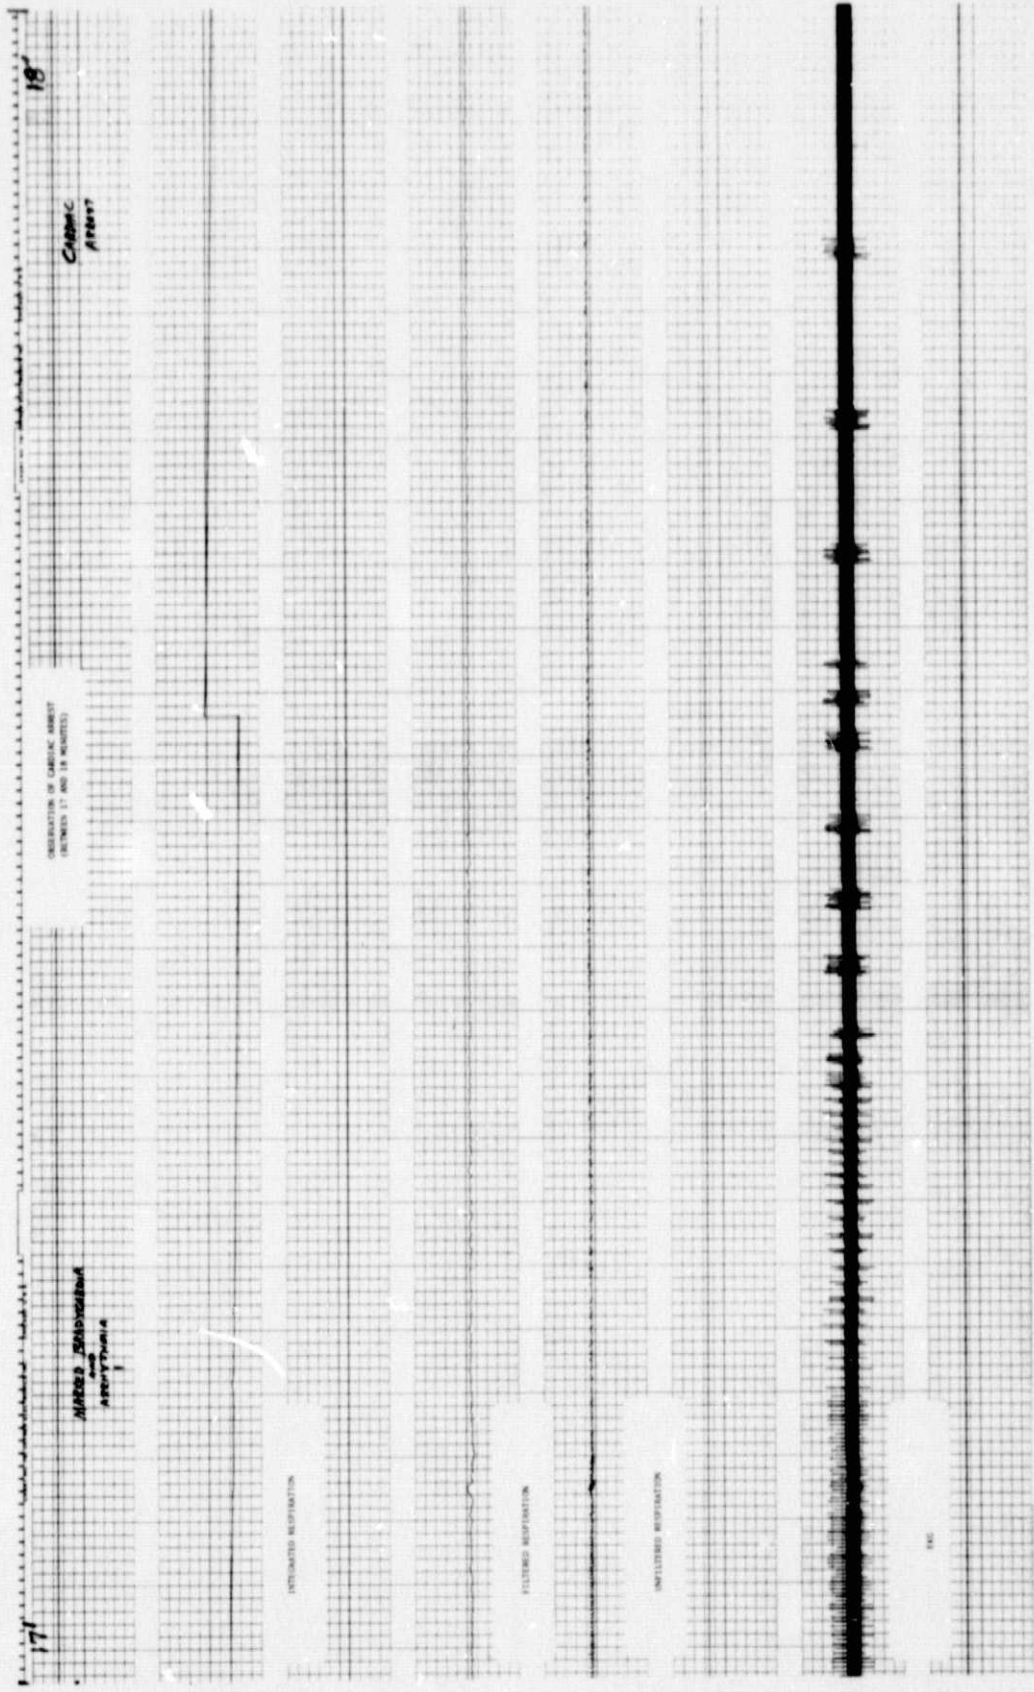
Figure 20.—Observation of cardiac arrest (between 17 and 18 min).
