Technical Memorandum 33-733

*Single- and Dual-Carrier Microwave
Noise Abatement in The Deep Space Network*

JET PROPULSION LABORATORY
CALIFORNIA INSTITUTE OF TECHNOLOGY
PASADENA, CALIFORNIA

August 1, 1975

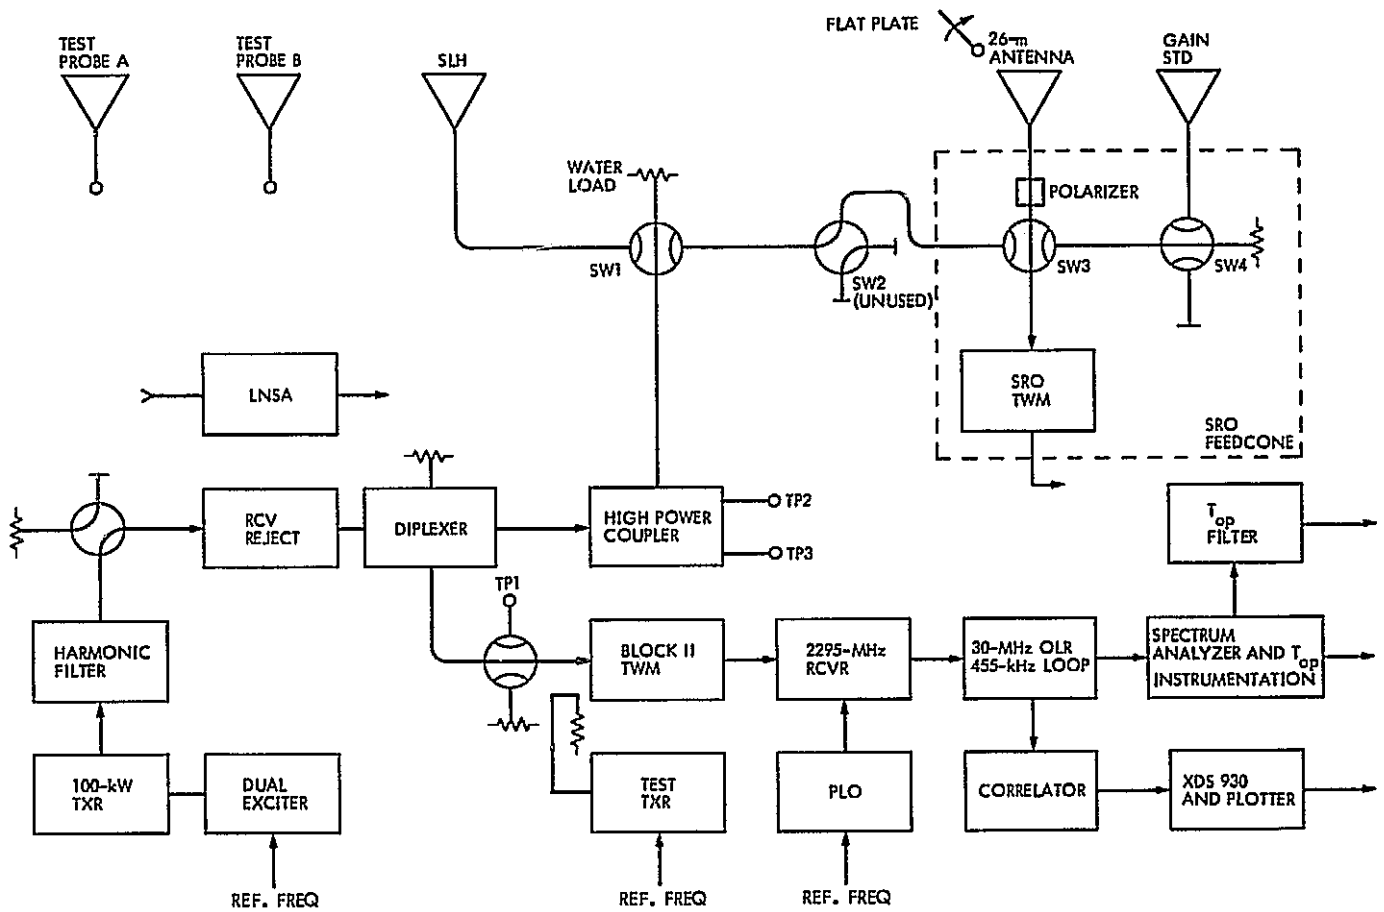
Figure 6. DSS 13 dual-carrier configuration

Considerable planning was required to outfit DSS 13 with a diplexed dual-carrier test capability, both in terms of the capability itself and desirable test features such as observation ports and air and water RF terminations as shown in Figure 6. A 100-kW klystron was made available. It is interesting to note, for the nominal dual 10-kW carriers, that the power density incident on a 26-m antenna is comparable to dual 40-kW carriers on the DSS 14 64-m antenna. Standard DSN 400-kW filtering was made available from 64-m network spares. Initially, a Block II traveling wave maser (TWM) was made available as the diplexed preamplifier for the DSS 13 receiver. Receivers in use at DSS 13 included the 2295-MHz R&D receiver operated both open loop and 455-kHz closed loop. Open-loop T_{op} instrumentation was available with 1-MHz bandwidth. The XDS 930 computer was used as a digital spectrum analyzer. A low-noise transistorized preamplifier was used with an analog spectrum analyzer (LNSA), for example, to examine receive band IMP, if any, directly from the klystron or from the test probes. A high-power waveguide directional coupler was available to sample forward and reverse transmitter power over a broad band. Four terminations were initially selected: (1) the complete 26-m antenna with S-band radar operational (SRO) feedcone, (2) the SRO feedcone without antenna, by way of a flat plate reflector over the feedhorn, (3) a water load, and (4) an air load called side-looking horn (SLH). A view of the DSS 13 side-looking horn installation is seen in Figure 7. This termination provides the simplest possible radiator, closely coupled in terms of numbers of

The air load (SLH) mode showed (via XDS 930 spectrum analyzer) relatively steady -175 ± 5 dBmW IMP with NB less than 1 kelvin at the predicted receive band frequency. The water load (Figure 6) provided comparable performance except that it tended to be mildly microphonic, i. e., shock-sensitive (produced NB and presumably transient IMP) under impact testing. These tests indicated the major noise-producing components were located beyond (antenna side) the SW1 in Figure 6. While these low-level signals were not ignored, the strong -135 ± 10 dBmW IMP with NB > 500 K in a 1-MHz bandwidth observed on the total 26-m antenna system received priority attention. These intermodulation products were, on the average, only a few decibels worse than then present at DSS 14. A hint of the problems to be later encountered was observed when the flat plate reflector was used; no repeatable difference in performance between the flat plate mode and the total antenna system mode was detectable.

In order to resolve the above performance, the diplexed system was terminated into a water load located on the unused SW4 port (Figure 6). Performance remained quite poor (-140 dBmW, 500 K). The waveguide run connecting the 26-m antenna electronics room with the SRO feedcone (SW1 to SW3) was next disassembled, cleaned, acid-etched, relapped, and flanges lightly greased according to current DSN standards (Ref. 18).¹² With the exception of familiar startup burn-in or "RF processing" (Ref. 19), and mild microphonics, the waveguide cleanup was considered successful as measured on the relocated water load.

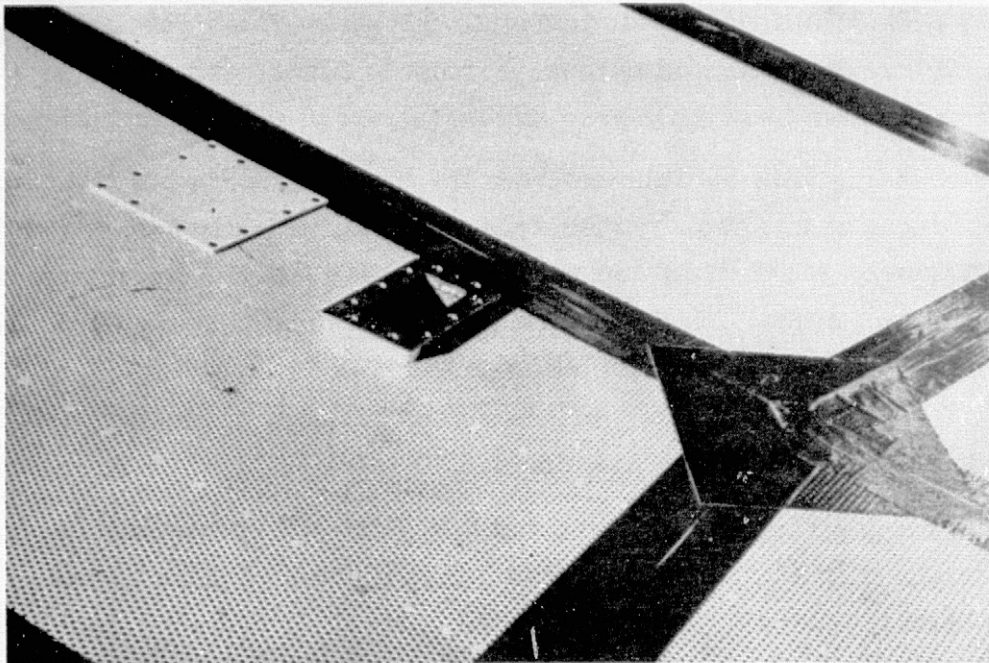
Figure 8. DSS 13 retaped main reflector and test probes

At this time (September, 1972), a substantial amount of questionably bonded hardware was removed from the exterior reflecting surfaces of the DSS 13 26-m antenna.¹¹ This hardware included the familiar conduits, lights, clamps, ladders, and other peripheral equipment. The reflecting surface was completely retaped with 100-mm-wide aluminum tape using newly available panel corner interface patches, as shown in Figure 8. Also shown in Figure 8 are the two surface test probes shown in the block diagram (Figure 6). One probe is broadband (waveguide bandwidth) while the other is a highpass filter, cutoff at 2200 MHz. With it, the receive band can be observed without simultaneously coupling in the strong transmitted signals near 2115 MHz.

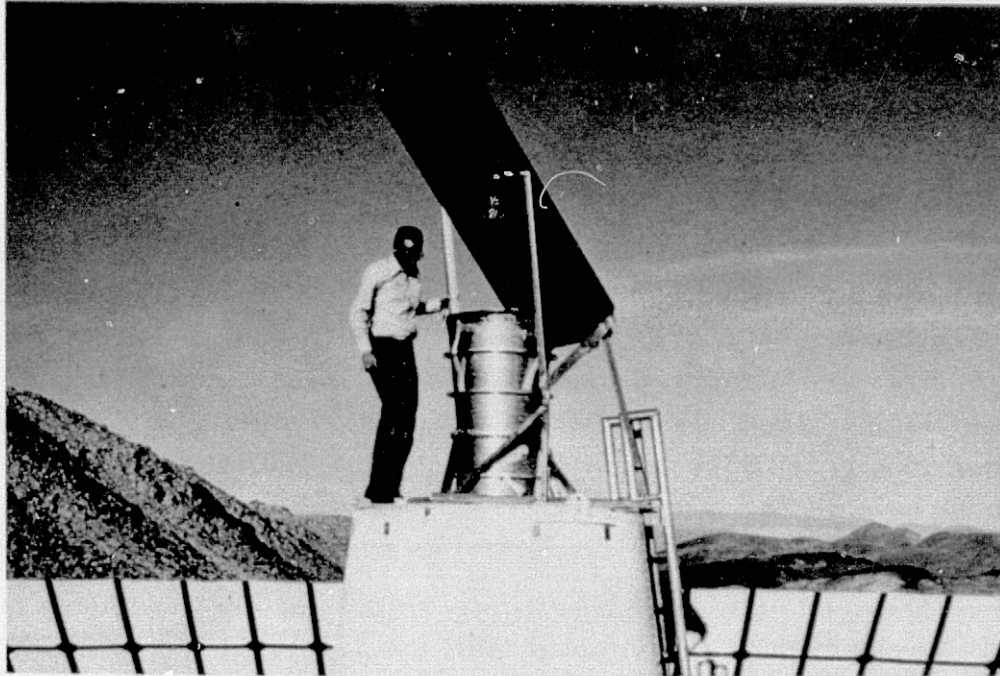
Figure 10. DSS 13 flat plate reflector on SRO feedcone

There were many questions as to whether the flat plate would be an effective switch (Figure 10) in providing high isolation from the antenna reflecting surfaces. Tertiary mechanisms, such as the previously mentioned support arm arcing, spillover, diffraction and others, might indeed support the observed intermodulation, in view of the tremendous dynamic range spanning uplink (+76 dBmW peak) and downlink (-135 dBmW average).

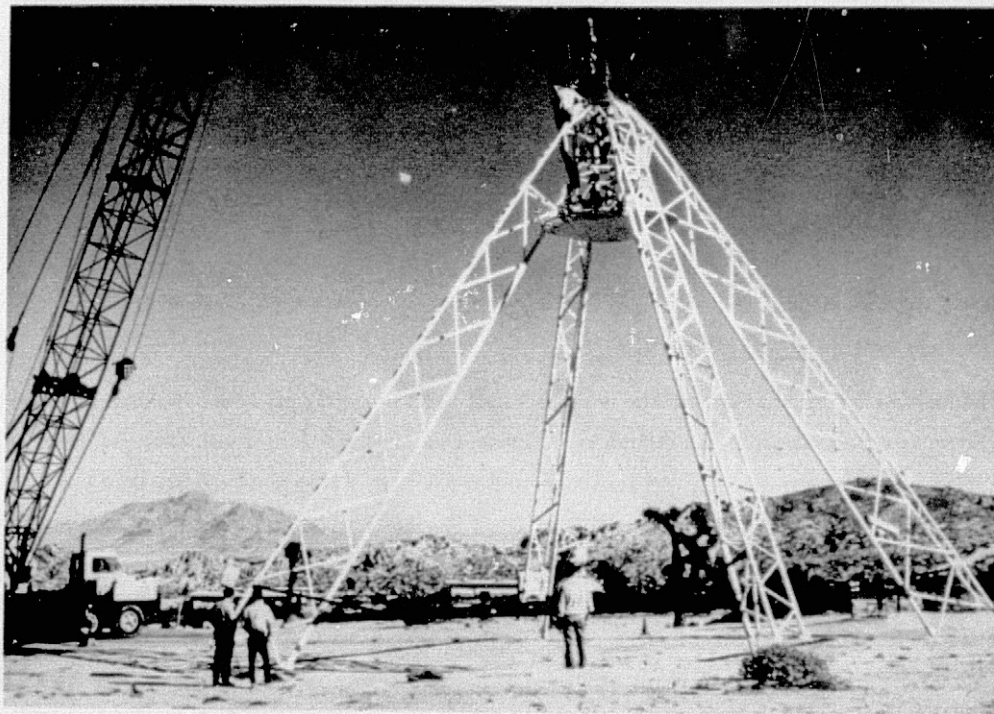
Figure 11. DSS 13 subreflector and quadripod removal

In order to provide a high-reliability answer to such questions, a more effective switch was employed. The subreflector and quadripod were removed as a unit (Figure 11), giving the feedhorn a clear field of view. Surprisingly,

performance with or without the quadripod/subreflector remained essentially the same, with the (not statistically significant) possibility that the mean level dropped 3 dB (-138 dBmW) after the quadripod removal. Samples of the receive system noise temperature, T_{Op} , and receiver closed-loop automatic gain control (AGC) IMP instrumentation recordings made during this initial period are available in Figure 12.

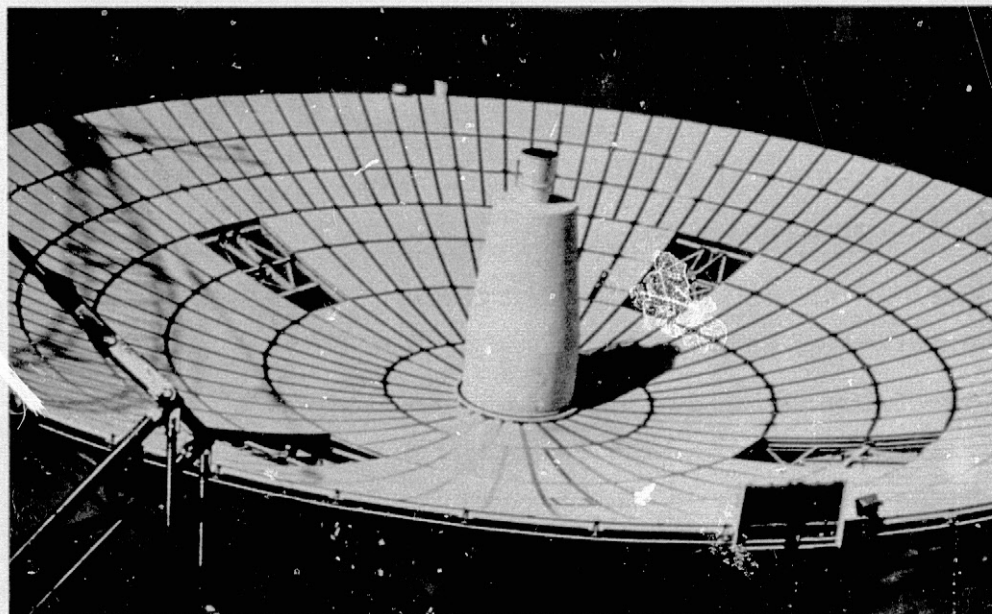
Figure 13. DSS 13 welded feedcone with SLH horn

Performance using the welded feedcone working into a clear field of view (Fig. 13) was as expected: NB less than 1 K, with IMP -172 ± 5 dBmW, for an extended test period including shock, vibration, solar illumination, and micro-phonics tests. The flat plate with all joints either welded or insulated was then tested with identical results. It should be noted, however, that such a flat plate test is a necessary but not sufficient test. Diffraction and spillover might still be possible problems after the quadripod/subreflector are installed. In view of the large dynamic range involved, the question still arose: What would the isolation of the flat plate reflector switch be with the quadripod in situ?

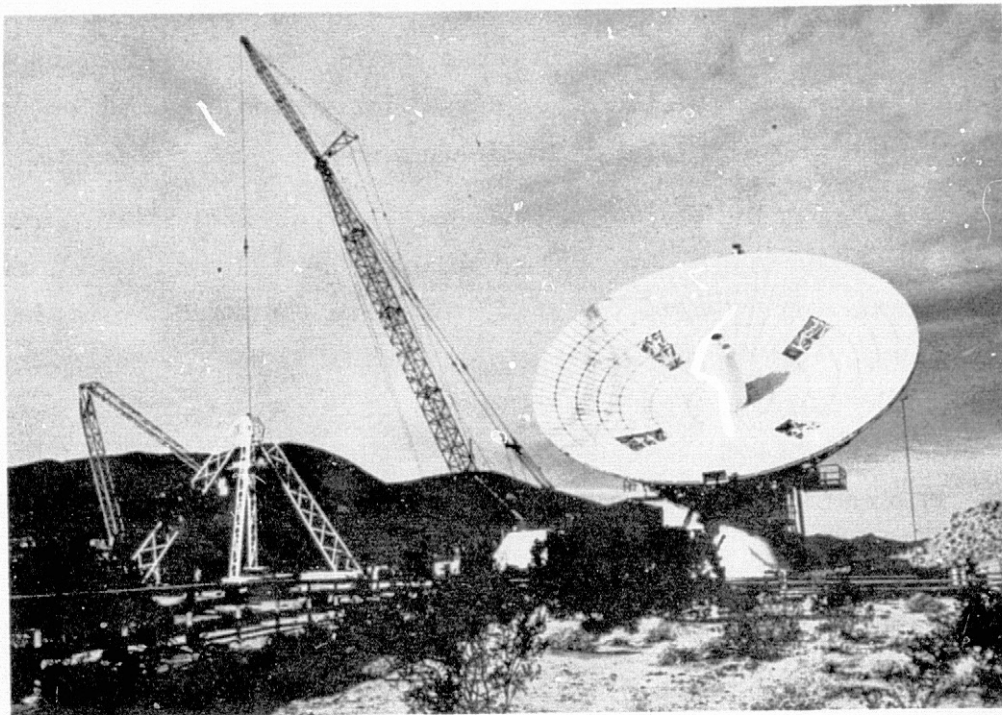
Figure 14. DSS 13 subreflector installation

"as-received" condition of the subreflector. A review of the calculated power densities on the subreflector and initial physical condition, compared with earlier experience with feedcone exterior power densities, initial physical condition, and poor performance, showed that, by a factor of 30 dB, the "as-received" subreflector would have failed. Figure 14, a photo taken when testing of the new feedcone was underway, shows the bonded subreflector being reinstalled in the quadripod (December 7, 1972).¹⁵

¹⁵ Examination of Figure 14 frequently raises the question: did the crane boom, cables, et al. intercept the transmitted beam, and if so, were noise bursts and/or intermodulation products generated? It did, and they were.

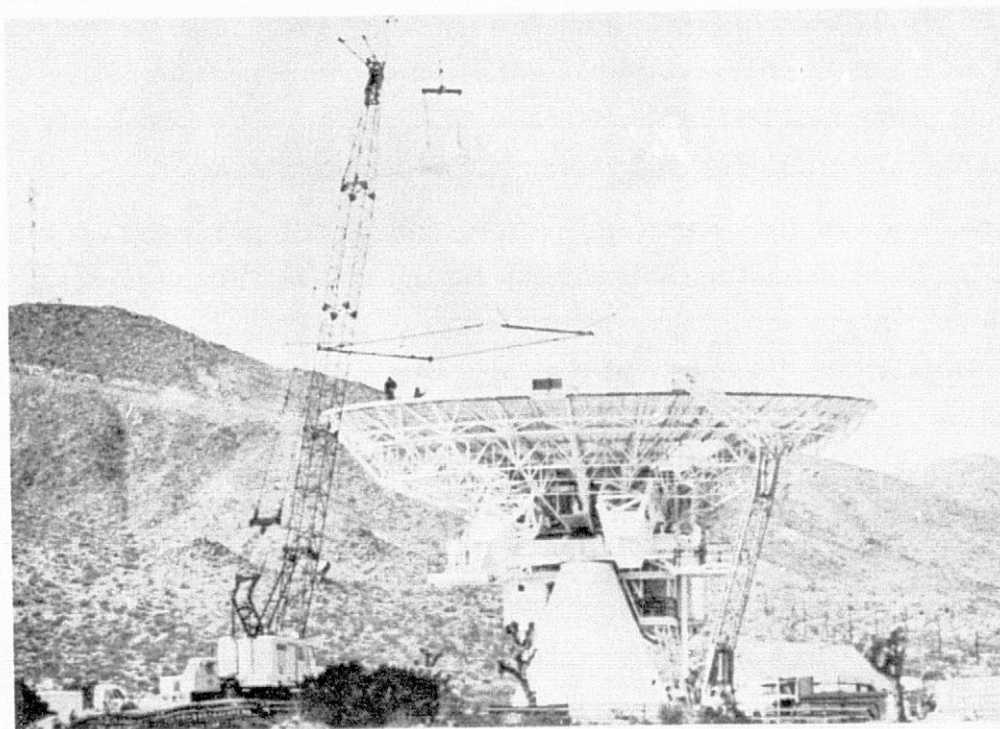
Figure 15. DSS 13 quadripod installation

After a high degree of confidence was obtained operating with the new feedcone, the quadripod was reinstalled (Figure 15). Questions requiring answers at this point were:

Reinstallation of the quadripod included retaping of the quasi-planar joints about the reflecting panels which had been removed for access (Figure 13). Also, attempts were made to shield the aluminum-to-steel interfaces, at both

the bases of the quadripod legs and the feedcone base, using aluminum tape. Because of the physical complexity of these joints, many overlapping and/or wrinkled tape joints became evident on visual inspection, leading one observer to comment on the probability of overdoing otherwise good practice.

Indeed, a strong indication that this might be correct was immediately obtained upon turn-on of the standard conditions: $N = 31$ dual 10-kW carriers. NB with accompanying IMP at -135 ± 5 dBmW were observed, which had the discouraging impact of returning the project to initial poor performance levels. Furthermore, the SLH reference facility was no longer available (used within new feedcone). Wind precluded use of the flat plate at that time. It was decided to remove the questionable metal tape in the regions surrounding the quadripod leg bases. Performance returned to an encouraging -168 dBmW level. The tape was reinstalled to determine repeatability. The -135 dBmW level repeated. The tape was removed a second time. The -168 dBmW level repeated. Confidence was gained in two areas: (1) the tape quality indeed was a problem area, and (2) a few poorly bonded joints (or possibly one) can cause essentially the entire problem. In retrospect, team members witnessing all of the above tests believe the -135 dBmW levels observed probably represent a saturated effect; i. e., a singular addition to, or subtraction from, a large number of poorly bonded joints goes totally unnoticed. The strong suggestion here is that a single uncontrolled installation of some peripheral device on the illuminated portion of DSN antenna reflecting surfaces will probably cause an unacceptable noise impulse and intermodulation interference.

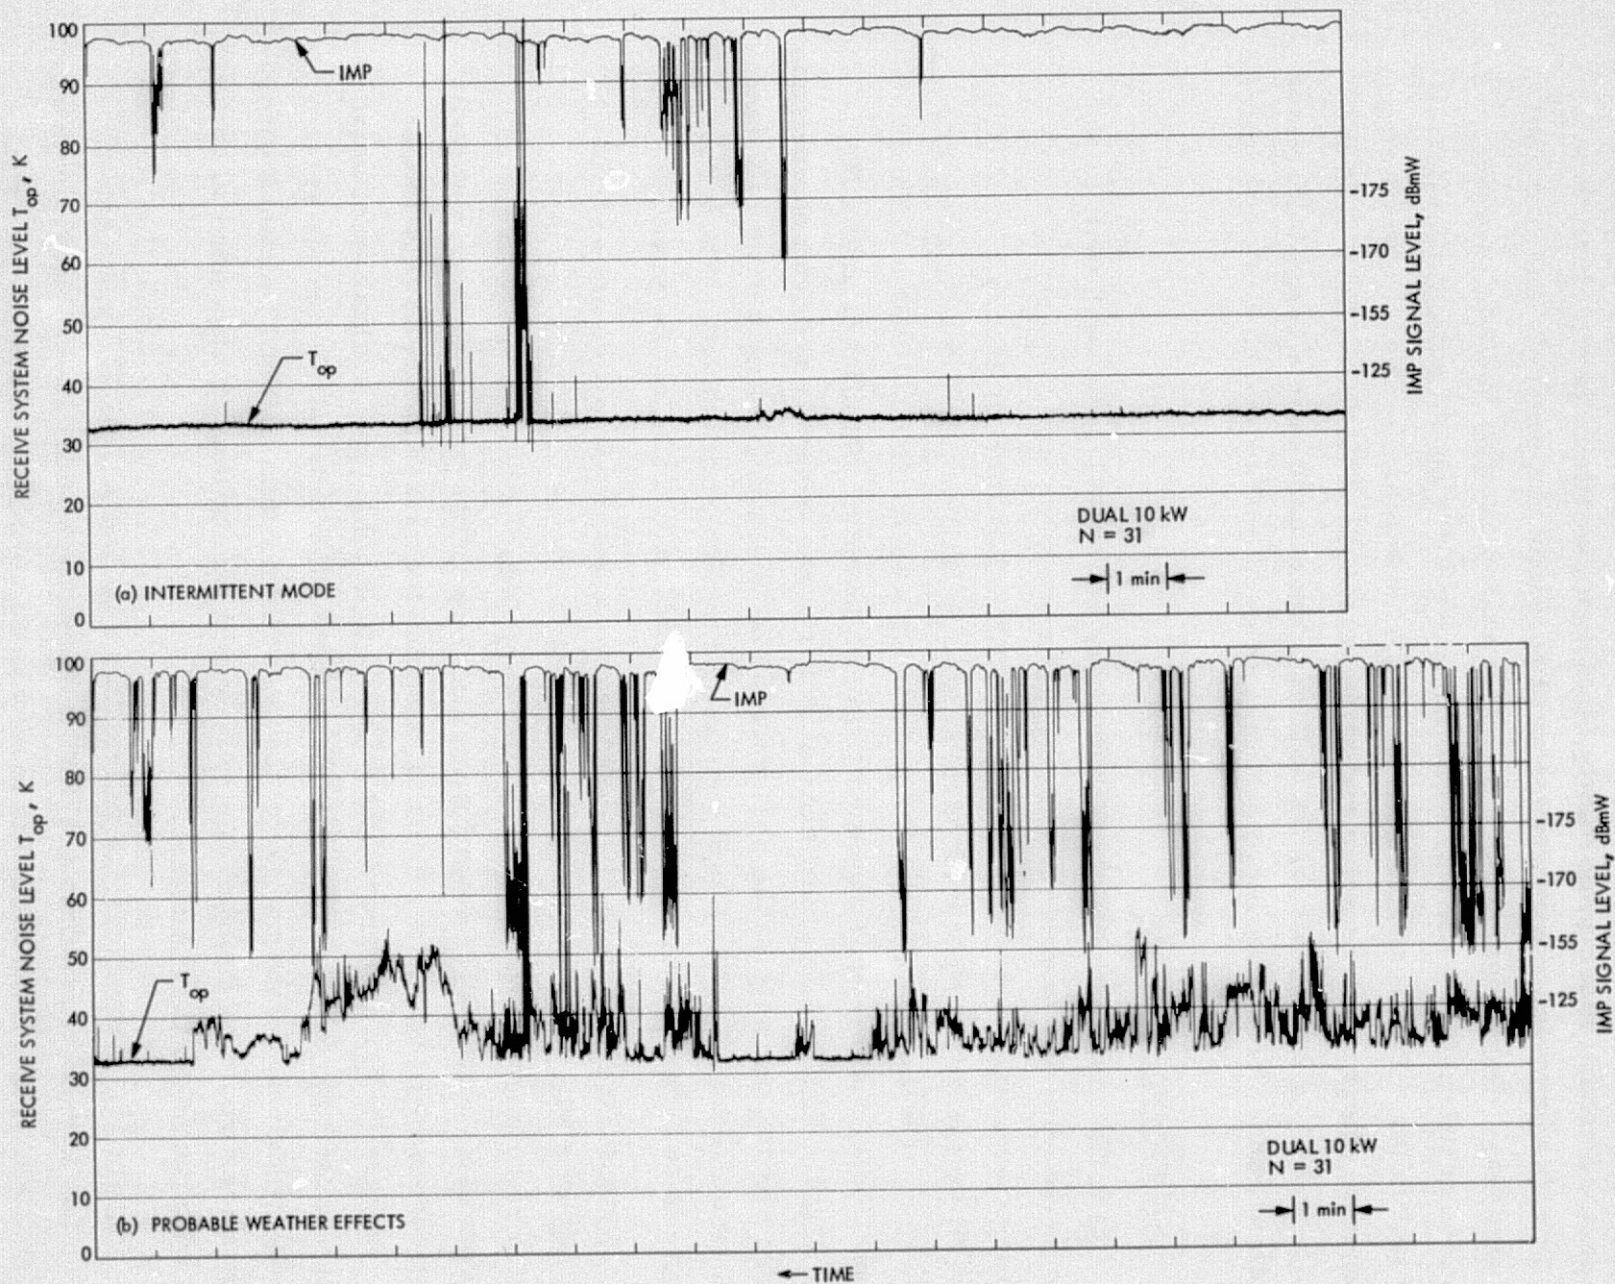
Figure 18. System noise level and IMP performance, DSS-13 antenna (Dec. 8, 1972): (a) during interim mode, (b) during probable weather effects

run, shown in Figure 18, is less encouraging. Some intermittent condition was present. Perhaps more importantly, inclement weather, particularly heavy fog or rain, impacted the otherwise good performance severely and in a complicated way. Data suggests that a totally wetted antenna surface provides a continuous noise-free reflector while an antenna drying out acts quite intermittent and noisy. These effects remain poorly understood. Even common environmental effects such as solar radiation remained to be more fully examined in the context of heavy, large, outdoor equipment used over a large microwave dynamic range, requiring large numbers of high-quality mechanical connections.

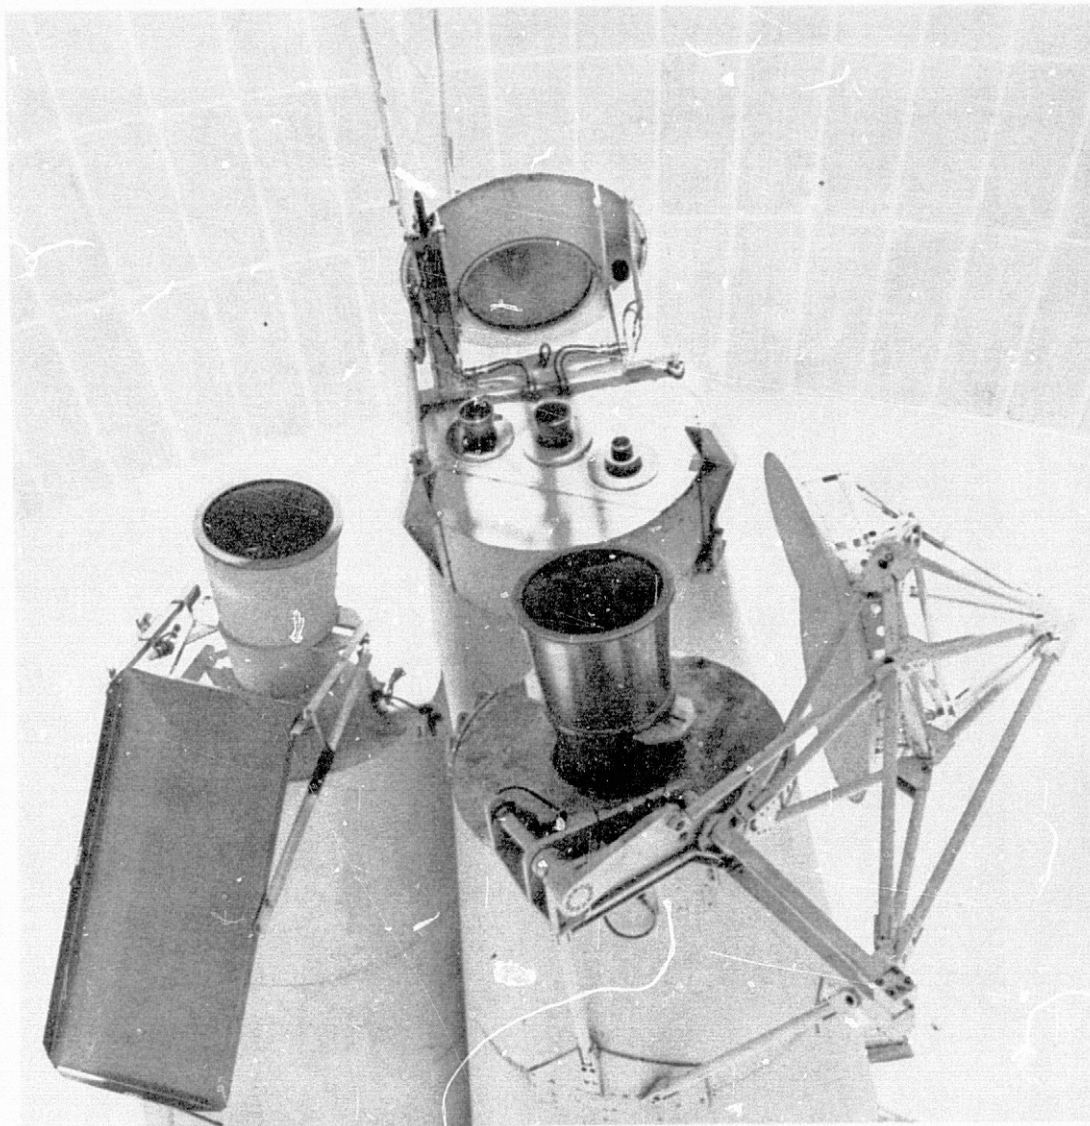
Figure 29. PDS, SMT, and MXK feedcone configuration, DSS 14

²⁹An additional view is available in Section IV (Figure 29). In Figure 29, the frequency of bolting of the feedhorn to feedcone roof interface should be especially noted.

On the tricone assembly, all exterior seams of the PDS feedcone were welded. Existing ladders, walk rings, clamps, lugs, and handrails on the PDS feedcone were removed. An all-welded ladder was installed on the PDS feedcone. MXK and SMT feedcones were installed on the top of the tricone. These feedcones were both largely welded except for their newly installed prototype S/X feed hardware. This equipment consists of an ellipsoidal reflector atop the SMT feedcone and a dichroic plate over the MXK feedcone (both shown retracted in Figure 29.) The PDS feedcone is shown with a stowed flat plate reflector in Figure 29. It was expected that the S/X feed hardware, consisting of many bolted and riveted parts, hydraulic actuation mechanisms, electrical cabling, and limit switches, would prove to be a troublesome and difficult-to-correct source of noise interference. This expectation was confirmed by later tests. All feedhorn to feedcone roof interfaces were reworked as was necessary at DSS 13. Additional bolts were added, surfaces smoothed, and light grease applied as on a waveguide flange. Seams were welded on the upper portions of tricone surfaces. Hatch details and feedcone mounting rings on the tricone roof were welded (resultant welded seams have cracks and voids which could not be corrected during the noise abatement program). On the main reflector surface, the ground service hoist air motor was relocated beneath the reflector surface.

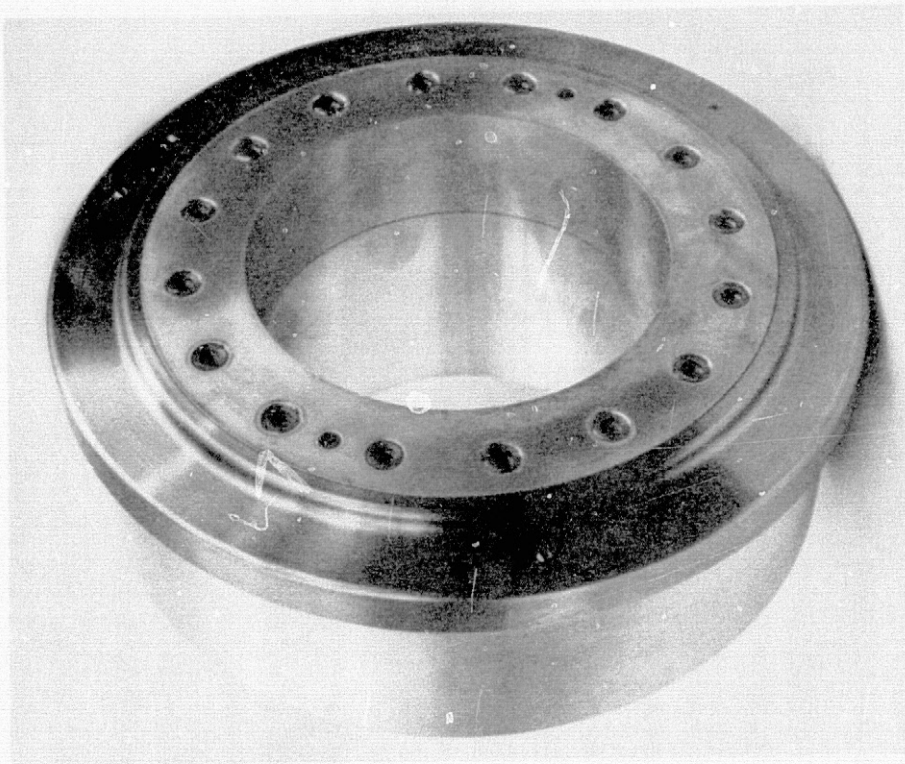
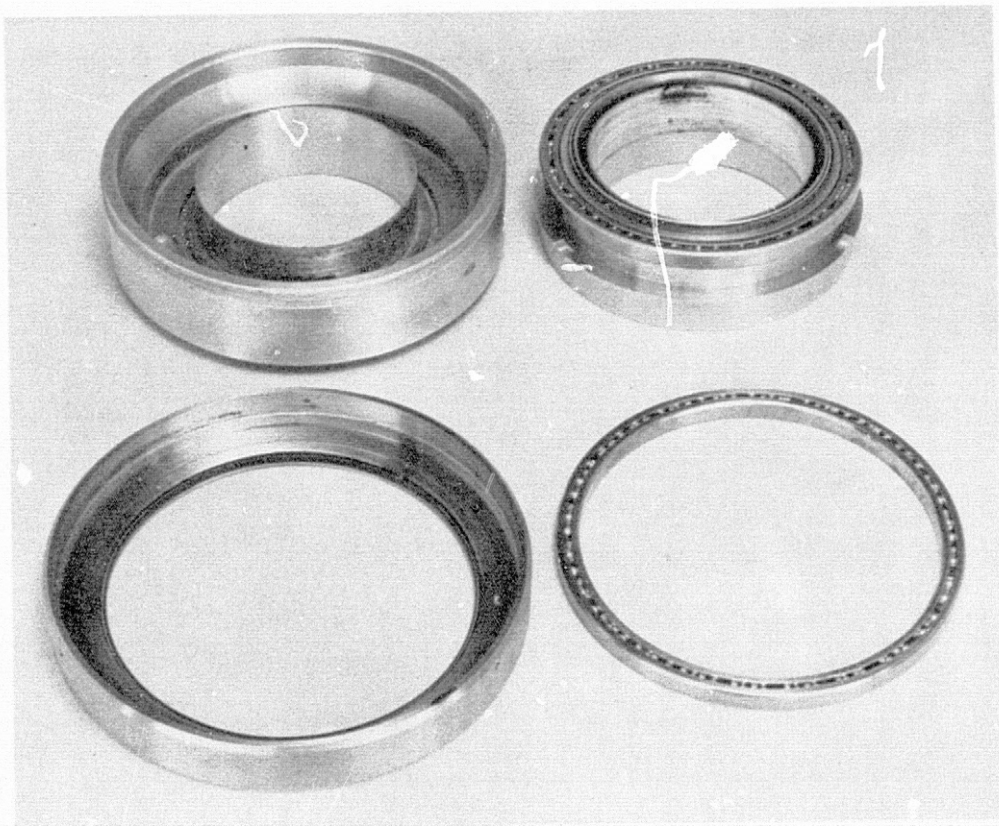
At DSS 14 one rotary joint in the PDS feedcone caused massive noise bursts (and occasional but not consistent transmitter high back power tripoffs) for a reason not observed at DSS 13. This component is shown assembled in Figure 37 and disassembled in Figure 38. A closeup (Figure 39) shows unmistakable arc pitting and metal galling. This damage was so extensive as to preclude a determination of whether a metal chip initiated the arcing, which then presumably contributed to the galling in the 0.25 mm choke gap. This event again demonstrates the extreme cleanliness needed in assembly of the waveguide system. Both remaining rotary joints in the PDS feedcone have operated without incident for approximately 5 years of heavy DSN and developmental radar service. Two units, returned from DSS 43, failed for a completely different reason. The initial assembly did not include proper bearing preload; thus the two sections of the rotary joint were free to wobble slightly and nearly contacted one another in the wrong regions. Light evidence of arc pitting was found.

Figure 37. Assembled S band rotary joint

Figure 38. Disassembled S-band rotary joint

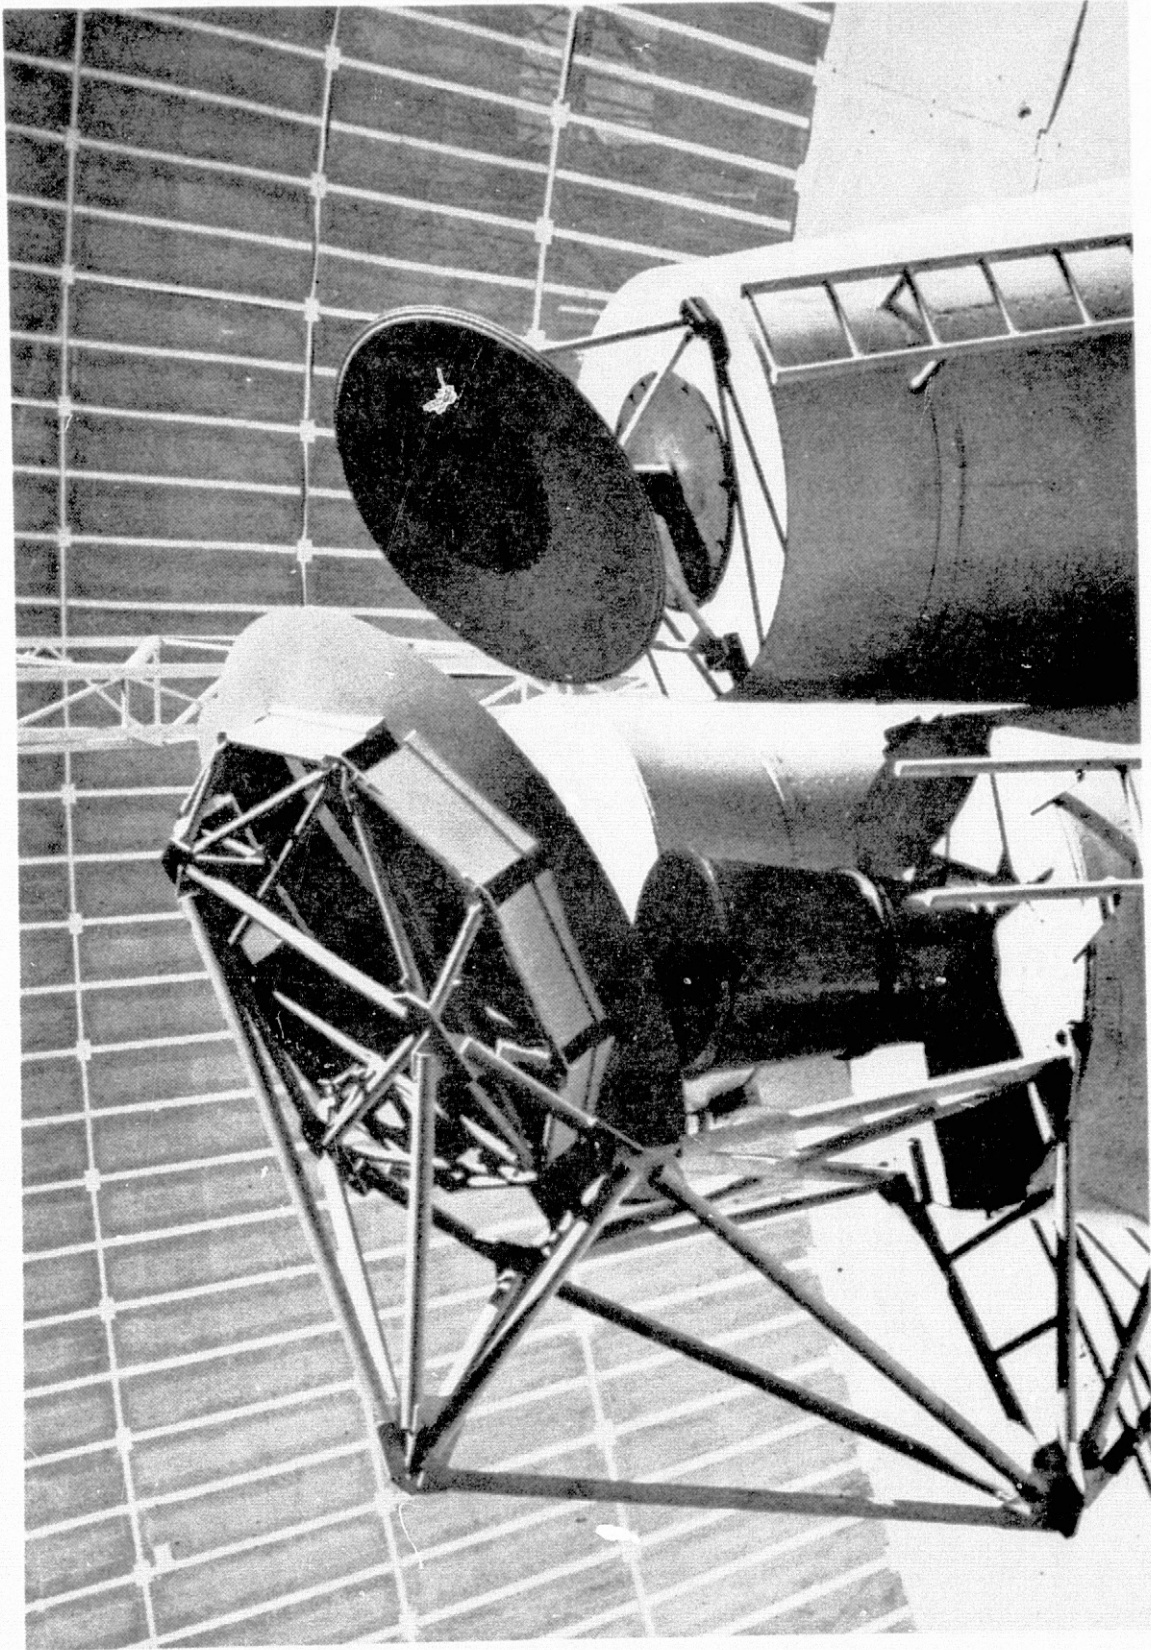
Figure A-7. Redesigned follow-on S/X feed at DSS 14

In Figure A-7, the dichroic plate is seen to be of single construction, despite slightly increased costs. Unfortunately, Figure A-7 illustrates some nonconformance with good practice. Although both feedcones shown are 100 percent

welded on the outside, the S-band horn mounting flange is not yet sufficiently bolted on a "5 bolts minimum per RF wavelength" basis. This feedcone system was constructed prior to full understanding of the necessity to thoroughly RF-bond this area and will require difficult and costly disassembly/rework. The X-band feedcone horn mounting flange in Figure A-7 is apparently also not sufficiently bolted; actually it rests on an 0.1-mm-thick insulator.

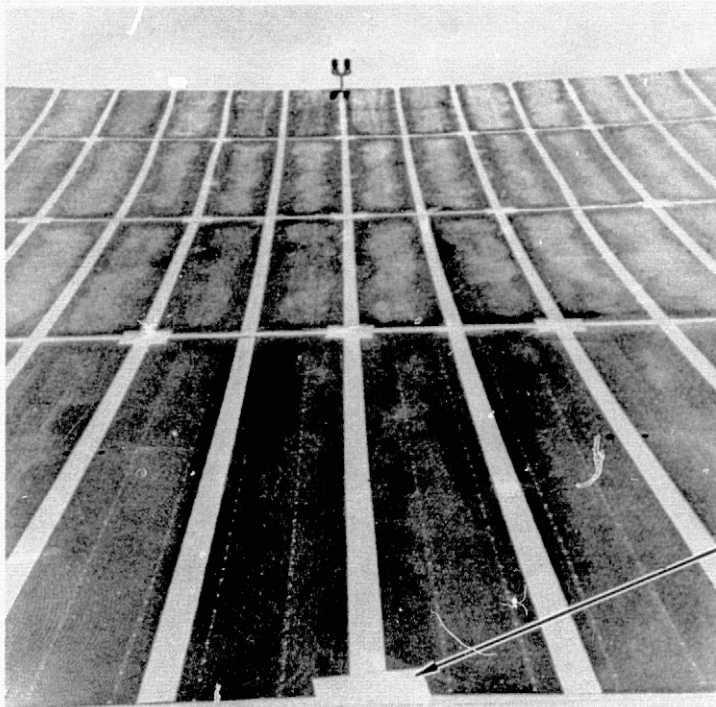
Figure B-7. Main reflector portion
completely taped

- (6) The perforated outer main reflector panels are constructed with two perforated metal sheets butted together on the common framework. These butt joints (minor radials) must be taped in the usual way (Figure B-1). These pieces of tape must not contact or pass over the (then existing) chord tapes. These minor radial tapes are trimmed so that a 6-12 mm (0.25-0.50 in.) reliable tape gap exists. Neither Kapton nor aluminum tape squares are necessary in these locations. This is illustrated in Figure B-6. A completely taped portion of the main reflector surface is shown in Figure B-7. (The preferred diagonal placement of Kapton and aluminum squares is not shown in this figure. As mentioned, the square manner illustrated in Figures B-7 and B-5 is no longer recommended.)

INCORRECT ORIENTATION
SHOWN (SEE TEXT)

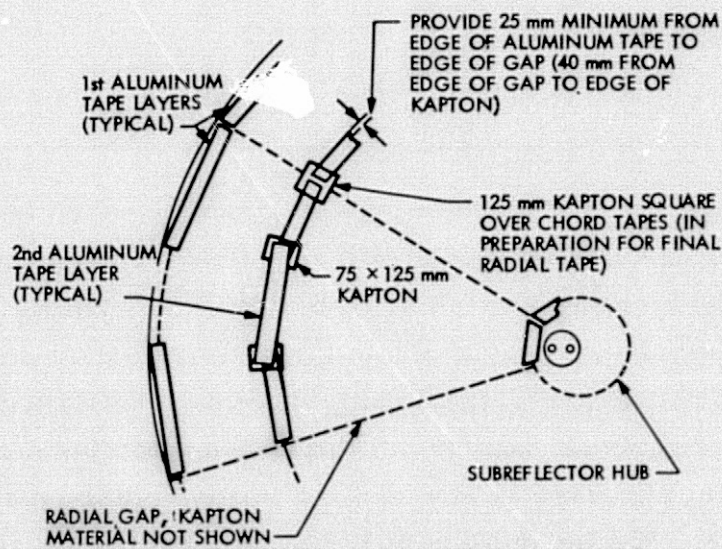
Figure B-13. Subreflector aluminum tape layout

- (3) Carefully burnish the first layer aluminum tapes. Hairline fractures in this location will develop microwave noise and must be eliminated. Replace any questionable aluminum tapes. As a general rule, do not burnish directly over a gap; rather, burnish along each side of the gap, say 40 mm (1.5 in) inwards from each edge of the 100-mm-wide aluminum tape, with allowance for the chord vs straight-line asymmetries.

- (1) The 100-mm (4-in.) aluminum tape must only be applied to clean dry Kapton surfaces at 10 deg C (50 deg F) or higher ambient temperature (preferably higher).
- (2) Start by covering all chord ends ("first aluminum tape layers" in Fig. B-13). Chamfer aluminum tape ends 3 mm (0.12 in.) by 45 deg. Begin aluminum tape 6 mm (0.25 in.) from a radial gap and work symmetrically from two radials towards the panel center (see Fig. B-13). Provide 25 mm (1 in.) minimum from the aluminum tape edge to the underlying panel gap, or 15 mm (0.6 in.) minimum from the aluminum tape edge to the properly applied underlying Kapton; in either case, the Kapton and aluminum tapes should be parallel, with equal edges of Kapton exposed.

- (4) Add the second aluminum tape layers next (Figure B-13). Begin by applying Kapton tape insulators 75 × 125 mm (3 × 5 in.) symmetrically over the ends of the first aluminum tape layers, with approximately 50 mm (2 in.) on top of the aluminum and 25 mm (1 in.) on top of the underlying Kapton substrate. The second aluminum tape layer is then symmetrically overlapped onto the insulated first aluminum tape layer 40 mm (1.5 in.) such that a minimum of 12 mm (0.5 in.) of Kapton surface barrier exists between the first and second aluminum tape layers. Remove and replace any questionable second aluminum tape layers at this point, even if it means replacing the Kapton tape insulators and first aluminum tape layers. This is one of the most difficult sub-reflector taping areas to handle.
