NASA CR-134769

ANALYSIS OF TURBOFAN ENGINE PERFORMANCE DETERIORATION
AND PROPOSED FOLLOW-ON TESTS

G. P. Sallee, H. D. Kruckenberg, and E. H. Toomey

AMERICAN AIRLINES, INC.

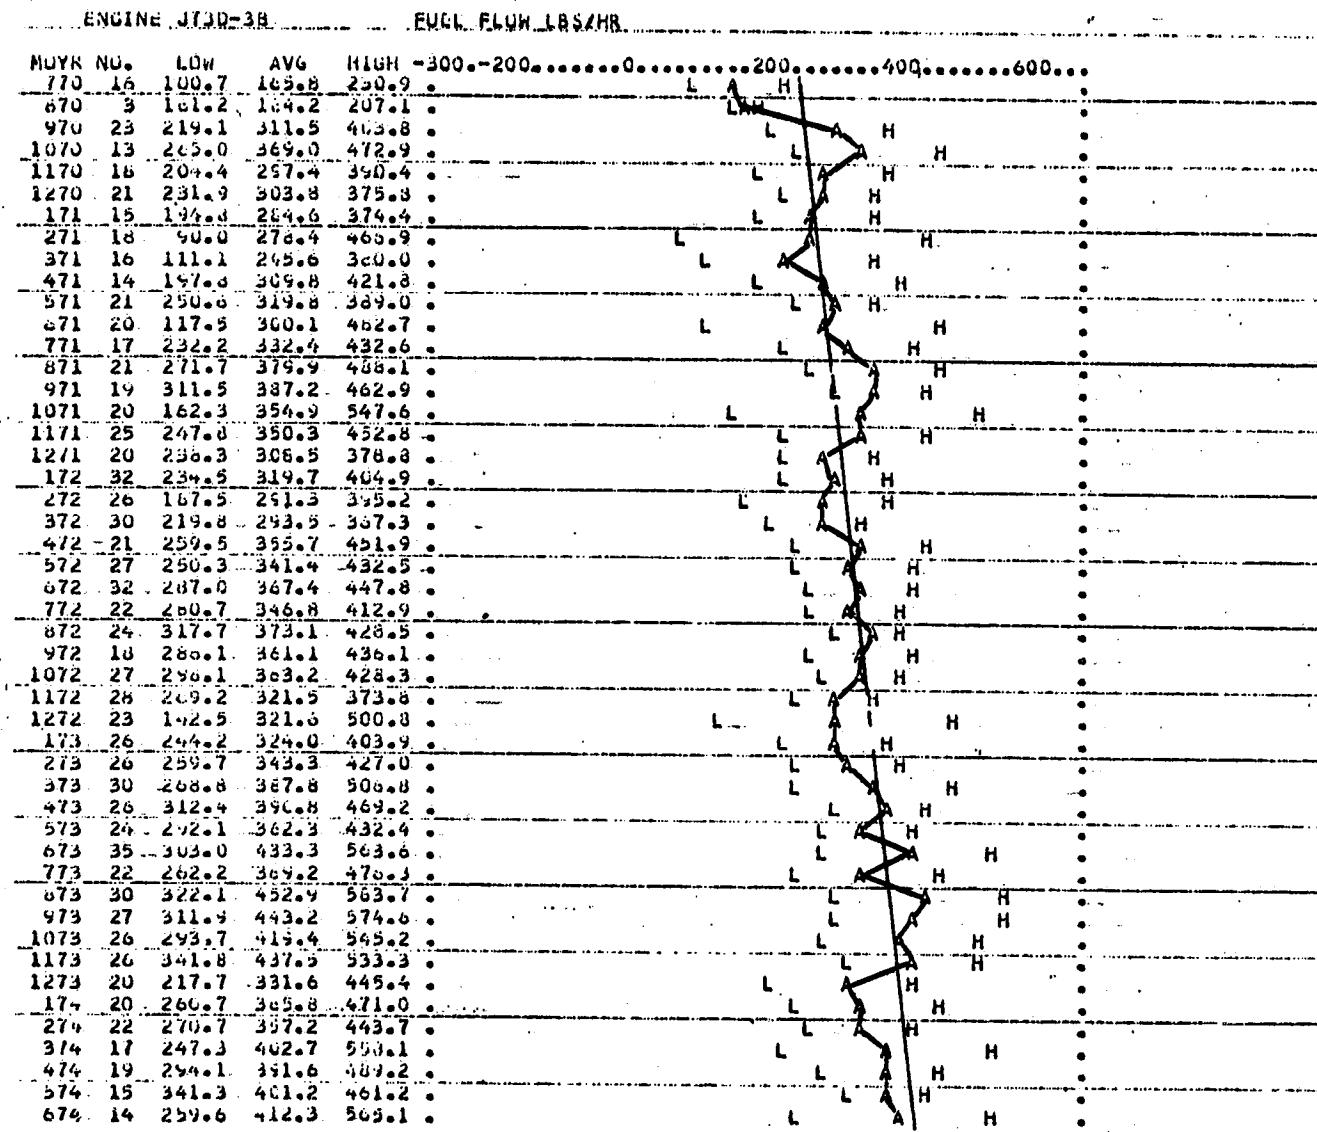
Figure 4. Test Cell Fuel Flow Trend Plot for JT3D-3B Cruise Power For Period 7/70 Thru 6/74

→ | ← 185 Lbs/Hr
increase

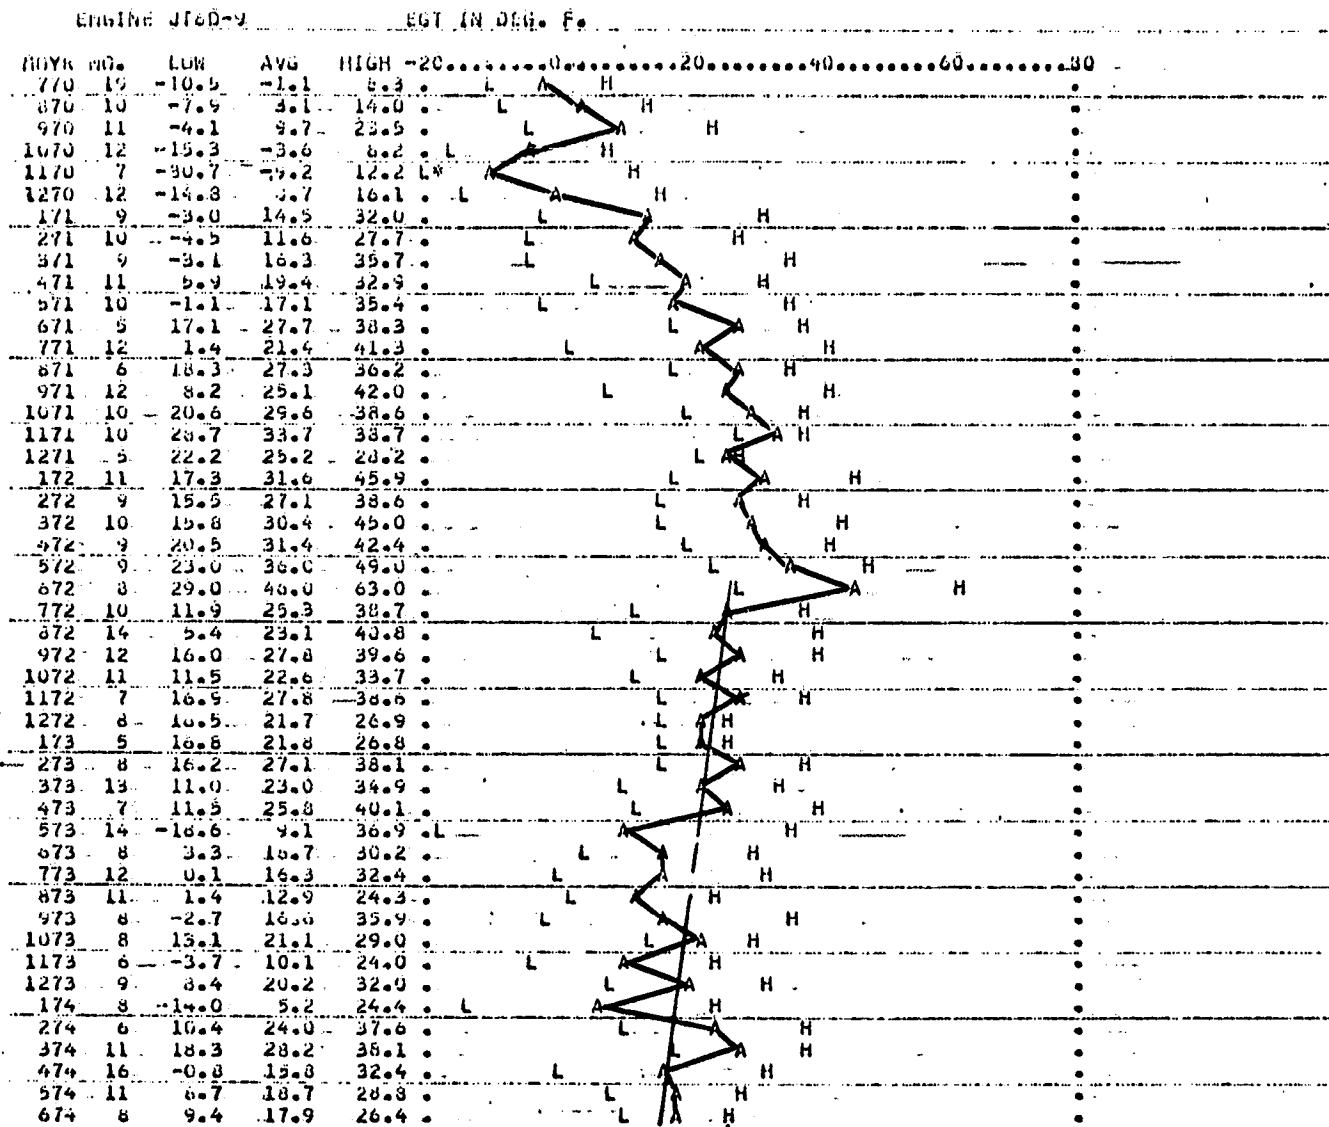
Figure 7. Test Cell EGT Trend Plot for JT8D-9 Cruise Power For Period 7/70 Thru 6/74

10 °F decrease since 7/72

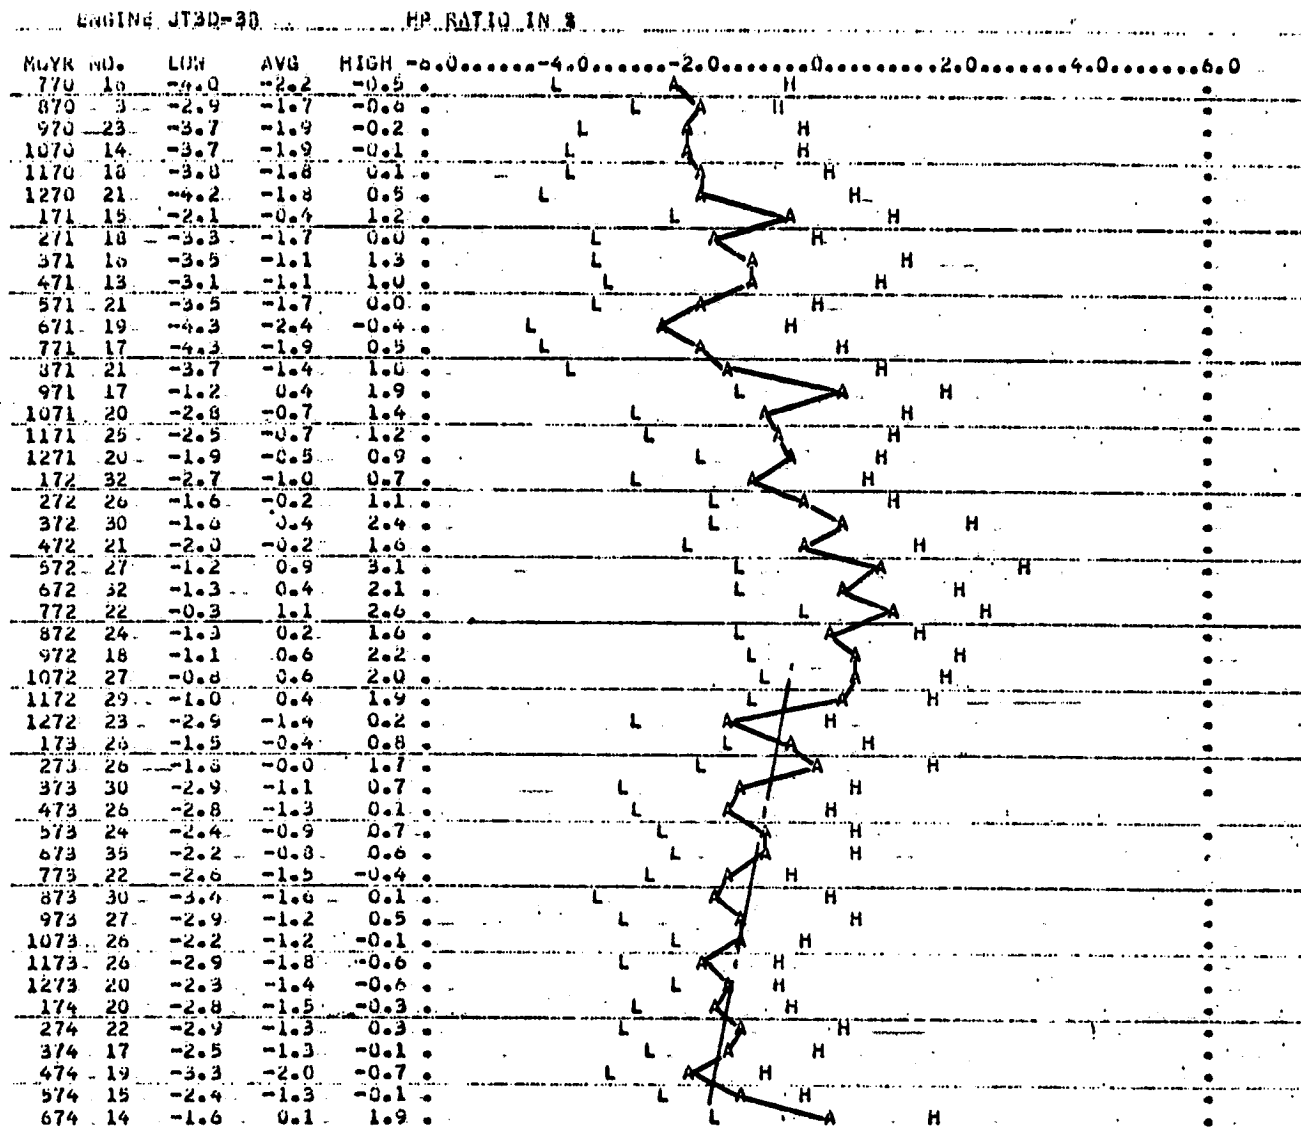
Figure 10. Test Cell A HP Ratio Trend Plot for JT3D-3B Cruise Power For Period 7/70 Thru 6/74

→ | ← 1.2 % decrease
in HP ratio
since 11/72

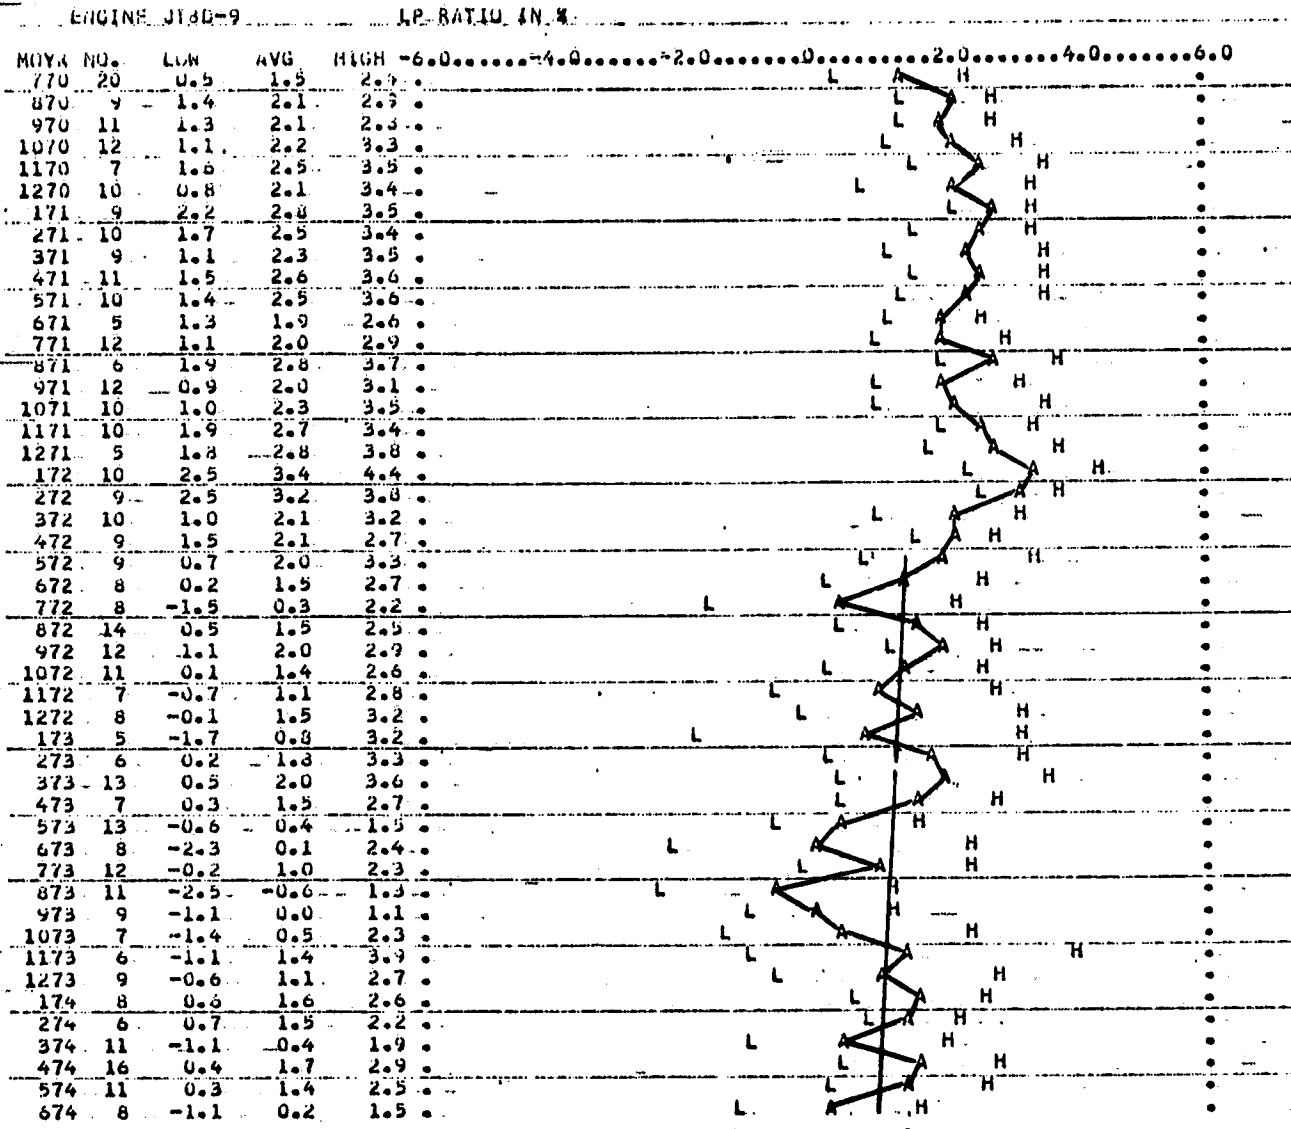
**Figure 11. Test Cell Δ LP Ratio Trend Plot for JT8D-9
Cruise Power
For Period 7/70 Thru 6/74**

5% decrease
 in LP ratio
 since 7/72

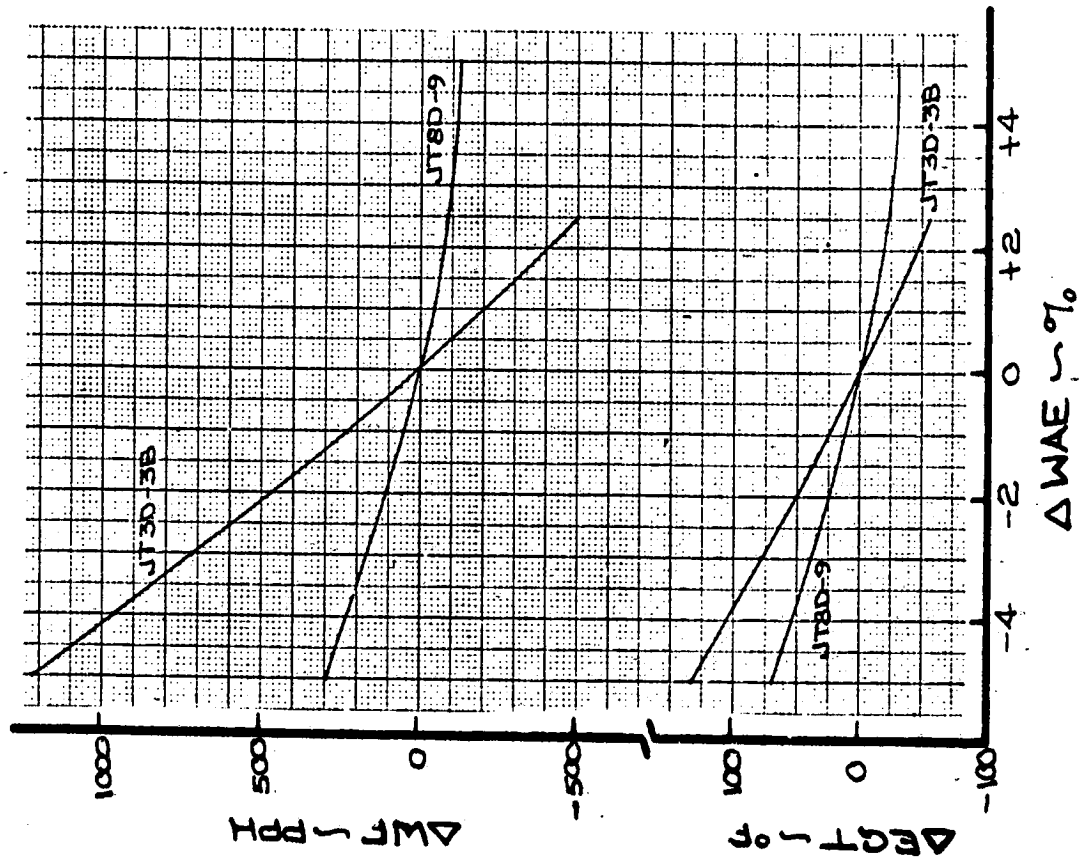
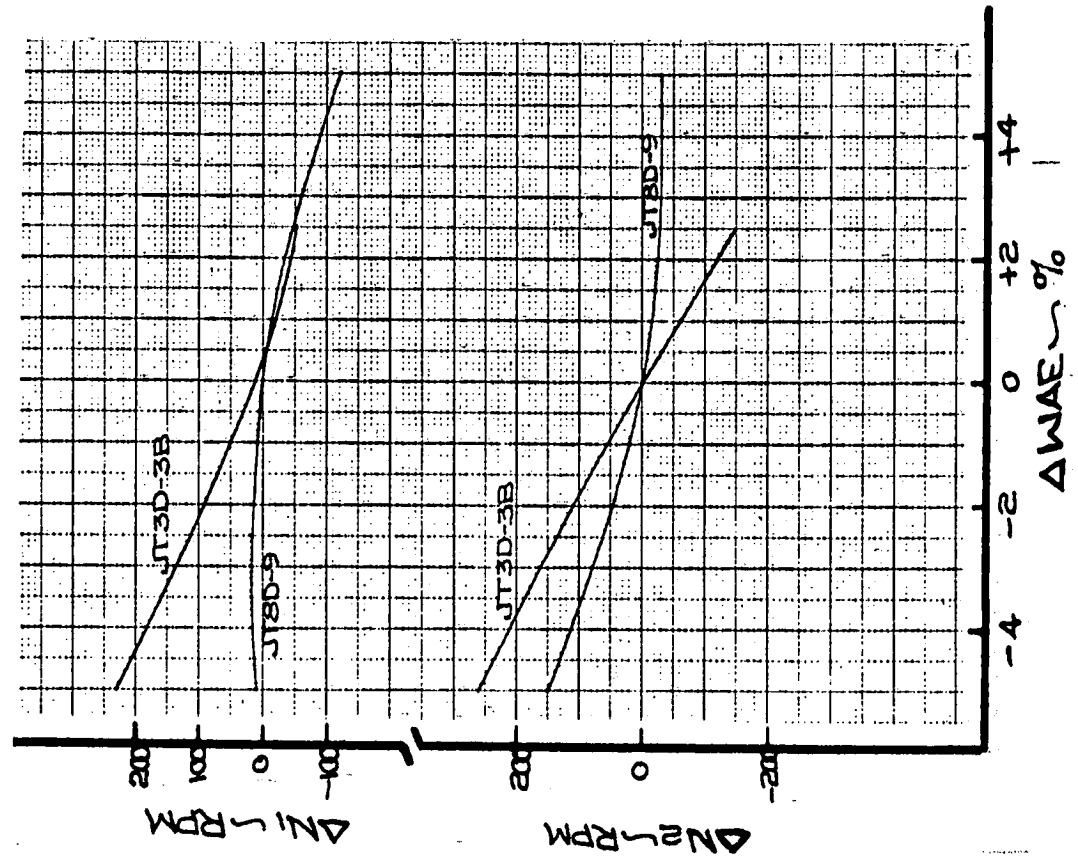
FIGURE 28. - LOW COMPRESSOR DETERIORATION
STUDY AT CONSTANT EPR

For reasons related to the parts inspection, the fuel consumption sensitivity to low compressor deterioration was analyzed in more detail. Figures 28 and 29 show the effect of primary flow and efficiency loss due to low compressor deterioration on the measured parameters of the JT3D and JT8D. While the low compressor deterioration, by itself, does not duplicate the shift in the measured test cell parameters, it does indicate that a significant increase in fuel consumption can result from degradation of this component. Differences between the JT3D and JT8D fuel flow increases, low rotor speed shifts, etc., were found to be due to the "matching" differences between a separate nozzle (JT3D) and a common nozzle (JT8D) engine. As shown in Figure 30, a reduction in low compressor flow capacity and efficiency in the JT3D-3B causes a reduction in low compressor flow and pressure ratio plus an increase in fan pressure ratio and total flow along the original fan operating line. In the JT8D, which has a single nozzle for both streams, the "rematch" is governed by the static pressure balance in the tailpipe. In this case, loss of low compressor flow capacity and efficiency causes some of the core flow to shift to the fan stream which increases the bypass ratio at about the same total flow. As shown in Figure 31, the fan pressure ratio increases. The fan pressure ratio increase is necessary to offset the effect of the increased fan flow. An increase in fan flow without a fan pressure ratio increase would produce a higher duct Mach number and too low a static pressure in the fan duct section of the tailpipe, but the increased fan pressure raises the static pressure in the tailpipe so that it is equal to the level of the static pressure in the engine stream in the tailpipe.

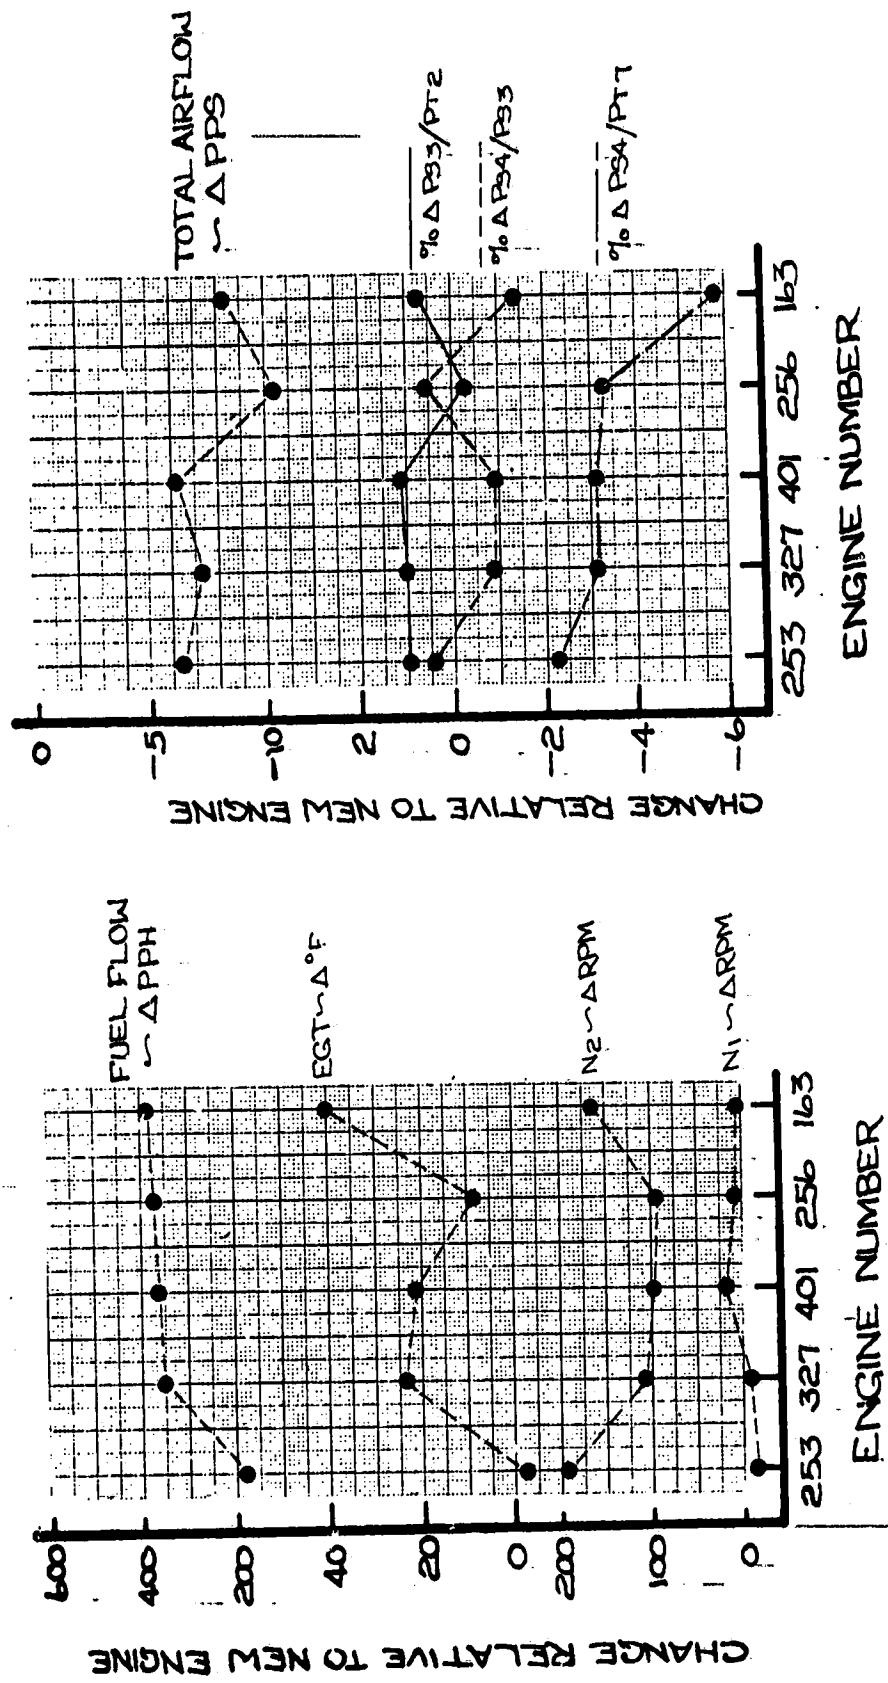
FIGURE 34. - COMPRESSOR DETERIORATION ON JT3D-3B ENGINE

and compressor deterioration that will line-up average deteriorated 3D and 8D engines are given in Figures 34 and 35. Test cell trend curves did show about a 2% and a 3% decrease in turbine expansion ratio (PS4/Pt7) in the JT3D and JT8D, respectively. This decrease in turbine expansion ratio can only be attributed to a loss in turbine performance (efficiency or leakage) or an increase in 1st stage turbine nozzle area. Therefore, while the fan and compressors are considered to be the major causes of the fuel consumption increase (based on parts condition) the turbines must contribute some to the fuel consumption increase.
