NASA TM X-64928

REPAIR OF MAJOR SYSTEM ELEMENTS ON SKYLAB

By Robert E. Pace, Jr.
Materials and Processes Laboratory

October 1974

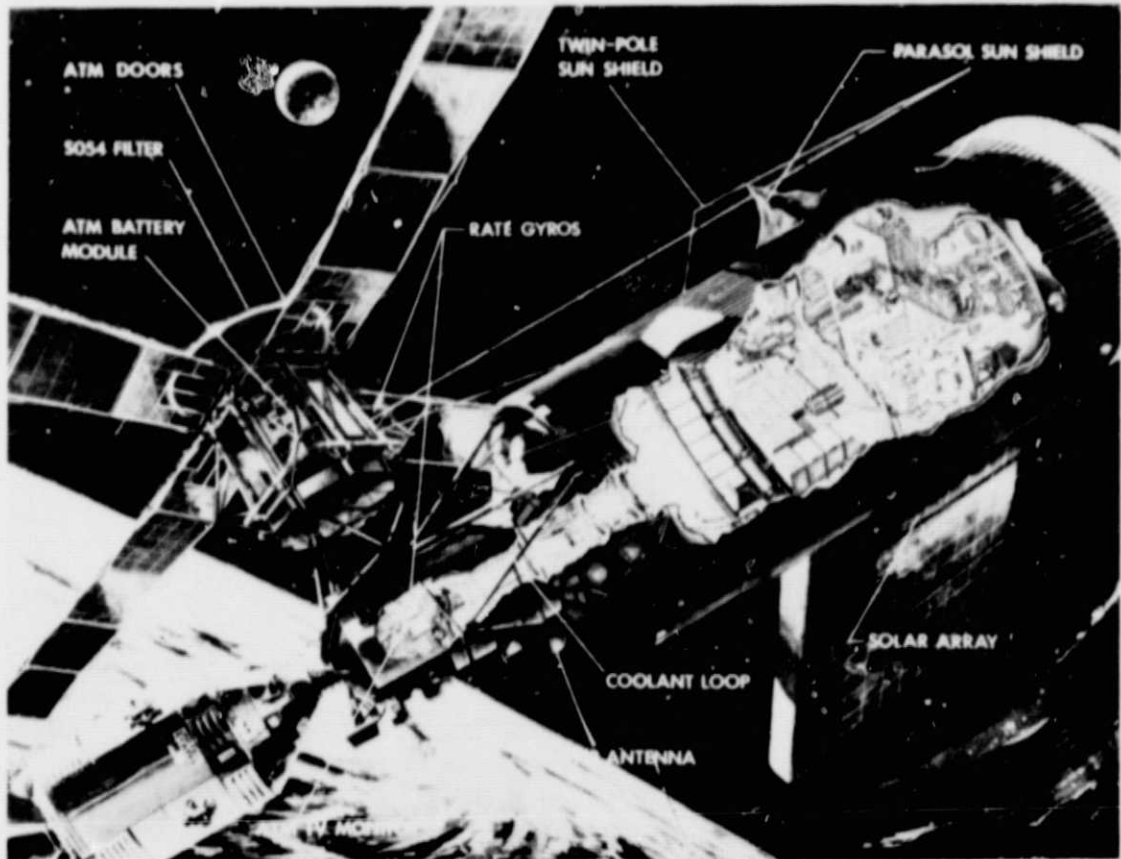
Figure 1. Locations of major maintenance activities.

Approximately 30 contingency maintenance tasks were performed by the Skylab crews; Table 3 lists these tasks by mission. Many of these involved major repairs to the cluster systems to permit continuation of the mission or to avoid significant compromises in attaining mission objectives. The locations of major repair activities are shown in Figure 1.

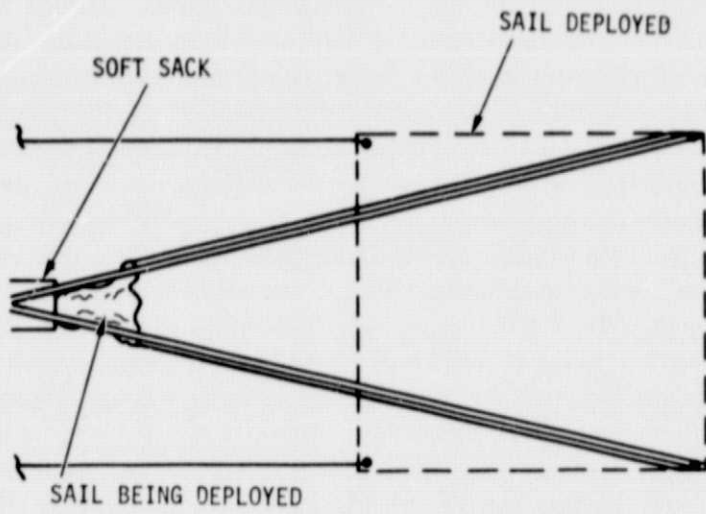
Figure 12. Sketch of sail deployment.

Figure 12 is a sketch of the deployed sail and Figure 13 is an actual view of the attached sail.

On August 5, 1973, the SL-3 crew began preparation for an EVA which would involve retrieving and installing film and also attaching the MSFC twin-pole solar sail. Prior to the EVA, the parasol was lowered as close to the Workshop wall as possible. The deployment procedure for the sail began August 6, 1973, with the Pilot translating himself through the airlock hatch to the ATM side, parallel to the damaged side of the Workshop, and mounted temporary foot restraints to the ATM hand rails (near an outrigger). When the foot restraints were in place and the Pilot was properly positioned, the Science Pilot, using the onboard extendible boom (for use on other EVAs), transferred to the Pilot a base plate fitting especially designed to hold the two sail poles in position over the Workshop. While the Pilot was clamping the base plate to an ATM outrigger, the Science Pilot, standing near the open airlock hatch, began assembling a 16.76 m (55 ft) pole from eleven 1.52 m (5 ft) sections, feeding the pole as he built it to the Pilot, who by this time was ready to receive it. The Pilot's position during this entire procedure was only slightly different from the one occupied during a normal EVA for replacing film canisters. After receiving the first pole, he positioned the base end into one of the two receptacles, or sockets, ("V" shaped) on the base plate. The second pole was received and attached in like manner in the other socket. As can be seen in Figure 11, a simple sketch of the pole, the end of the outward section of each pole has an eyelet through which is threaded a continuous loop rope. After the Science Pilot had transferred the sail package to the Pilot, he then hooked two corners of the folded sail onto the pole ropes (attach rings on rope). He then gradually pulled the ropes, alternately, sending the sail out along the poles in a manner similar to raising a flag. After full extension of the sail, the other two remaining ends of the sail were extended and tied off with ropes to the ATM outrigging.

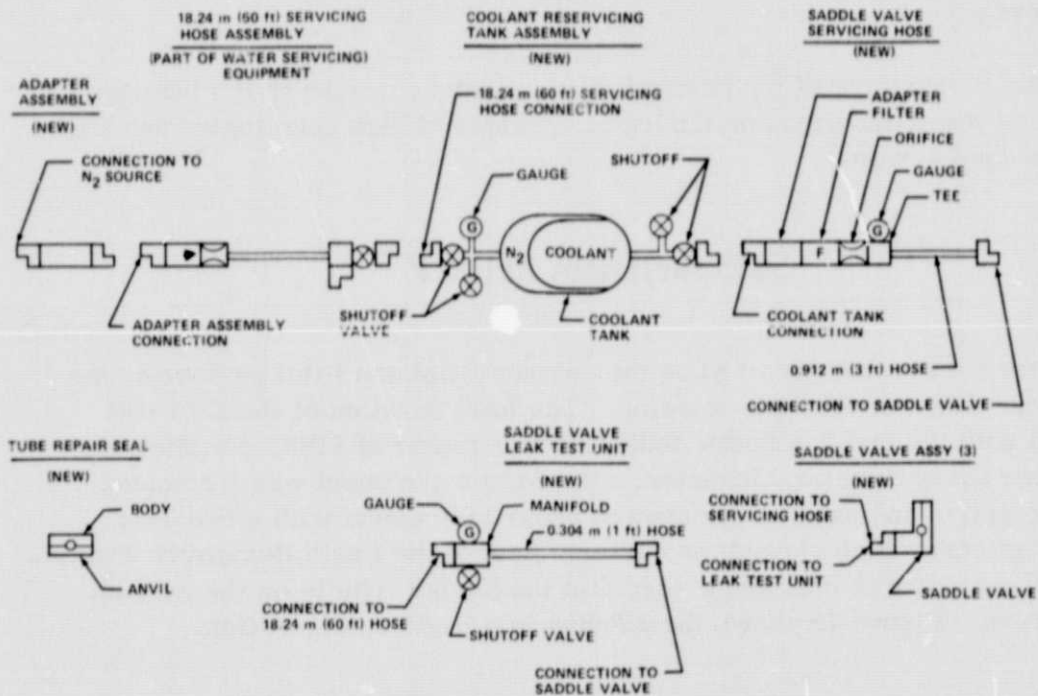
Figure 18. Coolant reservicing equipment.

On the 27th day of SL-3 the primary loop was shut down to prevent pump cavitation and possible damage after the pump inlet pressure had reached a low of 3.45 N/cm^2 (5 psia). Flight data also indicated that the secondary loop possibly was leaking but was still operational and providing the required cooling. The leakage rate was determined to be so small that the coolant loops could remain operational by replenishing the coolant. Since the coolant loops were not designed for onboard reservicing, efforts were initiated by ground personnel to devise a way to reservice the loops, develop the hardware and demonstrate its capability in time for launch of SL-4.

The procedure developed included stripping insulation from a coolant line near the cabin heat exchanger in the airlock module, piercing the line with a saddle valve assembly (Fig. 17) which had a quick disconnect for attaching a service hose and forcing coolant from a small storage tank by applying pressure from a 24.13 N/cm^2 (35 psi) source through a bellows arrangement. Parts for the reservice equipment were primarily qualified by similarity to equipment used in other Airlock Module applications. The tank was adapted from a

Command Module fuel tank. Figure 17 shows the reservice system schematically. The tank was launched with 19.05 kg (42 lb) of coolant.
