Document No. QTR-72-1039
Revision _____
Release Date DEC 5 1972

QUALIFICATION TEST REPORT
BUMP PROTECTION HAT
(SUBASSEMBLY OF
T020/M509 HEAD PROTECTIVE ASSEMBLY)

CONTRACT NAS 9-11905

GENERAL ELECTRIC
APOLLO AND GROUND SYSTEMS
HOUSTON PROGRAMS
Houston, Texas

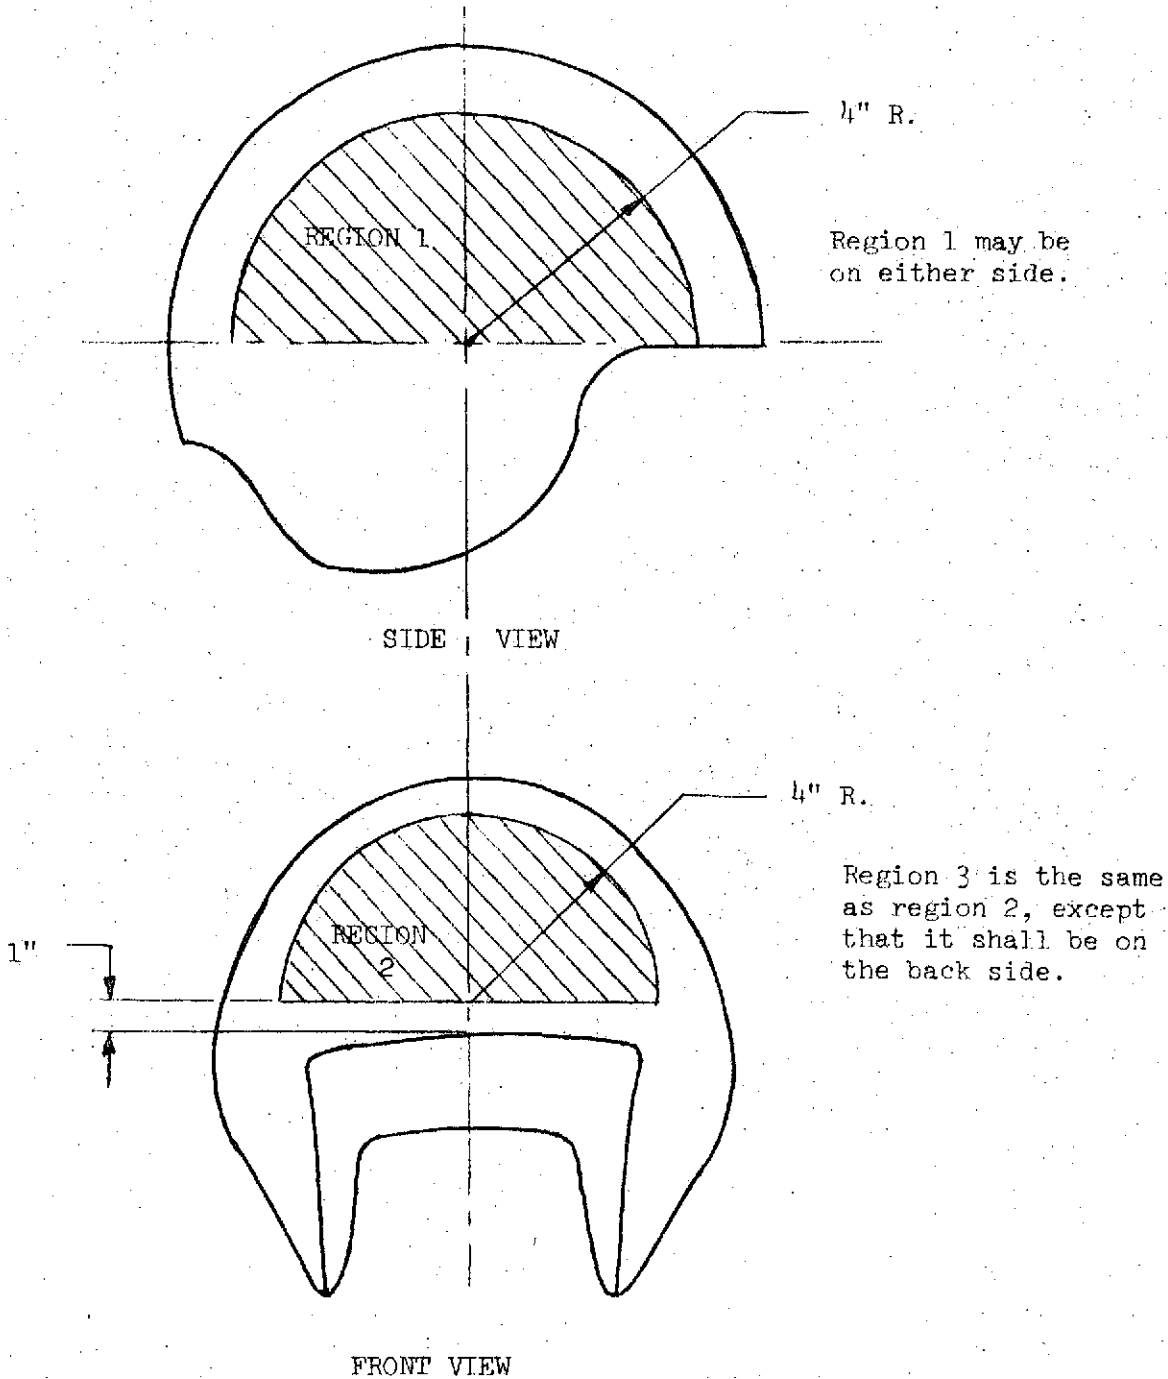
Figure 3

- a. Stop watch not calibrated.
- b. Region three on Fig 3 replaced by a top of helmet impact (see TPS 6E-TPS-C-010)

4. Perform the procedures indicated in Document QTP-72-1037, dated Oct 19, 1972, with the following exceptions:					[Stamp]			
a. Region 2 of Fig. 3 of QTP-72-1037 shall be replaced by a region consisting of a 4" radius circular area originating from the top center					[Stamp]

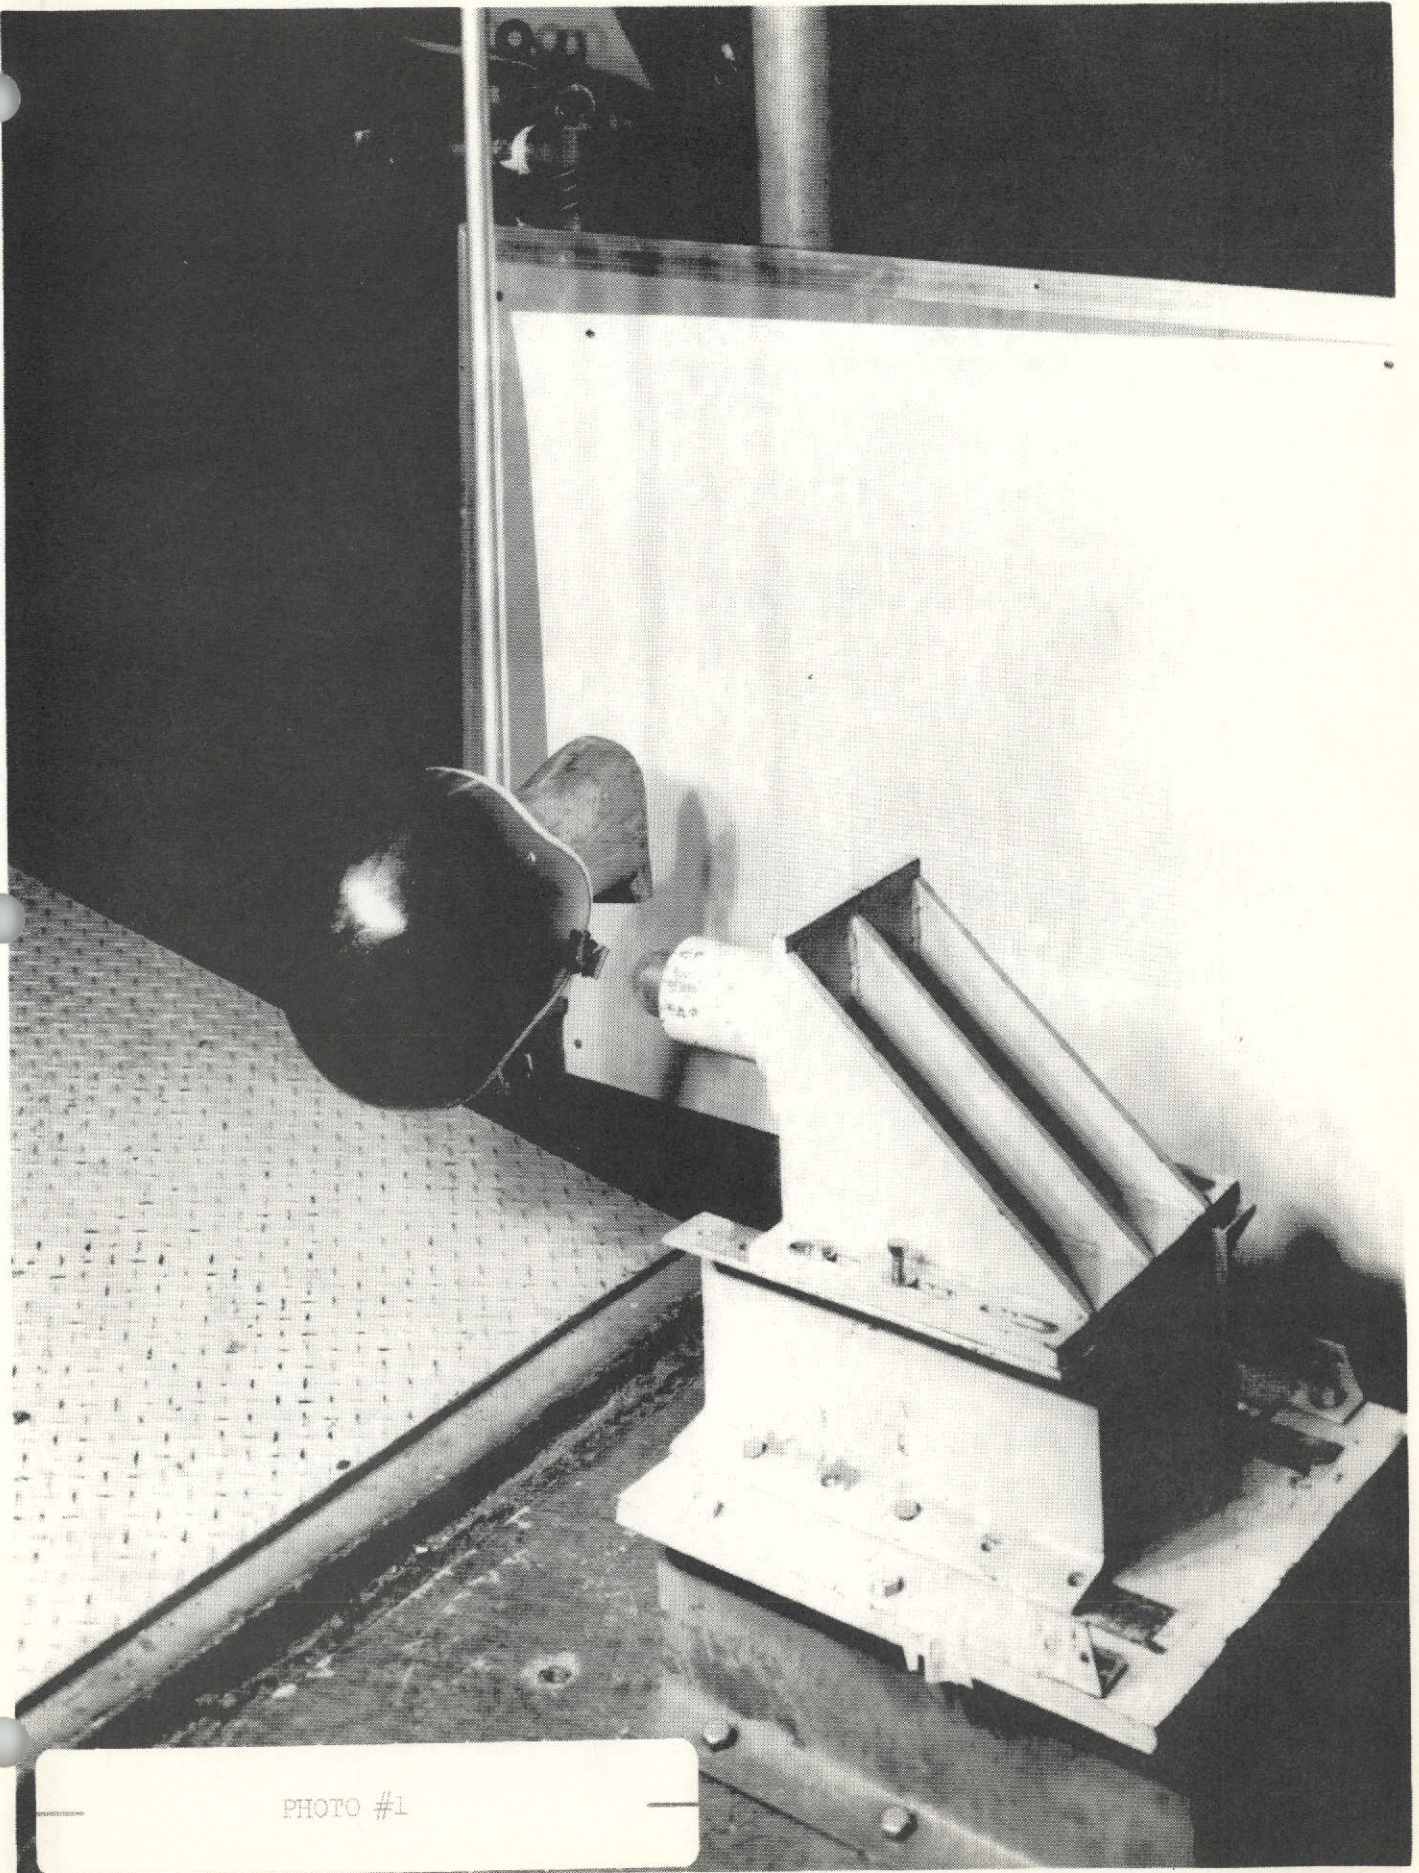
PHOTO #1

The test equipment is shown in Figures 1 and 2 of the test procedure (Appendix A). Photographs number 1, 4, and 8 of Appendix C show the test setup for the three impacts performed. The stop watch used during testing was not calibrated, as indicated on the Test Summary Sheet (Attachment A of QTP-72-1037).
