CHARACTERIZATION OF METALS MELTING DISCS
SKYLAB EXPERIMENT M551

By Robert E. Monroe
Battelle Columbus Laboratories
Columbus, Ohio 43201

January 1974

NASA-GEORGE C. MARSHALL SPACE FLIGHT CENTER
Marshall Space Flight Center, Alabama 35812

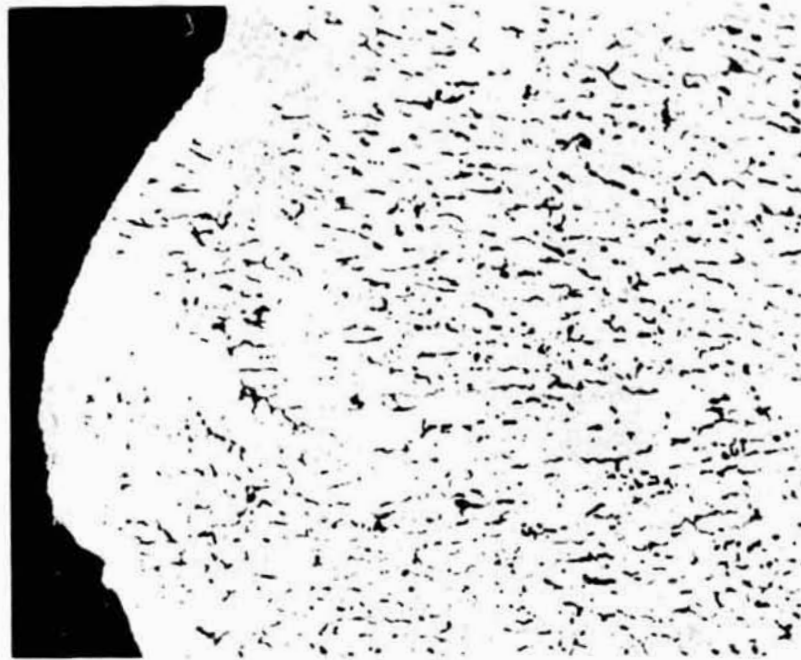
FIGURE A-6. SURFACE OF CUT ON INSIDE -H-1

Figures A-5 through A-10 show the appearance and microstructural details in the cut region. Several areas on the cut surfaces indicate the presence of a contaminant or reaction zone. This has probably come from material vaporized from the surface under the weld disc. The very wide cut that resulted in this disc is
