**SHUTTLE ACTIVE THERMAL CONTROL SYSTEM  
DEVELOPMENT TESTING**

**TUBE ANOMALY INVESTIGATION**

Report No. T169-28

5 April 1974

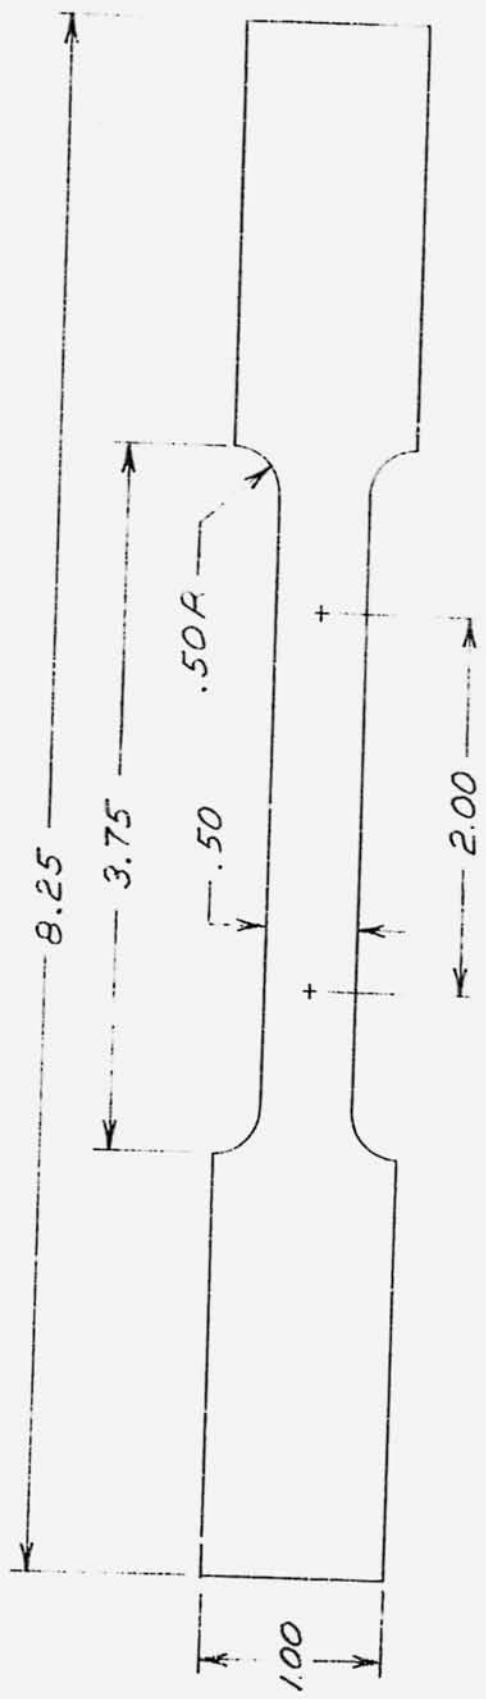
FIGURE 14  
TENSILE SPECIMEN ORIENTATION

Mechanical properties of the extruded tubing were determined in both longitudinal and transverse directions. Tensile specimen orientation and dimensions are shown in Figures 14 and 15. The results of the mechanical tests are given in Table 1. Considering the abnormal size of the test specimens, there was relatively little scatter in the data, with all specimens meeting the requirements for the -T42 condition.

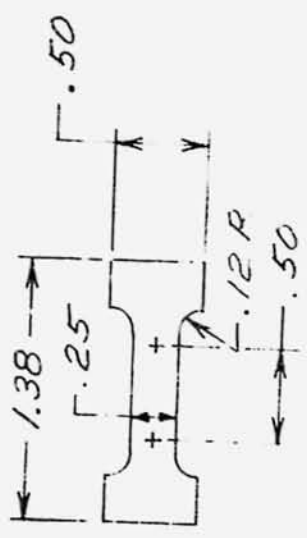
FIGURE 15

LONGITUDINAL TEST SPECIMEN

TRANSVERSE TEST SPECIMEN
