NASA TECHNICAL NOTE

NASA TN D-7775

LIGHTNING DAMAGE TO A GENERAL AVIATION AIRCRAFT - DESCRIPTION AND ANALYSIS

by Paul T. Hacker

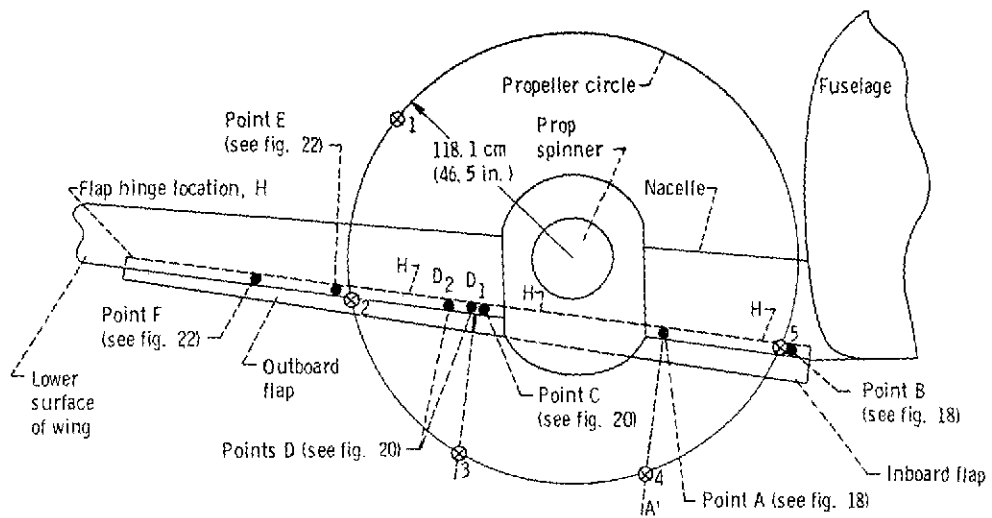
Figure 26. - Locations of sharp indentations (points A to F) on leading edge of flaps and estimated positions (1 to 5) of propeller tip at times strokes occurred.

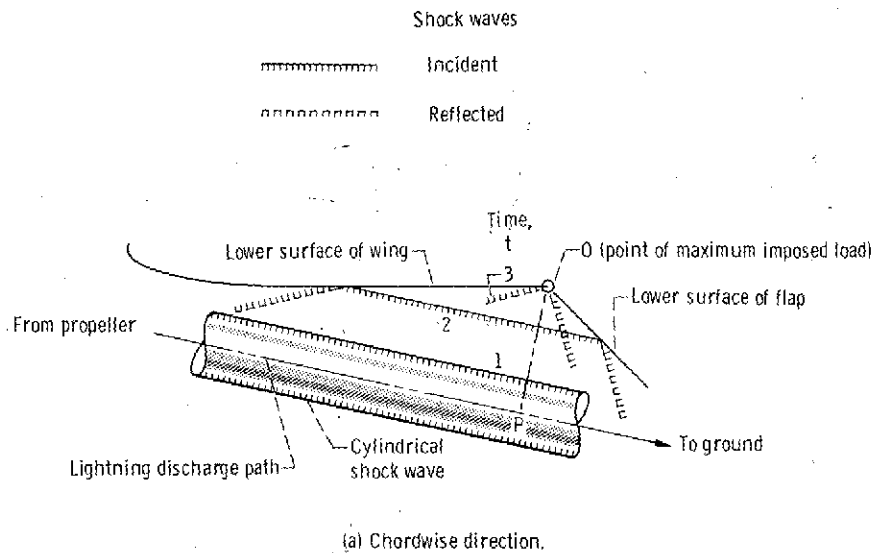
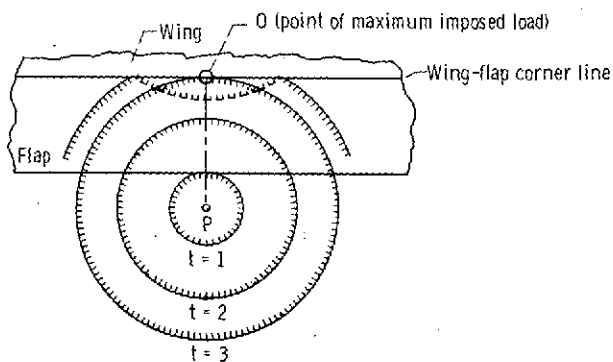
Figure 27. - Orientation of lightning path and shock wave with respect to lower side of aircraft wing-flap combination.

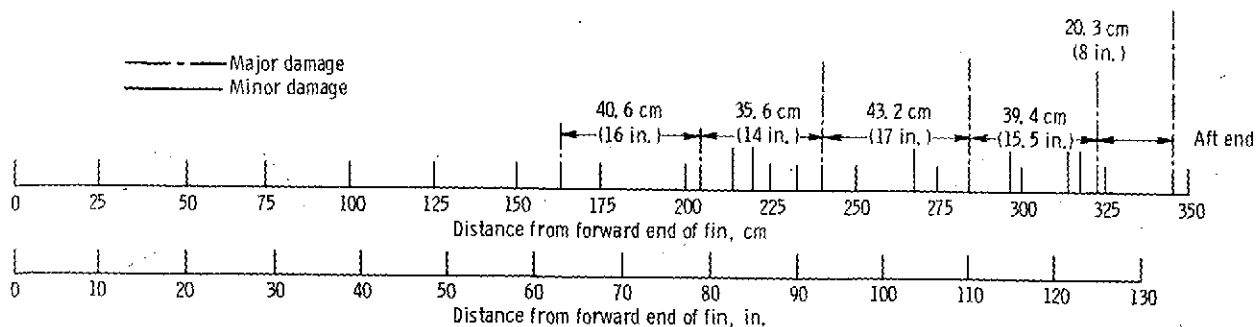
Figure 28. - Location of damage points along ventral fin due to swept stroke. (Length of line marking damage points indicates magnitude of damage.)

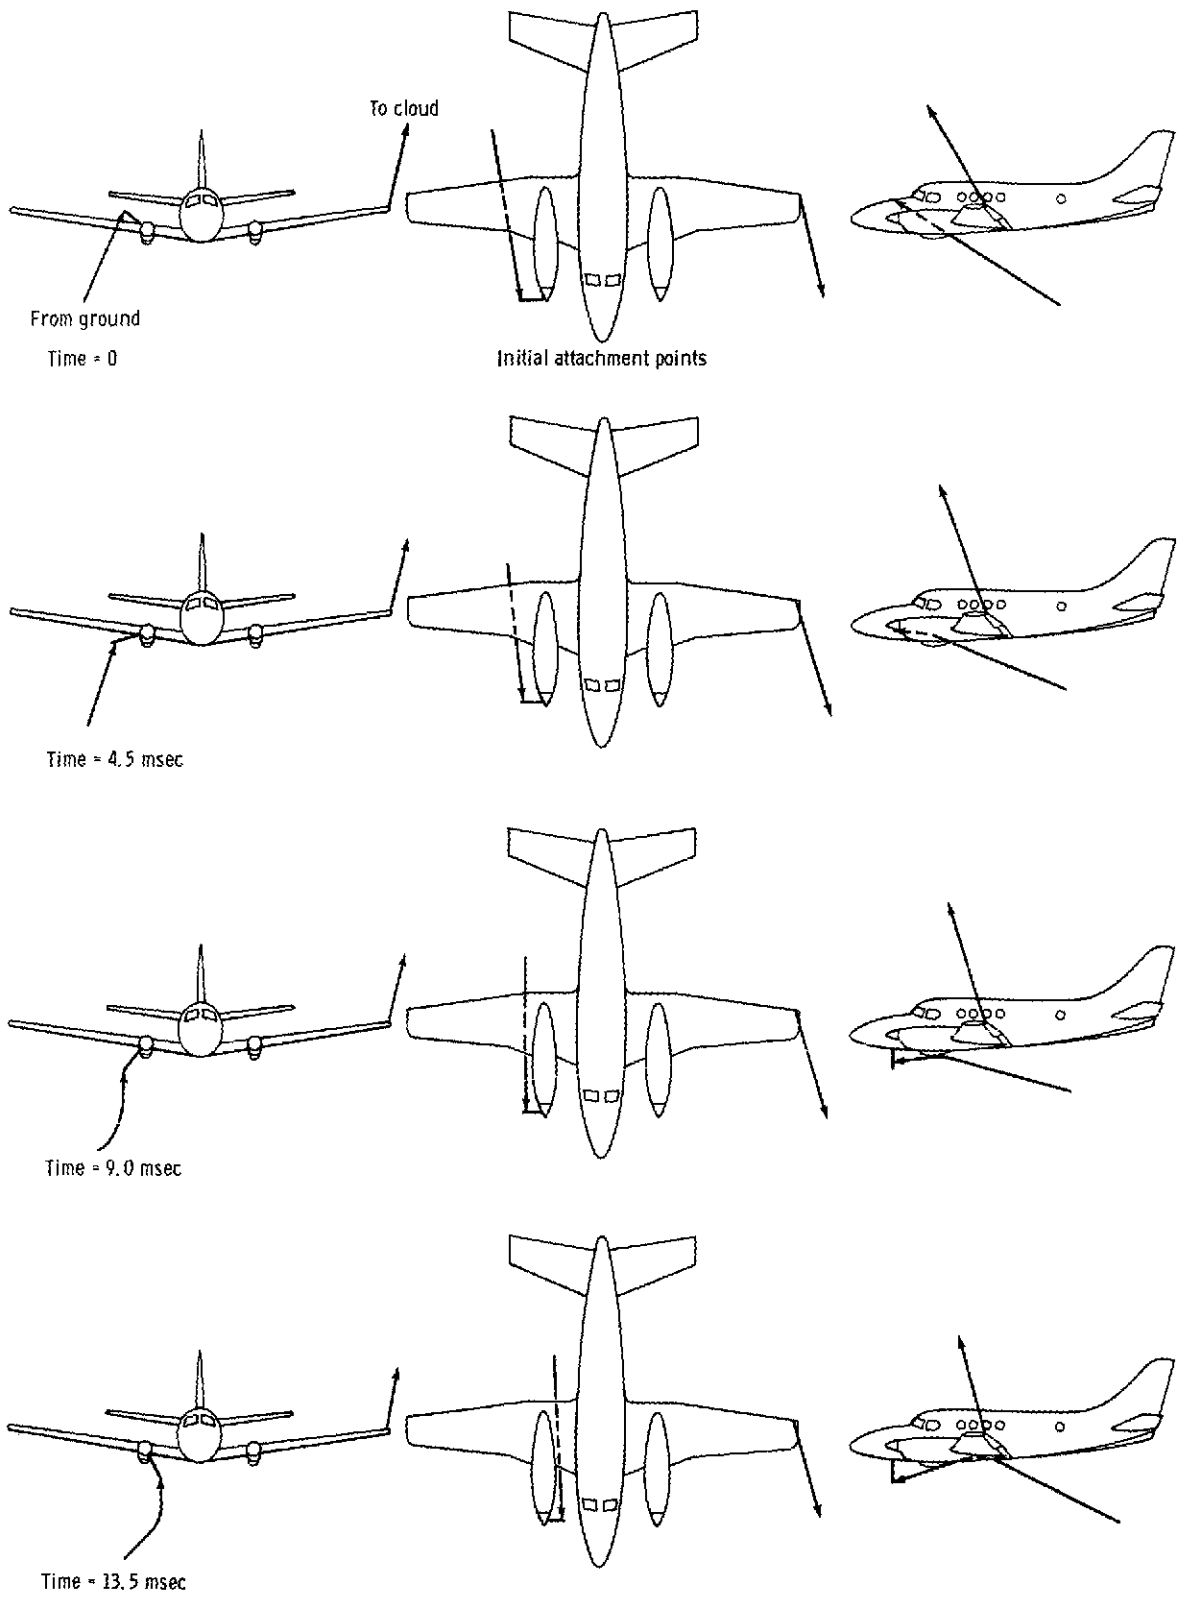
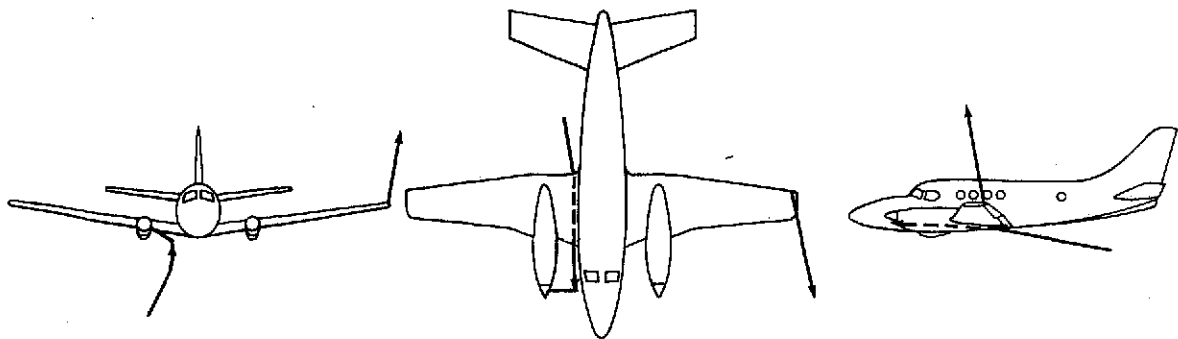
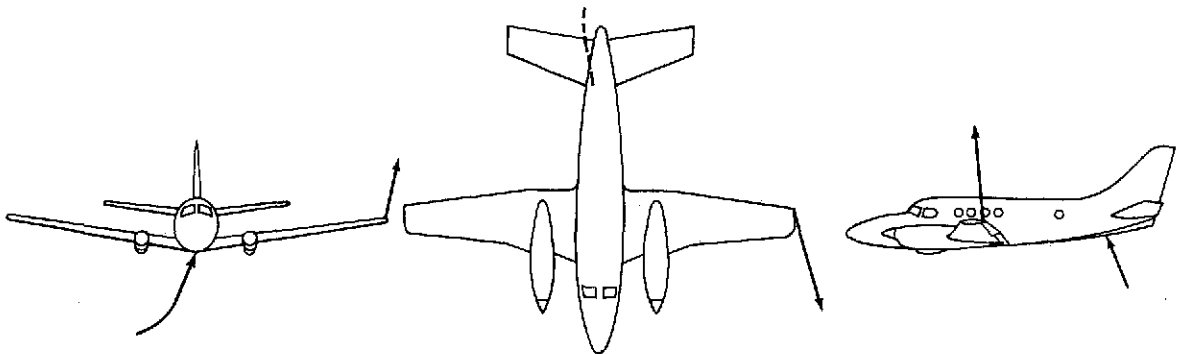
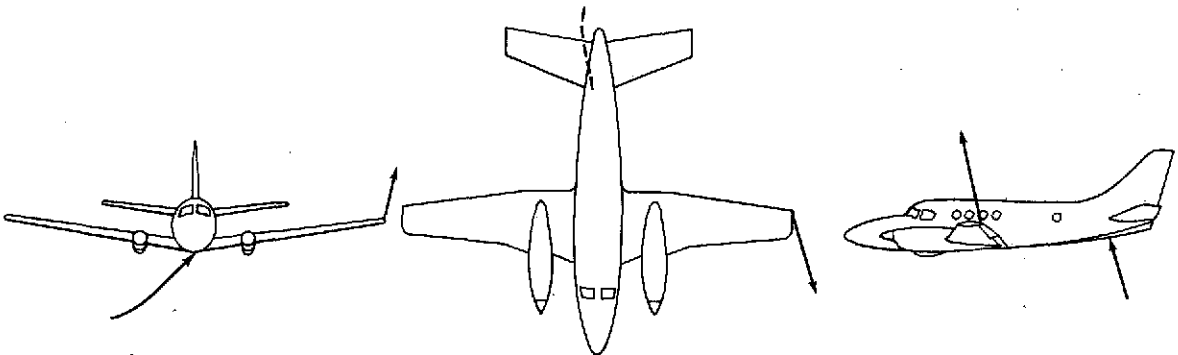
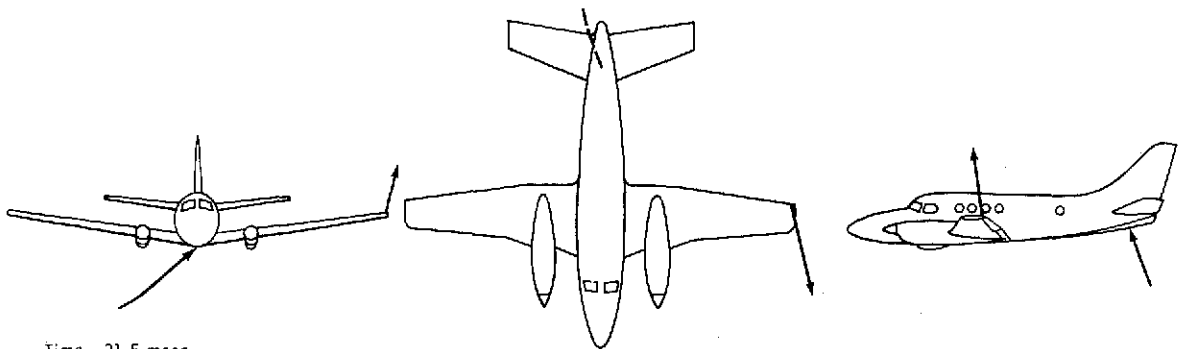
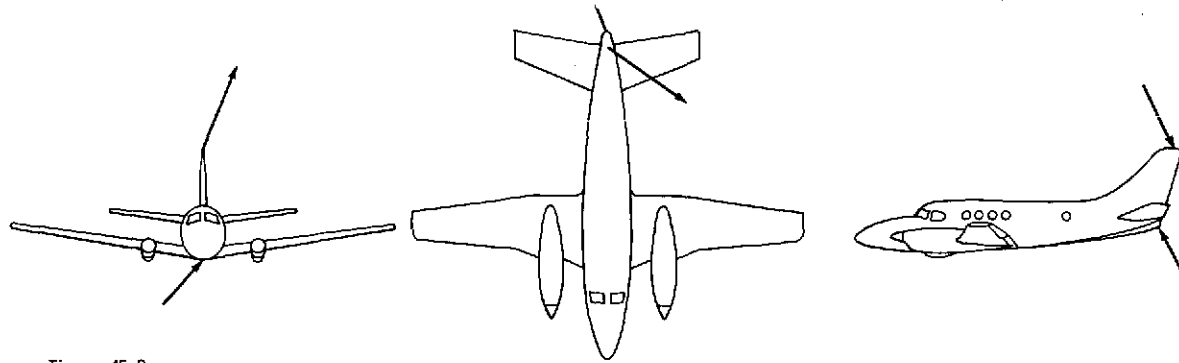
Figure 29. - Probable lightning path with respect to aircraft. (Indicated times are for high-current-stroke portions of discharge.)

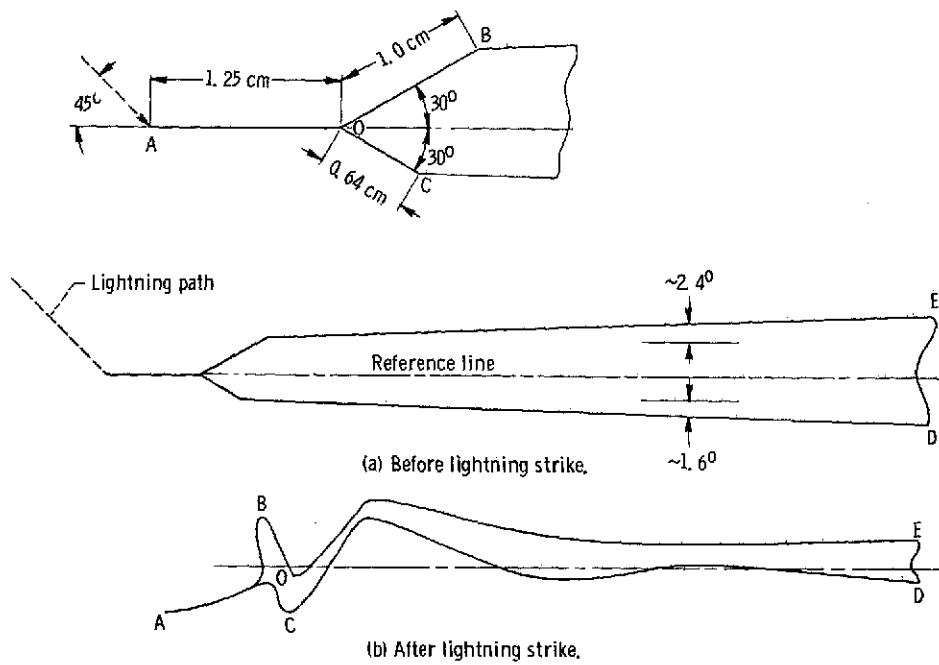
The calculated forces presented in table II are shown plotted on a schematic representation of the wing trailing-edge chordwise cross section in figure 31, in order to show the relation between the forces on the various segments and to compare the forces with the damage sustained (fig. 30). The directions of the calculated forces correlate very well with the damage. The forces on the trailing-edge segment (A-O) are downward, which agrees with the final configuration in the damaged area. The forces on A-O, especially near A, are mainly due to the lightning, which was assumed for the calculation to come from above and behind the trailing edge. If it had been selected as coming from above and forward, the downward forces on the upper surfaces and especially on the trailing edge would have been greater. If the lightning had come from below, the trailing edge would have been forced upward. The calculated forces on segments O-B and O-C near point O are such as to force the two segments together, which actually occurred. At points B and C, the calculated forces are such as to cause the points to move away from the interior and also to cause separation of segments O-B and O-C from segments B-E and C-D, respectively. Points B and C were actually pushed outward, and

Figure 30. - Approximate geometry of chordwise cross section of wingtip trailing edge.

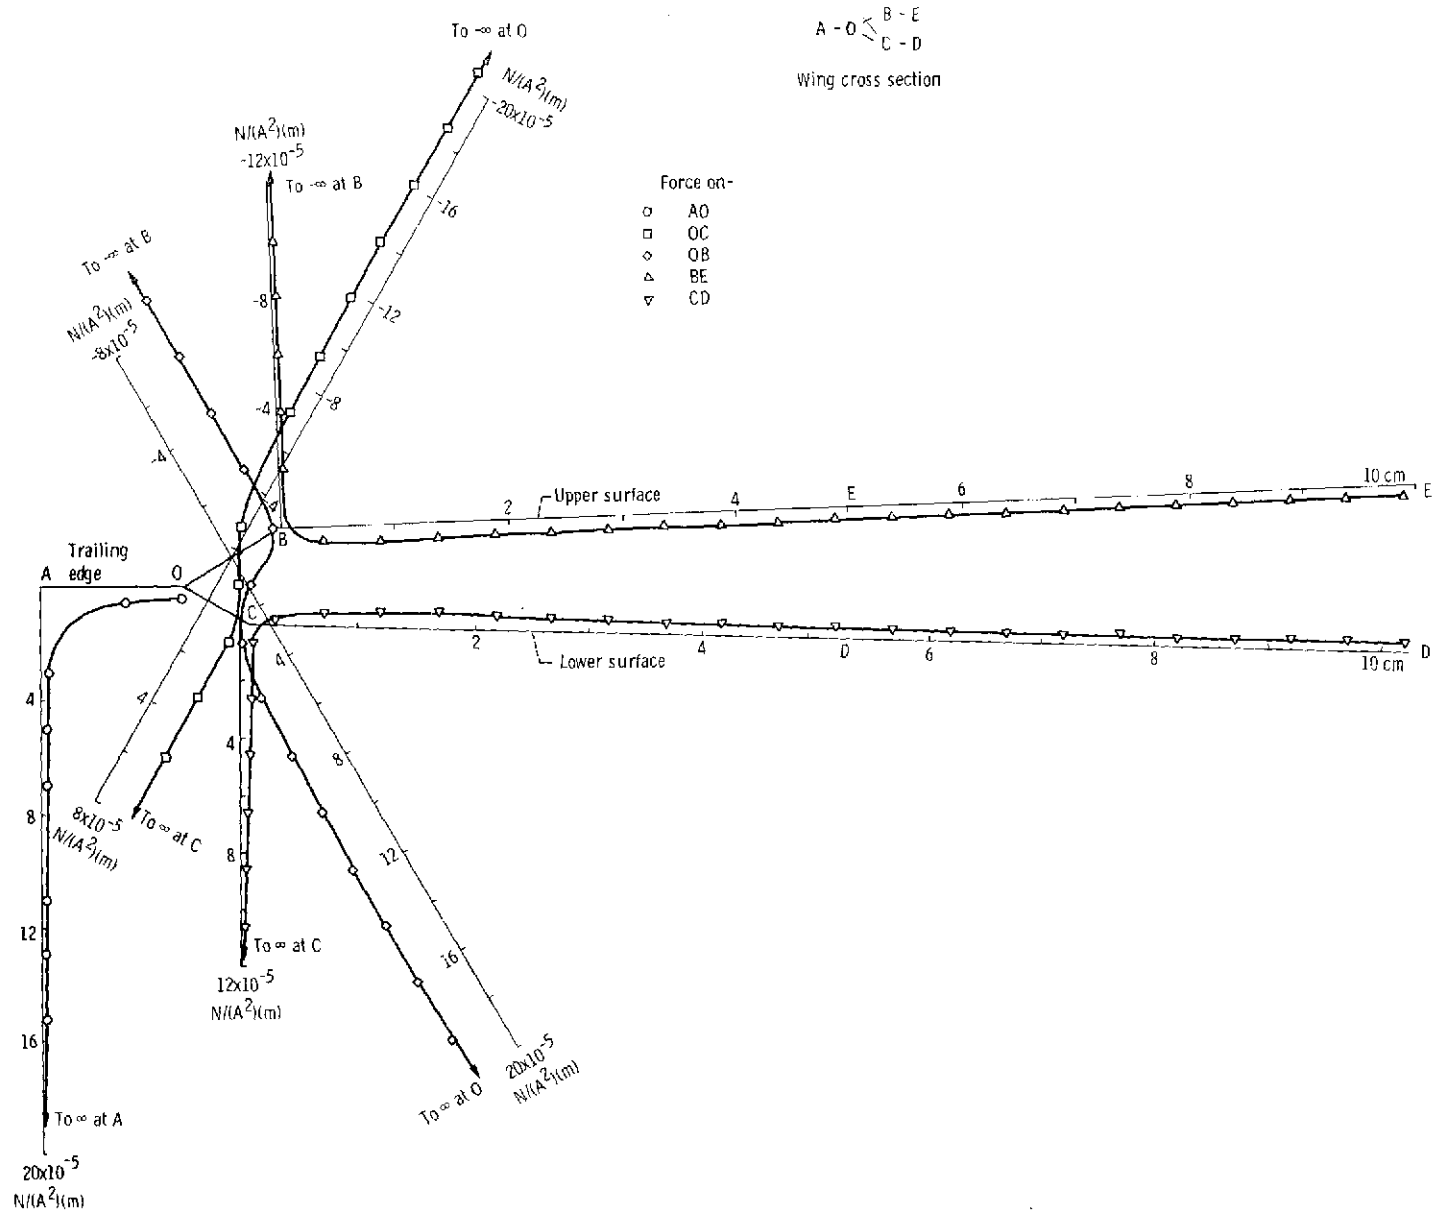
The forces presented in table II and figure 31 are the calculated forces per ampere squared for a 1-meter-long conductor. (The maximum current measured in a stroke portion of a lightning discharge was slightly greater than 200 kA, with 2 percent of all strokes greater than 100 kA (ref. 2).) For the trailing-edge segment (A-O), whose length is 1.25 centimeters (0.48 in.), the average force over its length would be about 10^{-5} N/(A²)(m). Thus, the average force for a 100-kiloampere stroke on segment A-O would be 1250 newtons (281 lbf). On the upper and lower surfaces, B-E and C-D, respectively, at about 2-centimeter (0.79-in.) position the force would be about 0.5×10^{-5} N/(A²)(m), which gives for a 100-kiloampere stroke a force of 500 N/cm (286 lbf/in.).

Figure 31. - Direction and magnitude of forces on trailing-edge surfaces of aircraft wing due to interaction of magnetic fields and electrical currents. (Force is in newtons per ampere squared of lightning current per meter of surface length of circuit.)

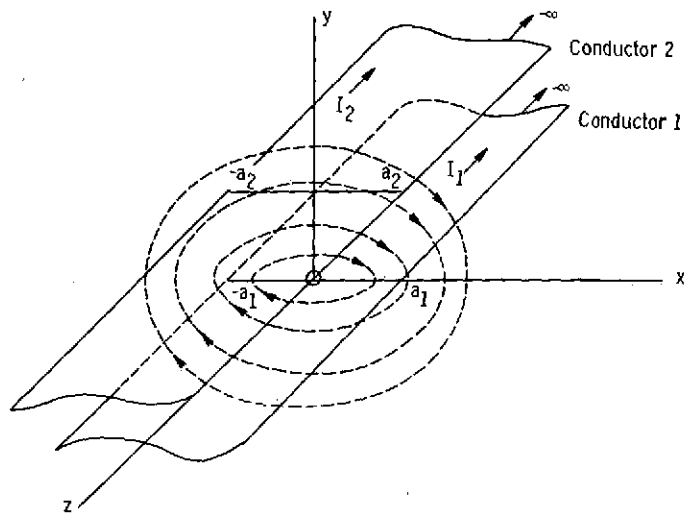
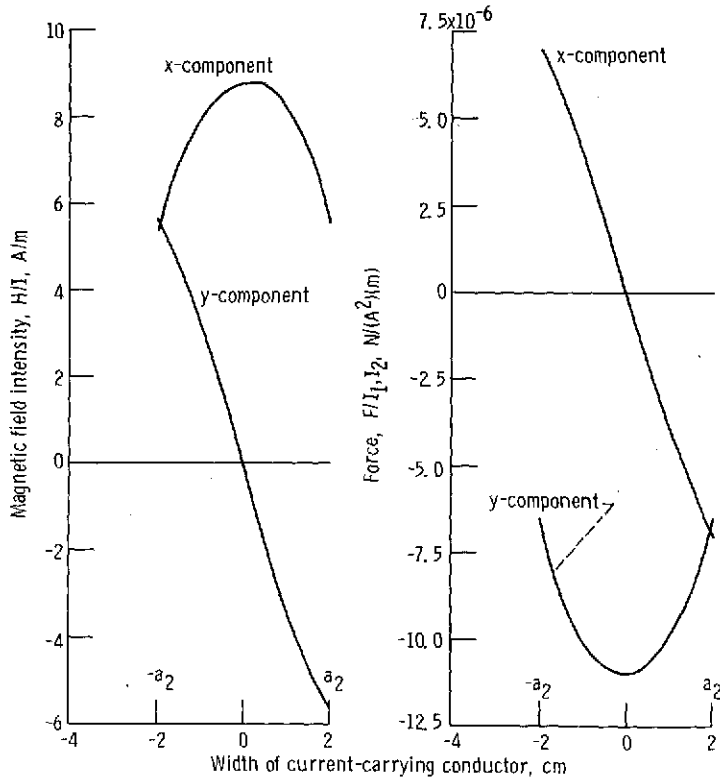
The x- and y-components of the magnetic field intensity on conductor 2 due to current flow in conductor 1 are presented in figure 32(b). The x- and y-components of the force per meter per ampere squared along conductor 2 due to the magnetic field of conductor 1 are presented in figure 32(c). The forces were derived from the magnetic field intensities of figure 32(b) by

Figure 32. - Magnetic fields and forces created by two infinitely long, 4-centimeter-wide, current-carrying conductors separated by 1 centimeter (assuming uniform current density in each conductor).

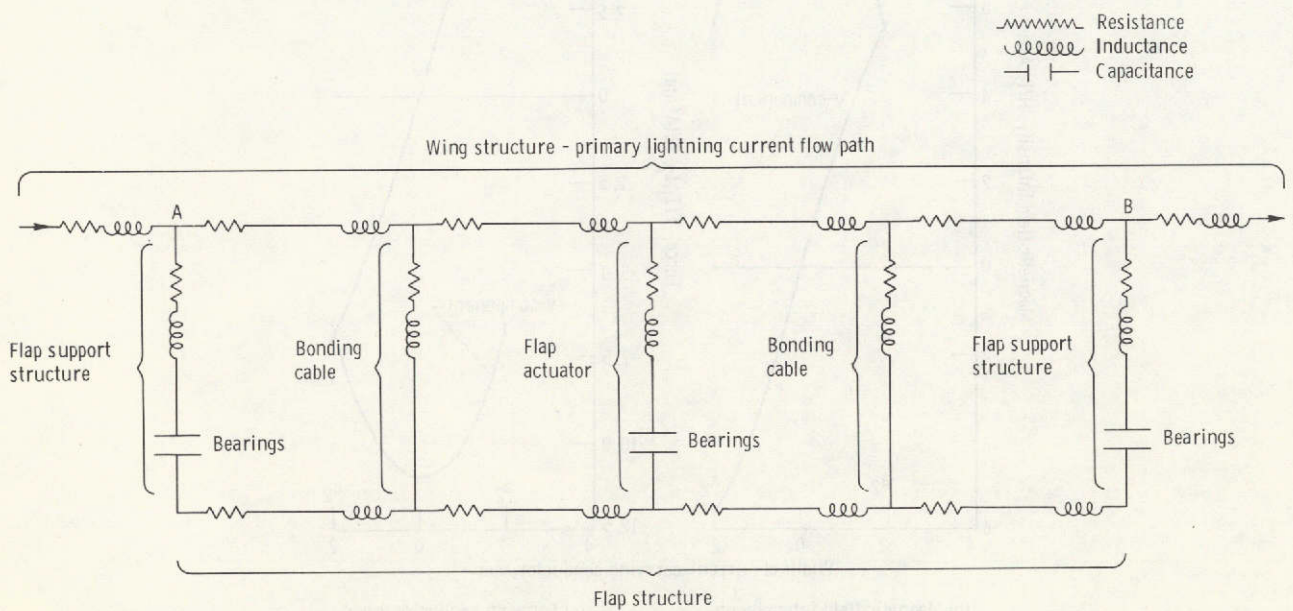
Figure 34. - Electrical circuit representation of wing-flap structure and interface attachments.
