NASA TECHNICAL
MEMORANDUM

NASA TM X-64819

MSFC SKYLAB INSTRUMENTATION AND COMMUNICATION
SYSTEM MISSION EVALUATION

Skylab Program Office

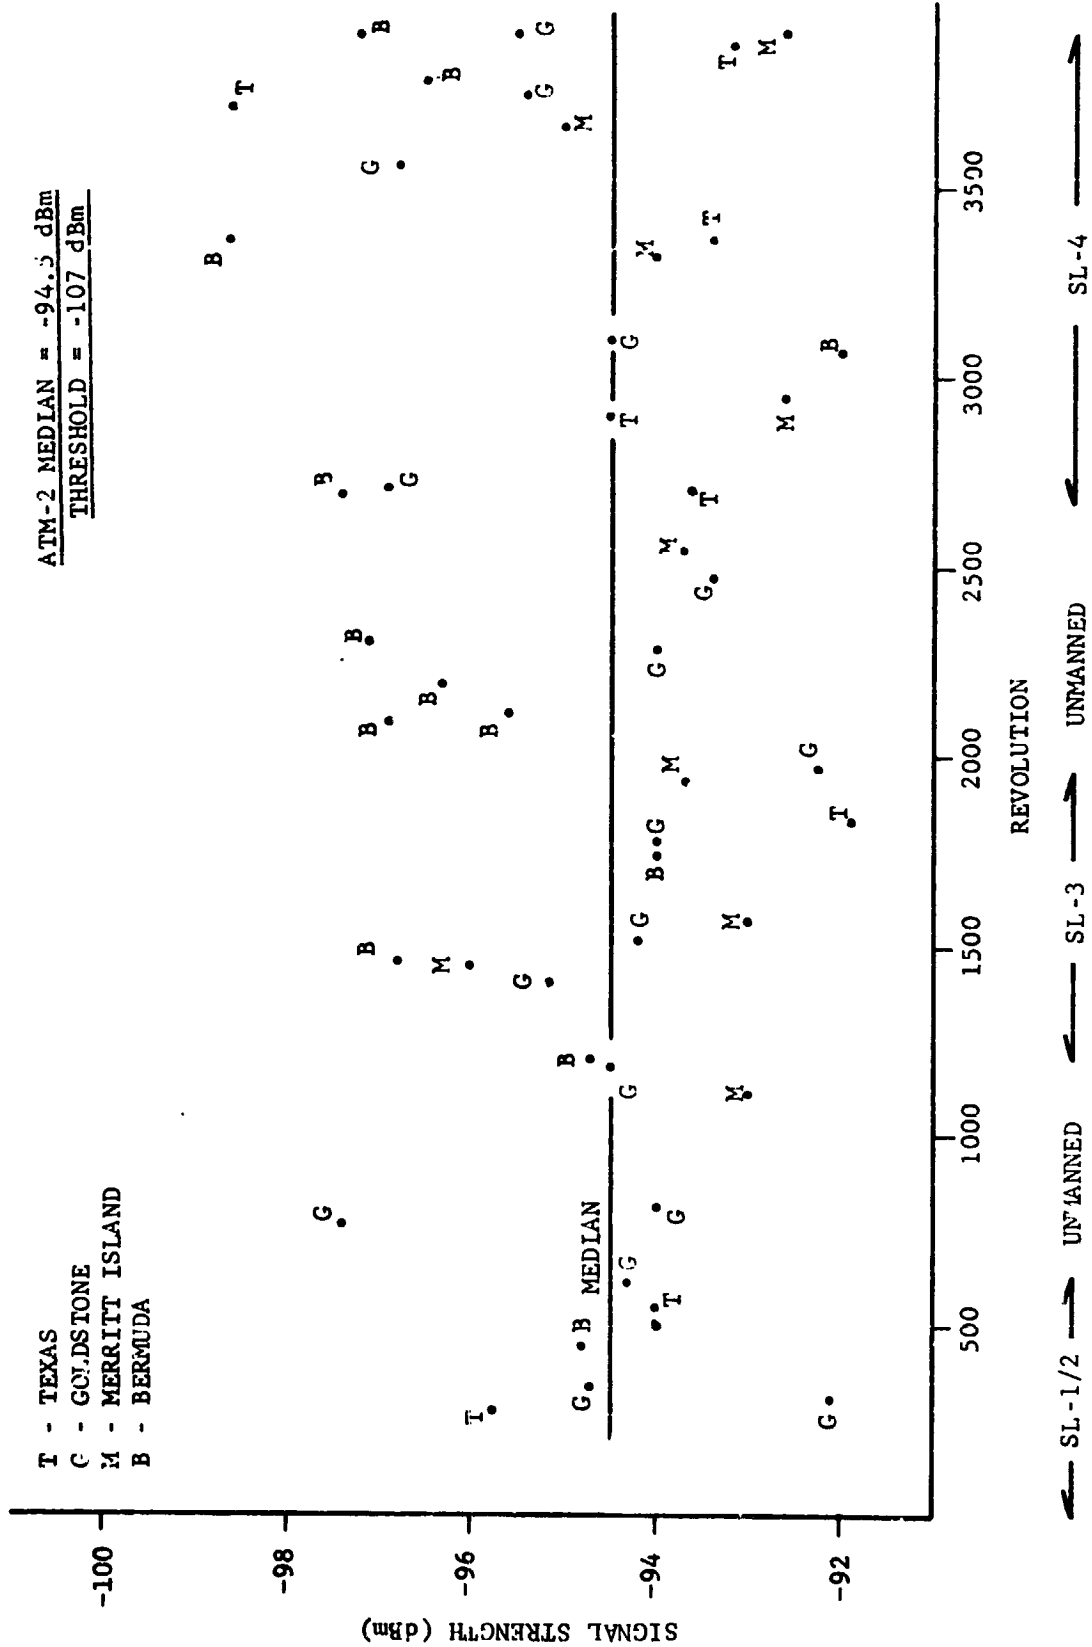
FIGURE 6-5. ATM-2 TELEMETRY LINK PROFILE

The approximately 3-dB difference in median signal levels between the ATM No. 1 and No. 2 links can be explained by referring to antenna pattern data. Available pattern data indicates that antenna gains derived over 70 to 80 percent of the aft ATM antenna exceed the levels derived from the forward ATM antenna by about 3 to 4 dB.

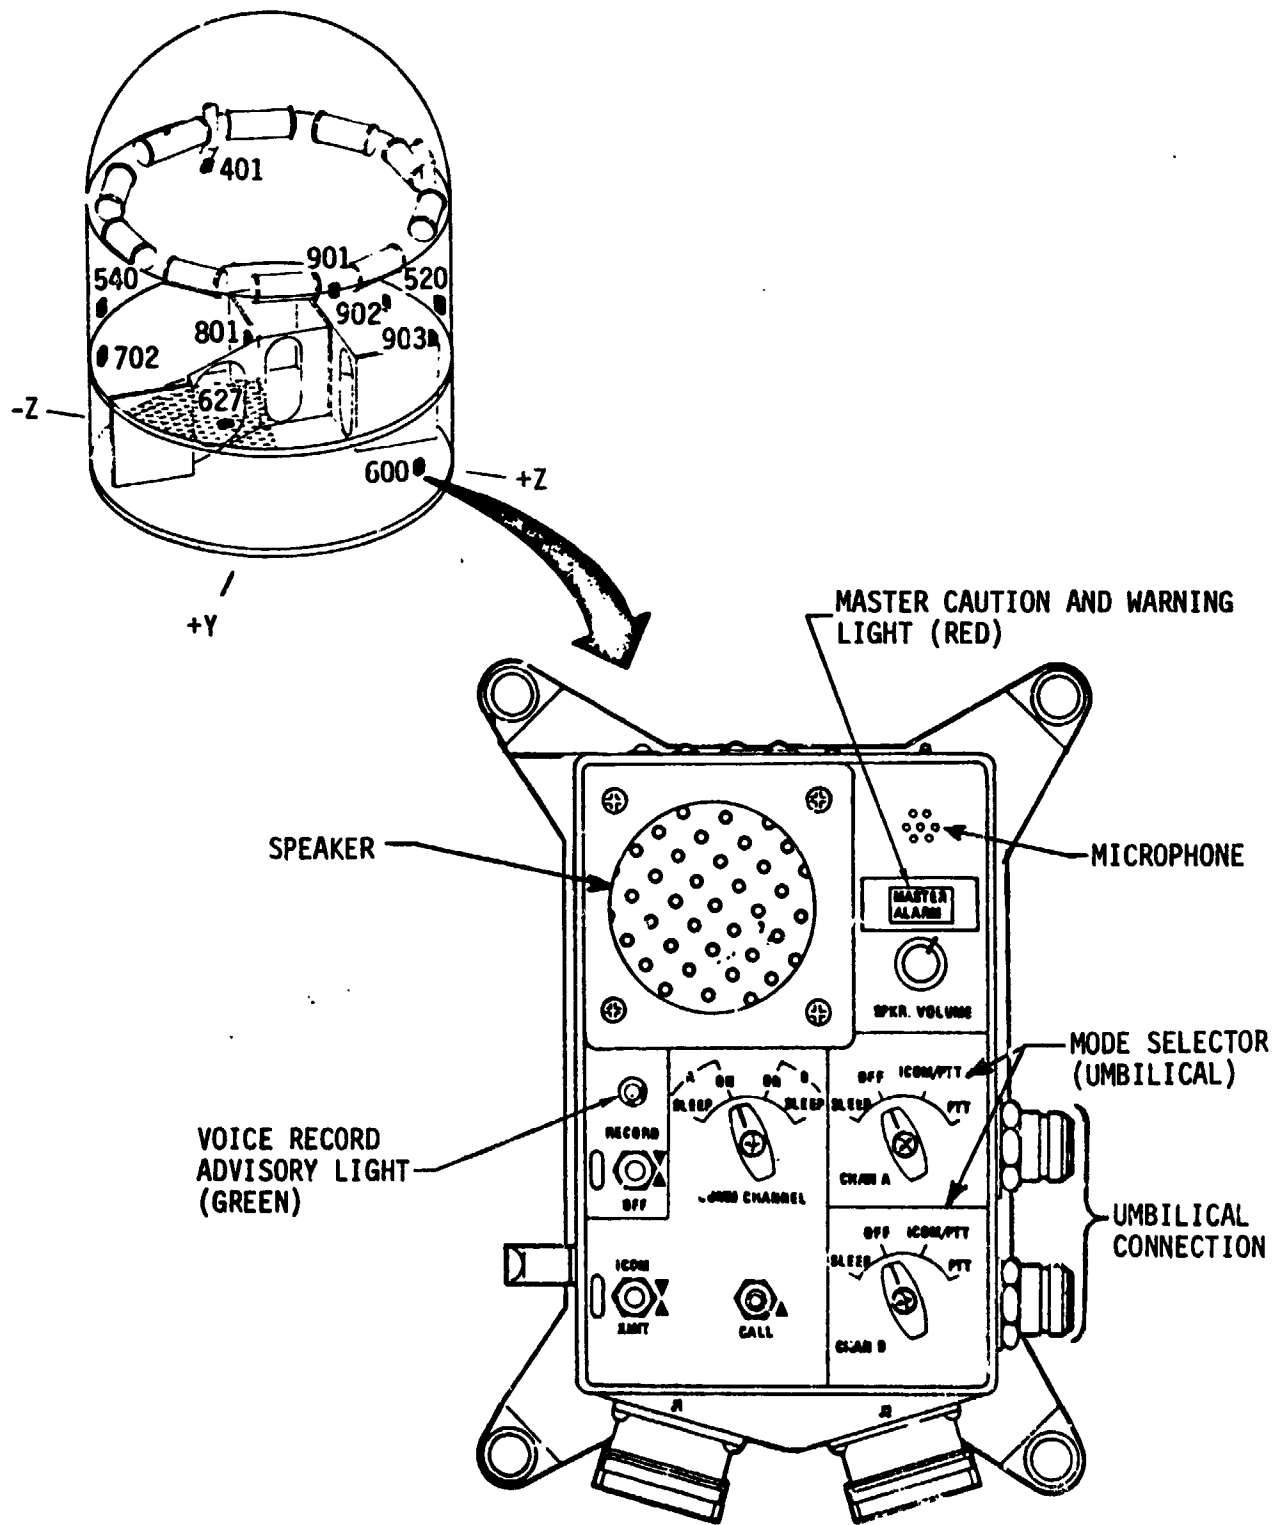
FIGURE 6-9 SIA PANEL AND LOCATIONS IN OWS

Audio feedback occurred primarily in the OWS between the SIAs at the wardroom (702), anti-solar scientific airlock, (540), and the one above the ergometer (627). See Figure 6-9. The three units located in the sleep compartments and in the waste management compartment did not cause any operational feedback problem primarily because of low usage, low speaker volume setting, and the relative isolation afforded by the walls in the waste management compartment.

At a crew debriefing, the first crew indicated the feedback was worse inflight than during the AM/MDA 5 psia tests. This can probably be attributed to the higher volume control setting required in the OWS and the larger number of SIAs used. Prior to the mission there was no way of assessing the extent of any SIA traffic, such that constraints could be put on their operational usage. As such, these constraints were developed during the mission. A second cause of feedback was the apparent difference in the speaker volume when the system was used in the intercom mode as compared to the PTT mode (transmit-to-ground). This was due to differences in sidetone levels presented to the CSM audio center earphone amplifier that was approximately 5 dB higher in the PTT mode. Thus, an adjustment of the SIA volume controls for satisfactory sidetone volume level during the ICOM mode would result in feedback during an SWS-initiated PTT mode (push-to-talk). Conversely, satisfactory volume level adjustment during the PTT function would result in low sidetone volume levels during the intercom mode.

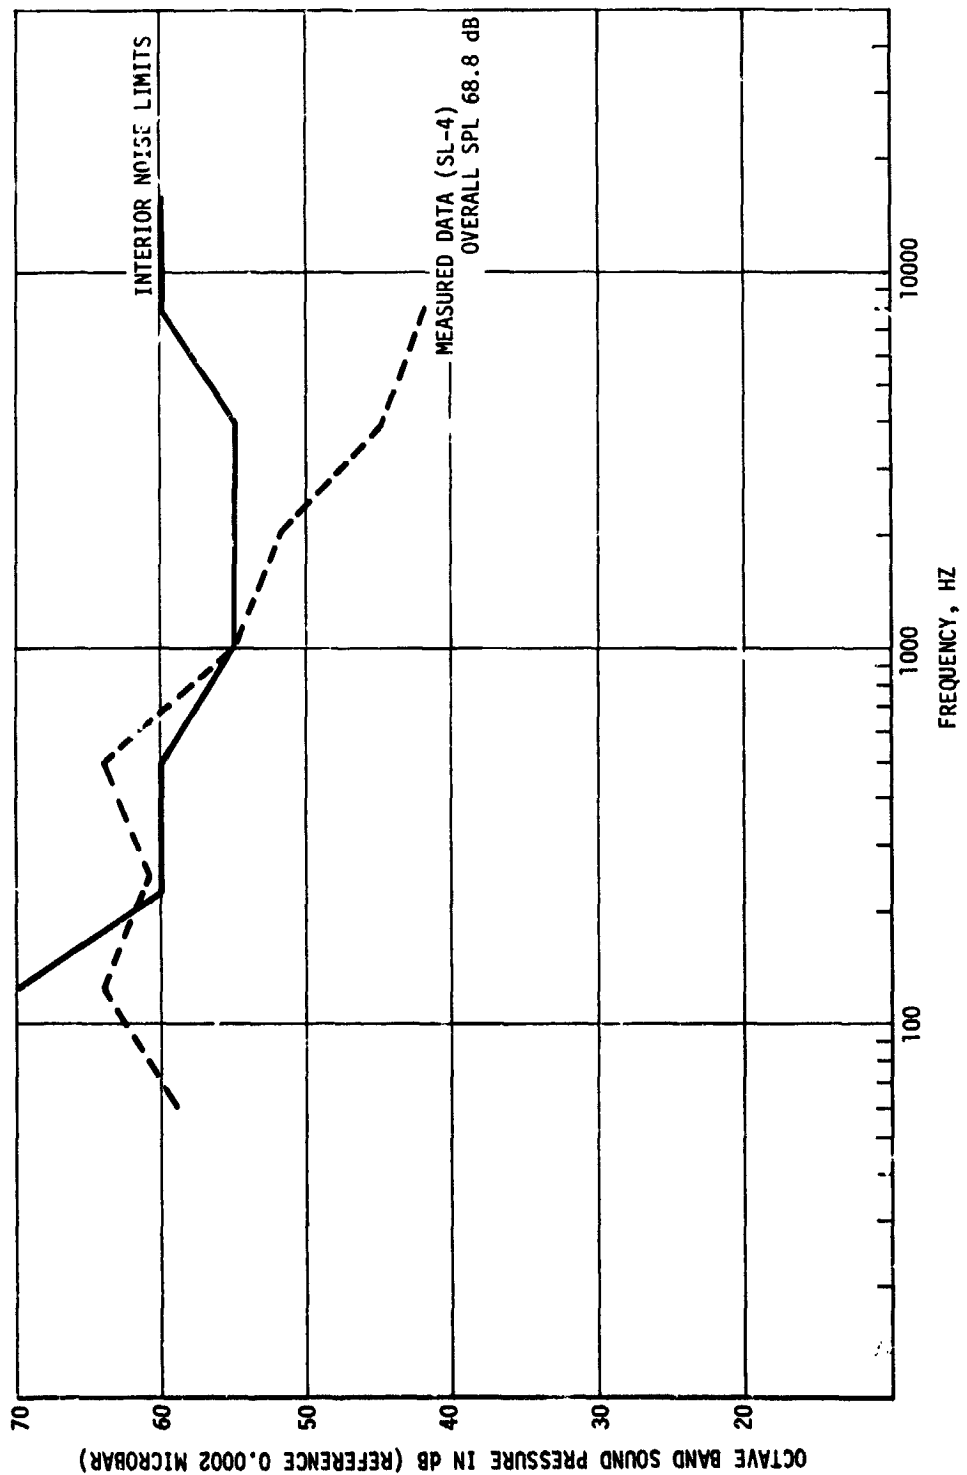
FIGURE 6-11 SOUND PRESSURE LEVEL AT ATM CONTROL AND DISPLAY CONSOLE SIA (EXPERIMENT M487)

As mentioned at a crew debriefing, direct communication in the 5 psia atmosphere could be maintained for distances between 5 and 8 feet beyond which the voice level had to be raised or required the use of the audio system. Continuous background octave noise measurements taken in conjunction with Experiment M/87 indicated an overall sound pressure level of 56 dB in the OWS and up to 68 dB in the MDA. (See Figures 6-11 and 6-12). In general, the OWS was evaluated as being very quiet. However, because of the Skylab geometry, aural communication could be conducted from the MDA/AM to the OWS by hollering, but required the use of the SIA when communicating in the opposite direction. (Additional details are described in the Skylab Interior Acoustic Environment Report ED-2002-1200-10, Martin Marietta Aerospace, Denver, Colorado. March 31, 1974.)

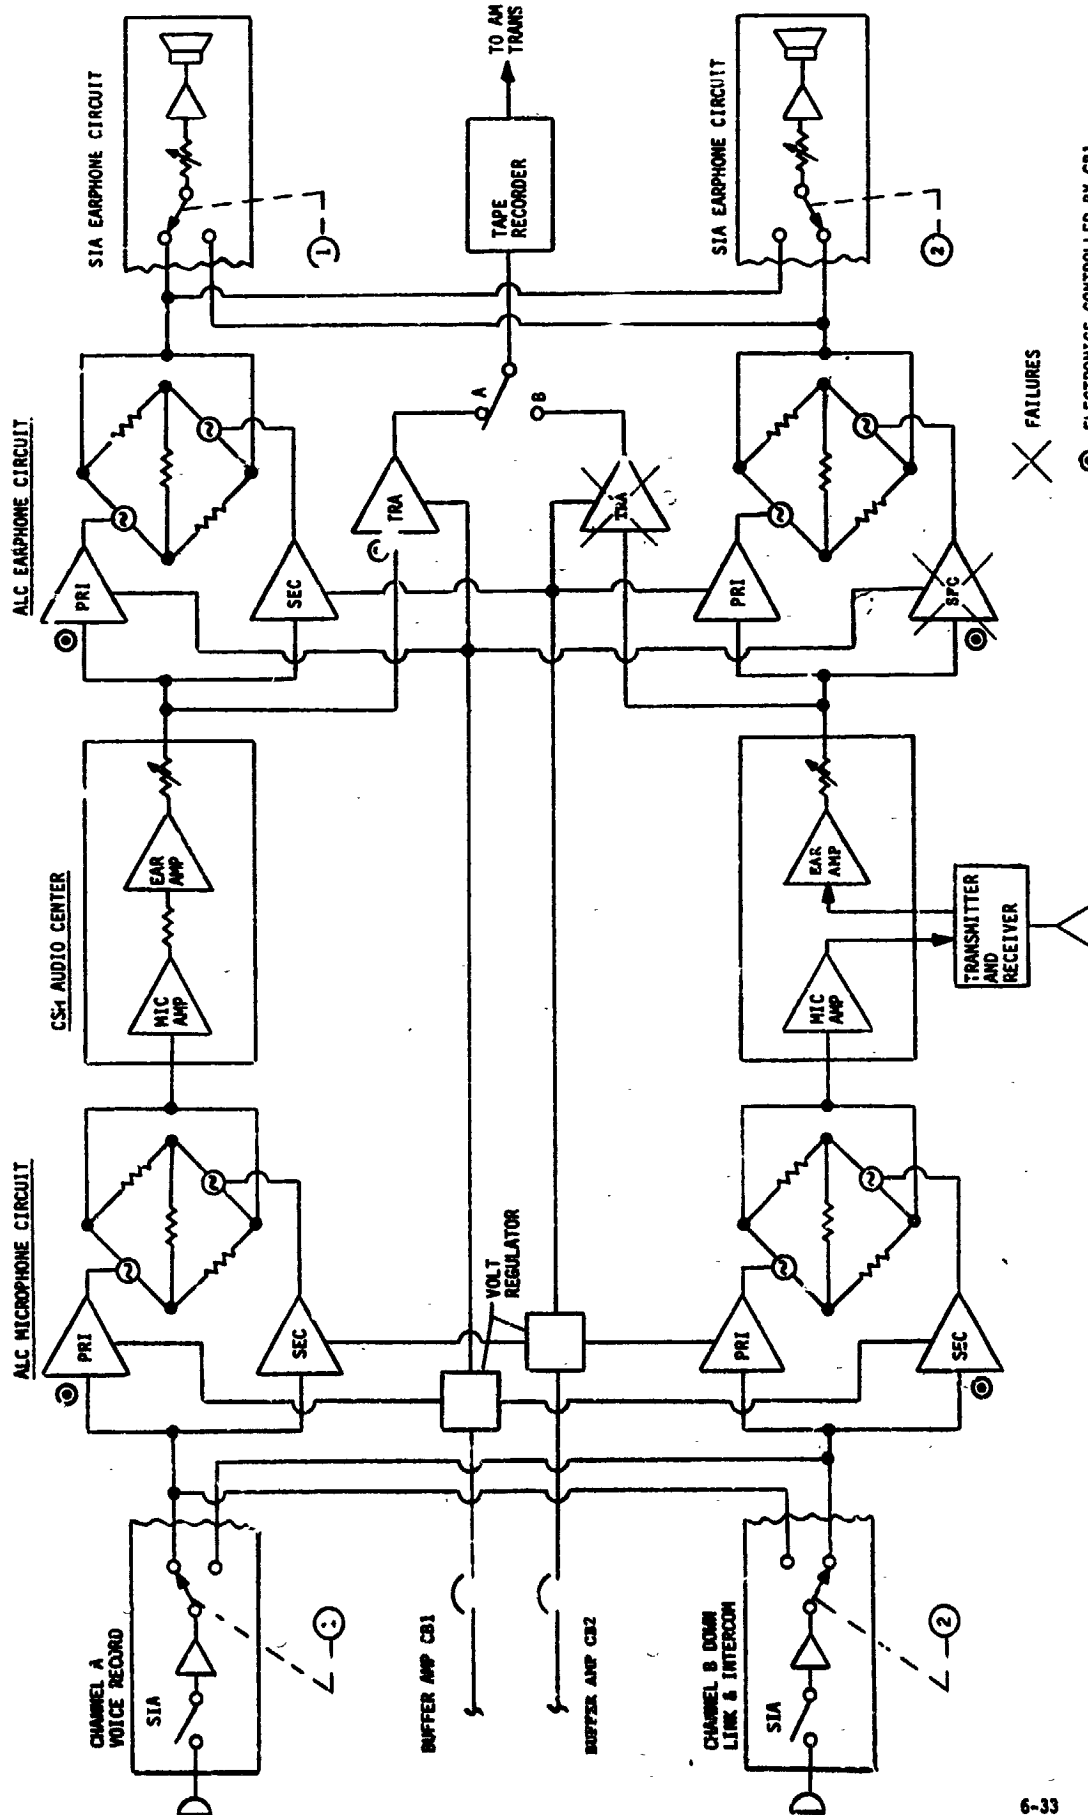
FIGURE 6-13 AUDIO FLOW DIAGRAM - ALC

(b) During the second manned phase, the first audio equipment problem occurred on DOY 213 when playback of the voice received at the STDN was garbled. Checks made on Channel B identified the failure to be the tape recorder amplifier in Channel B of the ALC (see Figure 6-13). This failure in no way degraded the normal intercom loop. Since Channels A and B were identical, the work-around was to reverse the channel configuration whereby Channel B was used for

intercom and downlink while Channel A was used for voice recording (see Anomaly Report No. 213 For additional details).

This problem was similar to a discrepancy that occurred for a short period on DOY 265. However, in that case the problem occurred in the CSM after undocking and was attributed to the CSM. The ground implemented a crew diagnostic procedure whereby the backup audio center was switched into the Channel B circuit. The problem still existed and troubleshooting of the earphone amplifiers of the Channel B was initiated. By opening and closing the two buffer amplifier circuit breakers sequentially, the noise disappeared when circuit breaker no. 1 was opened (see Figure 6-13).

As noted in Figure 6-13, opening circuit breaker 1 also disabled the remaining operational tape recorder amplifier of Channel A. Therefore, when voice recording was required it was necessary to go to the AM control panel and close this switch during voice recording. This procedure was tolerated since there were only 16 days left in the mission before final deactivation.

This procedure returned the system to full capability, but a redundant element in the voice recording system had been lost for the duration of the mission. On DOY 265, noise oscillations occurring at 4 Hz rate were heard on the intercom loop (Channel B) accompanied by a drop in the earphone level. However, communication could be maintained in spite of this anomaly. This discrepancy lasted no more than 1 day, and the Channel B ALC was identified as a possible cause. Following deactivation of Skylab on DOY 268, this same problem manifested itself in the CSM audio system after undocking had occurred. Because of this occurrence the noise problem was attributed to the CSM.

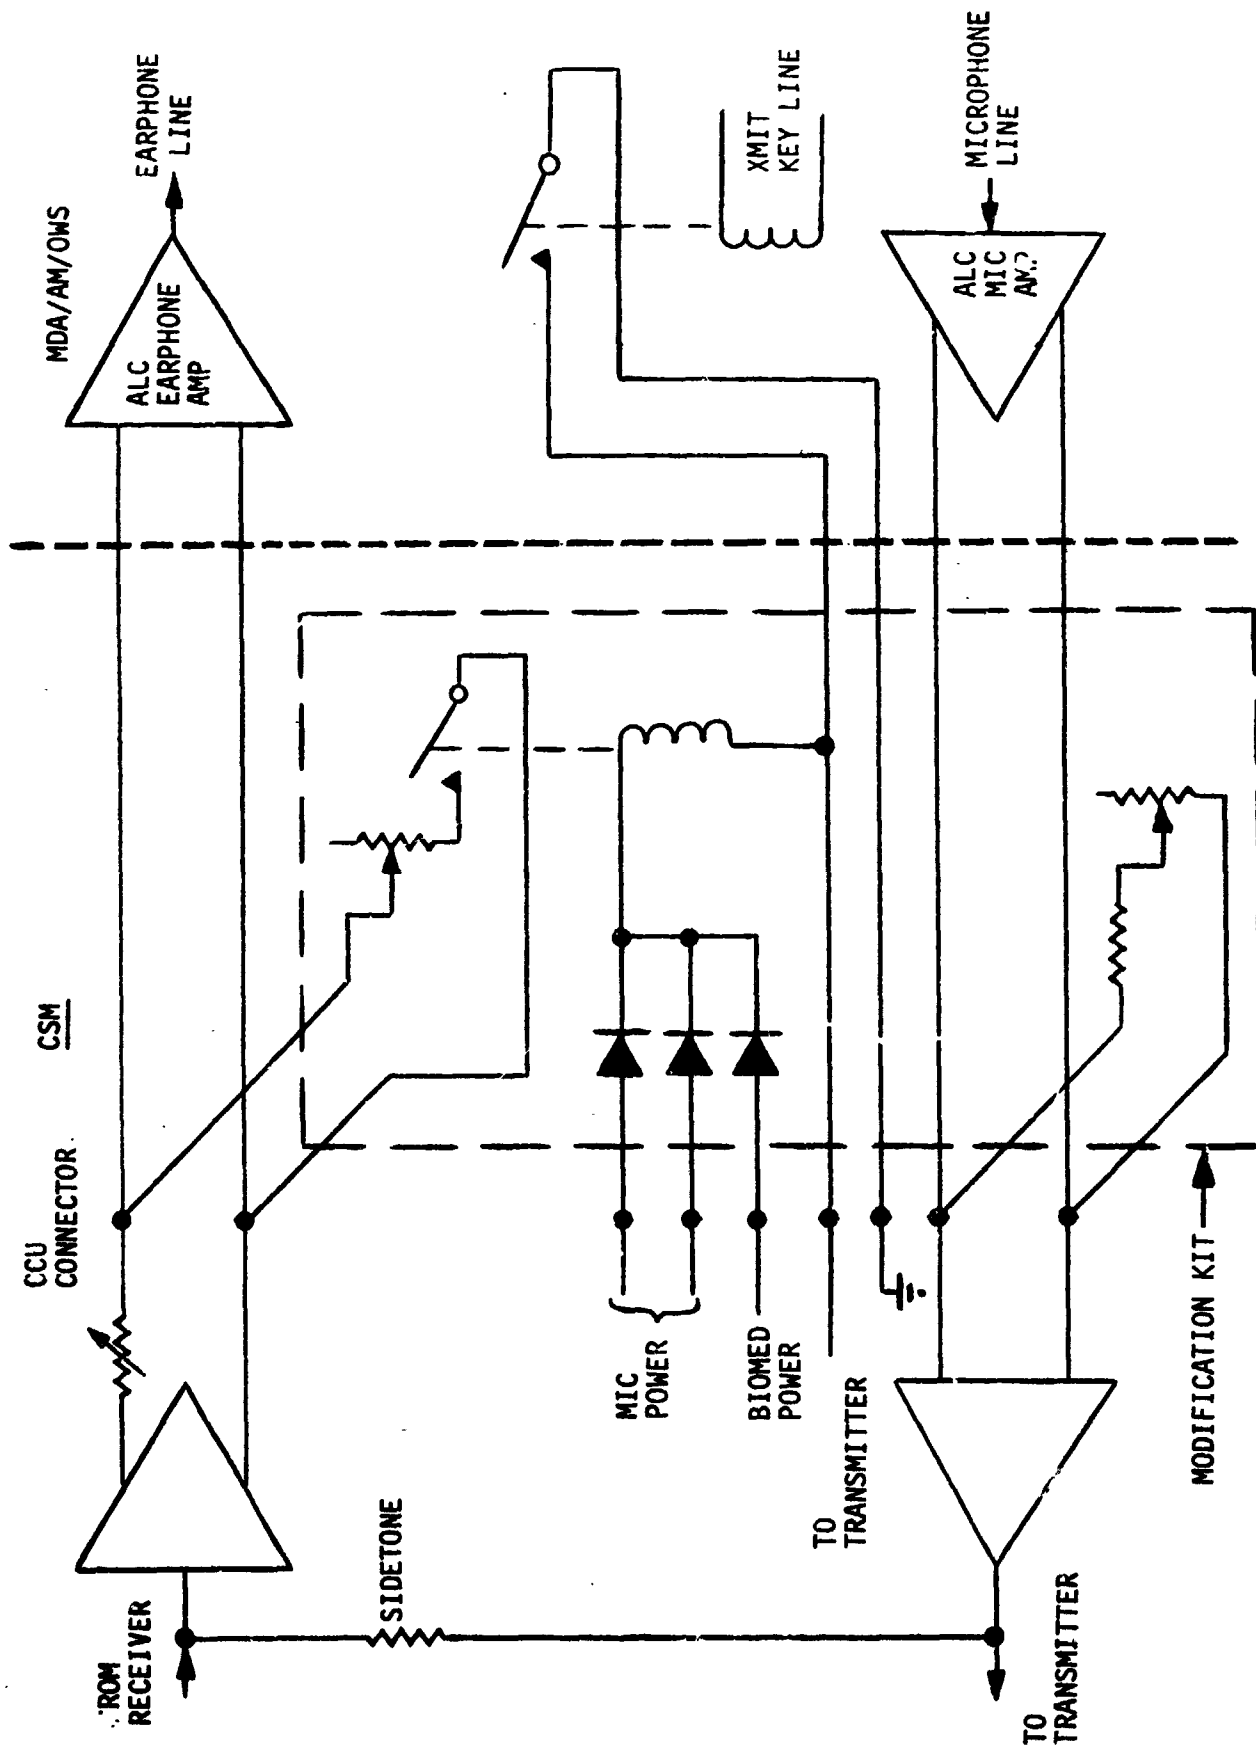
FIGURE 6-14 AUDIO ANTI-FEEDBACK ADAPTER

In evaluating a device to reduce feedback, three areas were investigated: (1) reduce the overall gain of the audio system; (2) provide better equalization in the sidetone level of the intercom and PTT mode; and (3) any modification would have to be easily installed inside the Skylab. The final modification as flown and installed during the third manned phase of the mission is shown in Figure 6-14. This kit modified the system as follows:

CSM audio center was reduced by a factor of 11 dB by the insertion of an additional load.

(2) Audio Antifeedback Modification Kit. In order to reduce the feedback prevalent during the first and second manned phases, an antifeedback network assembly was installed during the third manned phase. A block diagram is shown in Figure 6-14. The microphone signal to the CSM was desensitized by padding the line for an 11 dB signal attenuation. As noted on the AGC curve of Figure 6-16, attenuating the voice input by 11 dB shifted the normal operating range towards the knee of the curve. Decreasing the input to the CSM audio center also shifted the unvoiced microphone input away from the effects of the AGC action.

Different sidetone circuits were applied to the system when operating in the intercom and transmit-to-ground modes. When the SIA switch was depressed to XMIT, the sidetone was approximately 5 dB higher than when pressed to ICOM. In order to equalize these levels, a relay-operated load was inserted across the earphone lines from the CSM to the AM ALC only when the SIA switch was depressed to the XMIT mode. This was accomplished by connecting the ground side of the relay to the PTT ground line that, in turn, was controlled by the SIA

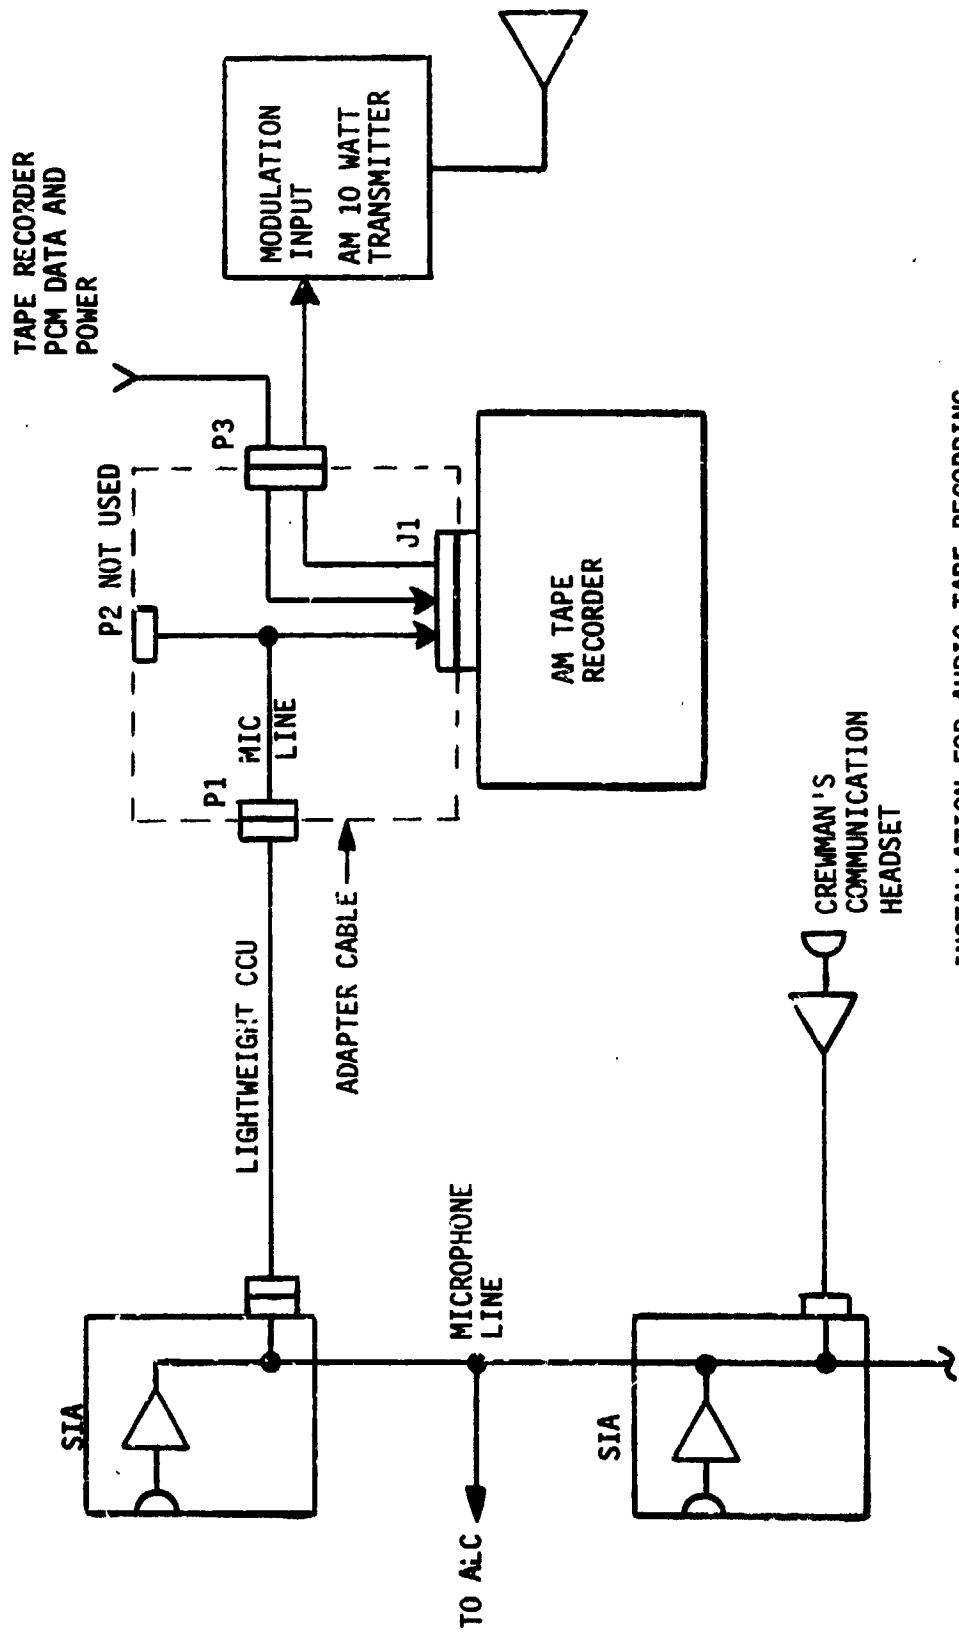
FIGURE 6-17a EMERGENCY TAPE RECORDER VOICE CABLE ASSEMBLY

(a) Direct Voice Record. This mode provided the capability to couple the microphone output of any SIA directly into a tape recorder (see Figure 6-17a). This was accomplished by connecting the lightweight communication umbilical to the SIA and interconnecting the bypass cable from this umbilical to the tape recorder. The third connector on this bypass cable was connected to the cable that was normally connected to the tape recorder. This configuration provides voice and data record capability and playback into the AM transmitters. Tape recorder playback yielded transmitter deviations between 35 and 140 kHz with satisfactory signal-to-noise ratio.

With the loss of a tape recorder amplifier in Channel B of the ALC, the STU-STDN facility investigated the possibility of providing an alternate means of recording voice if the remaining voice record circuit of Channel A should fail during the third manned phase. By analyzing the available electrical connections inside the Skylab, a contingency emergency/voice tape recorder adapter cable was developed as a backup to a Channel A failure and stowed in the CSM for SL-4.

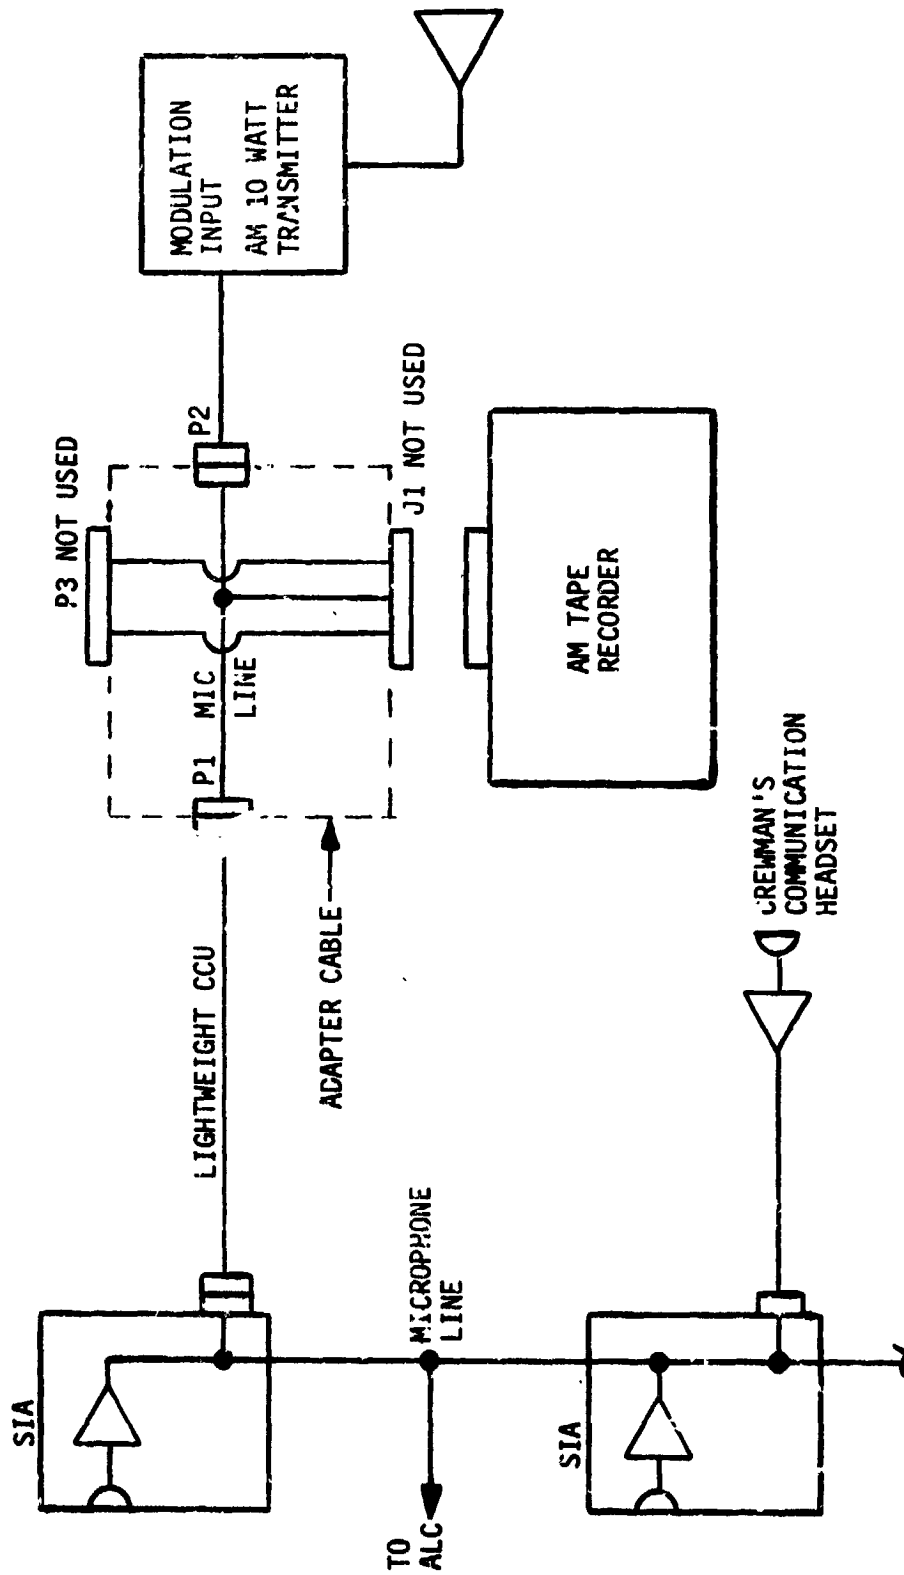
FIGURE 6-17b EMERGENCY TAPE RECORDER VOICE CABLE ASSEMBLY

(b) Emergency Real-Time Voice. The emergency real-time voice configuration is shown in Figure 6-17b. In this mode the cable containing the wiring from the tape recorder to the transmitter was removed and connected to one end of the adapter cable (P2). Connector P1 of the adapter cable was connected to the SIA microphone lines using an onboard lightweight communication cable. Tests conducted on the ground indicated transmitter peak deviations between 35 to 200 kHz depending upon the microphone used and speaker-microphone displacement.
