# THE IMPACT RESISTANCE OF CURRENT DESIGN COMPOSITE FAN BLADES TESTED UNDER SHORT-HAUL OPERATING CONDITIONS

## INTERIM REPORT

GENERAL ELECTRIC COMPANY  
Advanced Engineering and Technology  
Programs Department

NASA Lewis Research Center  
Contract NAS3-16777

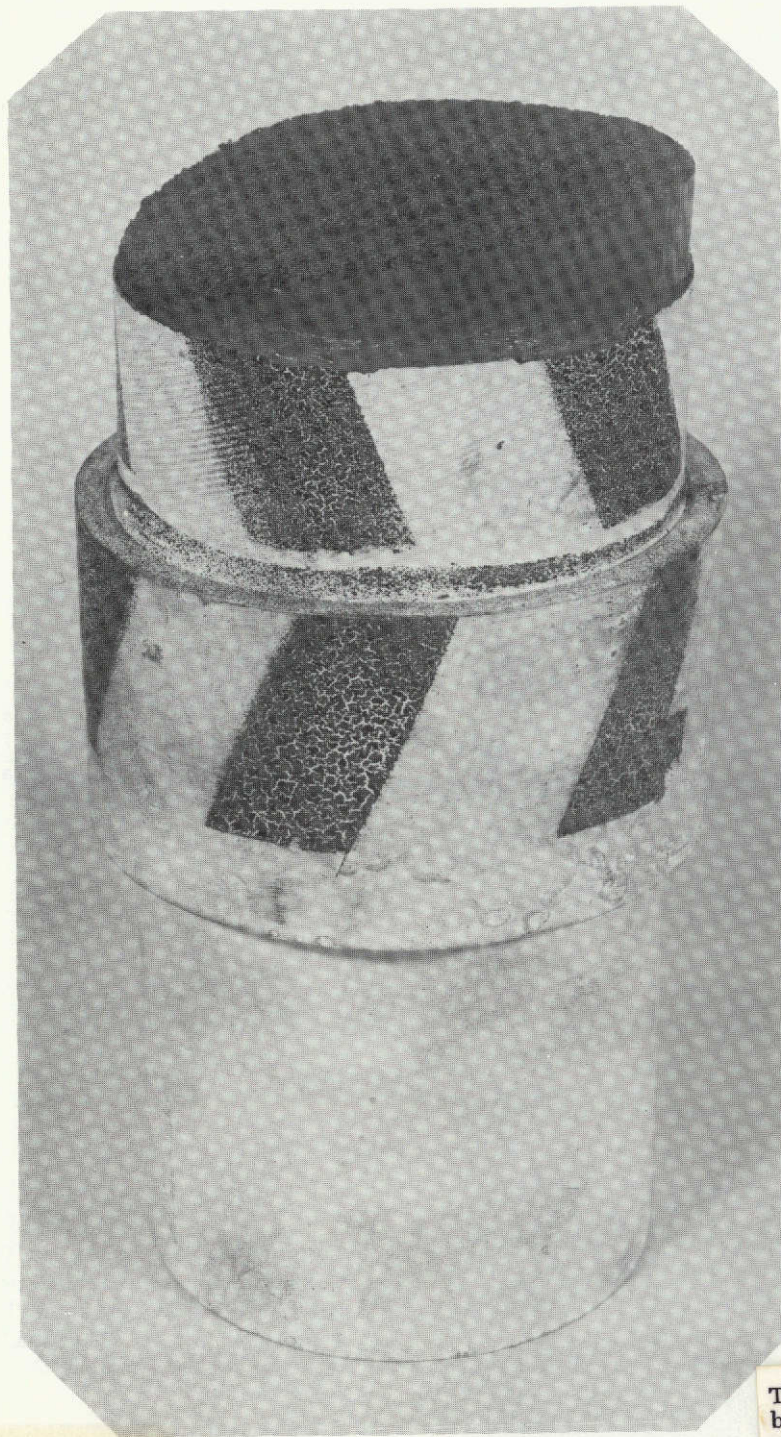
Figure 3. Photograph Showing Containment of Simulated (RTV) Bird After Impact, 12 oz Slice Removed.

- Simulated Birds - Silicone foam material (RTV) was used to makeup the simulated birds. They were made as either 3" or 4" diameter, hollow or solid cylinders such that the required weight bite could be obtained from a 2 1/2" slice. A typical simulated bird and cup after impact is shown in Figure 3.

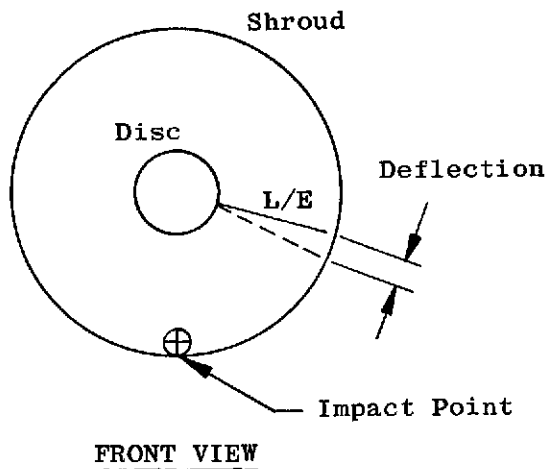
FRONT VIEW

Front and side views show position of blade leading edge before and after impact typical for 5 and 3 o'clock positions.

Deflections are a combination of bending and twisting.

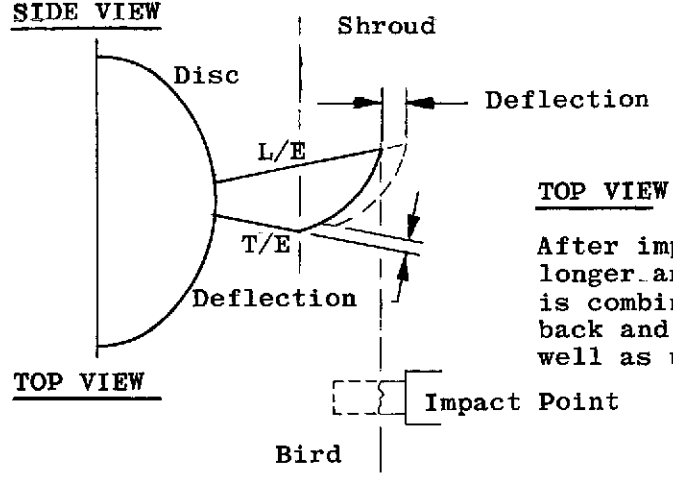
TOP VIEW

After impact blade appears longer and narrower. Deflection is combination of blade bending back and axially forward as well as untwisting.

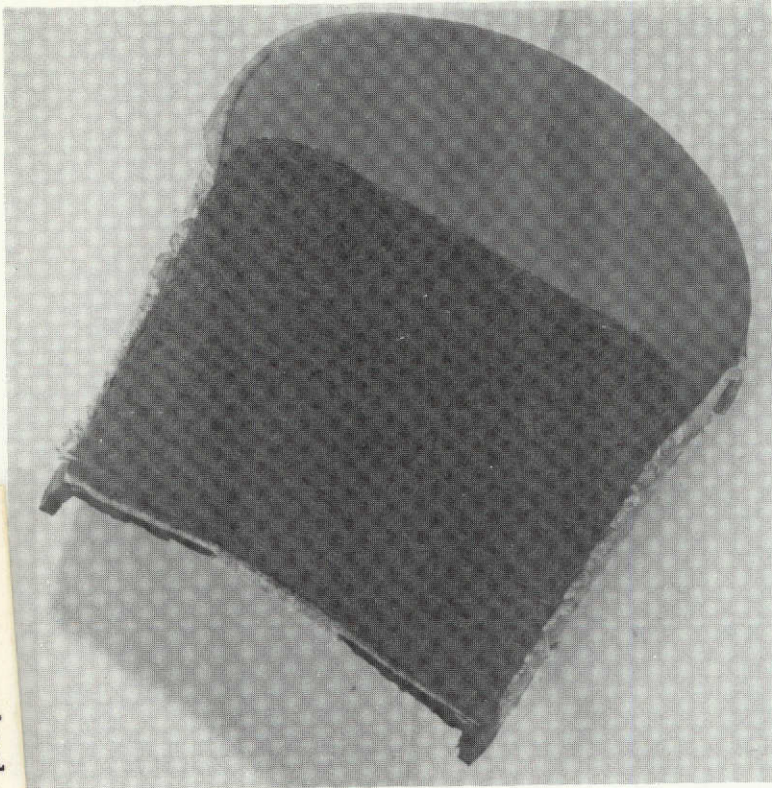
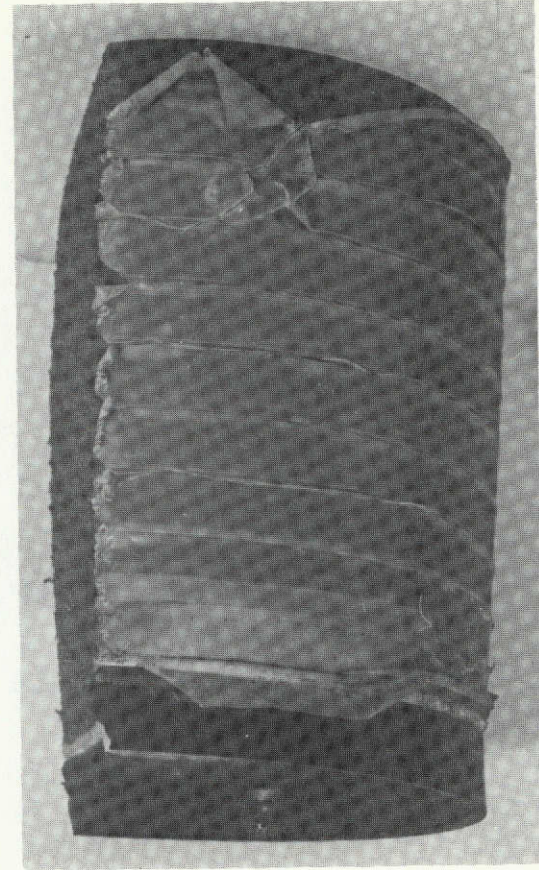
Figure 15. Typical RTV Recovered Projectile after Inertial Head Impacting of Composite Blades.

These facts have been greatly clarified during the present program by the recovery of projectiles after impact. A typical projectile recovered after testing is shown in Figure 15. The sliced plane is clearly shown as the dark region extending from the front of the projectiles, and tapering into the projectile toward the rear. The sharp intersection of the slice-plane with the front surface of the projectile shows the initial projectile "bite" that is set up as an initial test condition.
