NASA CR-WRL 10822-1-T

# ENGINEERING EVALUATION OF 24-CHANNEL MULTISPECTRAL SCANNER

Subject: Engineering Evaluation of 24-Channel Multispectral Scanner

### PERFORMANCE OF MSDS AS OF 2 AND 4 JUNE 1972

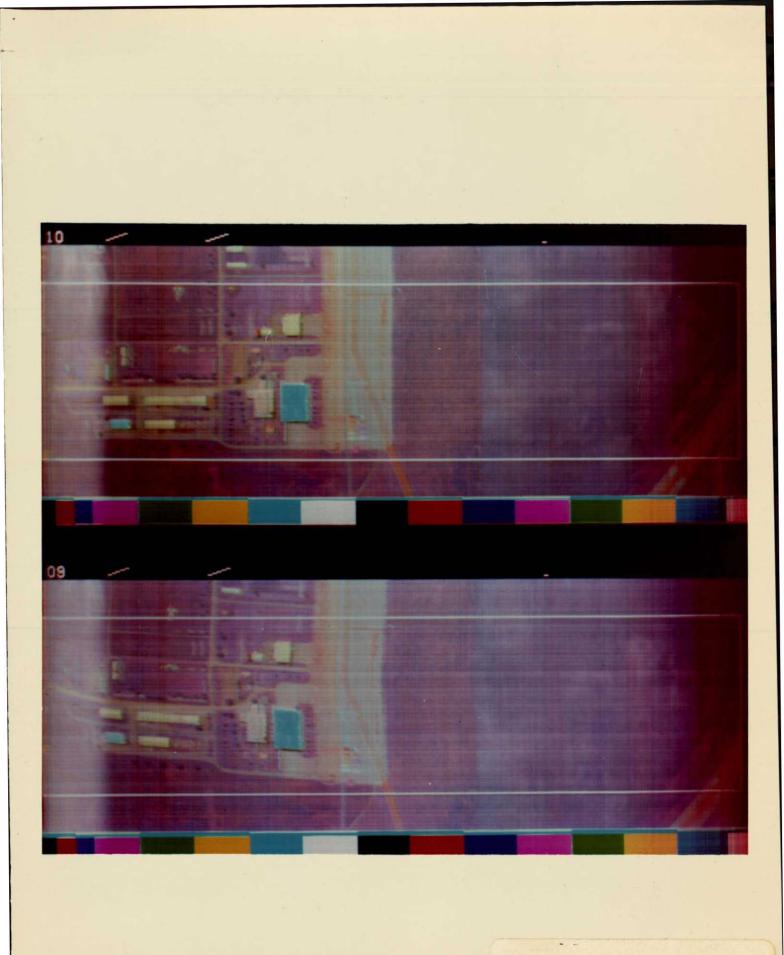
Inspection of the DAS film edits we received revealed a few instances where successive scan lines appeared to waver in and out of registration by plus or minus 1 resolution element. In Figure 4.2, edit 9, one can see jagged edges on the large blue building rooftop near the ramp while in edit 10 such jagged edges are not evident. Steplike variations in edges might be expected due to the effect of digitization, but oscillating variations such as those in edit 9 would be unlikely. Figure 4.1 shows two contour plots of tape edits we obtained which correspond to the two DAS film edits of Figure 4.2. The stairstep edges visible on some of the roads are due to the effects of digitization, which is not smoothed in these plots. Note that while the plot for run 9 (airspeed 270 knots and virtually no drift) looks very clean, the plot for run 8 (airspeed 160 knots with noticeable drift) shows jagged edges very much like those in DAS edit 9. - Close inspection of the contour plot for run 8 (plotted to a larger scale in Figure 4.3) indicates that the variations in registration of the scan lines can be identified across almost the entire width of the scan (note variations in edges of road at resolution element 15 and similar variations in edges of building rooftop near elements 292 and 315; especially near scan line 1722 - Figure 4.3). Listings obtained for our tape edits indicate that channel swapping did not occur during this edit, hence these registration oscillations could be due to variations in the timing of the start of each scan line. This phenomenon may be related to roll gyro problems.

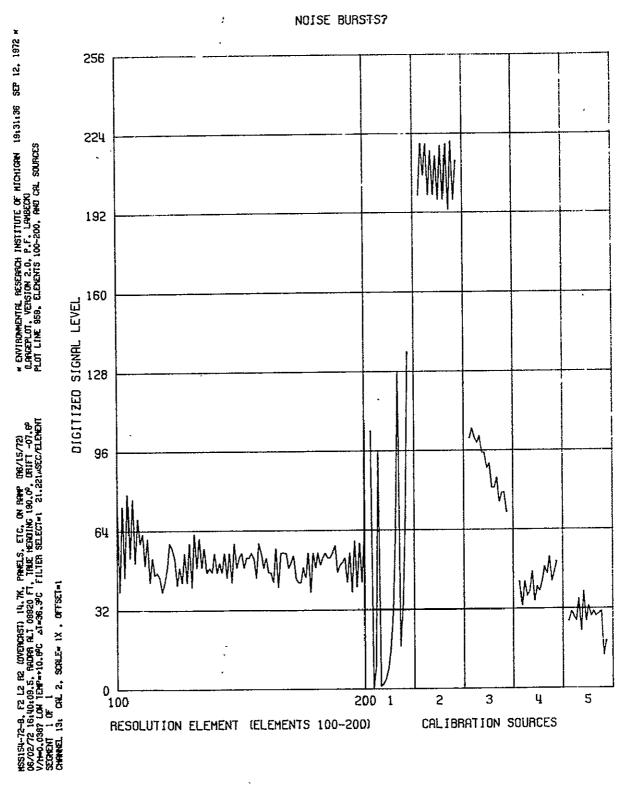
Figure 6.24

Figures 6.24 and 6.25 are segments of one scan line from a run on 2 June for channels 13 and 14. During this particular run, both of these channels experienced brief, intermittent bursts of noise. Note that for this scan line segment, these bursts of noise appear to alternate between the two channels. These noise bursts are probably due to cooler microphonics.

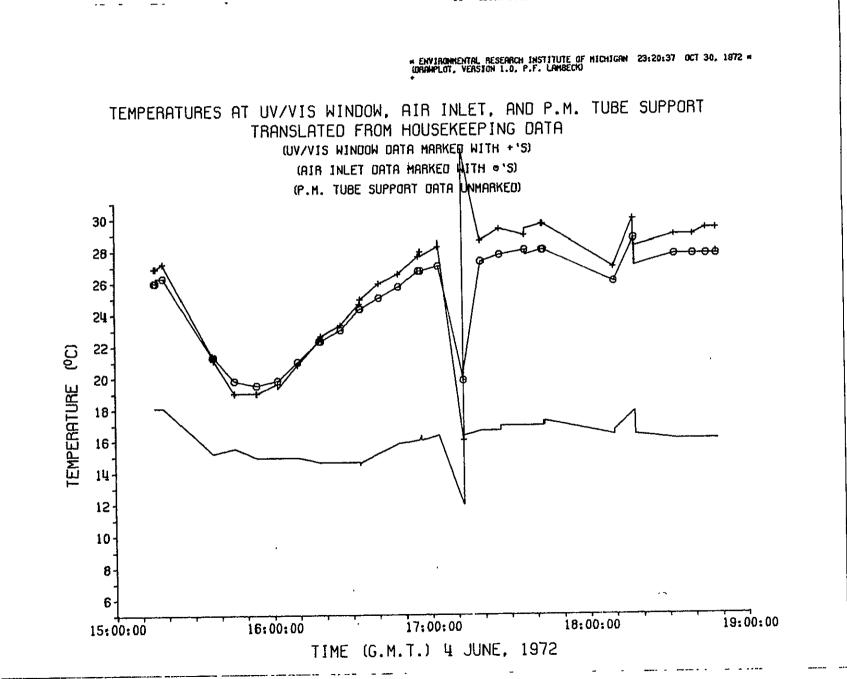
Figure 7.4

interior of the scanner to reestablish equilibrium with the aircraft surroundings after the jump from 1.7 thousand feet to 14.7 thousand feet which occurred around 15:30 GMT (compare channel 16 data to various temperature monitors). During run 14 (4 June) both the start ID and stop ID data for the first three temperature monitors was disrupted (17:12:30 GMT - Figure 7.4). The source of this disruption is not known. During run 20 another disruption occurred affecting all six temperature monitors (18:17:30 GMT - Figures 7.4 and 7.5). The abnormally high noise in channel 16 indicated for run 23 (18:44:56 GMT - Figure 7.5) was due to a low frequency noise ripple (or drift) in that channel during that run. Note that the data for the P.M. tube support (physically mounted on the baseplate but exposed to the air inside the optics compartment) indicates that the air temperature of the optics compartment was adequately controlled (Figure 7.4).

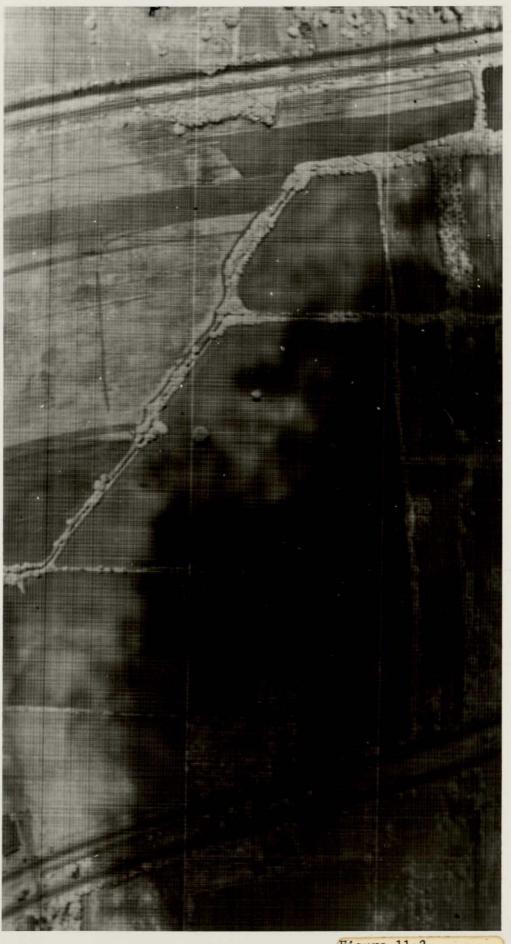
Figure 11.2 Inflight Film, Ch.8 1.5K ft. 6/4/72

Figure 11.1 is a print made from an RC-8 photograph taken from 1.5 thousand feet showing a cloud shadow which was present over a freshly planted field along the flight line north of the ramp during run 18 on 4 June. Figure 11.2 is an enlargement made from the inflight film recorder output for channel 8 during this run. Most of the horizontal streaks visible in this film are probably due to non-uniformities in the incremental movement of the film past the CRT which exposes it, while the lengthwise streaks are probably due to non-uniformities in the CRT phosphor or to nonuniformities in the staircase CRT sweep waveform.

Note the differences between Figures 11.1 and 11.2 in the location of various portions of the cloud shadow, indicating that the cloud was both moving and changing shape. Since the cloud was more or less following the path of the aircraft but at a slower speed, the outline of the cloud depicted in Figure 11.2 is elongated slightly in the flight direction relative to what appears in Figure 11.1. This indicates that the RC-8 film should not always be trusted to indicate the precise shape and location of a cloud shadow in the scanner data.

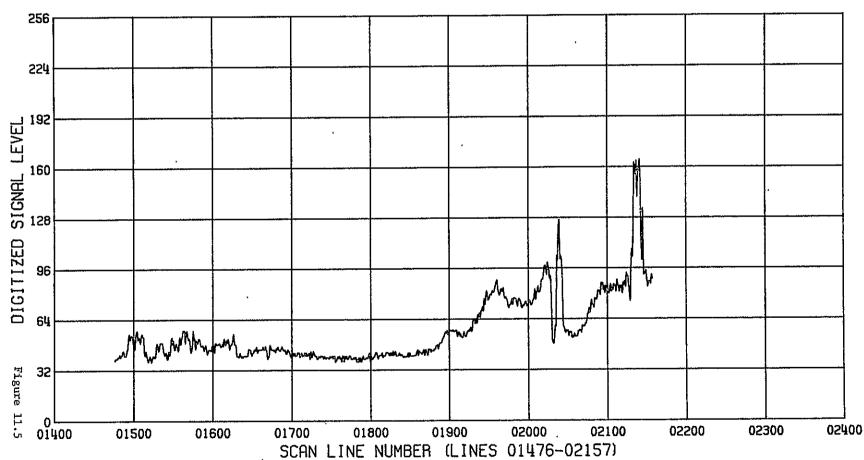
# SINGLE ELEMENT TRACED ACROSS CLOUD SHADOW

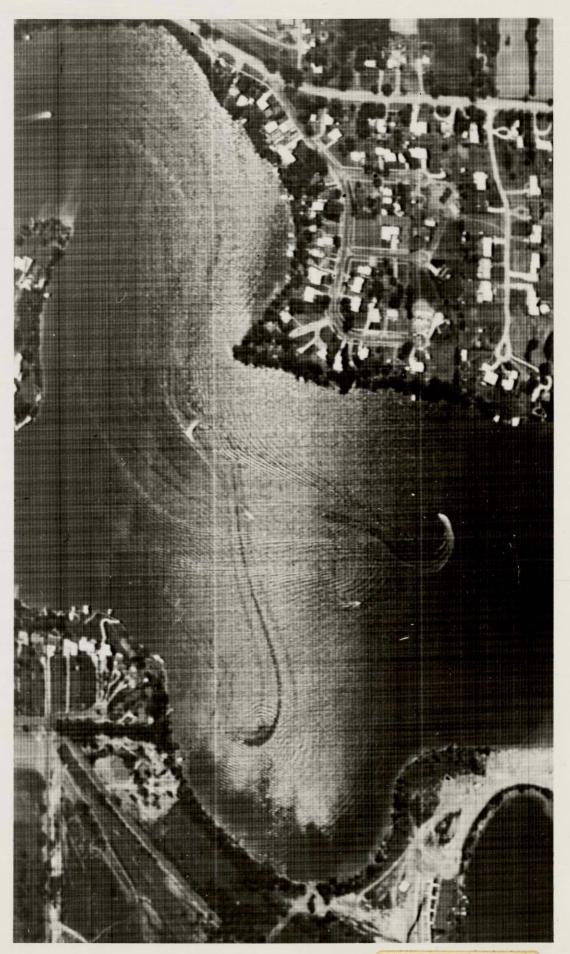
Figure 12.2 Inflight Film, Ch.3 1.7K ft. 6/4/72

Figure 12.1 is a print made from an RC-8 photograph taken over Belleville Lake during run 12 (1.7 thousand feet) on 4 June. Figure 12.2 is an enlargement of output from the inflight film recorder for this same portion of run 12 for channel 3. Note that sun glint forms a different pattern in the scanner data from that shown in the RC-8 photograph.

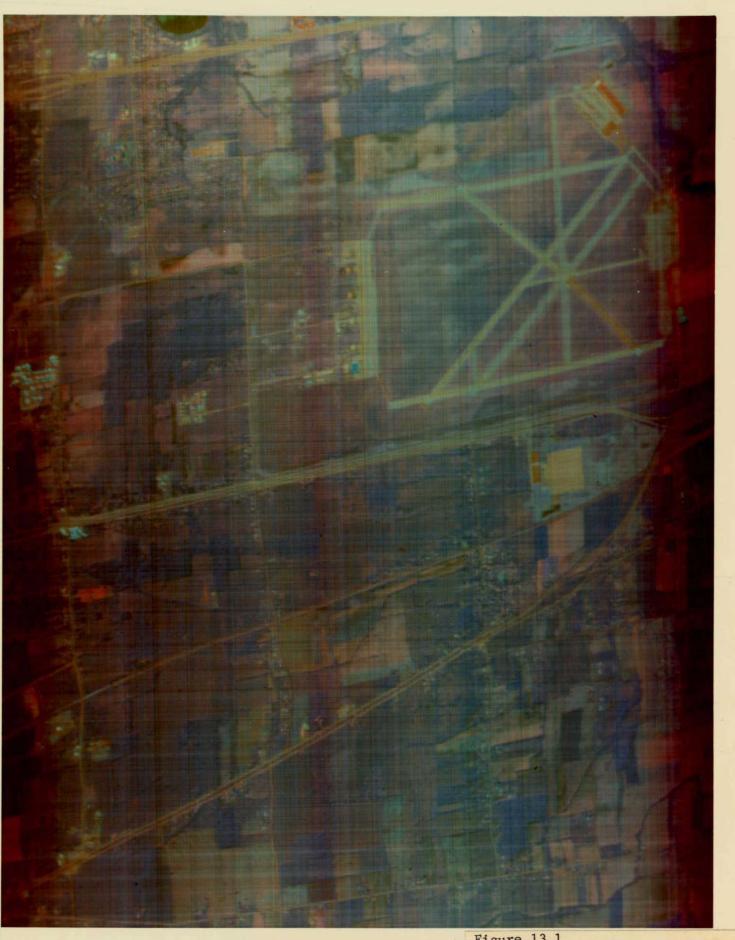
Figure 13.1 DAS Film, Run 2 14.7K ft. 6/4/72 19-R 2-G 11-B

Figures 13.1-13.6 are examples of some of the better DAS film edits we obtained for the 2 June and 4 June flights, representing various altitudes and V/H's. In general this film was distorted (compressed in scale by a factor of 5, more or less, throughout the first 100 elements or so of each scan line) and faded out with a sometimes ragged edge toward the end of each scan line. In a few instances film edits contained wavy distortions which thoroughly obscured the smaller features of the scene. In the figures presented note that there are some horizontal and vertical streaks similar to those in the inflight film printout, but a bit more subtle. The DAS film gives the impression of being a bit out of focus relative to the inflight film enlargements (see Figure 12.2), however features the size of one resolution element can be identified.

For Figures 13.1-13.5 channel 19 was used for the red gun, channel 2 for the green, and channel 11 for blue. In Figure 13.4 note that the seven tar paper strips can be seen separately (whenever the moire pattern present does not obscure them) even though the resolution element size in that figure is nearly identical to the width of these strips (3 feet). In Figure 13.5, edit 44, note that these strips cannot be seen separately even though they do appear separated in the graymap from the corresponding tape edit shown in Figure 10.4. This apparent lack of resolution appears partly due to the presence of vertical streaks in the DAS film, partly due to the reduced signal contrast over these strips resulting from the reduced scanner response along the scan relative to across the scan lines together with the effect of the overcast conditions for that day, and partly due to the lack of signal registration among the three channels chosen for this edit at its V/H of .16 which leads to a different moire pattern effect in each channel.

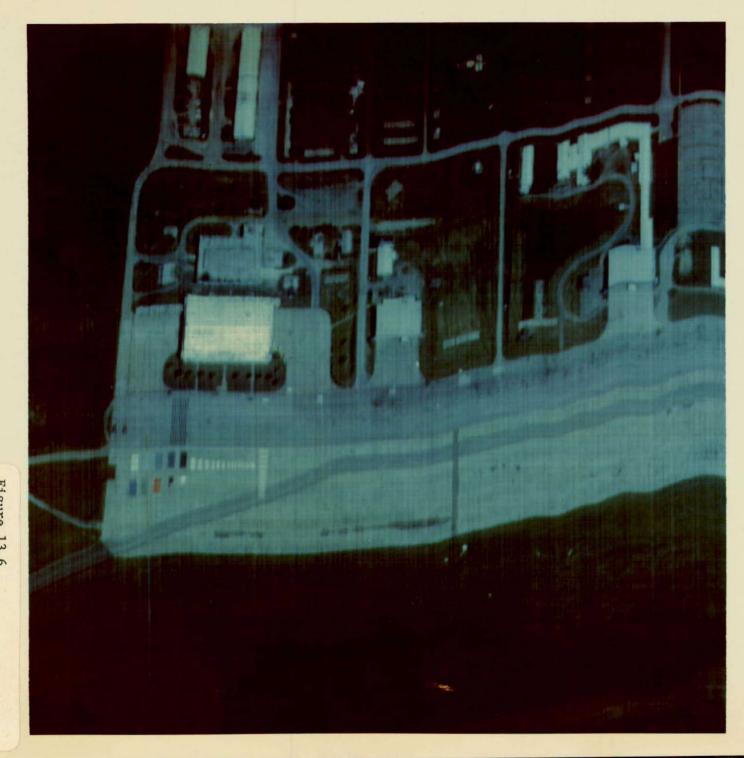
Figure 13.6 DAS Film, Run 20 1.7K ft. 6/4/72 6-R 4-G 2-B

Figure 13.6 is a crude attempt at producing a natural color DAS film print using channel 6 for red, channel 4 for green, and channel 2 for blue. The colors of the original DAS film edit were slightly more natural than what is indicated by this print. The distortion appearing in the upper half of the print comes from a deliberate 5° roll of the aircraft during this run to test the roll compensation of the scanner (which was not compensating properly during these flights).
