NASA TM X-64086

TEST OF LOX COMPATIBILITY FOR ASPHALT
AND CONCRETE RUNWAY MATERIALS

John F. Kennedy Space Center
Kennedy Space Center, Fla. 32899

December 1973

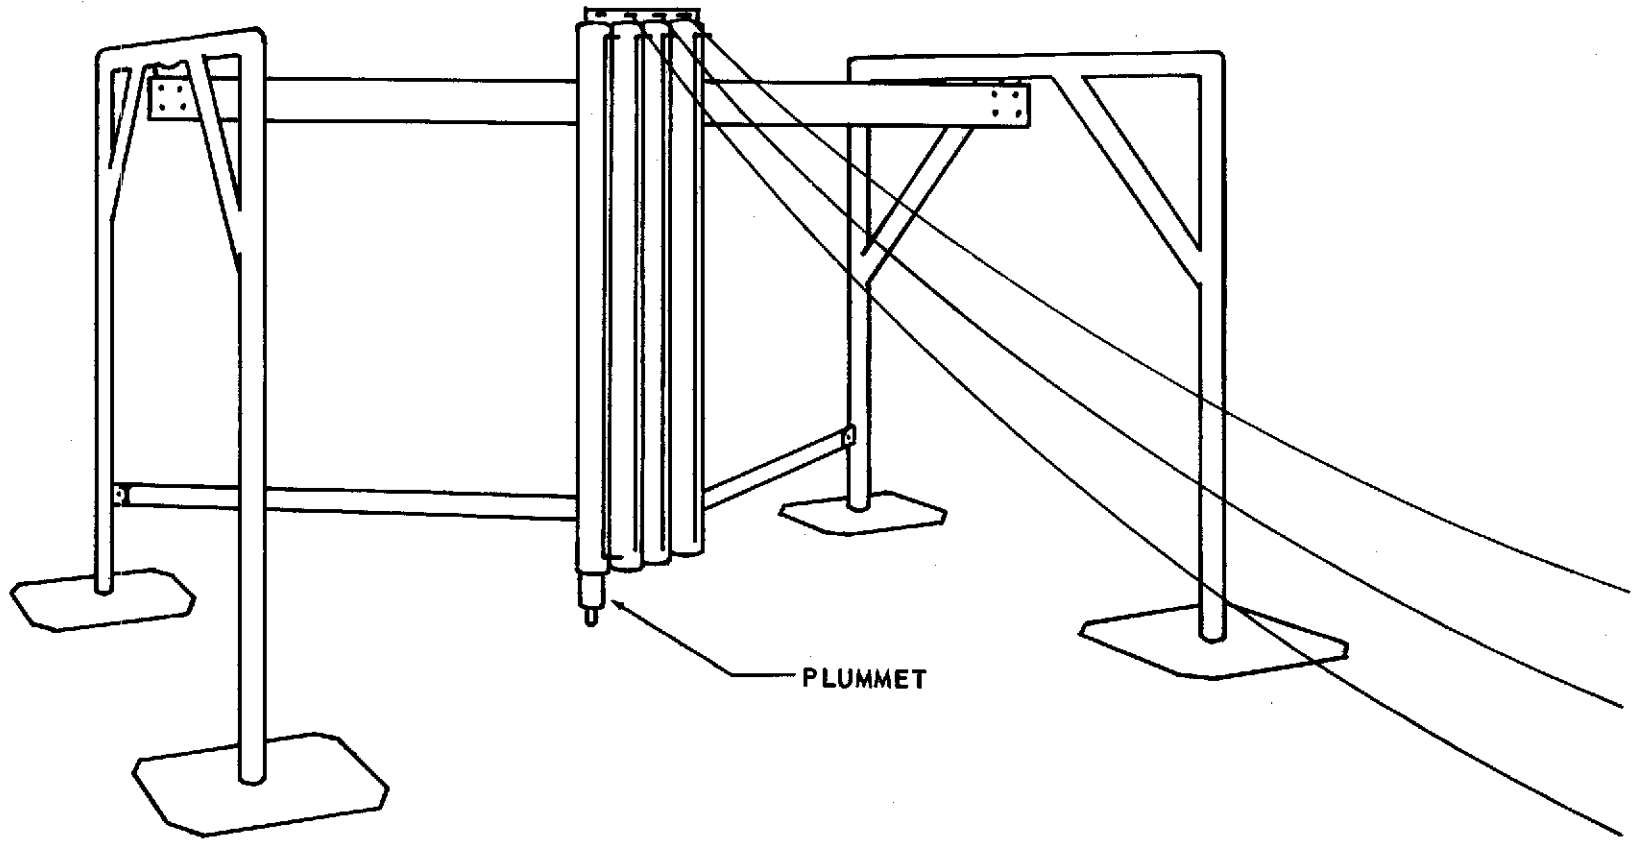
Figure 2. Impact Test Stand.

First Trial, Impact. - A test stand, shown in Figure 2, was fabricated to support four plummets, each held by a pin with a lanyard to permit remote individual release. The plummets weighed 9.07 kg and were 7.5 cm in diameter. Tips, 1.27 cm in diameter and approximately 3.8 cm long, were screwed into the bottom of each plummet. Each plummet was provided with a tube extending to within approximately 15 cm of the surface to be impacted. This prevented a plummet from falling over after being dropped and interfering with the impact of subsequent plummets. A rod screwed into the side of each plummet and extending through a vertical slot in each tube provided a handle by which the plummet could be raised to the top of its tube to be secured by a release pin. A slab of used asphalt pavement 2 meters square and approximately 5 cm thick was installed at the test site and an asphalt curb 7.5 cm high was built around its edge. The test stand was assembled over the slab with its feet level with the asphalt surface. A ring of flex line, perforated on the bottom, was coupled to the LO_2 delivery line and positioned over the middle of the slab. The slab was sponged dry to remove rainwater, and then a trial flow of LN_2 was performed. Three days later a 400 frame per second movie camera was installed, rainwater was again sponged from the slab, and 12 empty 0.5 liter aluminum beer cans were placed as shown in Figure 3 as blast

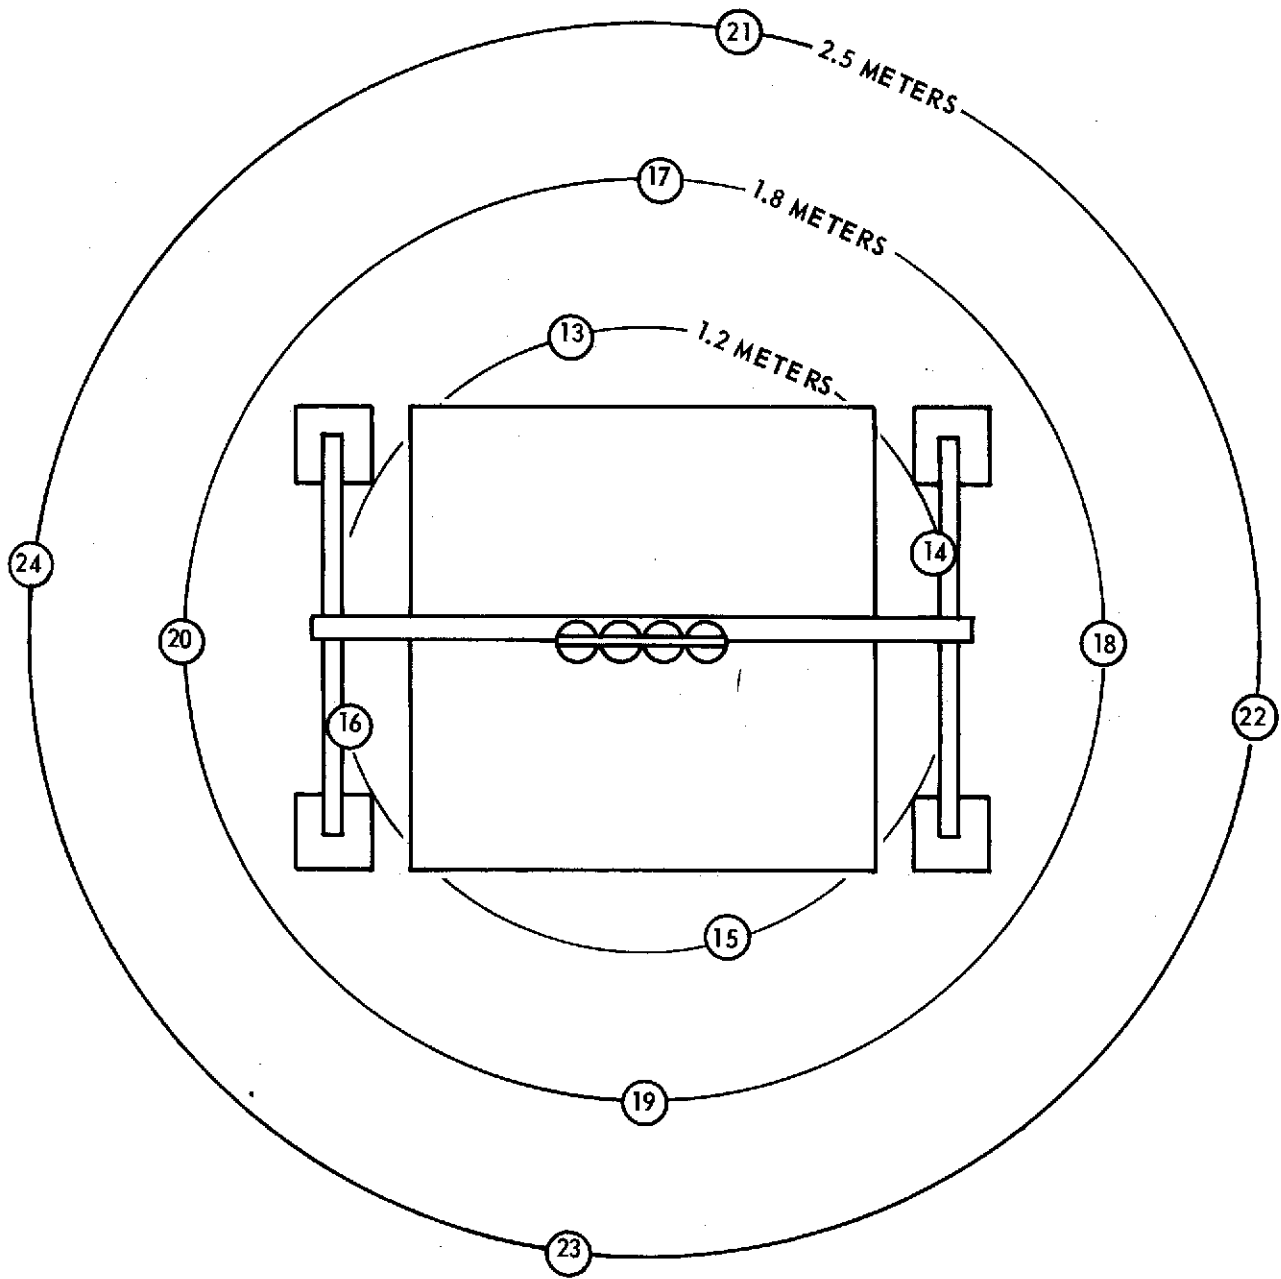
Figure 3. Blast Sensor Location, Impact.

sensors. The slab was then filled with LO_2 , which was allowed to flow for 10 minutes, and the four plummets were then dropped in succession with no detectable reaction.

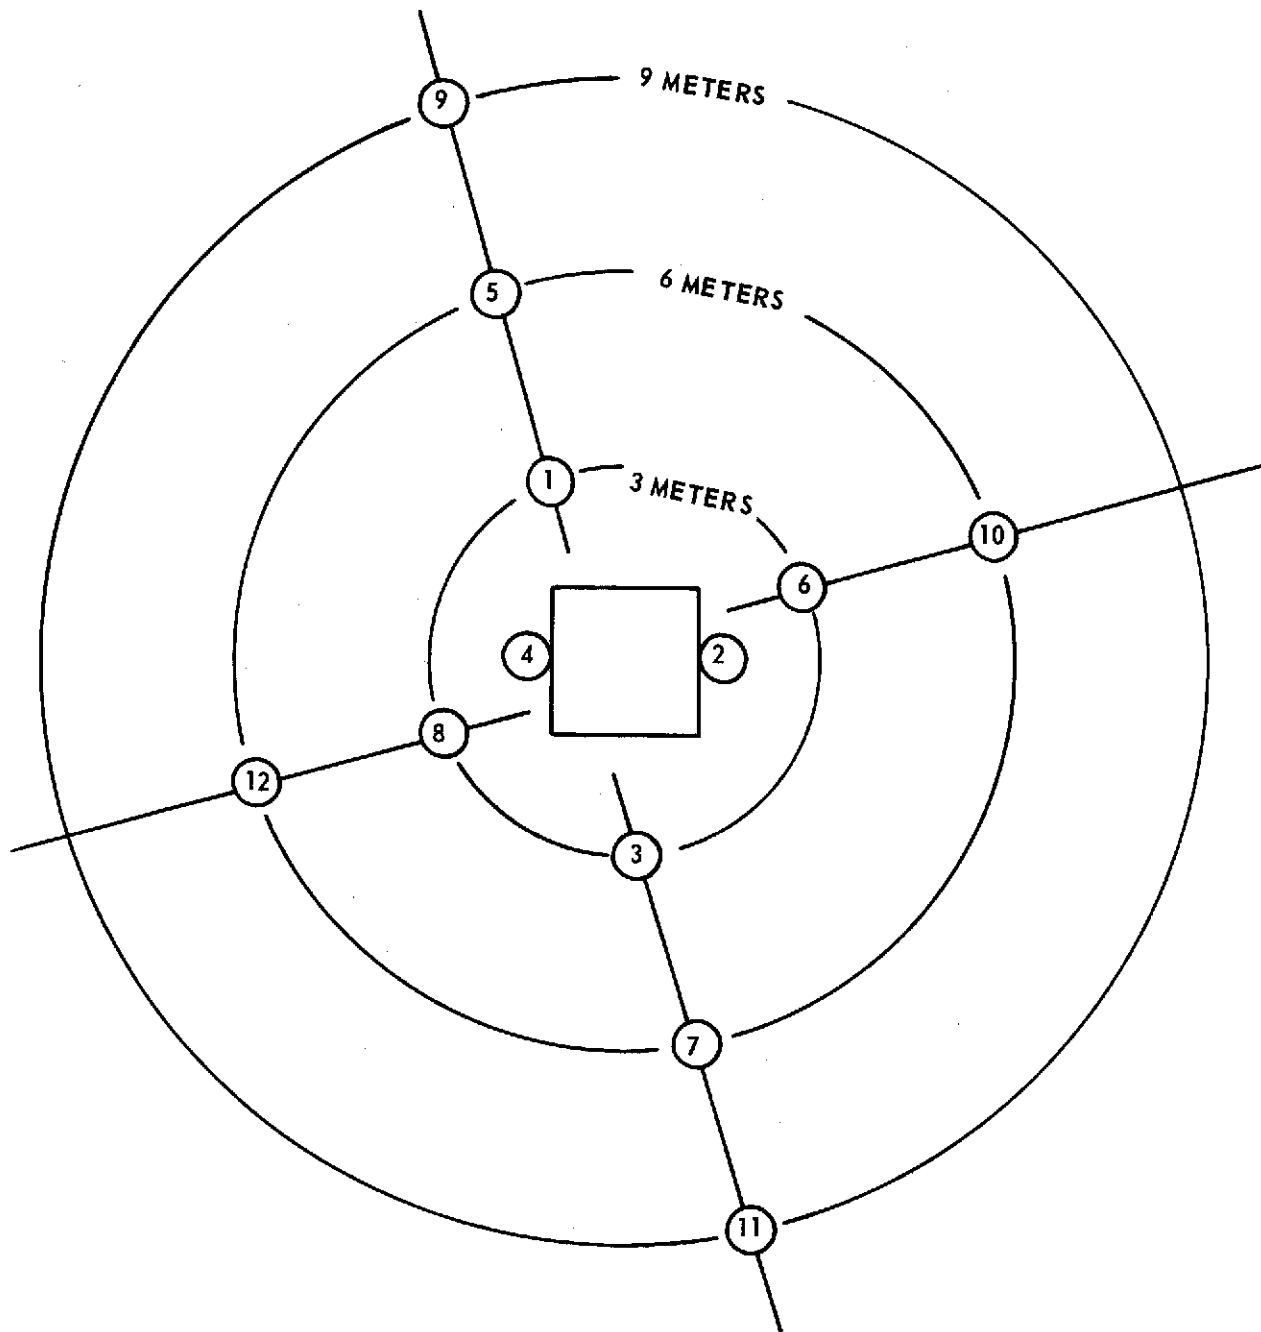
Figure 4. Blast Sensor Location, Blasting Cap.

Third Trial, Detonation. - The holes and the notch were repaired, the test fixture was removed, and rainwater was sponged from the slab. A No. 8 blasting cap with 15 cm of 21 gm per meter detonating cord was positioned on the slab. LO_2 was allowed to flow for 10 minutes; then the cap was detonated. Some smoke and flame occurred, but the reaction was confined to approximately a 2.5-cm depth of asphalt over an area of approximately 0.09 m^2 . Some beer cans, which were positioned as shown in Figure 4, had been overturned, but by the wind rather than the detonation. One can, No. 4, had been burned, and another, No. 3, had been struck by a small object which scratched the paint, but did not deform the can.
