# 1           **Subsidence damage assessment of a gothic church using** 2                           **Differential Interferometry and field data**

3           R. Tomás<sup>1</sup>, J. García-Barba<sup>1</sup>, M. Cano<sup>1</sup>, S. Ivorra<sup>1</sup>, M.P. Sanabria<sup>2</sup>, J. Duro<sup>3</sup>, G. Herrera<sup>2</sup>

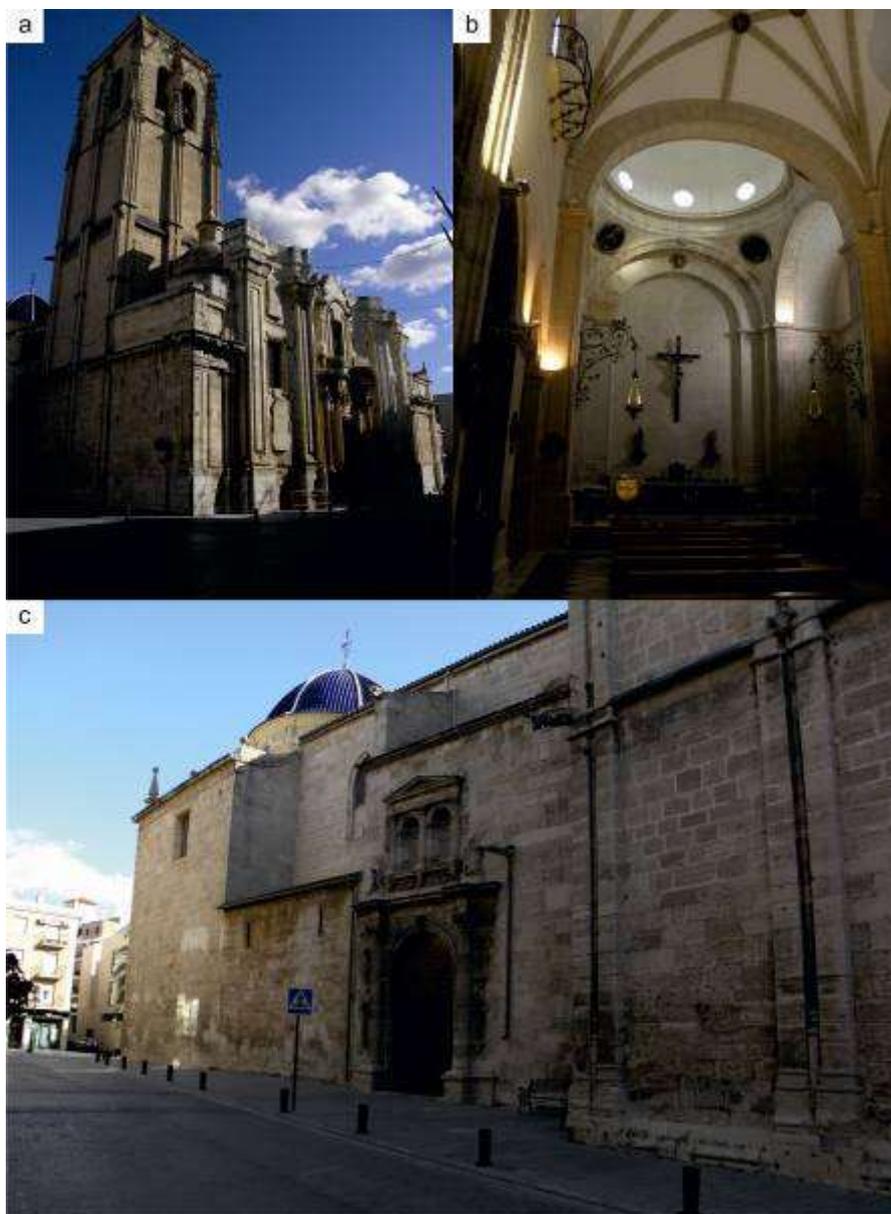
84 Figure 1. Photograph of the Santas Justa and Rufina church: (a) North-west corner. Notice the  
85 main door and the bell tower. (b) Main body. Observe the main chapel. (c) North façade with the  
86 Evangelio door. See location of these elements on Figure 2.
