Building monitoring during the partial implosion stage

J. Garcés¹, J.C. Botero¹, D. Murià-Vila²

(1) Universidad EAFIT - Colombia, (2) Instituto de Ingeniería- UNAM – México

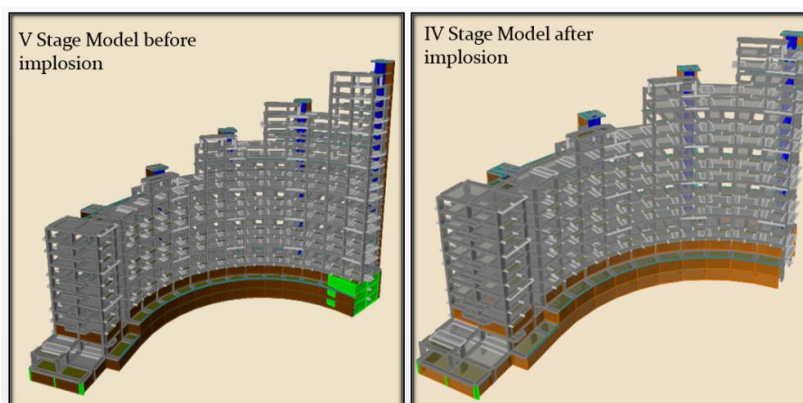
Figure3. Three-dimensional model before and after the implosion

The frequencies identified in the analytical model (Finite element software) before the implosion were 0.60, 0.73, 1.11, 1.63, 1.89 and 2.36 Hz. Frequencies corresponding to 1.11 and 2.36 Hz belong to the torsional/rotational mode.

After the implosion, the structure loses V stage and the model (Finite element software) reflects this fact. The frequencies identified in this case were 0.68, 0.81, 1.19, 1.89, 2.22 and 2.62 Hz. Frequencies corresponding to 1.19 and 2.62 Hz belong to the torsional/rotational mode.

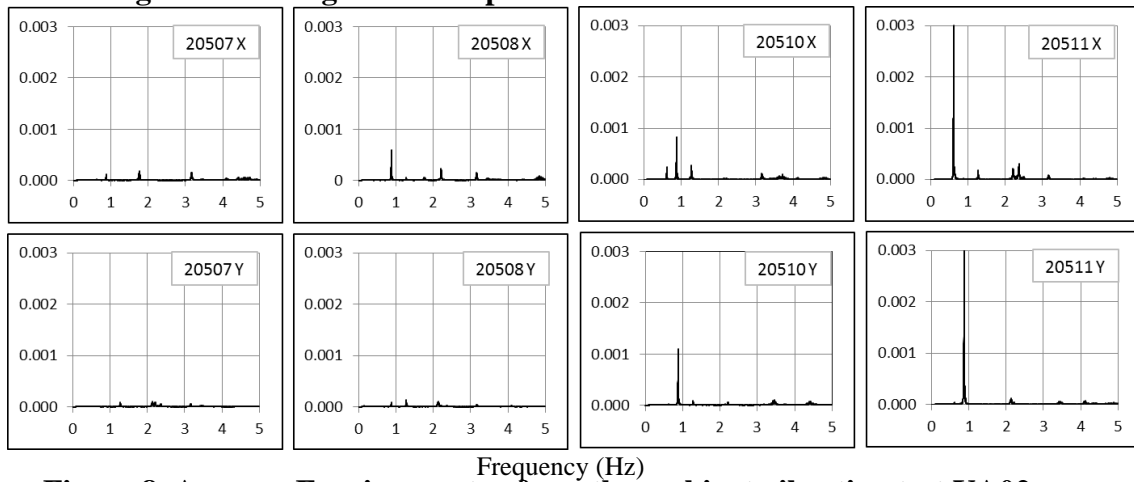
Figure 8. Average Fourier spectra from the ambient vibration test VA02

Figures 6 to 9 correspond to events prior to the implosion. It was determined that the frequencies associated with the first mode were close to 0.62 and 0.87 Hz, for the X and Y directions respectively. For the second mode values near 1.28 and 1.77 Hz for the X and Y directions respectively were obtained.
