Fatigue initiation and crack growth behaviour in GLARE from the Airbus MegaLiner Barrel test

Teardown fractography of a GLARE window panel (F4) from the Airbus MegaLiner Barrel (MLB) fatigue test.

NLR-TP-2006-276

May 2006

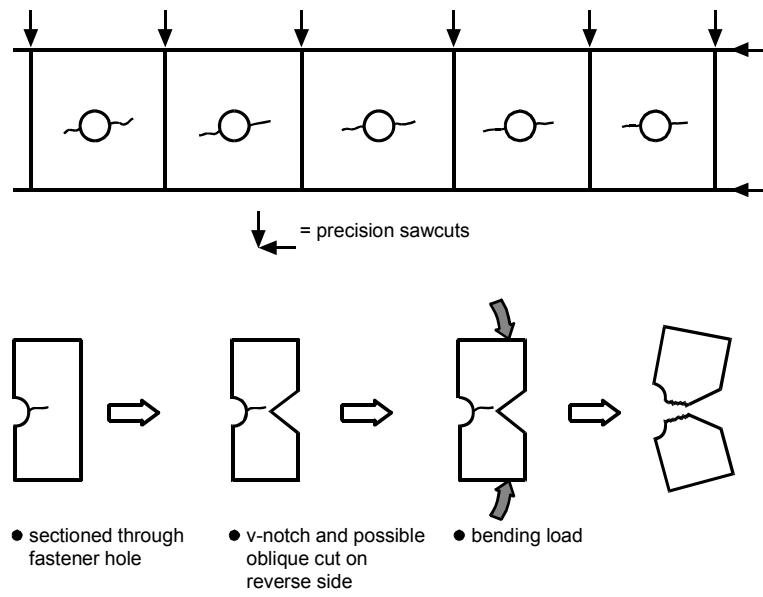
Fig. 3 Procedure for opening up cracks

The NDI-indicated fastener holes were opened up for optical fractography using the procedure shown in figure 3. This verified the NDI for all GLARE fastener holes with maximum crack lengths $\geq 0.24\text{mm}$. Also, there were only 4 false calls for a total number of 216 inspected fastener holes. These results demonstrate that our NDI capability will detect most cracks in GLARE during teardown.
