NLR-TP-2002-294

Patch repair of cracks in the upper longeron of an F-16 aircraft of the Royal Netherlands Air Force (RNLAF)

W.G.J. 't Hart and J.A.M. Boogers

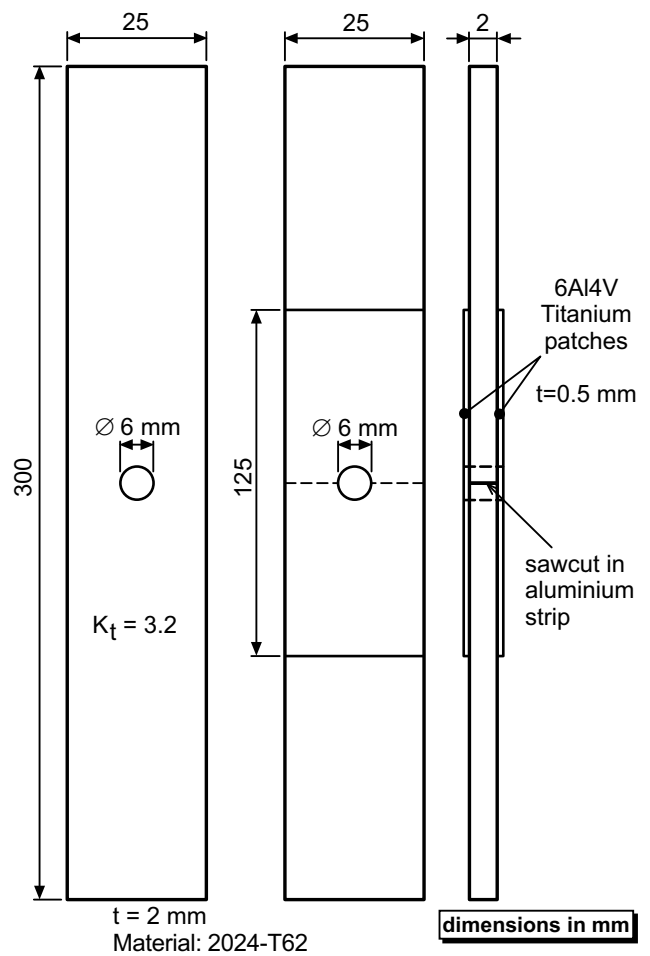
Fig. 5 Fatigue specimens for flight simulation fatigue testing

In order to assess the performance of the patch repair, limited fatigue tests were performed on notched 25 mm wide aluminium strips with and without a patch repair, figure 5. Two open hole specimens and two patch repair specimens were prepared. A fastener of 6 mm in diameter was installed in the central hole of the repaired coupon specimen. The fastener was torqued at 3 Nm, simulating the panel attachment to the longeron flange. However, load transfer occurs exclusively through the bonded Titanium patches.

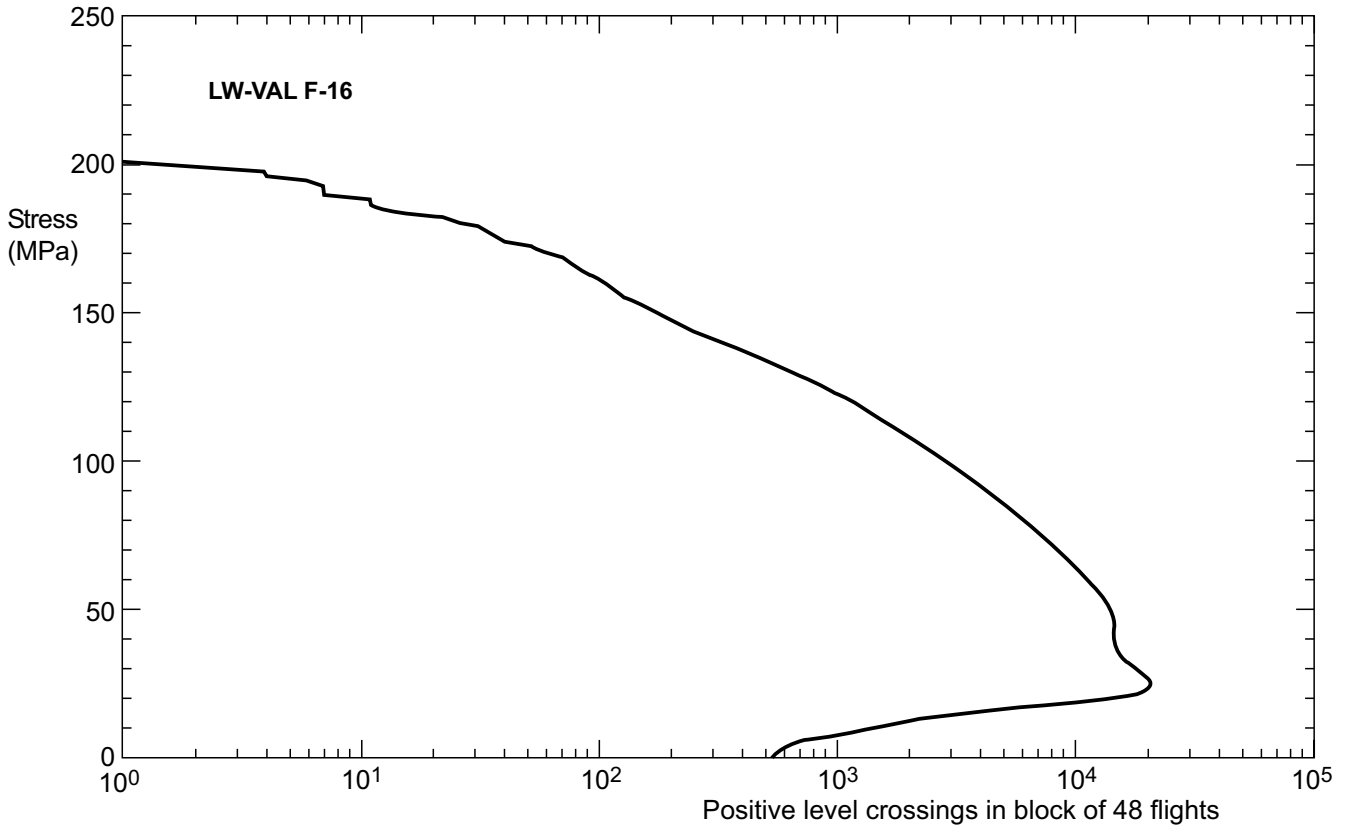
Fig. 6 Stress and cumulative level crossings of 100%-LW-VAL F-16

However, no directly usable sequence for the fatigue testing machine was available. Measurements on F-16 aircraft of the RNLAf showed a more or less similar shape of the forward fuselage and the wing root bending spectrum. Therefore the LW-VAL F-16 load sequence was selected, this being representative for the wing root bending moment for a severe EPAF** usage, figure 6. For ease of testing the negative stress levels in the sequence were set to zero. To obtain a reasonable testing time for the specimens with the central hole, the fatigue tests were executed at 130 % of the LW-VAL load sequence. This means that the maximum gross stress in the specimens was 268.5 MPa. According to GD-16 PR8150 [4] the maximum spectrum stress for longeron 16B1111 is 196.77 MPa (28.11 ksi).

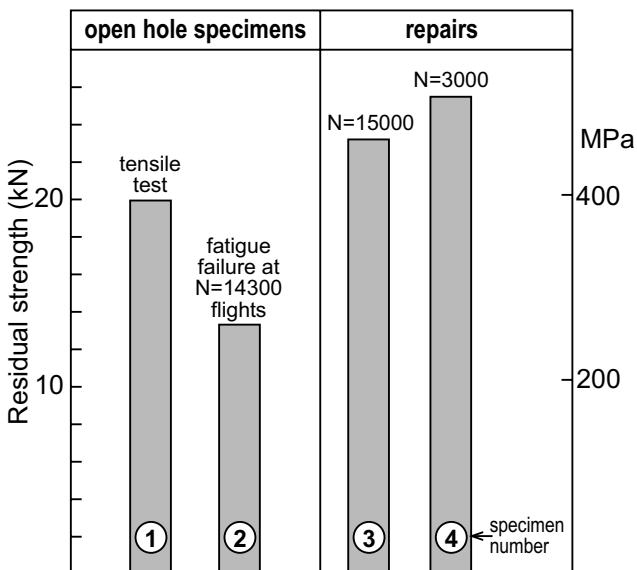
Fig. 7 Test results of experimental programme

Figure 7 gives the test results. The static failure load of the undamaged open hole specimen was 19.9 kN, specimen 1. Fatigue testing at 130 % LW-VAL resulted in a life of 14300 flights, specimen 2. Specimen 3 demonstrated that the repair survived 15000 flights after which a residual strength of 23.1 kN was obtained. NDI before residual strength testing showed local delamination at the edges of the titanium patches. Specimen 4 did not show signs of debonding after testing for 3000 flights. The residual strength was 25.3 kN. Figure 8 shows the failed repair specimens. Both specimens showed tensile failure of the
