**PILOT PROJECT FOR FARMER-MANAGED IRRIGATED AGRICULTURE
UNDER THE LEFT BANK OUT FALL DRAIN (LBOD),
STAGE-I PROJECT, PAKISTAN**

**MAINTENANCE PLANS FOR IRRIGATION FACILITIES
OF PILOT DISTRIBUTARIES IN SINDH, PAKISTAN**

**Volume Two
Heran Distributary, Sanghar District**

**December 1997
Hyderabad Office
PAKISTAN NATIONAL PROGRAM
INTERNATIONAL IRRIGATION MANAGEMENT INSTITUTE**

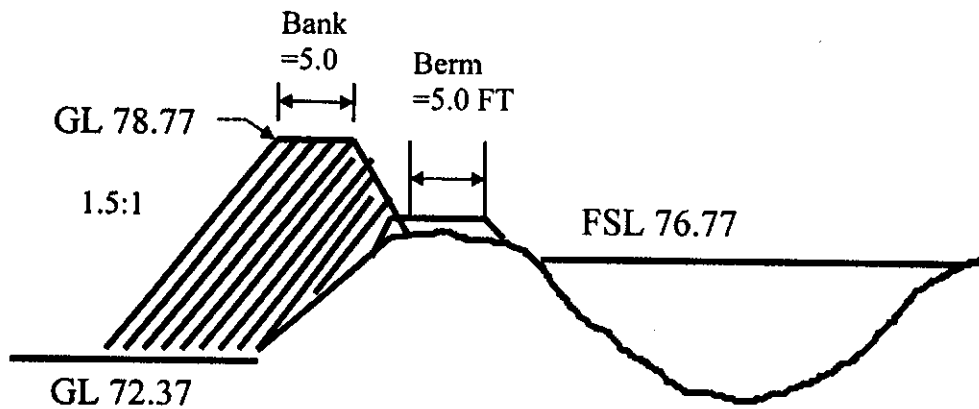
Typical x-section at RD 9.3 of NIP

7.4.1 Cost-Estimation for stabilizing the left bank from RD 8.6 to 10.1

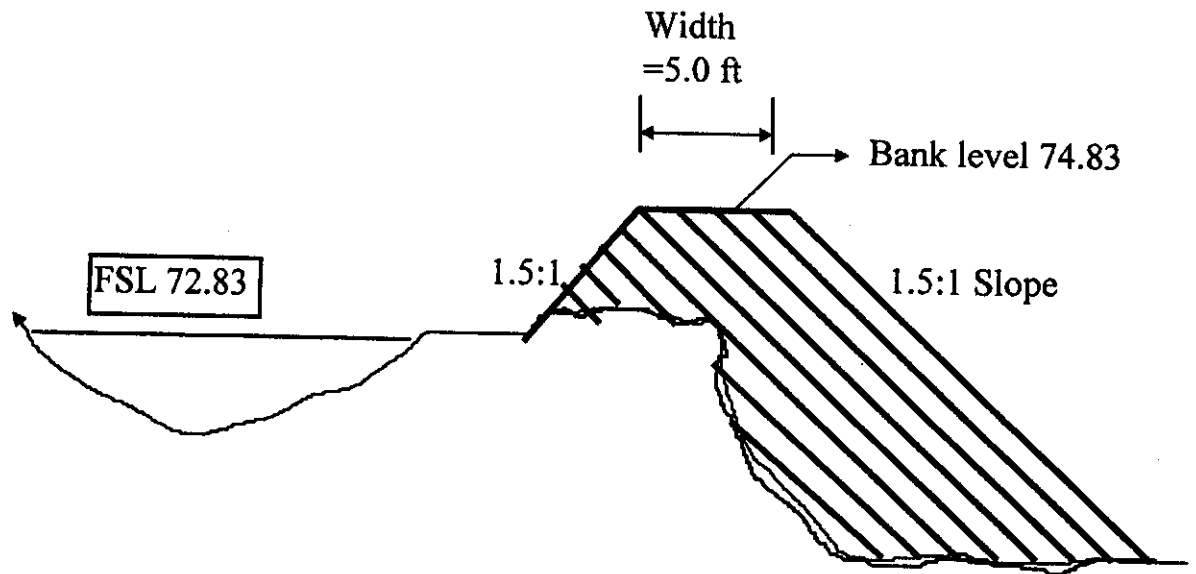
Typical x-section of non inspection path of Heran Distributory, Sanghar.

The Water Users Federation (WUF) identified the need for the maintenance of left side bank from RD 23 to 27 (about 4000 ft length). This portion was always creating problem of breach, seepage and slippage of water. Therefore, the nearby area could not be cultivated. Looking into the problem, the IIMI field staff prepared a cost-estimation for raising and strengthening the bank of Distributory from RD 23 to 27.
