### THREE CASE STUDIES: MOISTURE CONTROL IN A HOT, HUMID CLIMATE

Warren R. French, P.E., RRC, CCS, President  
French Engineering, Inc., Houston, Texas

## PRE-MANUFACTURED HOME IN SOUTHEAST TEXAS

### MODERN OFFICE BUILDING IN LOUISIANA

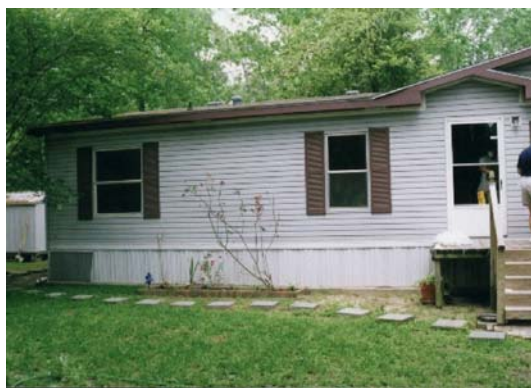
**Figure 1**

This project was a small pre-manufactured home located in the pine woods of East Texas. See Figure 1.

It had been occupied for approximately two years in 1999, when during the second Summer, the owner observed mold growth on the surface of certain walls and ceilings. Several of these areas were adjacent to bathroom facilities, and initial steps of action included correction of any plumbing leaks or suspected problems with respect to direct water leakage in these “wet” areas of the residence. However, these initial measures were not successful in addressing the problems, which continued to manifest themselves during the cooling season of 2000. Younger members of the family reportedly began to experience respiratory and allergy problems, when indoor air quality testing was conducted to assist in determining the extent and severity of these problems. Ultimately, the family had to abandon the residence due to adverse health effects to their small children. A full remediation of the mold and mildew problems was implemented by the owner and

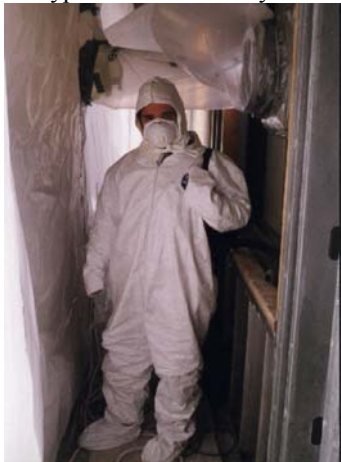
**Figure 7**

The third project was a four-story office building recently completed on the lake front shore near New Orleans, Louisiana. See Figure 6. We were retained by the general contractor to assist in determining the cause for mold and mildew growth, as well as to diagnose the cause for several specific chronic leak locations. See Figure 7. Our investigation included a review of the original construction documents, visual

inspections, selective demolition, field leak testing, and a thermal and vapor flow analysis of the typical wall assembly. See Figure 7.

component. We also performed a thorough review of the original construction documents pertaining to typical details and assembly materials. Based on our investigation and analysis, we were able to ascertain that the windows were not allowing direct water leakage into the wall cavity. However, due to a lack of detailing and specific instructions in the original construction documents, there were no particular assemblies or air barriers stipulated within the documents or actually constructed in the field. In addition, we determined that the majority of the concealed condensation and associated mold growth was occurring due to excessive moist air infiltration through numerous unsealed openings within the exterior building envelope. Since no provisions for air barriers or vapor retarders located at the outside plane of the wall were stipulated or required within the documents, the general contractor and subcontractors provided typical masonry walls with appropriate protection from direct water leakage, but nothing to alleviate moist air migration. Accordingly, the combination of air diffusion and air leakage caused condensation where the vinyl wall covering had been utilized as an interior finish. It was noted that there was no mold growth observed above the suspended ceiling, since there was no vinyl wall covering used at those locations. There were unsealed openings that allowed excessive air infiltration around the window perimeters, at enlarged openings occurring at the roof parapet coping, as well as through cracks in the masonry and gaps within the cladding sealants. These problems were confirmed by the results of our thermal and vapor flow analysis.
