NASA TECHNICAL NOTE

NASA TN D-6979

APOLLO COMMAND MODULE LAND-IMPACT TESTS

by J. E. McCullough and J. F. Lands, Jr.
Manned Spacecraft Center
Houston, Texas 77058

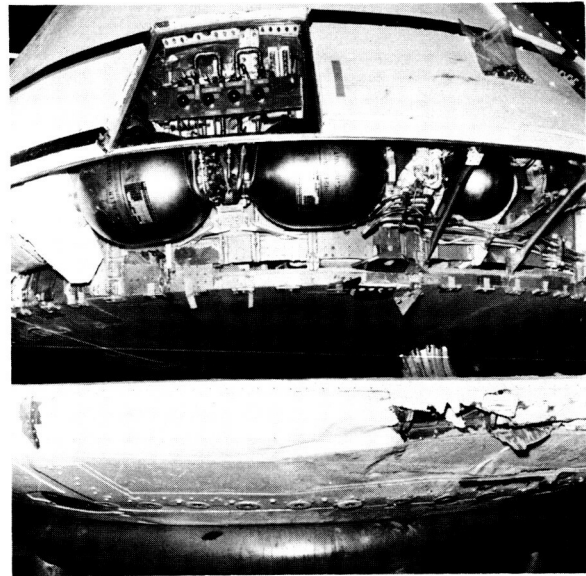
(f)

The aft-bulkhead core failed in shear in an area approximately 6 feet in diameter in the +Z sector, and a crack through both face sheets extended approximately 36 inches from the center in the +Z direction (fig. 31(e)). The oxidizer tanks were crushed, and the fluid from the tanks escaped and entered the crew compartment through the crack in the aft bulkhead. The aft bulkhead was separated from the crew-compartment sidewall through an included angle of 196° (fig. 31(f)).
