**APOLLO 15 MISSION REPORT**

**MANNED SPACECRAFT CENTER  
HOUSTON, TEXAS  
DECEMBER 1971**

MSC-05161

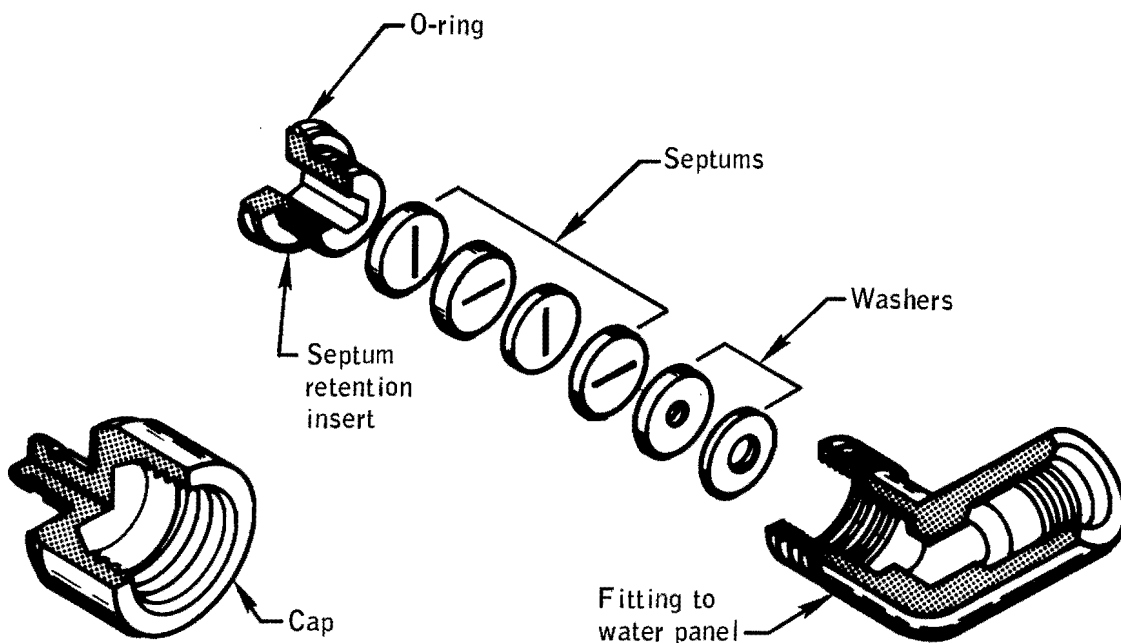
Figure 14-2.- Water panel chlorine injection port.

Minor leakage was noted from the chlorination injection port when the cap was removed to perform the prelaunch water chlorination. The cap was reinstalled and the leak ceased. A leak of approximately 1 quart in 20 minutes also was noted at the chlorine injection port as the crew removed the injection port cap for the third injection at about 61 hours. The crew tightened the septum retention insert (fig. 14-2) and satisfactorily stopped the leakage. Leakage recurred at about 204 1/2 hours and was corrected.

Postflight inspection and dimensional checks of the injection port assembly showed that all components were within established tolerances.

However, when the insert was tightened in accordance with the drawing requirements, the resulting septum compression was apparently insufficient to prevent the insert from loosening as a result of "O-ring drag" when the cap was removed. This allowed water leakage past the relaxed septums.

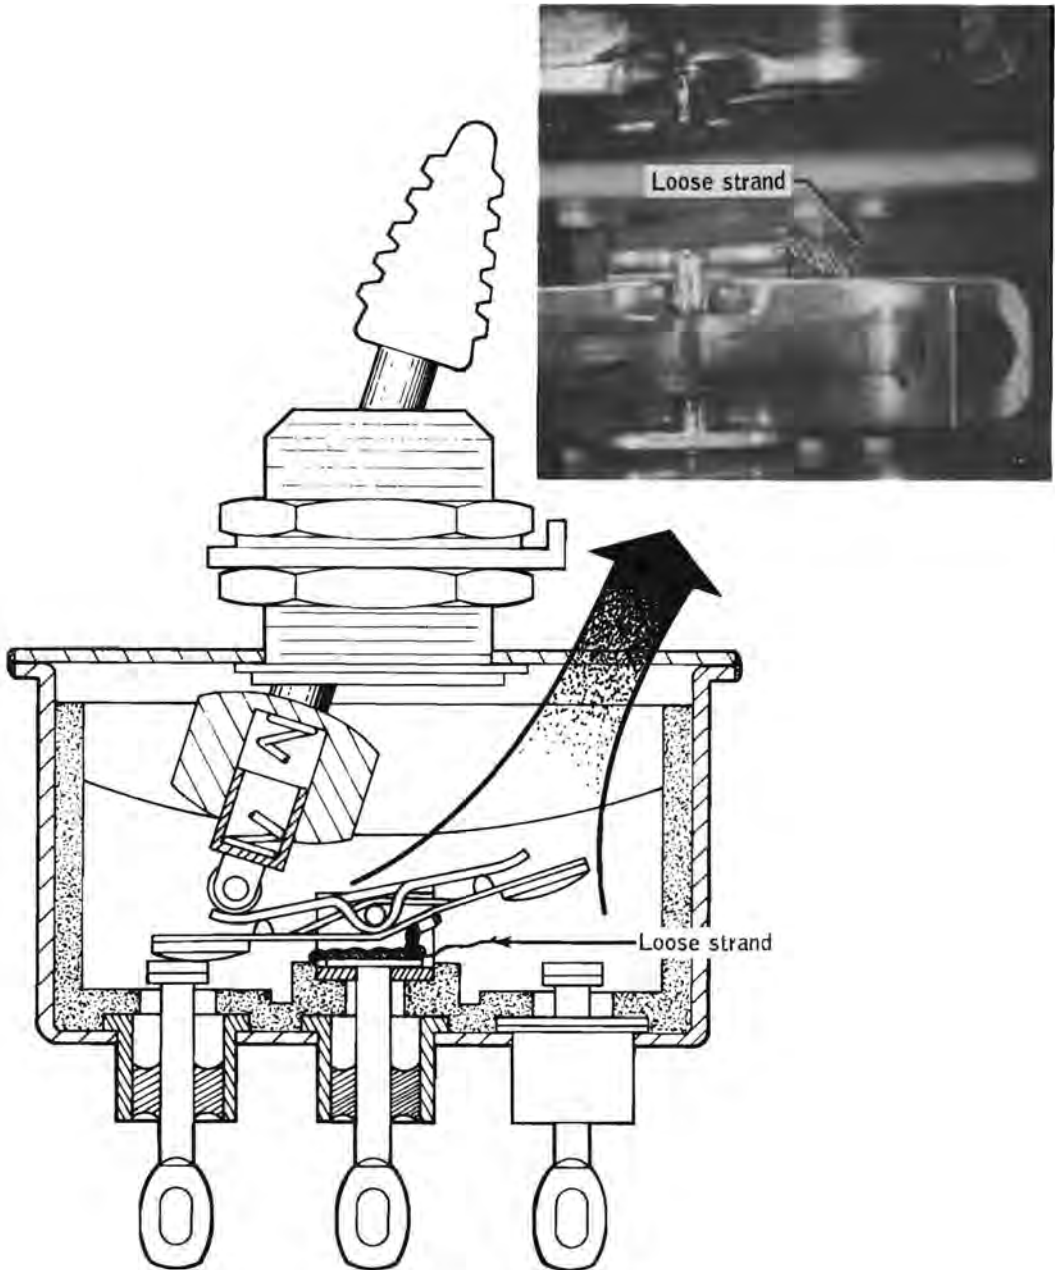
Figure 14-4.- Service propulsion system delta-V thrust switch.

The delta-V thrust switch (fig. 14-4) was shorted to ground both before and after removal of panel 1 from the command module during post-flight testing. After a change in panel position, the short-to-ground disappeared. The switch was then removed from the panel and X-rayed. The X-rays showed a wire strand extending from the braid strap which was thought to have caused the grounding problem. After switch dissection, an internal inspection verified that a strand extended from the braid strap; however, it did not appear to be long enough to cause a ground at any point within the switch (fig. 14-4). The bracket assemblies (pivot brackets, pigtail braids, and movable contacts) and the plastic liner were removed from the switch. Microscopic examination revealed that a wire strand (approximately 0.055 inch long) was present on the flange on terminal 2 (fig. 14-5). The strand appeared to be attached, but was later moved quite easily.

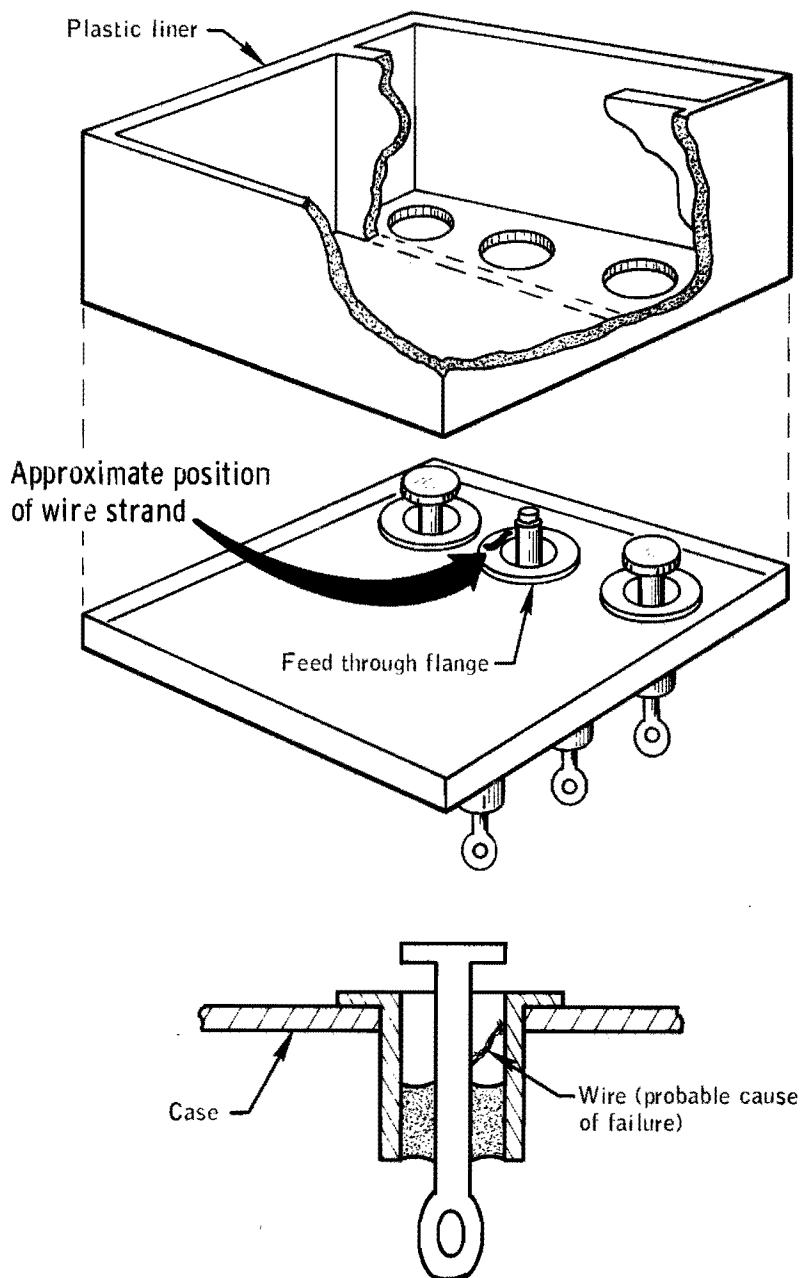
Figure 14-5.- Disassembled service propulsion system thrust switch.

liner and the flange surface; therefore, it is postulated that it might have been enclosed in the cavity of feed-through terminal 2 (fig. 14-5). The maximum clearance between the interior of the feed-through terminal wall and the terminal itself is 0.040 inch. A 0.055-inch-long wire strand could easily have bridged this distance, and yet is short enough to move quite freely within the feed-through terminal cavity. In fact, the strand subsequently fell into the cavity. Examination of the strand and cavity wall showed evidence of arcing. The strand could not be detected on the X-rays because that area was obscured by other poles in the switch.

Most of the switches on Apollo 16 and 17 spacecraft (3000 or 4000 series) required for crew safety or mission success were screened according to the following procedures.

- a. Additional inspection points were employed during manufacturing.
- b. The switches were X-rayed prior to acceptance testing.

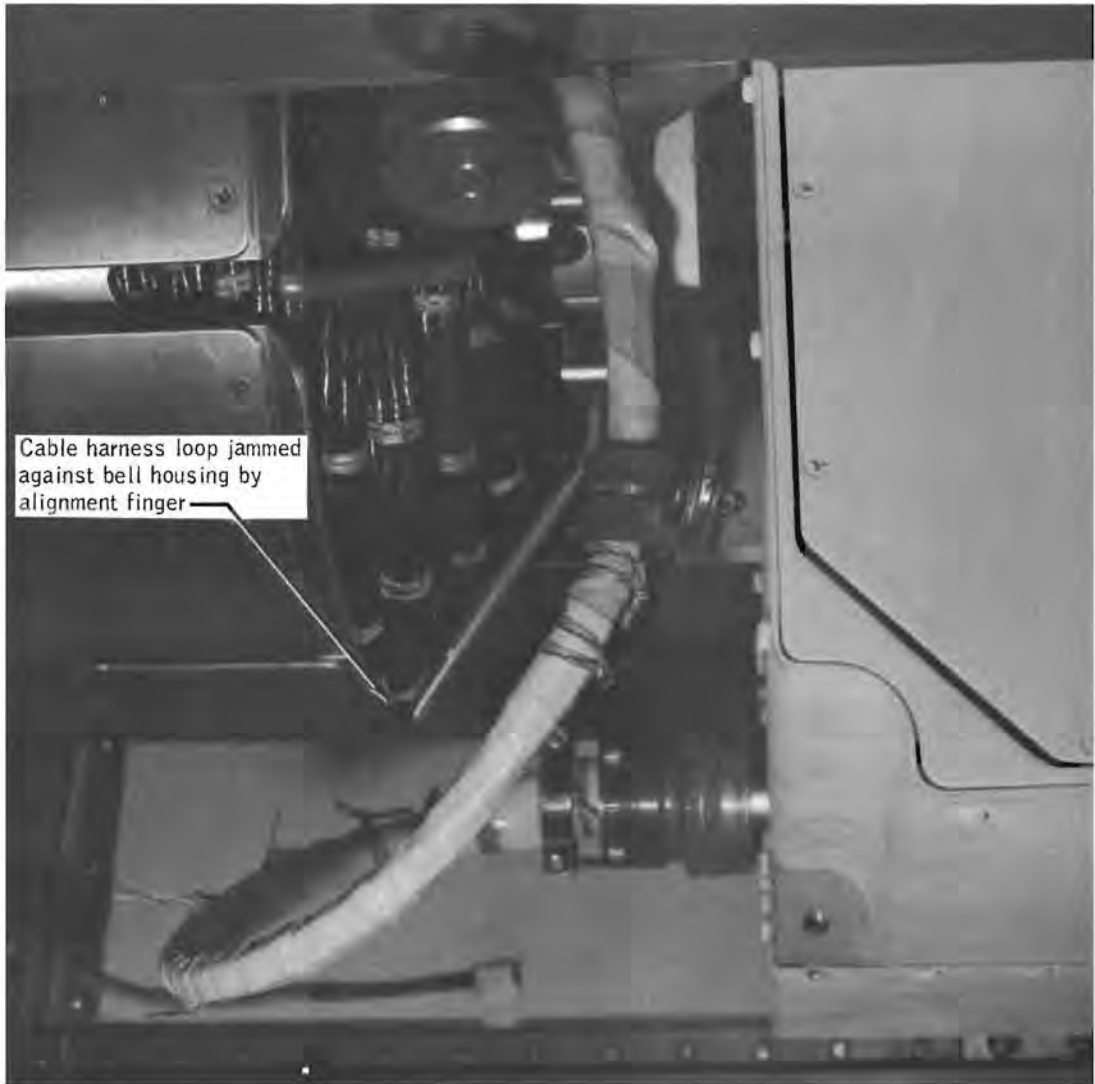
Figure 14-8.- Side view of mass spectrometer deployment mechanism (experiment attached).

An inflight test of the Apollo 15 boom indicated that the problem was a function of temperature. Testing and examination of the Apollo 16 spacecraft showed that the failure was possibly caused by pinching of the cable harness during the last several inches of boom retraction. The cable could have been pinched between the bell housing and rear H-frame bearing (figure 14-7), or a cable harness loop was jammed by a boom alignment finger against the bell housing (fig. 14-8).

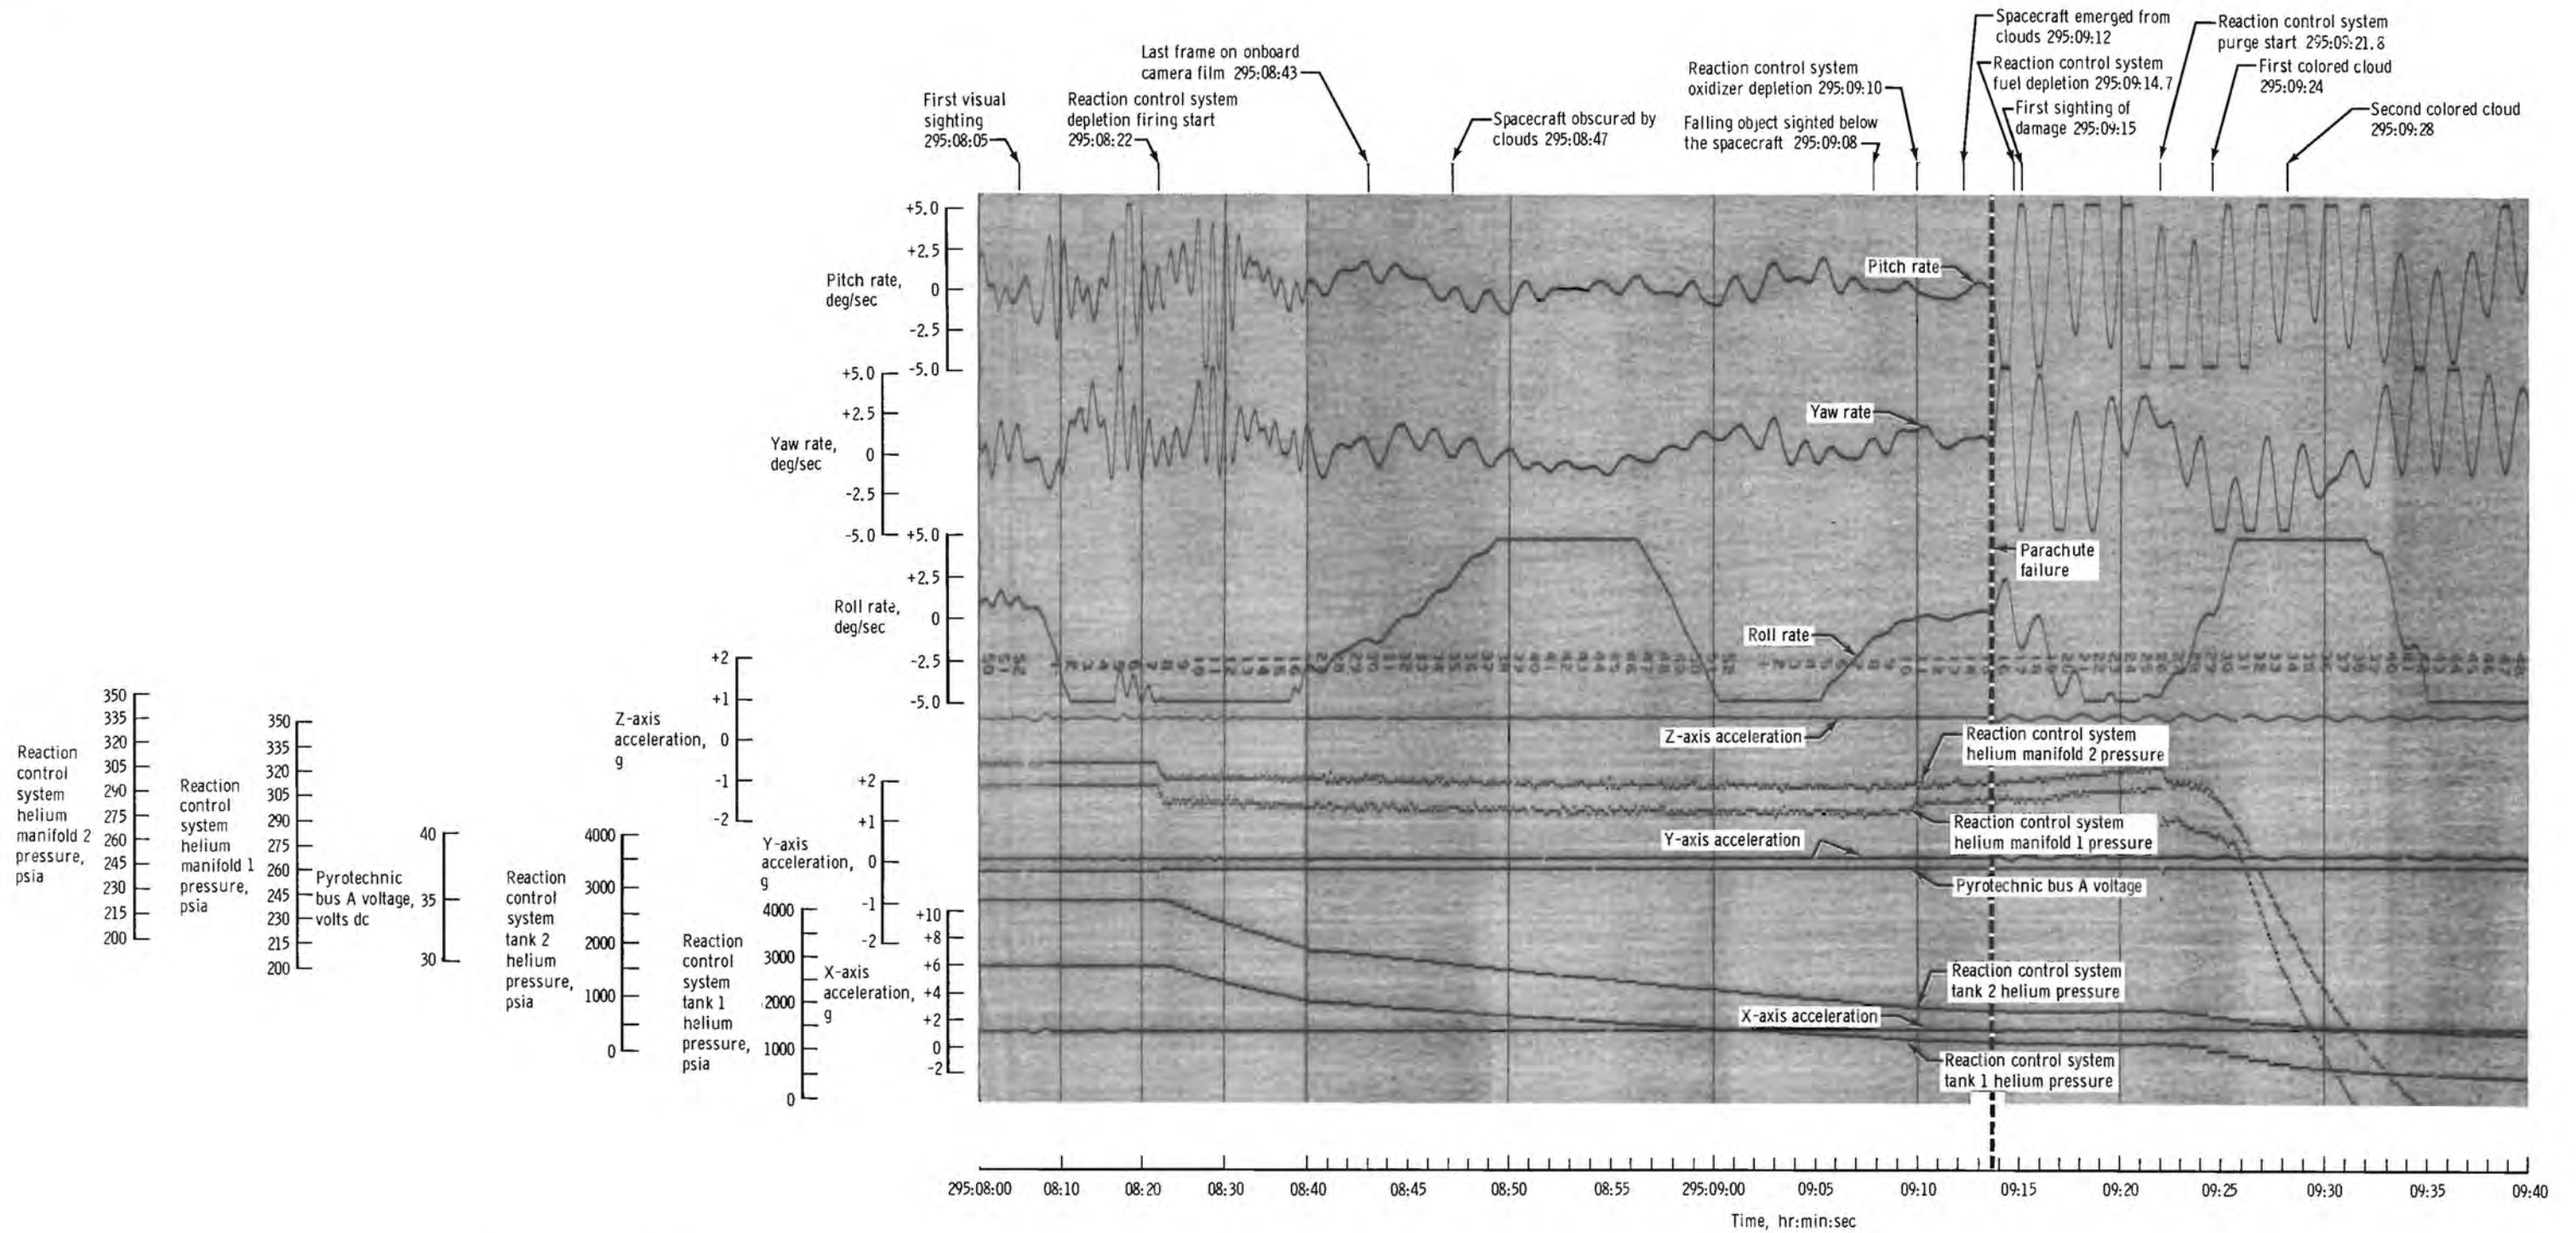
Figure 14-13.- Sequence of events during descent on the main parachutes.

The command module reaction control system depletion firing was considered as a possible candidate because of the known susceptibility of the parachute material (nylon) to damage from the oxidizer. Also because the oxidizer depletion occurred about 3 seconds prior to the anomaly, and fuel was being expelled at the time the anomaly occurred (fig. 14-13). Further, the orientation of the main parachutes over the command module placed the failed parachute in close proximity to the reaction control system roll engines. Testing of a command module reaction control system engine simulating the fuel (monomethyl hydrazine) dump mode through a hot engine resulted in the fuel burning profusely; therefore, the fuel dump is considered to be the most likely cause of the anomaly.

the time delay which inhibits the rapid propellant dump may be changed from 42 to 61 seconds. This could provide more assurance that the propellant will not have to be burned through the reaction control system engines in the event of a land landing. A detailed discussion of all analyses and tests is contained in a separate anomaly report (reference 7).

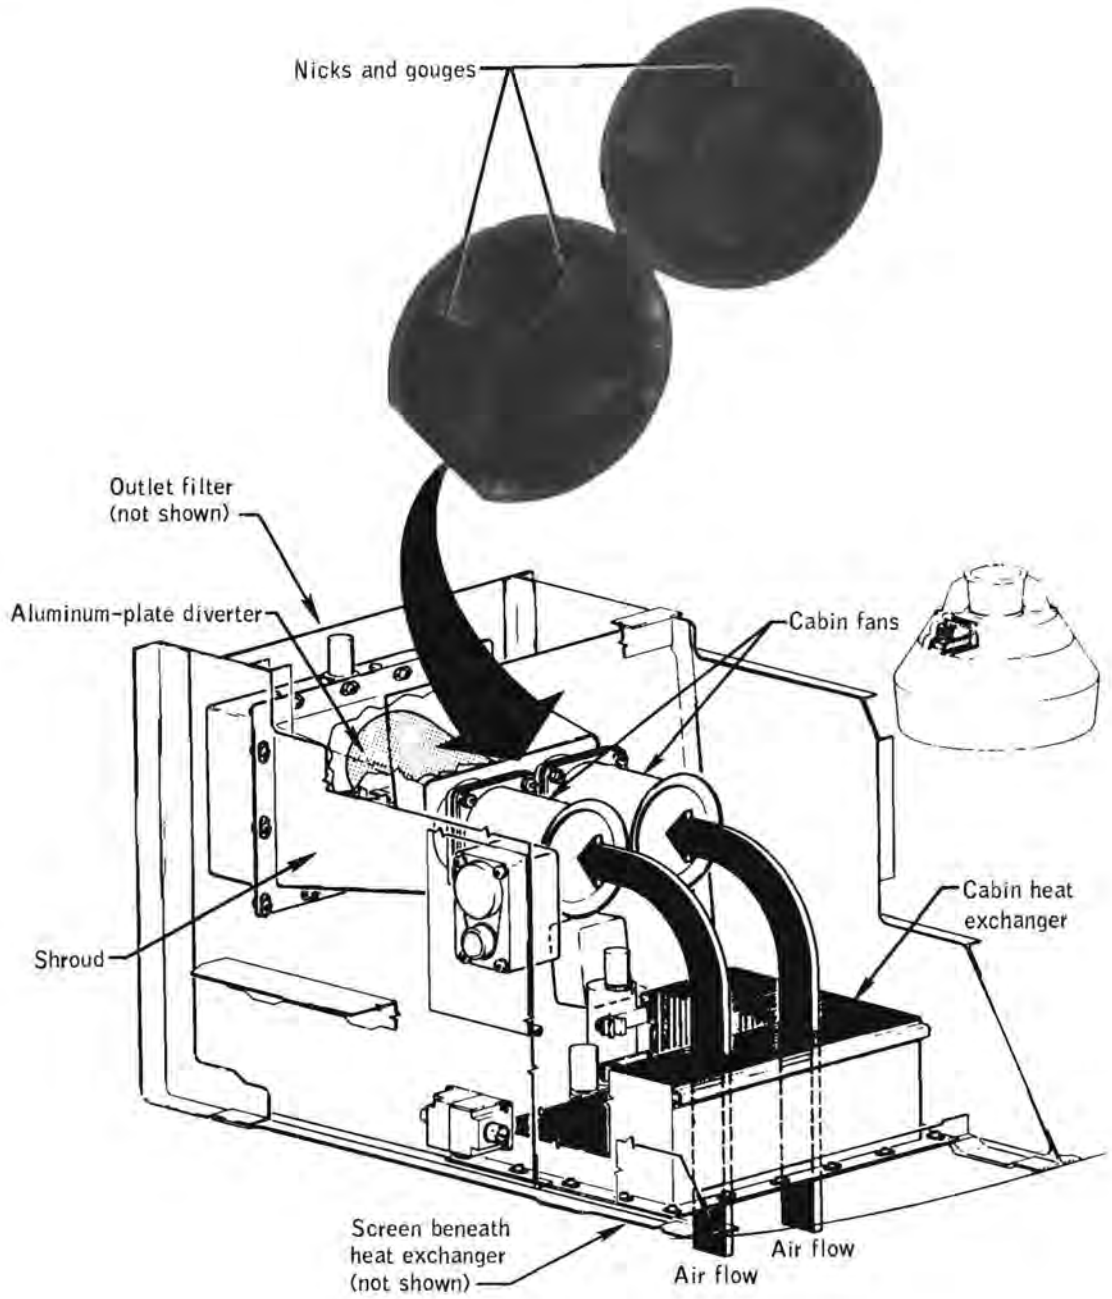
Figure 14-19.- Cabin fan installation.

During portions of the flight when the cabin fans (fig. 14-19) were activated, the crew heard sounds like an object striking the blades. Cycling the fans several times allowed the object to be retained in a position that precluded it from interfering with fan operation.

Inspection of the fans revealed considerable gouging on the leading edges of the blades of both fans (fig. 14-19). No marks were found on the outlet de-swirl vanes of either fan. After extensive examination, including the lunar dust filter, a 1/4-inch washer was found in the ducting.

Although the fan inlet is protected by screens in addition to the heat exchanger core, the outlet is relatively open and the washer could have

drifted in and out when the fans were not operating. The outlet was protected only during the limited time when the lunar dust filter was installed. The washer could also have been left in the duct during assembly.

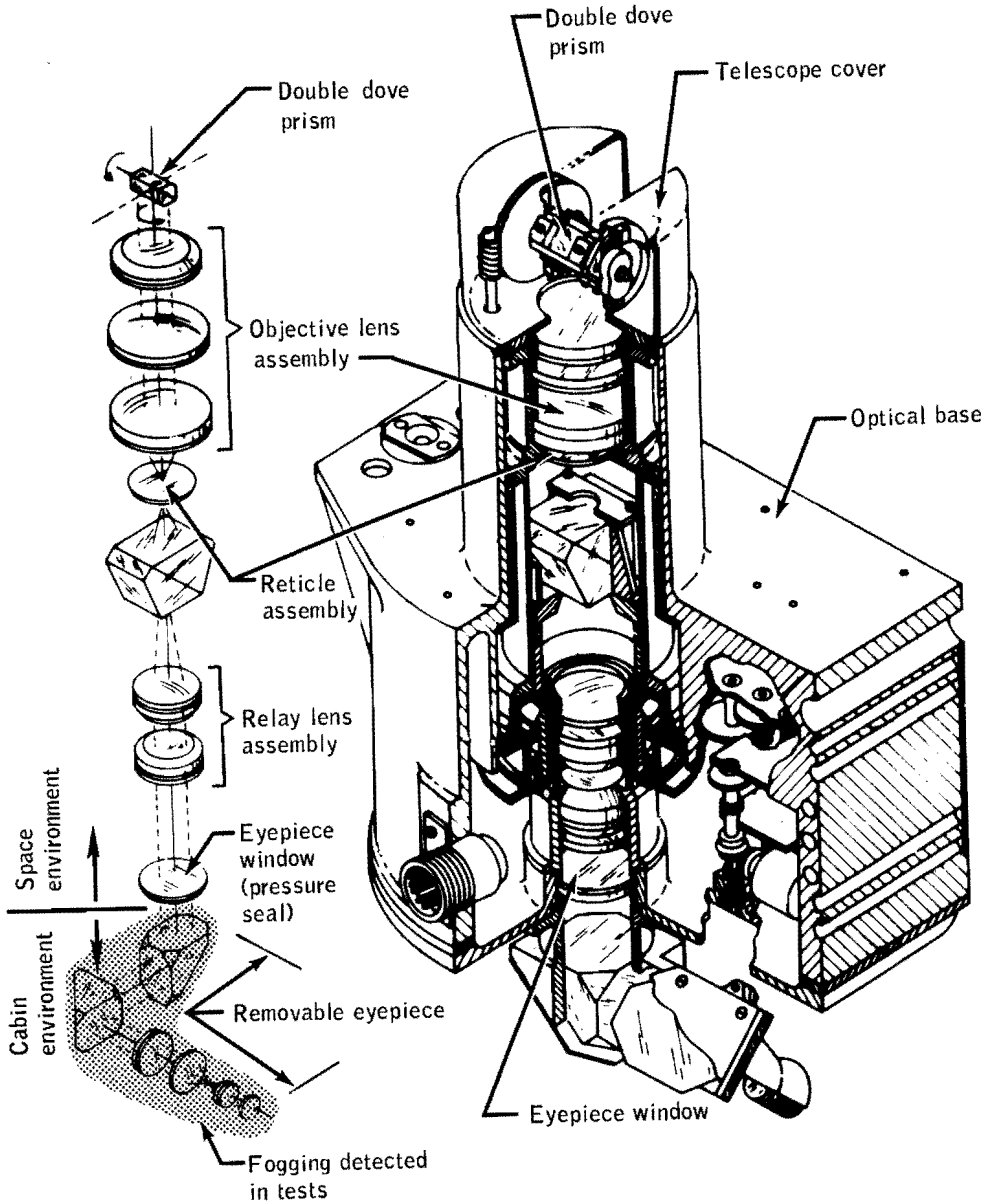
Figure 14-20.- Scanning telescope assembly.

Visual observations through the telescope (fig. 14-20) were made at the spacecraft manufacturer's facility, and no degradation could be observed. A luminescent transmittance test was performed on the telescope before removal from the spacecraft and transmittance was calculated to be 25 percent. This compares with an acceptance test value of 55 percent. The decrease is due to the entry environment and sea water contamination. The 30-percent decrease agrees well with the expected results and is not significant as far as being able to see and recognize constellations is concerned. For comparison, the earth's atmosphere normally causes a 50-percent loss in star intensity; therefore, observing stars from earth with a telescope with a 50-percent transmittance would be equivalent to observing stars from a spacecraft in flight using a telescope with a 25-percent transmittance.

A heater will be added to the removable eyepiece to prevent fogging in the eyepiece assembly and on the eyepiece window.

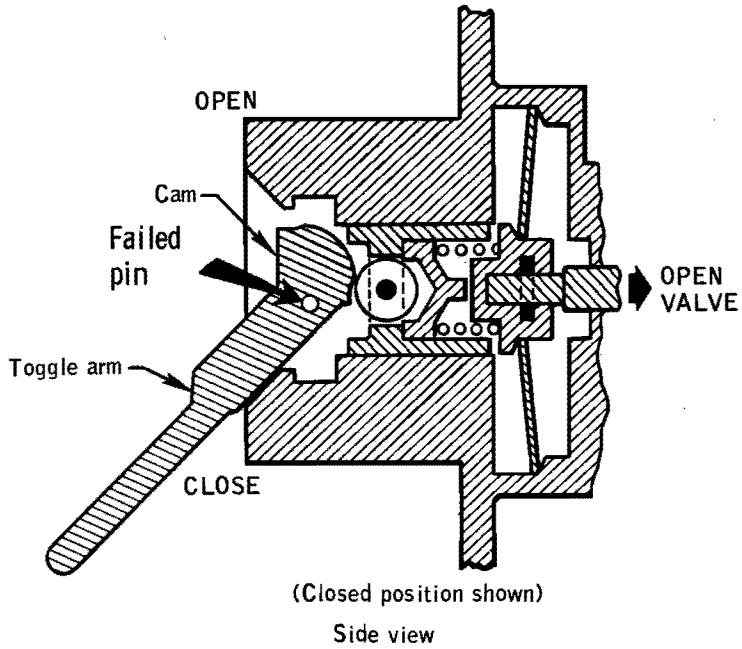
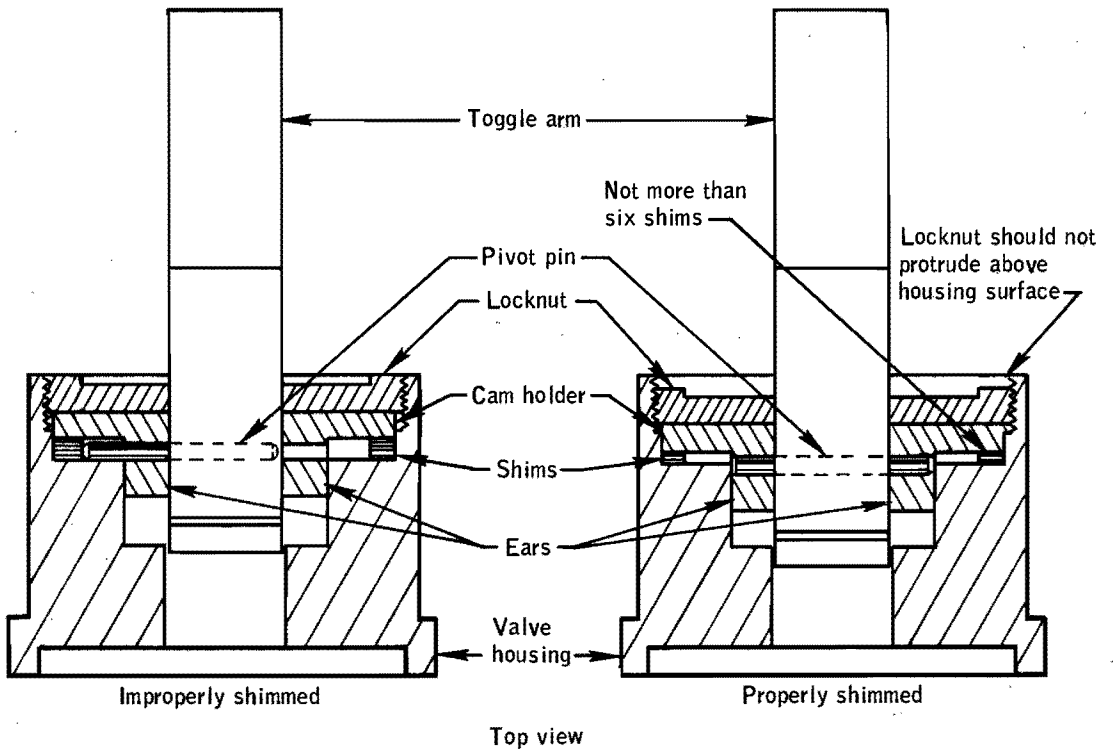
Figure 14-22.- Oxygen regulator shutoff valve.

The pivot pin attaches the toggle arm to the cam holder and is retained in place by the valve housing when properly assembled (fig. 14-22).

Failure analysis showed that the pivot pin failed in single shear and bending. This failure resulted from improper shimming which allowed the pivot pin to come out of one side of the cam holder as shown in figure 14-22. Analysis and testing has shown that the pin strength is adequate in double shear, but will fail in single shear and bending with a force of about 70 pounds applied at the tip of the toggle arm when it is in the closed position. No marks were found on the toggle arm to indicate that it had been struck by some object.

Inspection criteria to assure that valves now installed in other spacecraft are properly assembled have been developed from a study of adverse tolerance buildups associated with the valve components. These criteria are that the lock nut does not protrude and the number of shims does not exceed six (fig. 14-22).

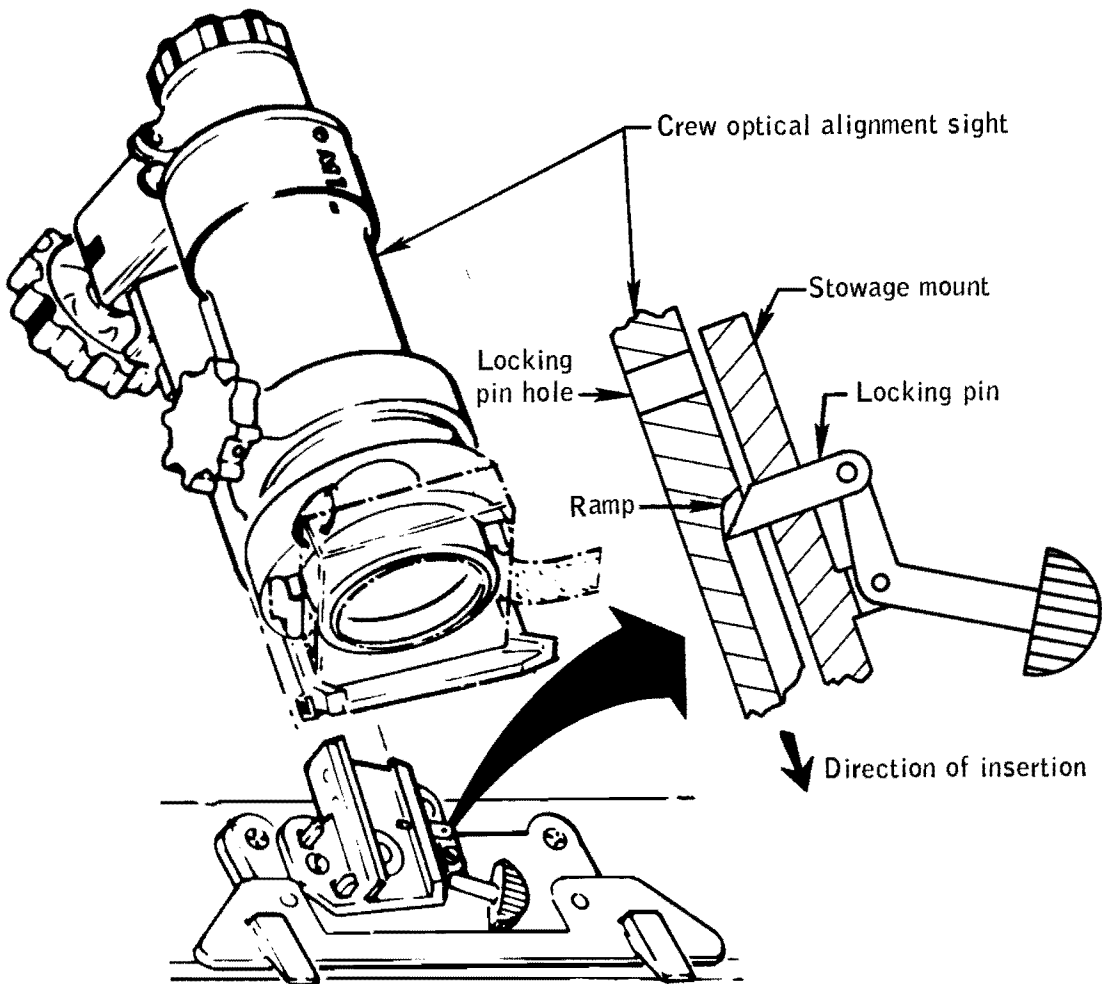
Figure 14-23.- Crew optical alignment sight stowage.

The crew optical alignment sight fell from its stowage mount during landing because the locking pin which secures it was not engaged.

Normally, when the sight is placed into the mount, the locking pin is raised automatically by a ramp and the pin is moved into the locking

pin hole by spring action (fig. 14-23). Postflight examination showed that the ramp had been gouged preventing raising of the pin by the ramp. The cause of the gouge is not known.

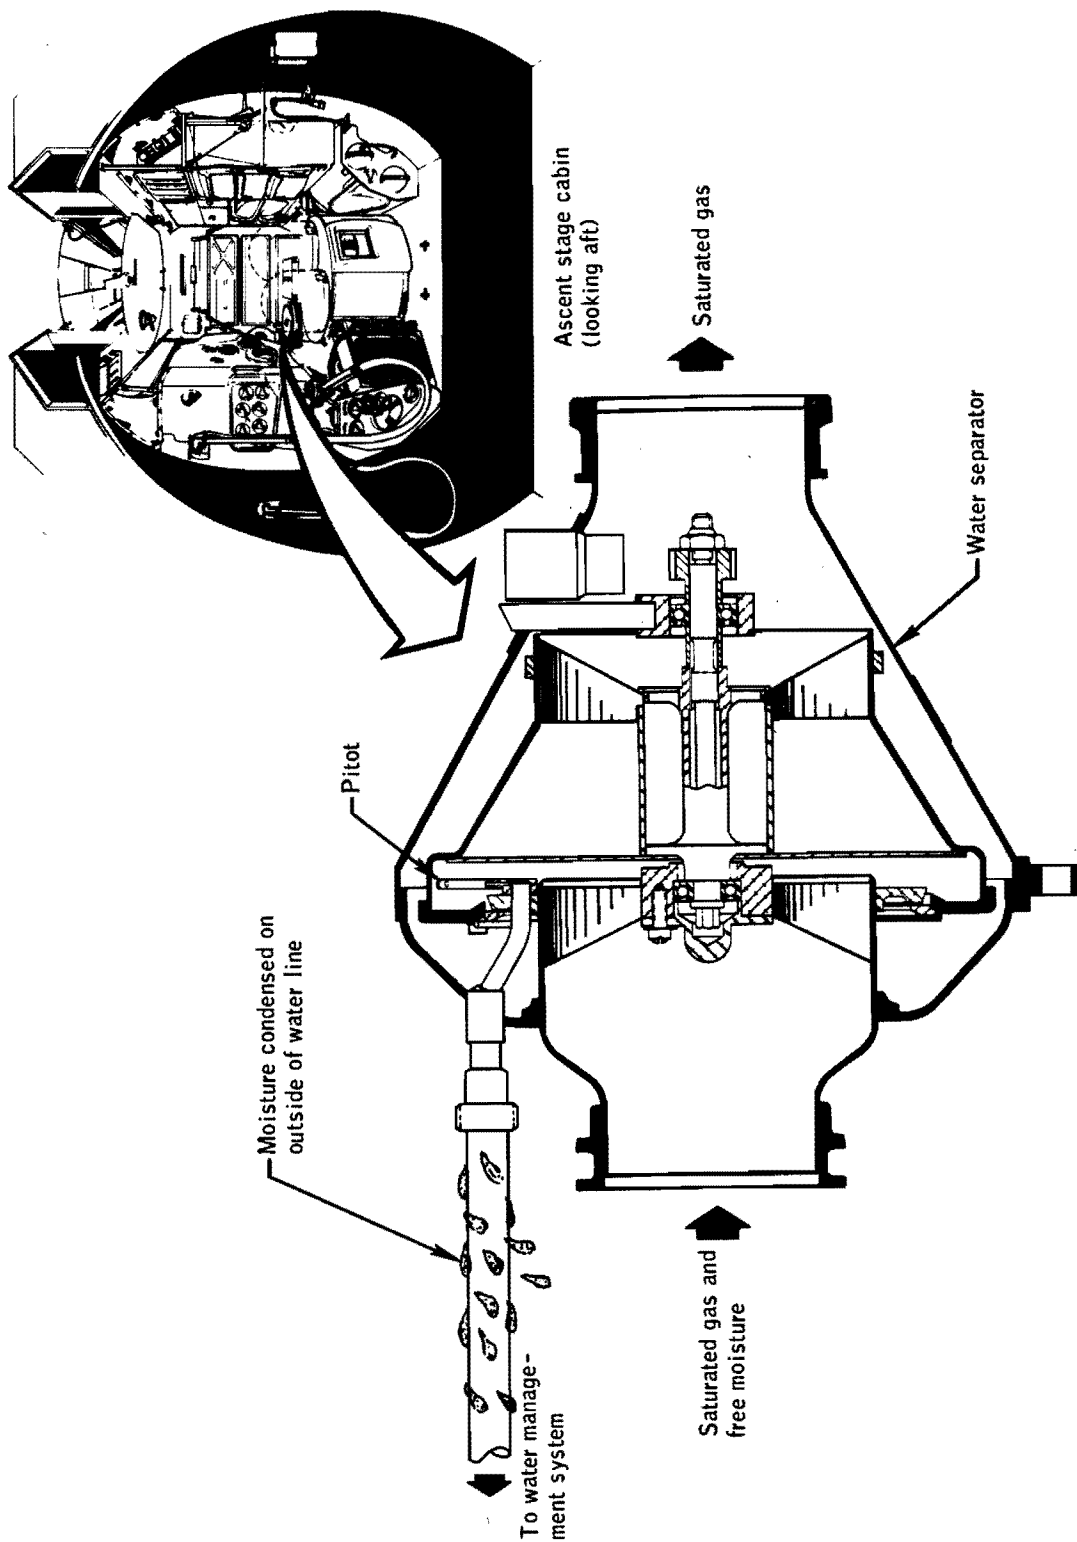
Figure 14-27.- Cross section of water separator.

Cabin atmosphere is cooled and passed through one of the water separators (fig. 14-27) where condensed water is separated by centrifugal force and picked up by a pitot tube. The water is then piped from the pitot tube, through a check valve, to the water management system where it is used in the sublimator.

conditions, water would condense on the outside of the line (fig. 14-27), and when the cabin was depressurized for the standup extravehicular activity, the water on the outside of the line would boil, freeze, and sublime, thereby freezing the water in the line.

Analysis shows that as little as a 0.01-inch film of water on the outside of the line will freeze the line at cabin depressurization. Freezing within the line will cause the separator to slow down and stall because of excessive water. Separator 2 had not been used. Therefore, no water was in its outlet line to freeze. Consequently, it operated successfully when activated.

Analysis and tests have shown that freezing of the line will not damage any spacecraft hardware. If such freezing occurs, the other separator would be used. Therefore, no corrective action is required.

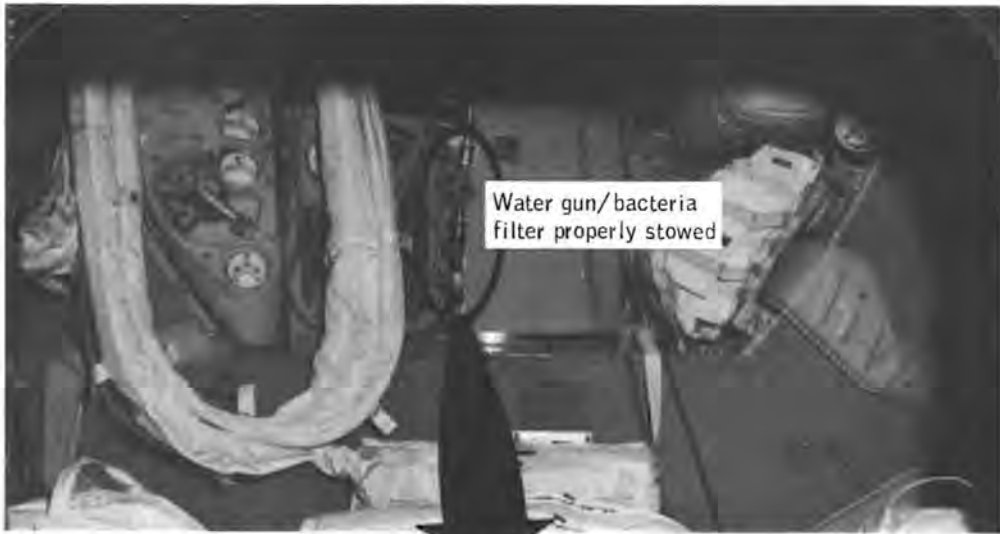
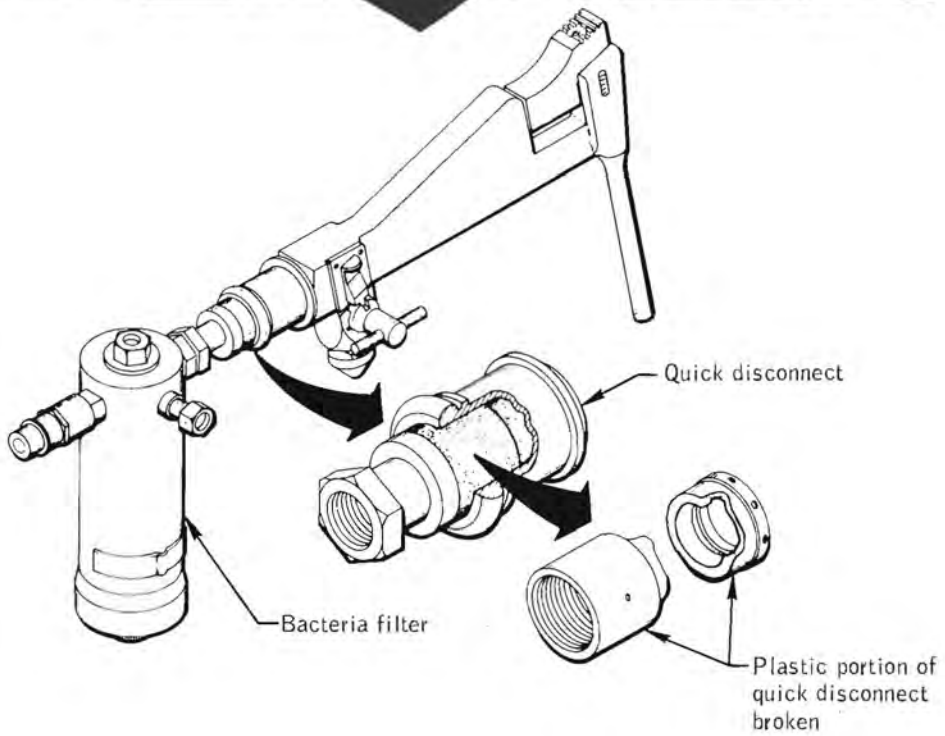
Figure 14-28.- Water gun/bacteria filter.

A water leak occurred at the quick disconnect between the bacteria filter and the water gun (fig. 14-28) shortly after the first extravehicular activity. The leak was caused by the plastic portion of the disconnect being broken and was stopped by removing the filter.

When the water gun/bacteria filter combination is properly stowed, the gun is held in a U-shaped boot (fig. 14-28). Both the gun and filter are held in place by straps with the hose protruding above the liquid cooling assembly. Bending the hose can easily exceed the force required to break the quick disconnect between the bacteria filter and the water gun if the filter is not strapped down. A test showed that a torque of 204.6 inch-pounds caused a similar quick disconnect to break in half.

Based on the torque value of 204.6 inch-pounds, a force of approximately 27 pounds applied at the hose quick disconnect interface would break the disconnect between the filter and the water gun.

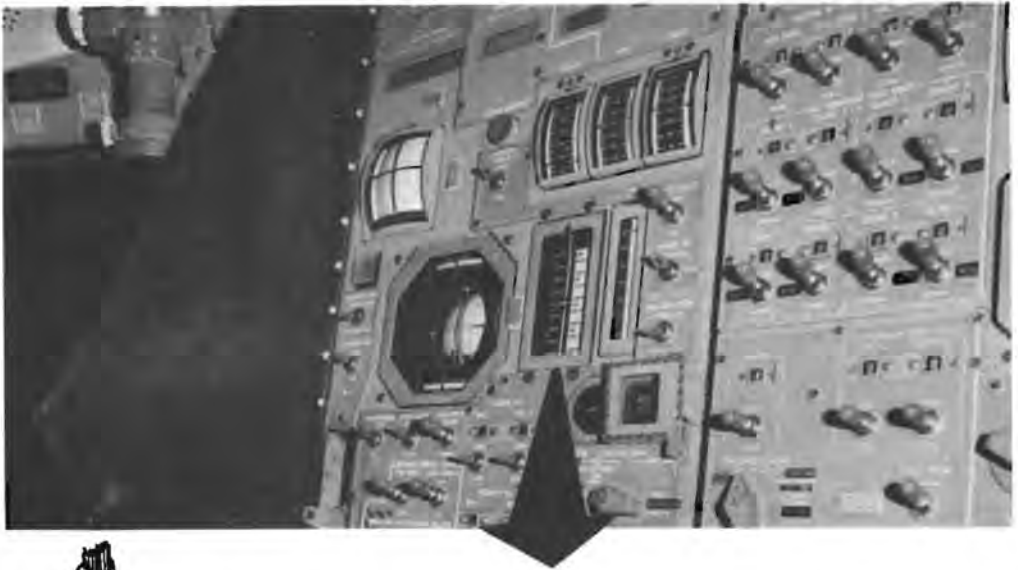
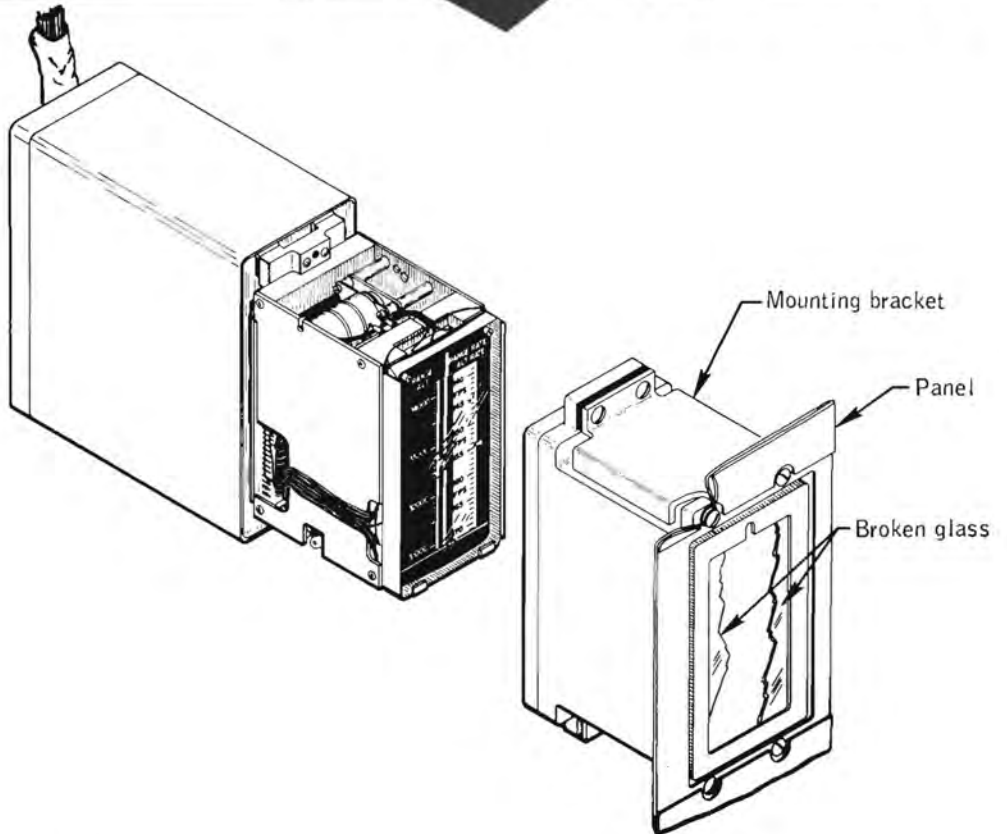
Figure 14-34.- Range/range rate meter mounting.

Sometime prior to ingress into the lunar module, the window of the range/range-rate meter broke (fig. 14-34). Upon ingress, the crew saw many glass particles floating in the spacecraft, presenting a hazardous situation.

A surface flaw deeper than the threshold depth for the glass operating stress must have existed on the outside of the meter window at launch. The flaw started growing as the cabin depressurized during the launch phase, and finally grew large enough for the glass to break.

For future missions, an exterior glass doubler will be added to the window to reduce the maximum operating stress to less than 2000 psi. This will increase the threshold flaw depth to 0.0036 inch and the critical flaw depth to 0.032 inch. This should prevent future fatigue failures since there are no reported fatigue failures in soda-lime glass at stresses below 2000 psi. In addition, all similar glass applications in the lunar

module and command module were reviewed and changes are being made. In the command module, transparent Teflon shields will be installed on the:

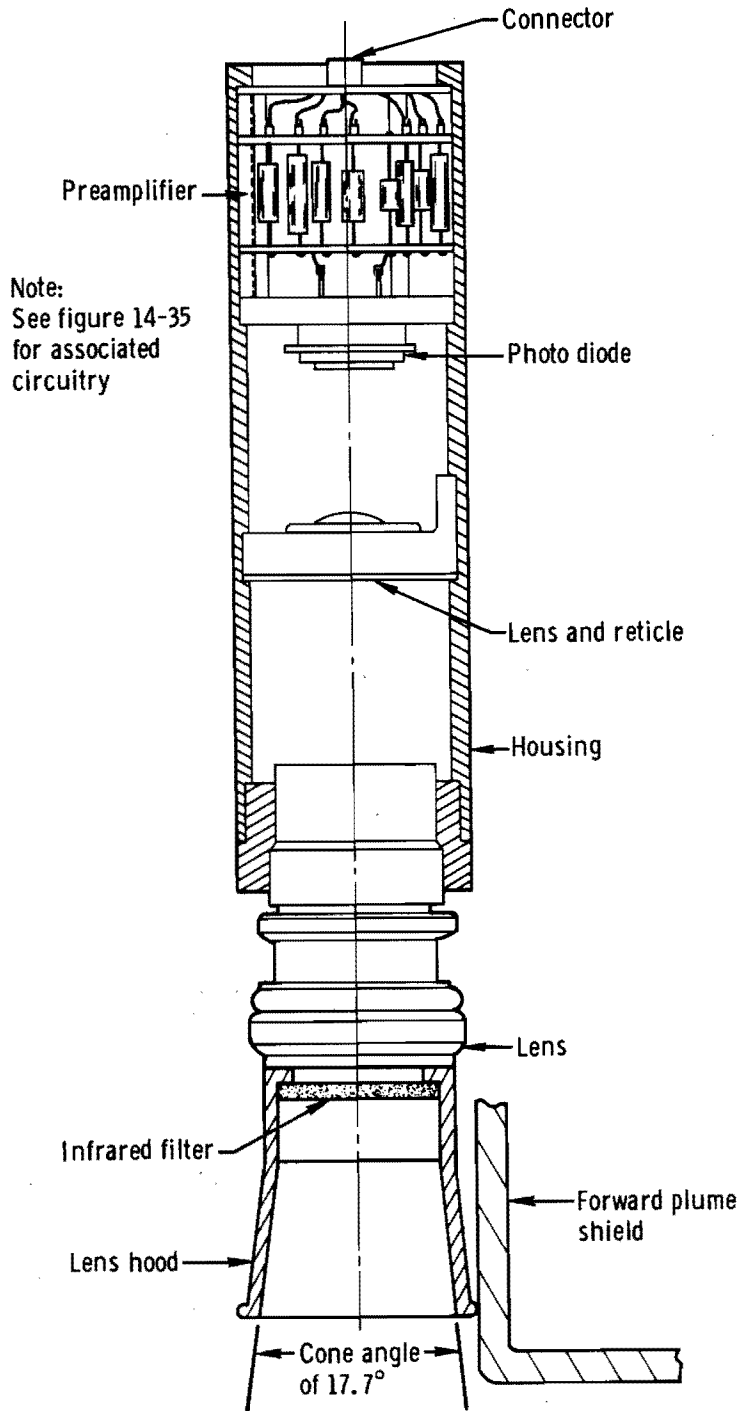
Figure 14-35.- Velocity/altitude sensor assembly.

Telemetry received from the first panoramic camera pass on revolution 4 indicated that the velocity/altitude sensor (fig. 14-35) was not operating correctly.

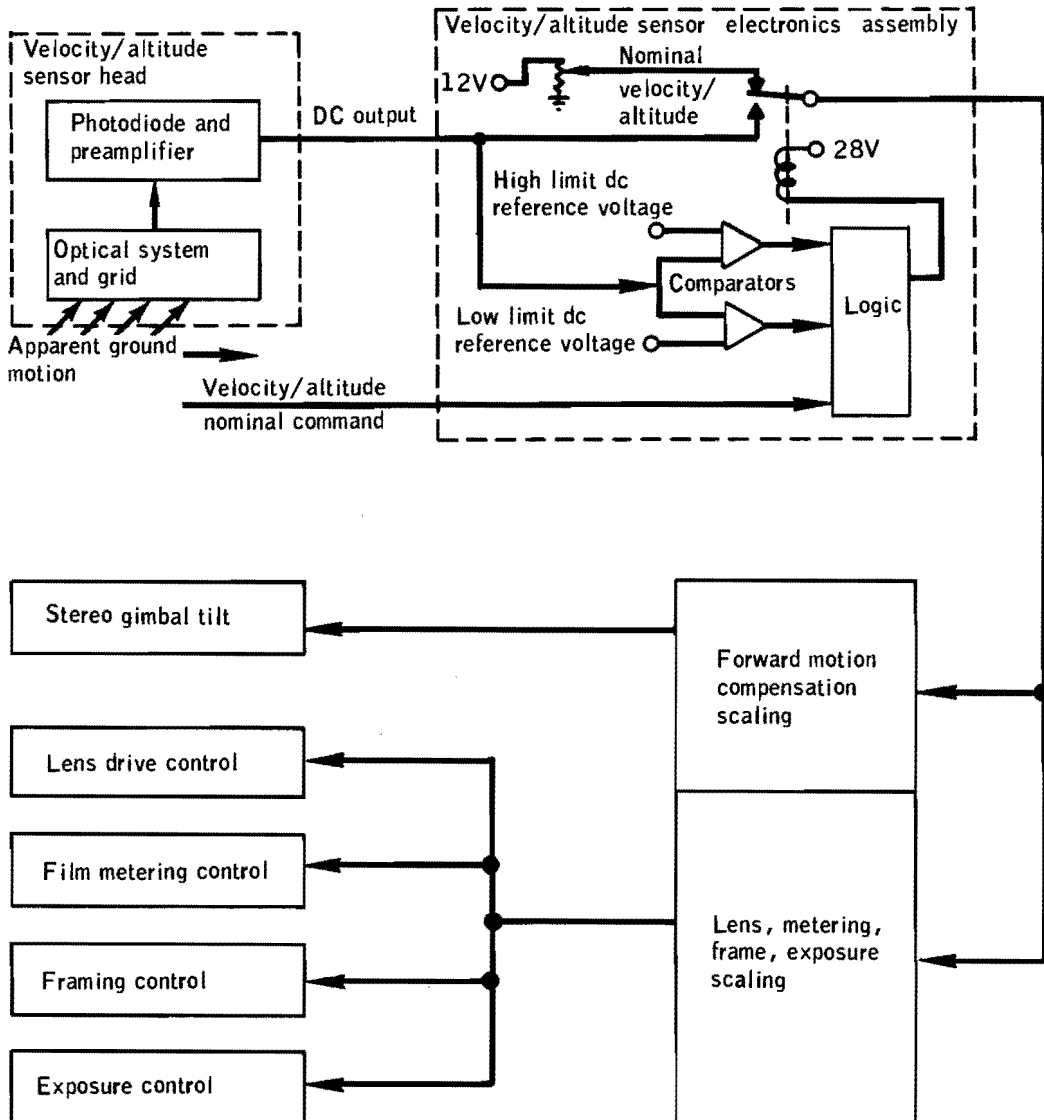
Figure 14-36.- Velocity/altitude output circuitry.

Breadboard tests and circuit analyses of the velocity/altitude electronics (fig. 14-36) did not indicate failure. Tests were conducted in which endless belts of lunar scene photography from Apollo 8 and 15 were passed in front of velocity/altitude sensors. Sensors from the prototype and qualification units, and flight unit number 1 were used. By varying the illumination level, sensor performance somewhat similar to the Apollo 15 anomaly could be obtained.

The results of the tests, coupled with analyses of the basic sensor design, indicate that the problem is related to the optical signal-to-noise ratio. The remaining flight hardware will be modified to improve this ratio. The optical signal will be enhanced by increasing the lens aperture from f/4.0 to f/3.5 and by deleting the infrared filter. The optical noise (reflections) will be reduced by increasing the length of the lens hood and by repositioning the sensor so that the camera's forward plume shield will not be in the field of view of the sensor. In addition, a manual override of the velocity/altitude sensor will be provided on the remaining flight units. By using a three-position switch, two preselected velocity/altitude ratios will be provided, as well as the automatic function.
