**APOLLO 15 MISSION REPORT**

**MANNED SPACECRAFT CENTER  
HOUSTON, TEXAS  
DECEMBER 1971**

MSC-05161

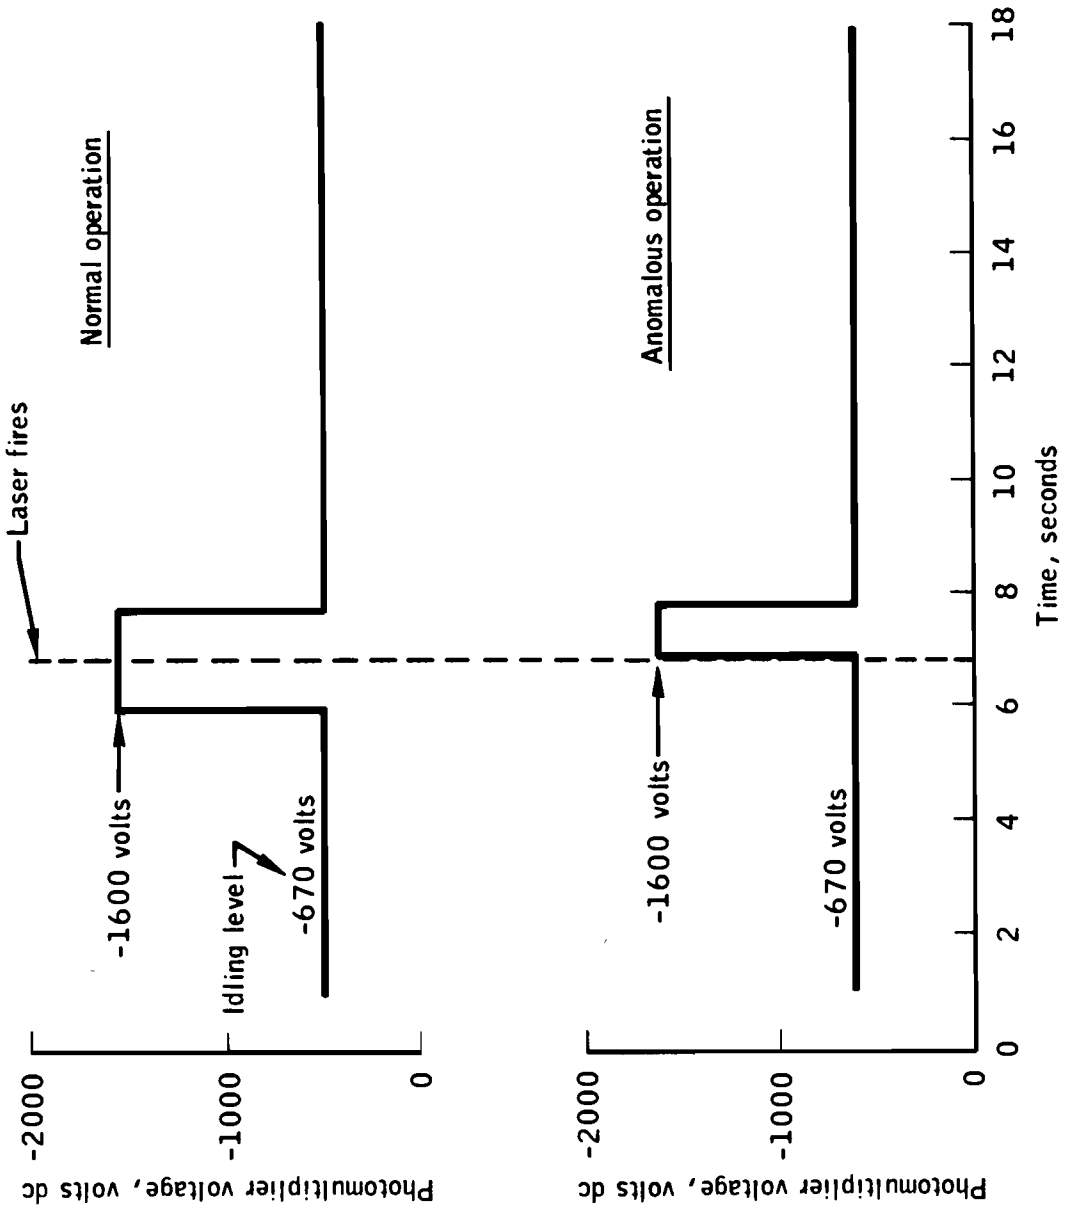
Figure 14-37.- Comparison of photomultiplier power supply voltages.

- a. Altitude data became intermittent after revolution 24 as the result of a decrease in the laser output power.
- b. Beginning with revolution 38, the photomultiplier tube high-voltage power supply was held in the idling (minimum-voltage level) mode until after the laser fired, thereby causing the receiver to miss the return pulse from the lunar surface (fig. 14-37). No altitude data were obtained after this anomaly occurred.

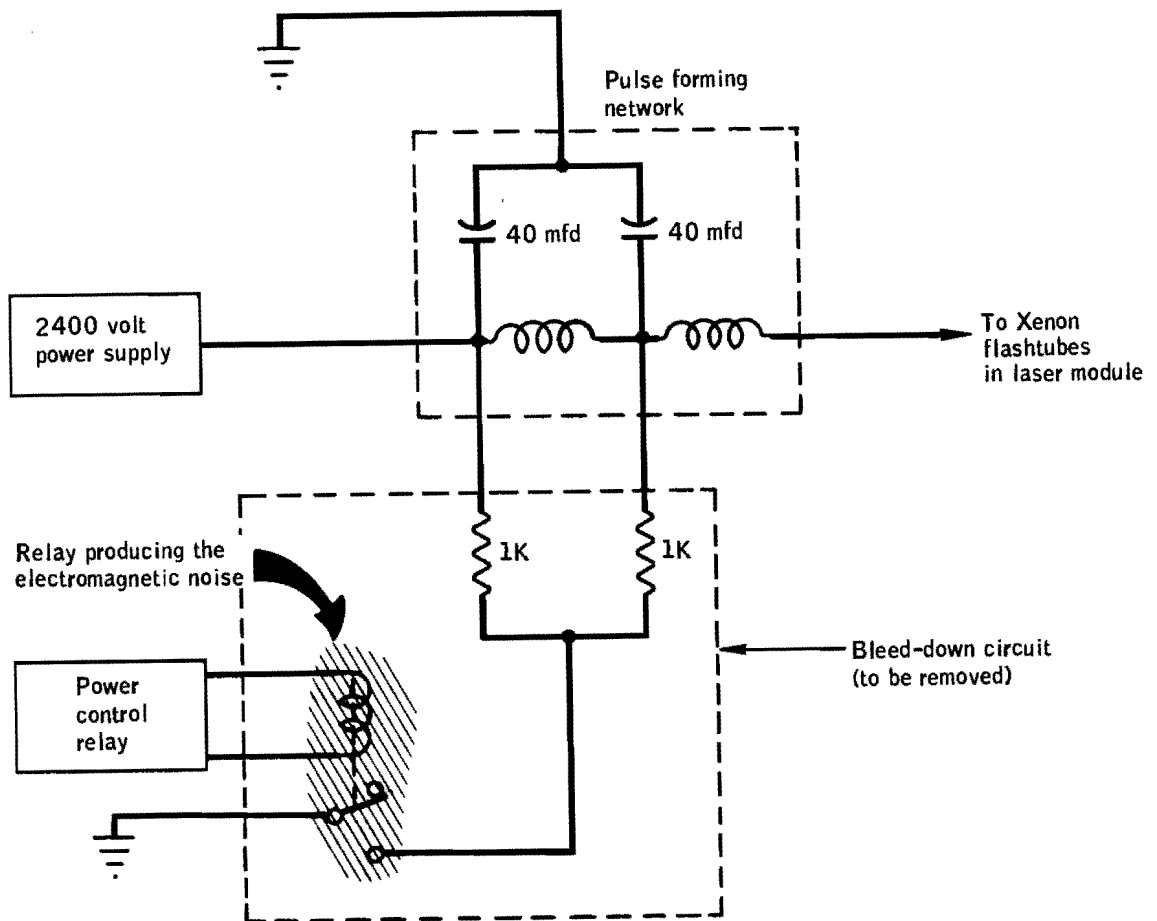
Figure 14-38.- Pulse forming network bleed-down circuit.

The photomultiplier tube power supply anomaly was duplicated when a relay which had been removed from a flight unit because it had an audible "buzz" was installed in the prototype altimeter. The relay serves no function in flight, but is a safety precaution for ground personnel working on the altimeter (fig. 14-38). The relay contacts close when the altimeter is turned off, discharging the high voltage stored in the pulse-forming network capacitors.

It is suspected that the audible "buzz" is accompanied by electromagnetic interference that is coupled into the video amplifier in the laser receiver (fig. 14-39). The video amplifier is a principal element in the automatic gain control circuit which controls the output of the photomultiplier tube power supply. The electromagnetic interference from the relay can thereby result in the automatic gain control holding the power supply in the idling mode until the pulse forming network is discharged in firing the laser. The relay and resistors that comprise the bleed-down circuit will be removed from the remaining flight altimeters.

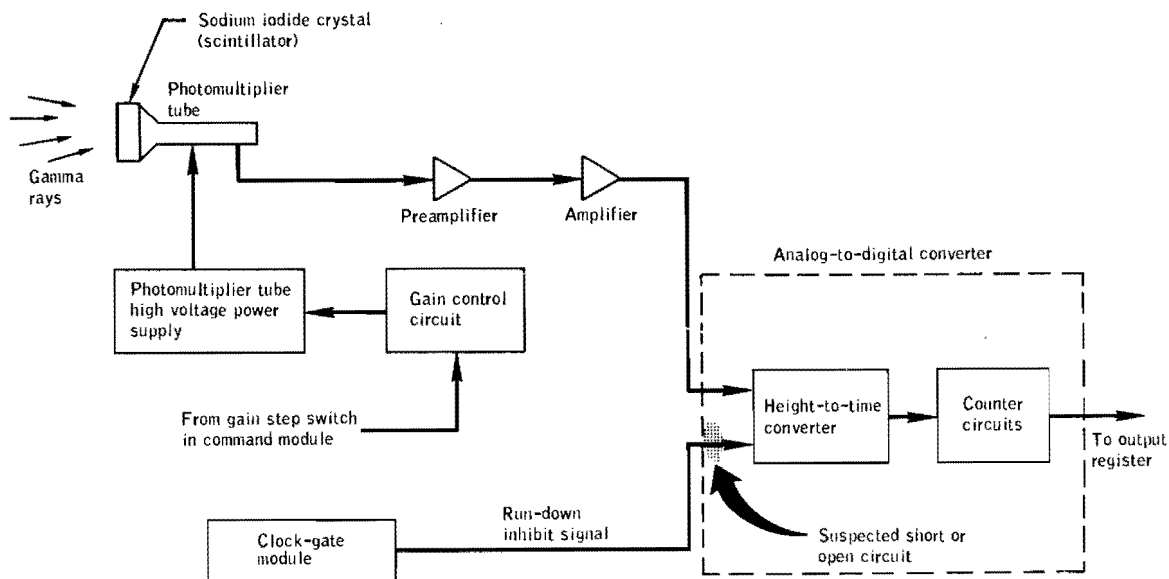
Figure 14-40.- Gamma ray spectrometer circuitry.

During the mission, the gamma ray spectrometer experienced a downward gain shift of approximately 30 percent, but this was compensated for by commanding the high-voltage step function from the command module. The drift decreased with time at an initial rate of 1 percent per hour and a final rate of 0.4 percent per day. Near the end of the mission, the gamma ray spectrometer was operating in a relatively stable state at 824.8 volts (high voltage step 6). (A step 4 voltage of 777.8 volts was the normal position in preflight operation.) The spectrometer to be flown on Apollo 16 was aged at flux rates representative of those encountered in lunar operation. The unit has stabilized after having experienced a gain change of approximately 8 percent.

After transearth injection, a temporary eight-channel zero reference shift was observed. This shift disappeared when the instrument was re-powered after the transearth extravehicular activity, and subsequent instrument operation was normal for about 25 hours during transearth coast. Shortly before entry, the offset shift reappeared and remained until the experiment was turned off. Normalization of the data during processing will compensate for this offset.

Tests conducted with the qualification unit verified that the change in gain was due to aging effects of the photomultiplier tube in the gamma ray detector assembly as a result of high cosmic ray flux rates in lunar operation. The zero shift appears to be associated with the run-down inhibit signal between the clock-gate module and the analog-to-digital converter (fig. 14-40). Absence of this signal at a particular point in the analog-to-digital converter removes a 3-microsecond offset in the pulse height analyzer. The resulting effect is an overall eight-channel offset in the spectrum. The qualification unit was partially disassembled and tests showed that either an open or a shorted wire within the pulse height analyzer can result in an eight-channel offset. An inspection of the circuit in the qualification unit disclosed no design deficiency which would cause this type of failure. Since the eight channel zero offset does not significantly impact overall data quality, no corrective action is contemplated.

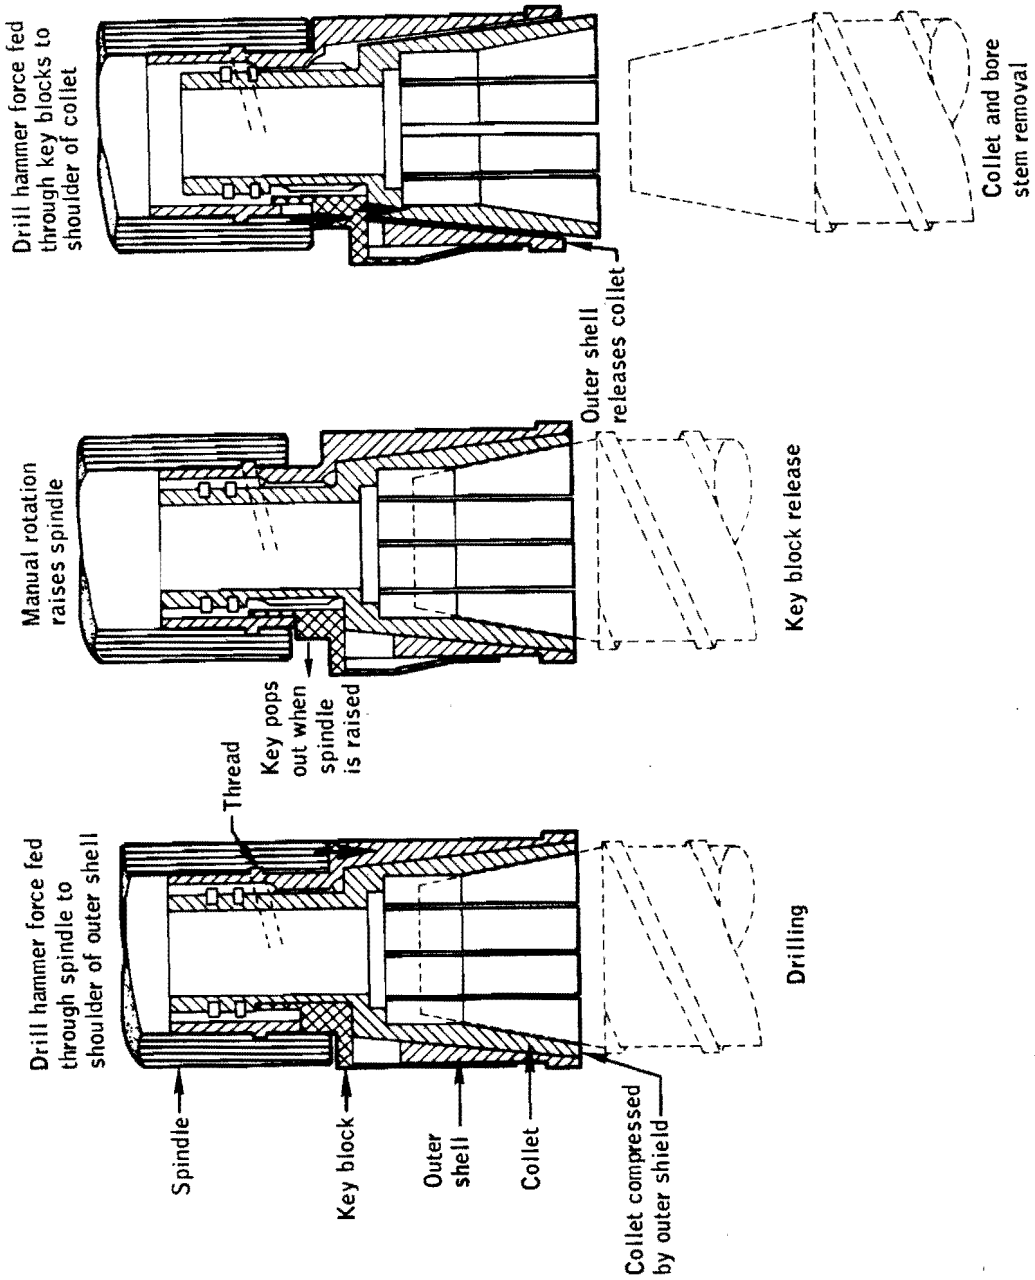
Figure 14-42.-- Release of bore stem from drill.

In the bore stem drilling position, the key blocks are restrained inside, and the spindle drives against the shoulder of the adapter outer shell (fig. 14-42). The operational sequence to release the bore stem from the adapter includes the following steps:

In development ground tests, the soil friction usually kept the bore stem from turning in this operation. When there was insufficient friction from the soil, the bore stem was grasped with the gloved hand. On Apollo 15, the soil did not hold the bore stem, and the core-stem wrench was used to hold the bore stems for this operation.

The single-purpose core stem wrench is fitted to the 0.983-inch-diameter titanium core stem, but the 1.088-inch throat will admit the 1.075-inch-diameter bore stem. The softer bore stem (boron-fiberglass laminate) can be deformed and present some difficulty in wrench removal, with possible damage to the bore stem. A wrench to fit both bore and core stems will be provided.

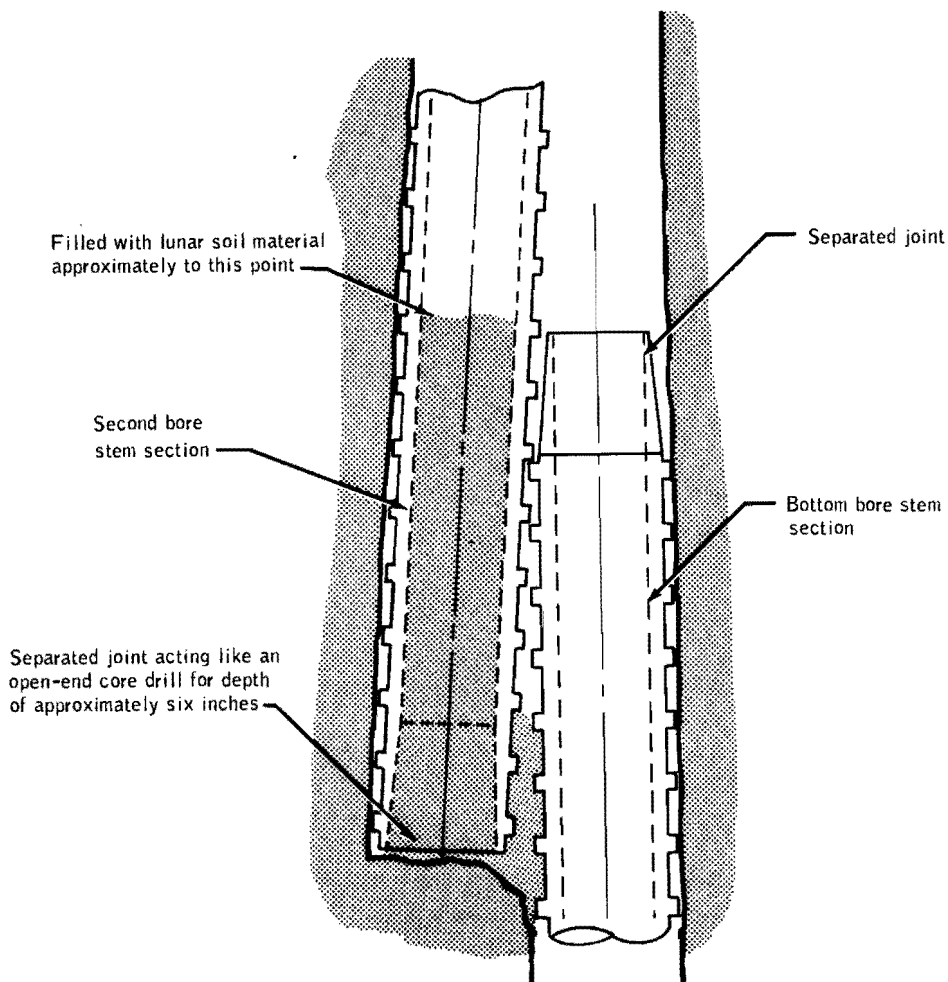
Figure 14-43.- Bore stem joint separation.

14.4.1.3 Bore stem damage near first joint.- The probe would not go to the bottom plug of the bottom bore stem in hole 2, but stopped at a point about 6 inches above the first joint. Examination of photographs and heat flow probe data indicate that, near the end of the bore stem drilling operation, the first joint was separated when the drill and drill string were moved vertically (up and down) in an attempt to improve the drill penetration rate. Easier penetration (for approximately 6 inches) was reported by the crew, but it resulted from the bottom of the second section apparently performing more in a coring manner (fig. 14-43) with the lunar soil entering the second section of the bore stem.

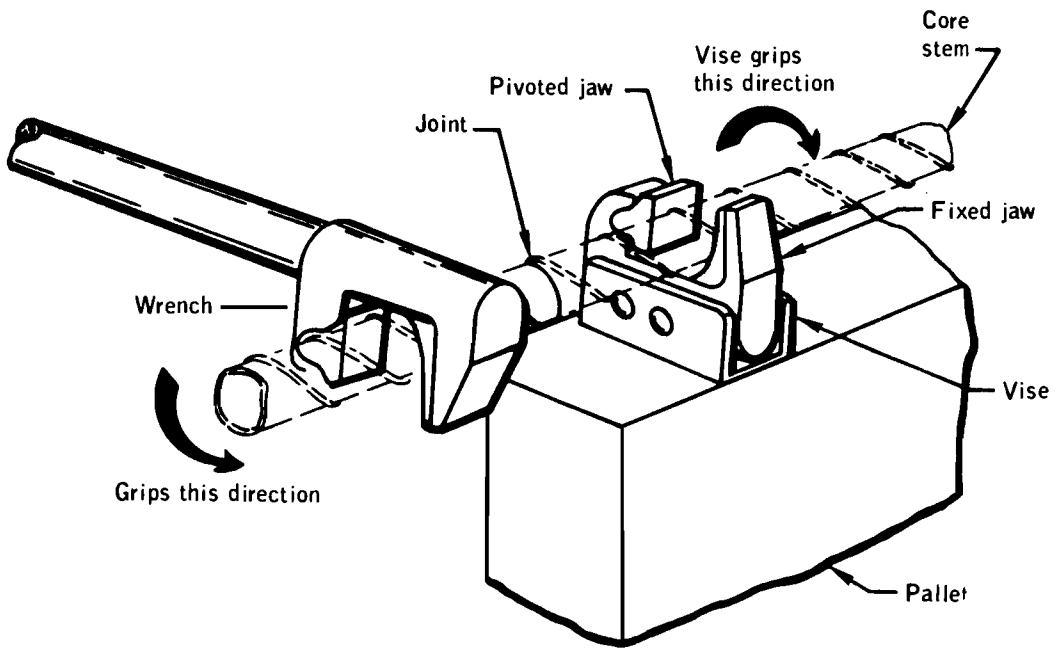
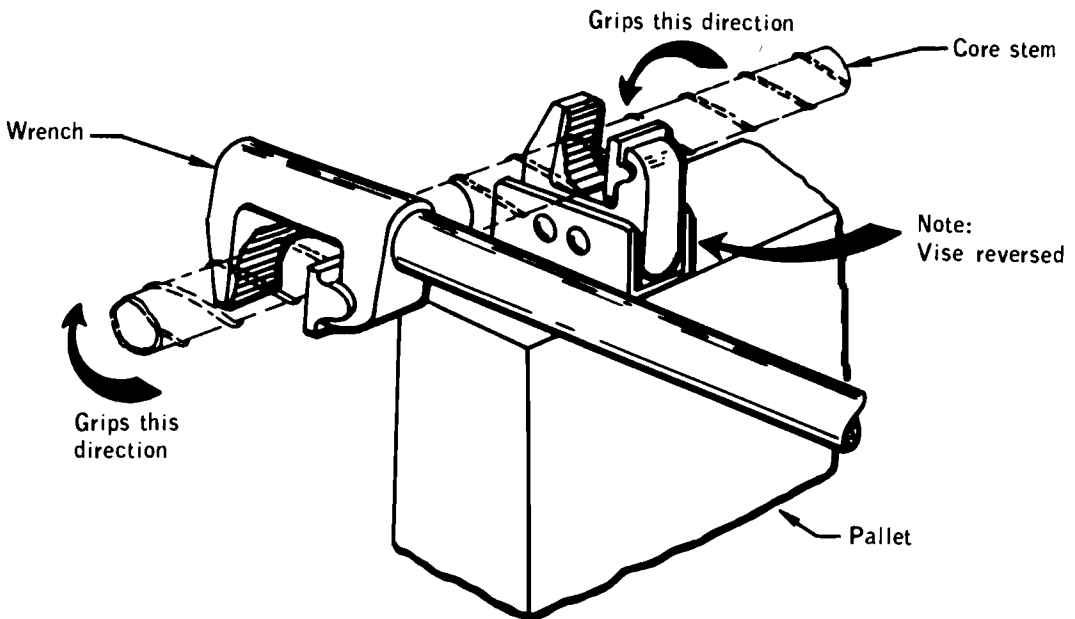
Figure 14-44.- Installation of core stem vise on rover pallet.

As mounted, the vise would hold the core stem so that the joint could be tightened by rotating the wrench on the adjoining section. However, the vise would not hold in the opposite direction so that the joint could be loosened and separated (fig. 14-44). Working on the inboard side of the vise, the core stem could have been held properly for loosening; however, there is insufficient clearance on the inboard side of the vise for wrench rotation, and the distance to the other side of the lunar roving vehicle is greater than the length of a core stem section.

The installation drawing of the vise was in error and has been corrected to assure correct orientation of the vise for Apollo 16. The training vise was installed backward from the erroneous drawing, but correct for loosening the stems.

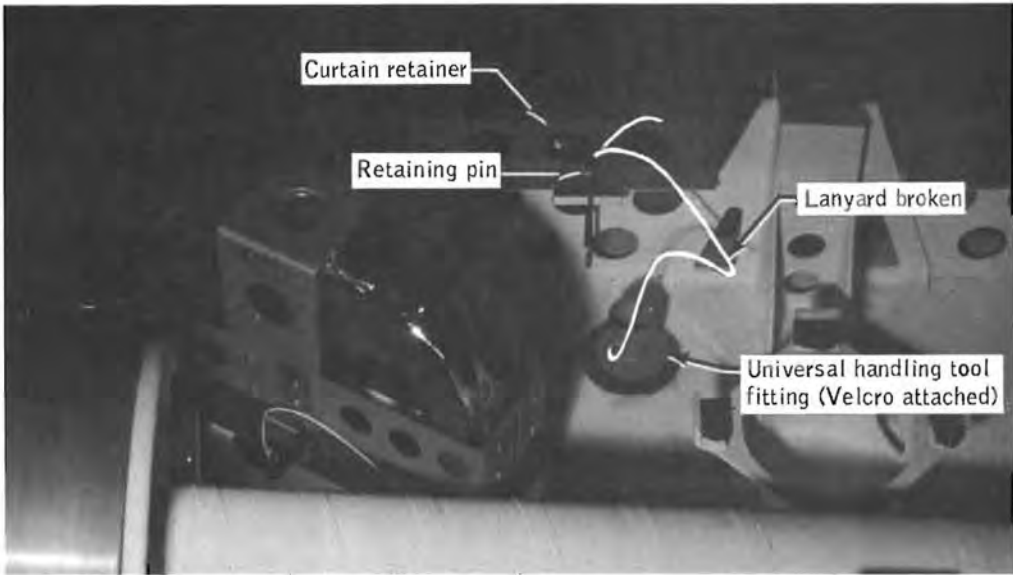
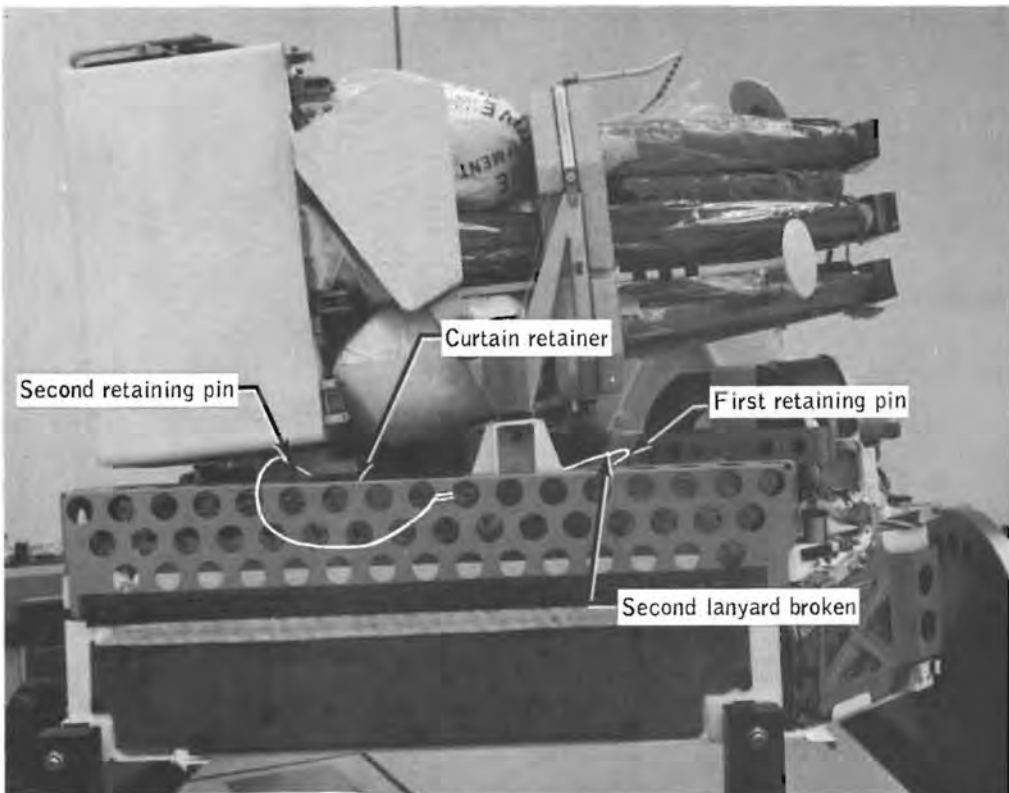
Figure 14-45.- Central station rear curtain retainer removal.

To remove the retainer for the central station rear curtain, added for Apollo 15, it was necessary to remove two retaining pins (fig. 14-45). The two pins, a universal handling tool fitting, and the curtain retainer are joined by a three-section lanyard. When the universal handling tool was inserted in the fitting and raised to remove the first pin, that section of the lanyard broke. When an effort was made to remove both pins simultaneously by inserting the handle under the lanyard joining the two pins, that part of the lanyard broke. The pins and retainer were then removed by hand.

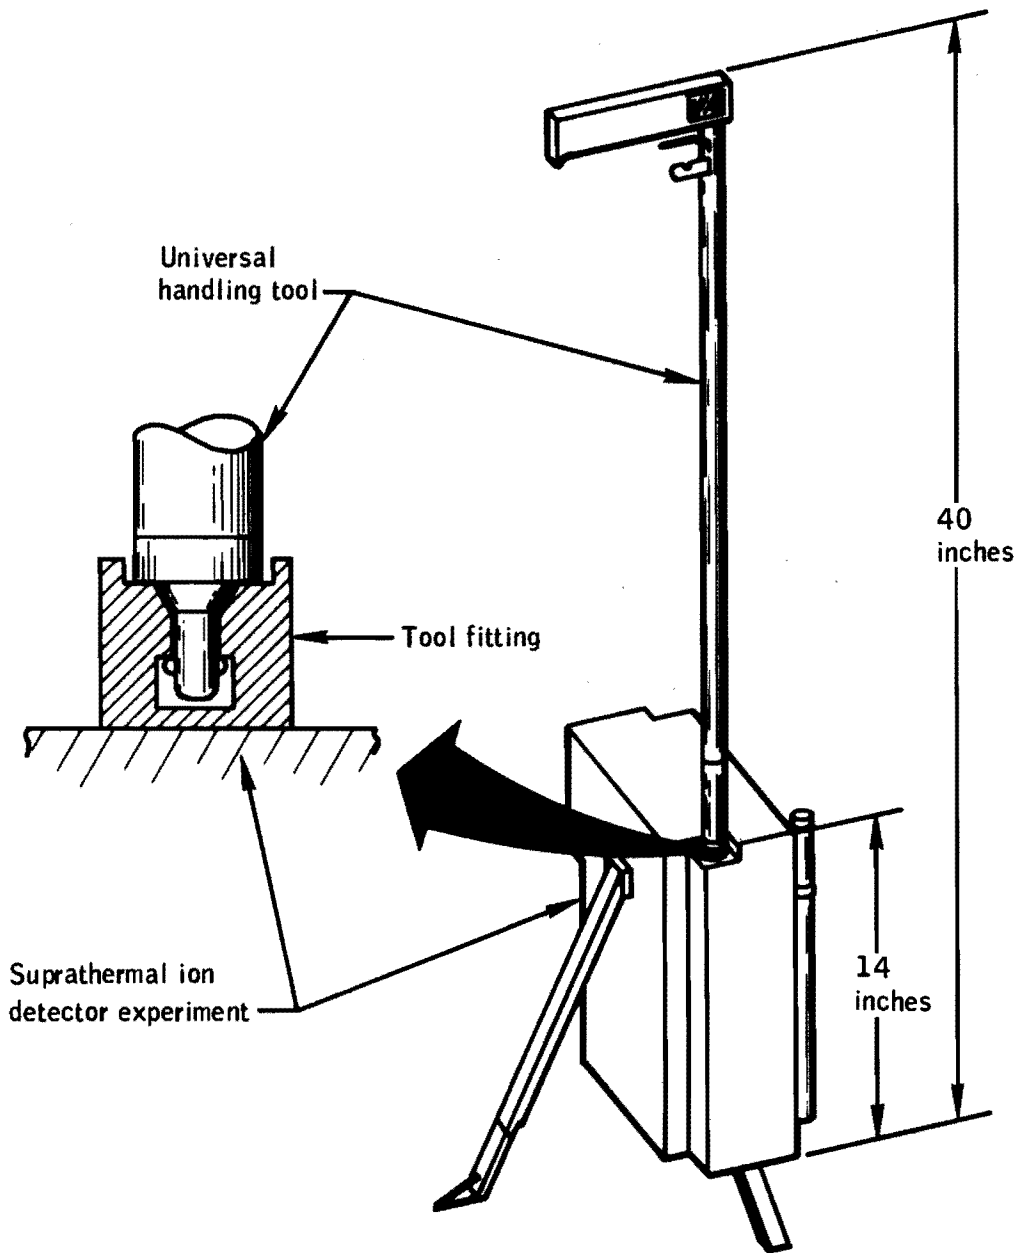
Figure 14-46.- Universal handling tool - suprathreshold ion detector experiment interface.

While carrying the suprathermal ion detector experiment from the sub-pallet to the emplacement site, the experiment fell off the universal handling tool at least twice. The experiment sustained no visible damage and has been operating satisfactorily.

The universal handling tool fitting on this experiment is in the highest location above the lunar surface of any of the fittings and presents an awkward position of the tool for insertion, locking, and maintaining lock in the fitting (fig. 14-46).

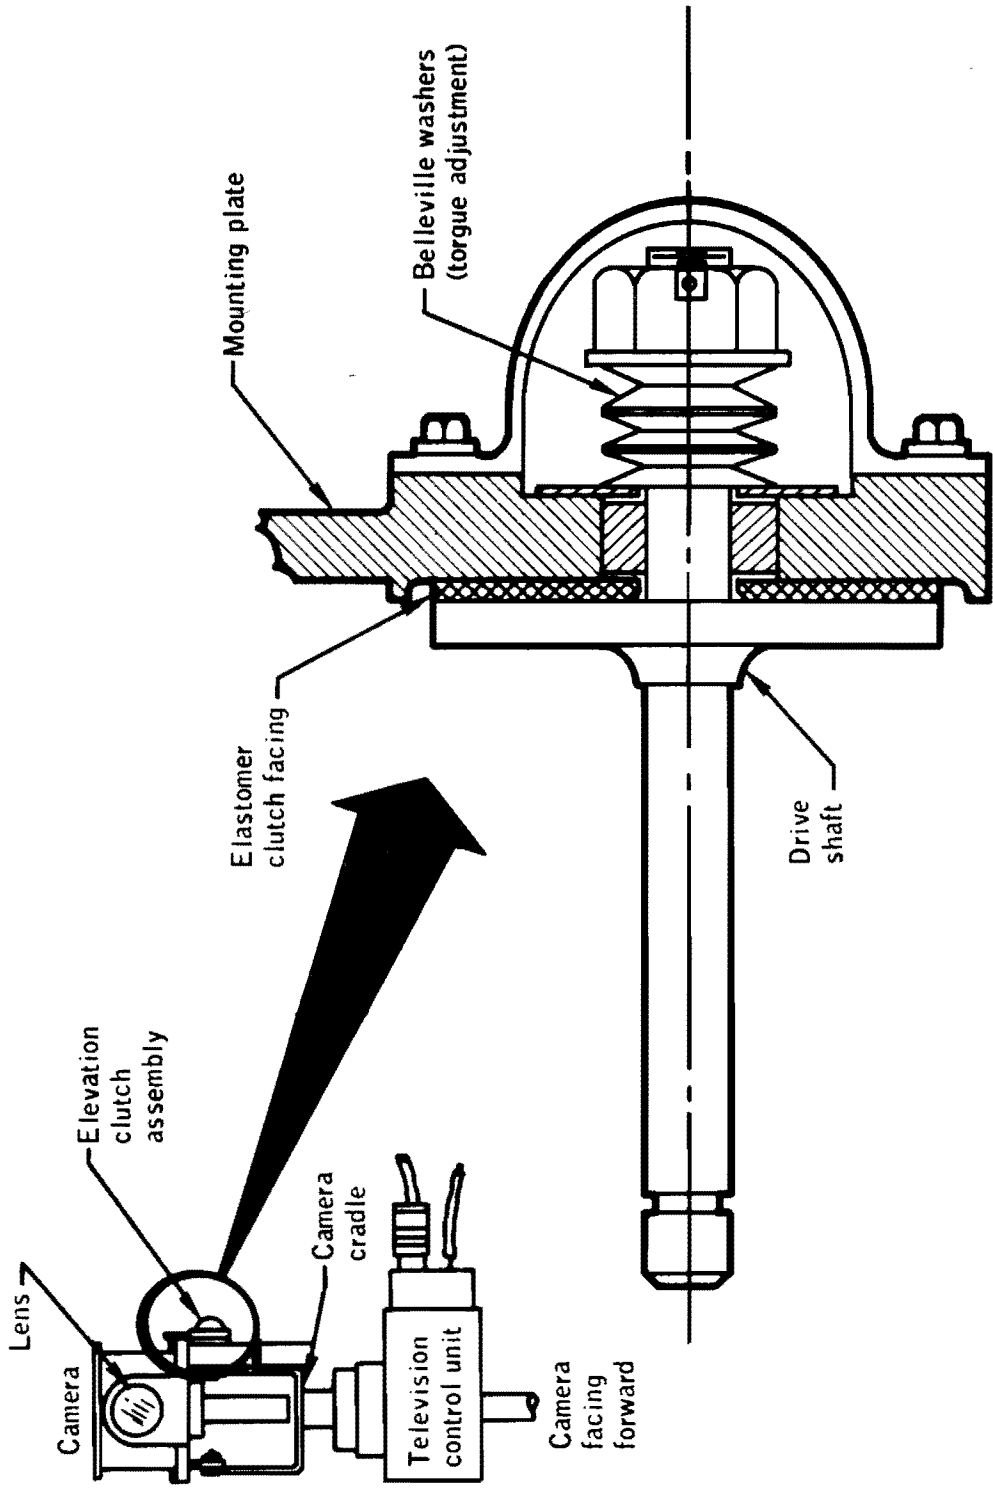
Figure 14-47.- Camera elevation control clutch.

Elevation control is provided to the camera cradle through a friction clutch (fig. 14-47) which allows manual override of the ground-commanded camera positioning. The camera-cradle pivot point is approximately 3 inches below the center of gravity of the cradle with the camera mounted. As the camera moves away from the horizontal position, the unbalanced moment becomes progressively greater, and a higher torque load must be supported by the clutch mechanism.

The elastomer clutch-facing material provided the required stable friction properties in the specification and qualification test temperature range (122° F, maximum). However, the maximum temperature on the television control unit during the third extravehicular activity has been calculated as approximately 180° F. Materials specifications show that the compressive strength of the elastomer degrades rapidly at this temperature, and ground tests with flight unit 4 verify severely degraded performance with time at elevated temperature.

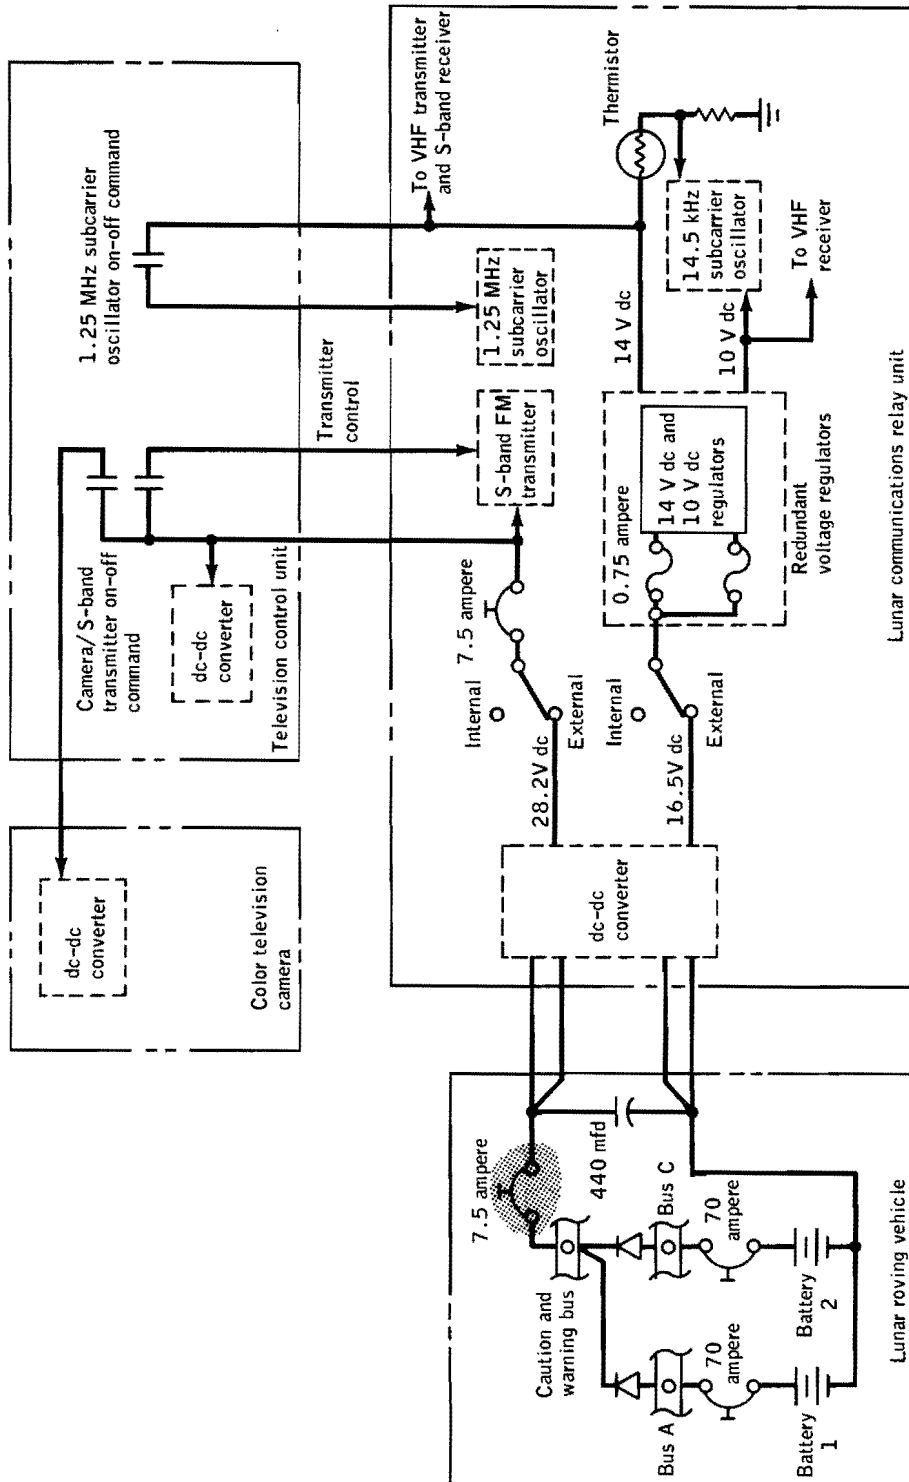
Figure 14-48.- Lunar roving vehicle/lunar communications relay unit/ground controlled television assembly power distribution.

In laboratory tests, the fault which duplicated the flight data was the opening of the lunar roving vehicle power line prior to the 440-microfarad capacitor (figs. 14-48 and 14-49). The tests show that the decay time of the lunar communications relay unit 28-volt and 14-volt power is increased by discharging the 440-microfarad capacitor. Other induced faults resulted in shorter power decay times, affecting the received signal accordingly. The temperature measurement output (see thermistor in fig. 14-48) is proportional to the decay in 14-volt power. Consequently, the 6-percent decay of the flight temperature measurement corresponds to a 1.4-volt decay. This characteristic was duplicated when the lunar roving vehicle power line was opened. The 28-volt power decayed to 21.8 volts dc as the 14-volt power decayed to 12.6 volts. The RF transmitter power at this voltage will be decreased by 6.4 dB, and accounts for the total signal loss at this time since the ground receiver would be below its operating threshold.

The lunar roving vehicle power line has a 7.5-ampere circuit breaker forward of the 440-microfarad capacitor (fig. 14-48). Testing a 7.5-ampere circuit breaker under elevated temperatures (180° F) and at vacuum conditions showed that the current capacity is also dependent on the connecting wire size because the wire provides a heat sink to the circuit breaker thermal element. The rover 7.5-ampere breaker used 20-gage connecting wire. Test results show that the breaker, with 20-gage connecting wire, at elevated temperatures and under vacuum conditions, will trip at 3.3 amperes. This corresponds to the calculated lunar communication relay unit load at the time of power failure.

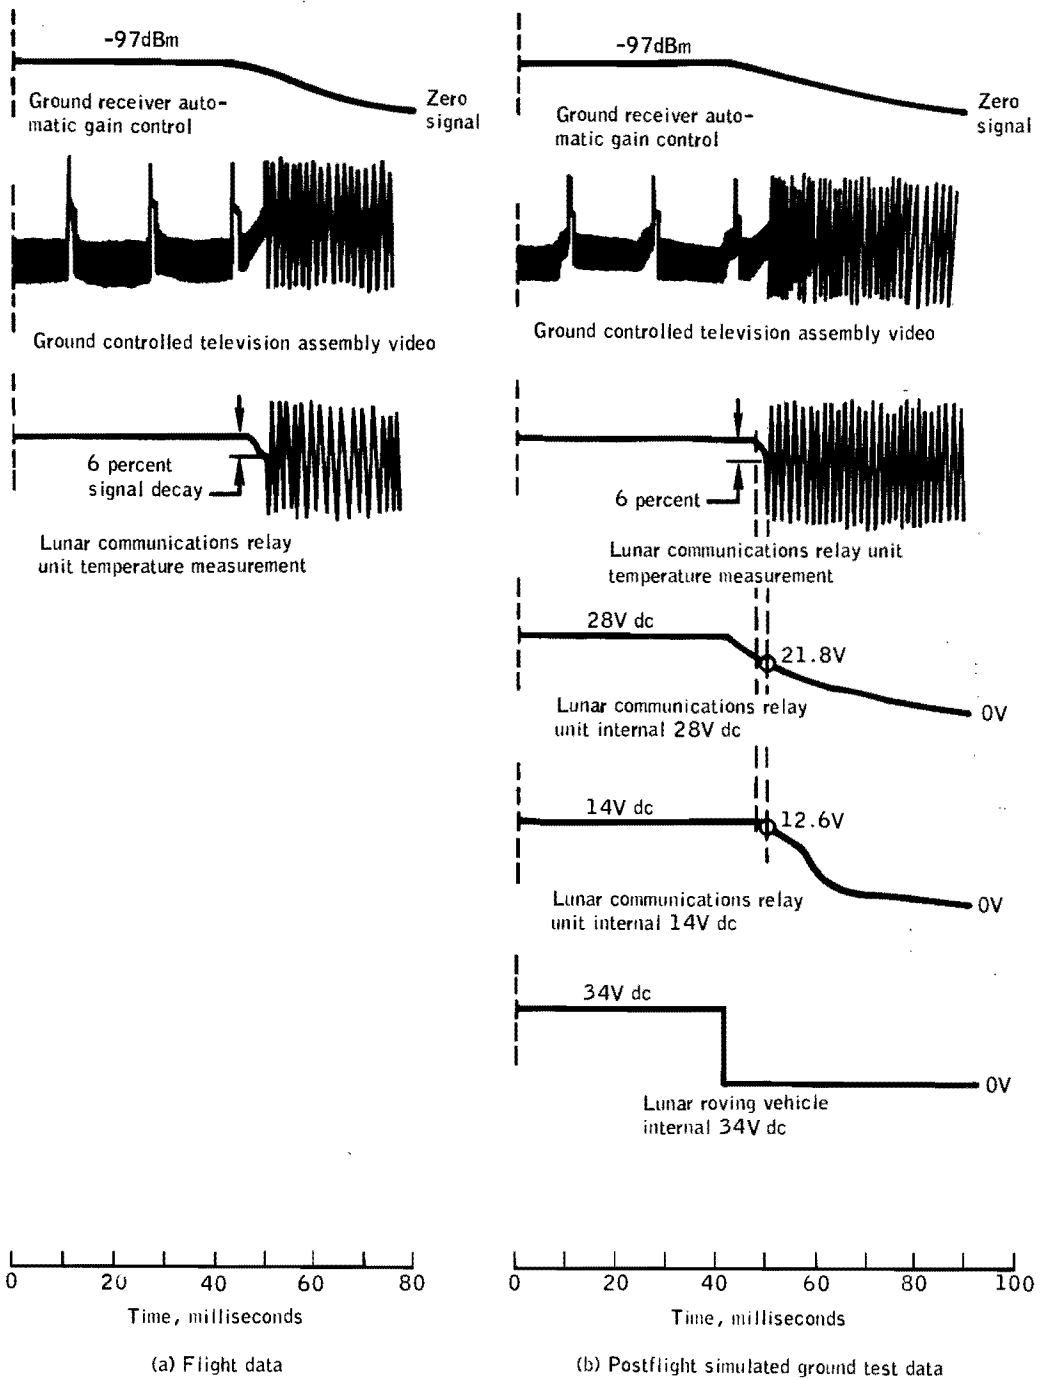
Figure 14-49.- Comparison of signal deterioration characteristics.

The flight data (fig. 14-49) shows that the automatic gain control measurement began to fall followed by the video signal decay. This was followed by the decay of the lunar communications relay unit temperature measurement. The RF signal level then decreased below the ground receiver's threshold as indicated by complete signal loss. The overall loss of the downlink signal within 5 milliseconds is indicative of 28-volt d-c power loss. Decay of the temperature measurement is indicative of 16.5-volt d-c power loss. The lunar communications relay unit dc-to-dc converter (fig. 14-48) supplies both the 28-volt and 16.5-volt d-c power. To verify loss of 16.5-volt power, an uplink voice signal was transmitted to key the VHF transmitter on. No signal was received on the Stanford

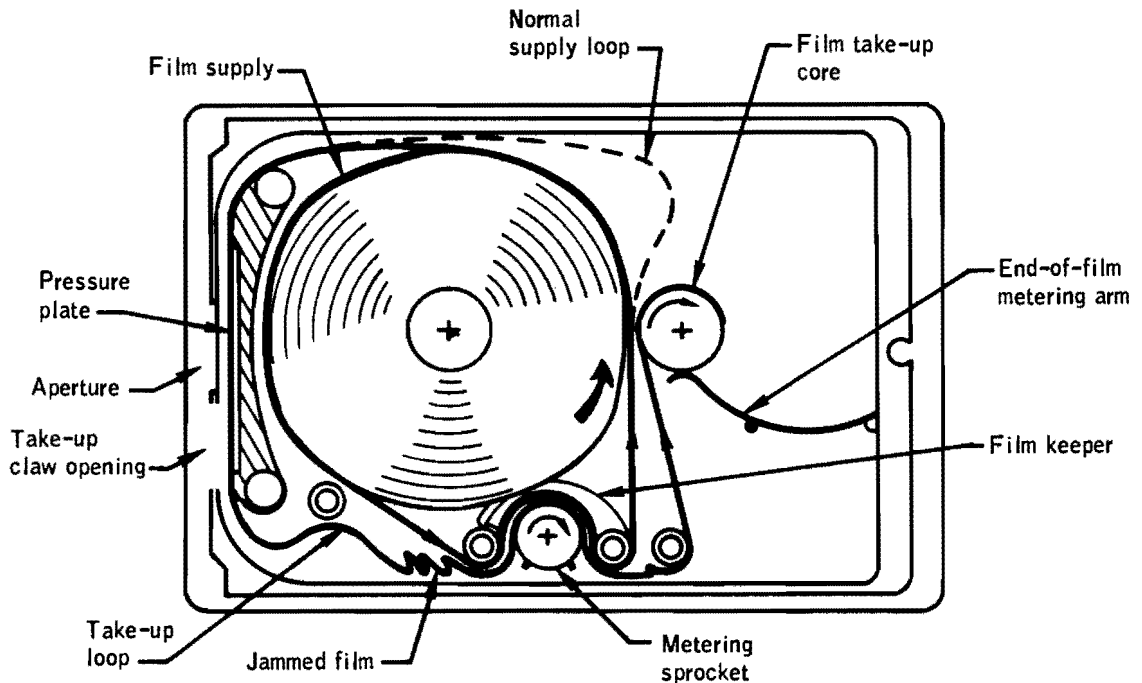
Figure 14-50.- Lunar surface 16mm camera magazine.

a. The first magazine used had drive-spline damage and scratches on the front face, indicating that the installation in the camera was improper and that the magazine and camera were misaligned. Misalignment of the floating female spline of the camera with the male spline of the magazine caused metal to be removed from the brass male spline. In normal camera operation, the take-up claw advances one frame of film for each exposure while the metering sprocket replenishes the supply loop and removes a frame from the take-up loop, thus retaining the same amount of slack film in both loops. When the metering sprocket is not driven because of mismatching, the camera claw removes film from the supply loop, which is not being replenished, and adds it to the take-up loop, resulting in the jammed condition shown in figure 14-50. Two other magazines had damaged drive

splines, indicating that mismatching occurred on at least three occasions. Lunar surface pictures which include the 16-mm camera show that a strip of tape that is installed for latch stowage protection was not removed prior to installation of a magazine. Leaving the tape strip in place could have contributed to the camera/magazine mismatching.

b. During troubleshooting between extravehicular activities, the crew manually advanced the film through the aperture in all remaining magazines. The amount of manual advancement varied from five to twenty-one frames in the jammed magazines. The film supply loop (fig. 14-50) normally contains three to five excess frames. The normal procedure is to inspect the magazine for proper frame alignment in the aperture area, and manually advance the film not more than one frame, if required to obtain proper alignment. The excessive manual advancement depleted the film supply loops in all magazines.

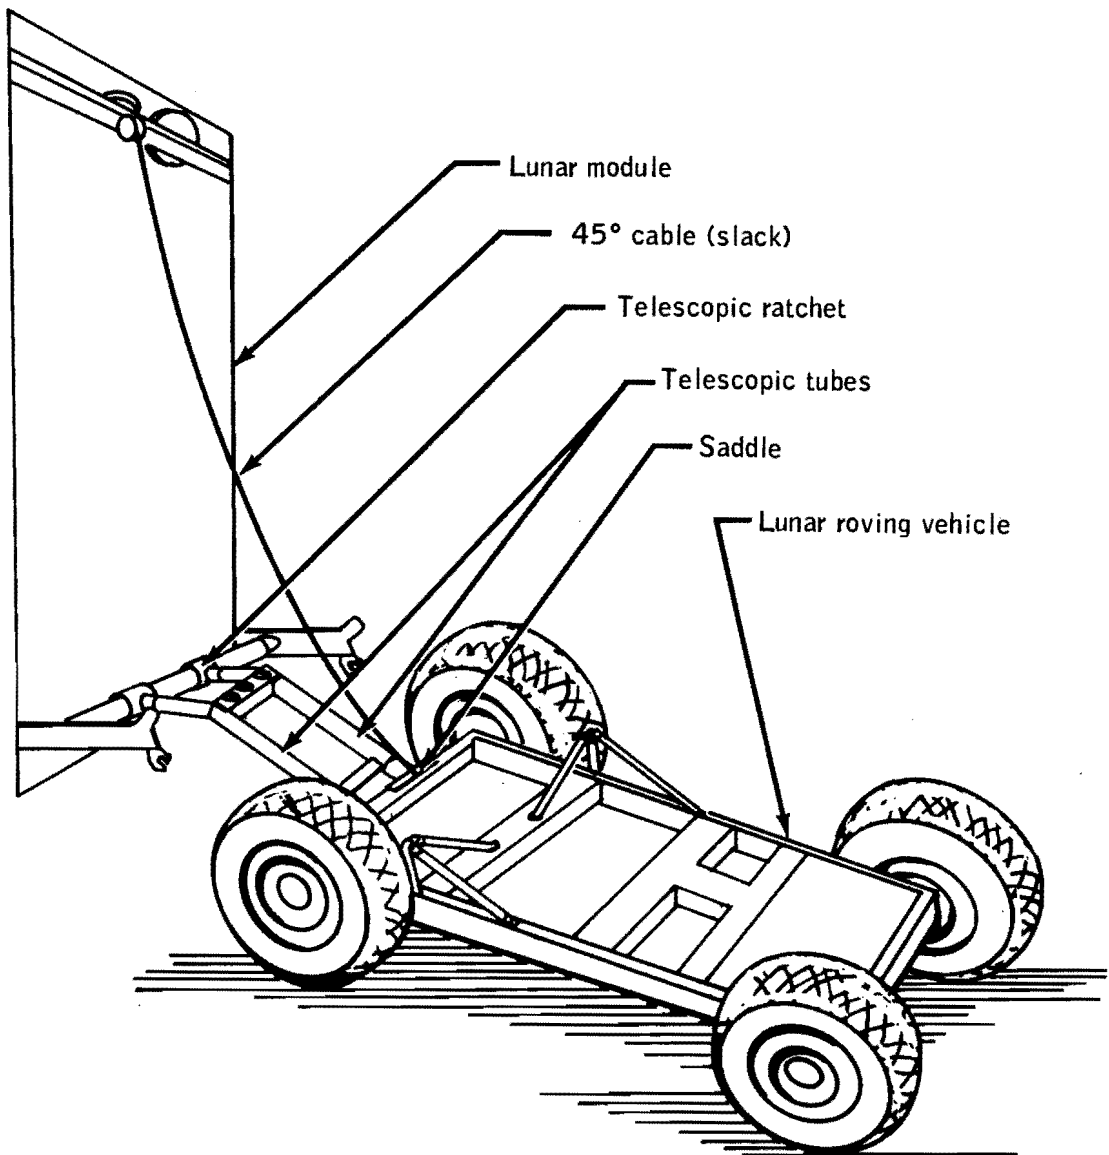
Figure 14-55.- Lunar roving vehicle deployment.

Ground tests have shown that if the partially deployed lunar roving vehicle resting on the surface but not yet detached from the saddle (figure 14-55) and lunar module, is rolled either to the left or right, the saddle/rover chassis interface will bind. The interface can be released, and the saddle dropped to the ground by one crewman adjusting the roll back to zero while the other taps the saddle with a hand tool. The corrective action is to insure adequate crew training.
