MISHAPS WITH OXYGEN IN NASA OPERATIONS

by Paul M. Ordin
Lewis Research Center
Cleveland, Ohio

TECHNICAL PAPER proposed for presentation at
Oxygen Compressors and Pumps Symposium
sponsored by the Compressed Gas Association
Atlanta, Georgia, November 9-11, 1971

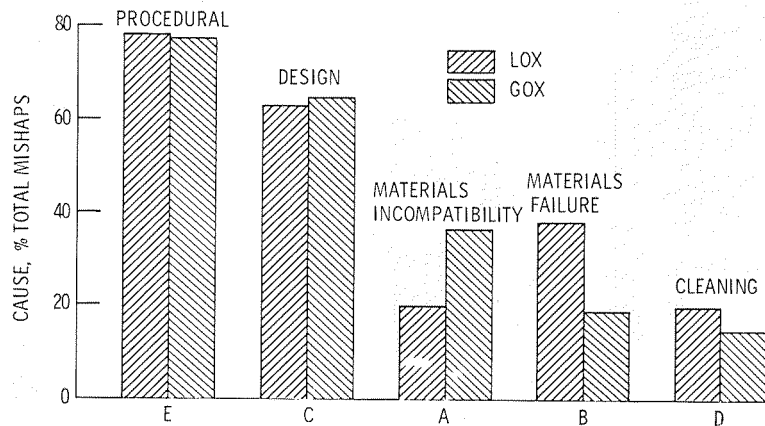
Figure 3 shows the comparison of the number of mishap causes for the liquid and gaseous oxygen. Note the substantial increase in gaseous oxygen mishaps due to material incompatibility. With respect to possible reactions between the materials and oxygen, we should expect a greater number of mishaps with gaseous oxygen since a small volume of gas is generally a prerequisite to the ignition of the material. The thermal mechanism of ignition assumes hot spots could not occur without the presence of the gaseous phase at the spot. The large heat sink provided by LOX contact precludes hot spots on immersed materials unless the heat source is strong and is abetted by concurrent chemical reactions between LOX and the material being heated. The liquid, therefore, would have a reduced effect on initiating any reaction of the materials with oxygen until sufficient heat was transferred to form the gaseous state. Adiabatic compression as a means of producing high temperature for ignition of the materials also becomes inefficient at cryogenic temperatures. The theoretical temperature due to adiabatic compression can be calculated from the values of final and initial pressure and the ratio of specific heats (1.4 for oxygen). A pressure ratio of about 47,

Figure 3. - Comparison of cause factors for liquid and gaseous oxygen.

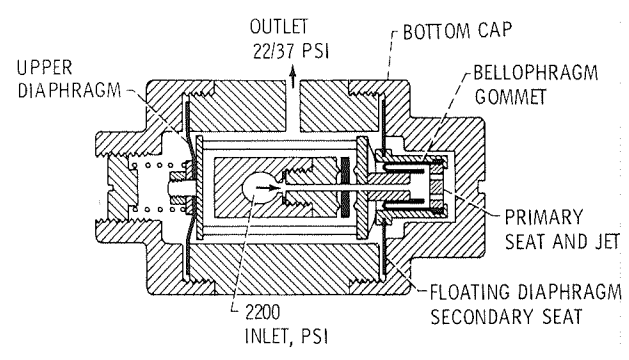
equipment for launch facility operations. The probable source of the fire was the regulator primary seat made of nylon. Ignition was most likely promoted by small metal particles which were found in the system. A schematic diagram of the resuscitator regulator is shown in Figure 5 and a photograph of the ruptured safety valve in Figure 6. A view into the regulator body illustrating the burned portions is shown in Figure 7.

Figure 5. - Cutaway sketch of the resuscitator regulator illustrating the functioning position of various components

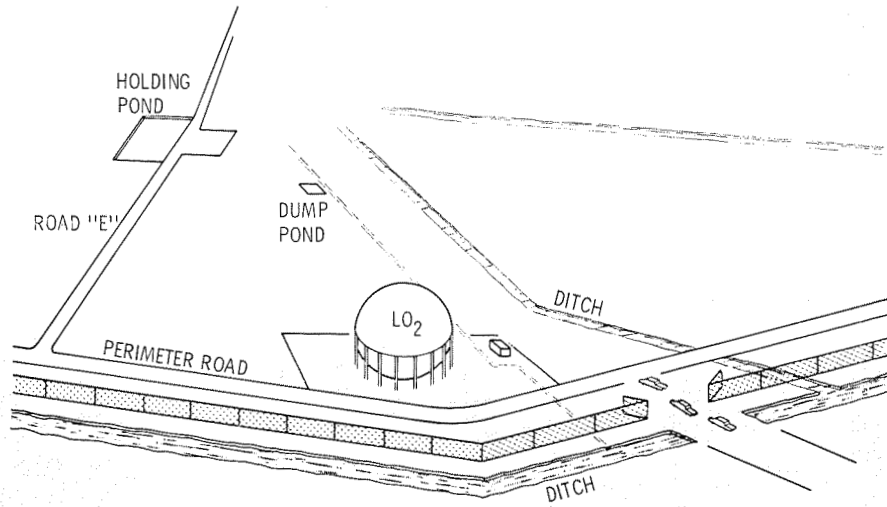
During launch pad clearing operations, three security cars were driven into an oxygen enriched area, the guards parked their cars, shut the engines, and got out for an inspection of the area. The LOX which was being dumped as part of normal operations vaporized and created an oxygen cloud which drifted into the path of the cars causing severe fire damage to the three vehicles. Prior to and during LOX pump operations for loading the Apollo Saturn vehicle, the LOX used in the storage area piping chilldown is normally drained into a ditch beyond a perimeter fence. Location of the LOX storage tank, three parked cars and drainage ditch is shown schematically in Figure 8. The drainage ditch approximately 40 ft. wide and 5 ft. deep is located about 227 ft. from the liquid oxygen storage tank.

Figure 8. - Storage and drainage ditch area.

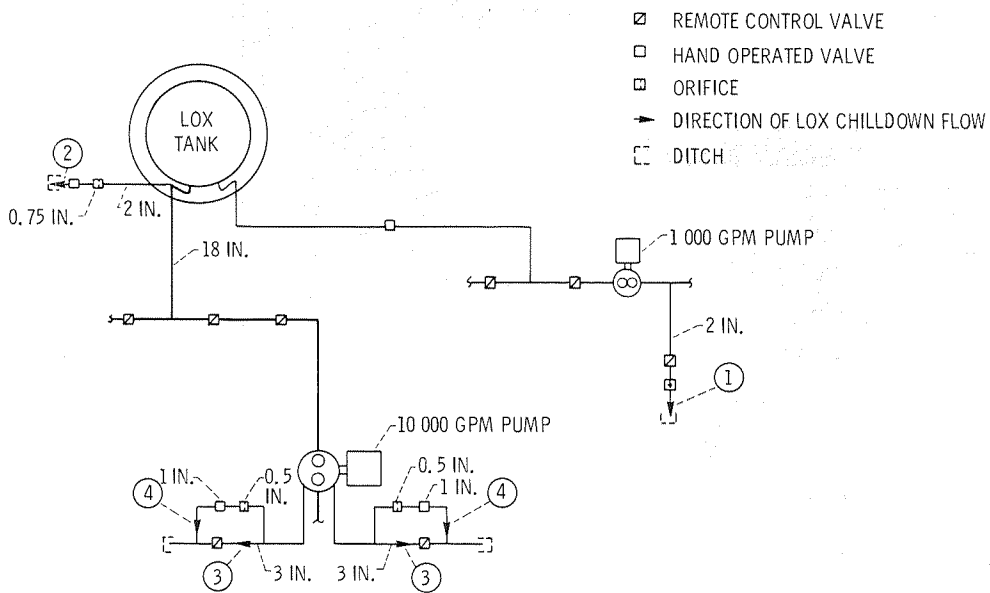
A schematic showing the LOX chilldown outlets to the ditch is shown in Figure 9. Outlet number 1 used to chilldown the 1000 gpm pump was opened for 40 minutes and dumped 8000 gallons into the ditch. Outlet number 2 used to chilldown the 18" tee at the suction inlet of the 10,000 gpm, dumped a total flow of 2250 gals. Outlet number 3, used to chilldown the 10,000 gpm, and outlet number 4, opened after the three minute drain of outlet 3, passed a total of 860 gallons into the drainage ditch. The quantity of LOX dumped into the ditch was about

Figure 9. - LOX system schematic showing LOX chilldown outlets to ditch.

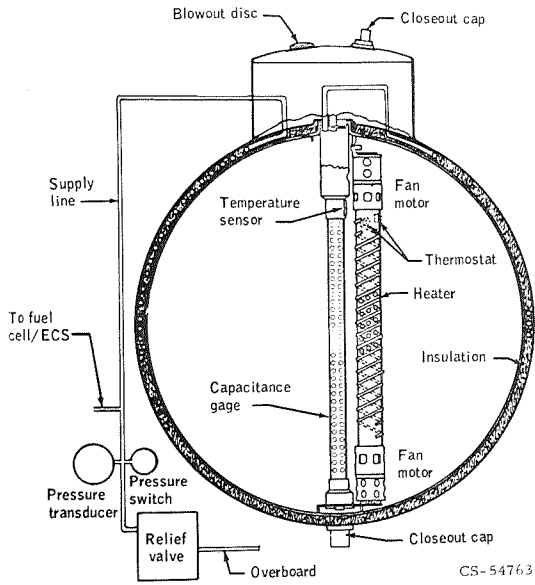
The oxygen and hydrogen tanks and fuel cells are located within the service module of the spacecraft. The arrangements of the equipment are shown in Figure 15. The internal components in the oxygen tank are shown in Figure 16. Two heaters in each tank supply the heat necessary to maintain the design pressure in the oxygen tank. Fans circulate the oxygen over the heating elements to reduce any stratification present in the supercritical oxygen.

Figure 16. - Oxygen tank no. 2 internal components.

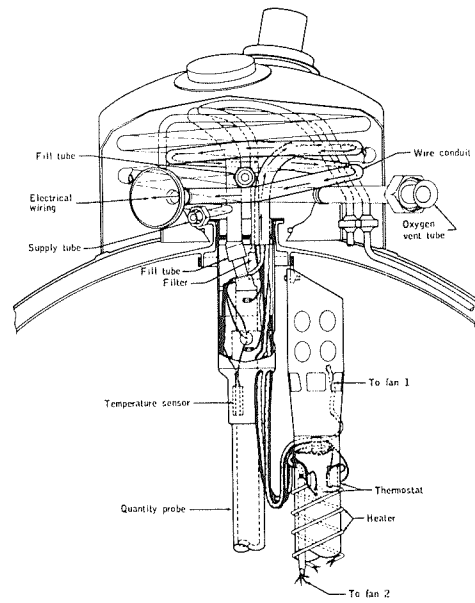
The wiring conduit which contained the power leads for the fan motors and heaters and the instrument leads are fed through the vacuum shell in a hermetic seal which are then passed into the oxygen vessel through about 1/2 inch diameter tubing. Figures 17 and 18 show the oxygen tank wiring and lines. The 1/2 inch diameter tubing containing the wiring was formed into a 10 inch coil with about 3 turns. The interior of the conduit is open to the pressurized oxygen to the point of the hermetic seals.

Figure 17. - Oxygen tank wiring and lines.

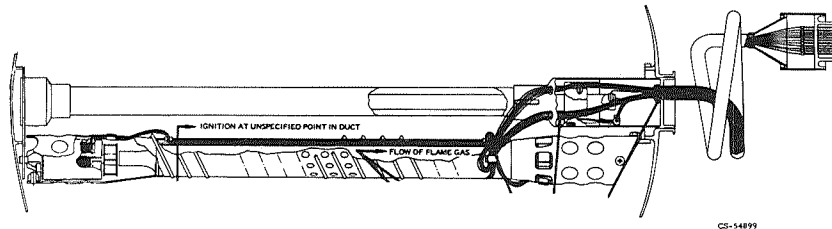
The insulation on the power wires may have become abraded due to vibration of the conduit and the rubbing of the wires against each other. The method of assembling leads into the conduit may have introduced strains into the wires causing increased insulation wear. These conditions could then lead to situations where sufficient energy, produced by shorting power leads, could ignite the surrounding Teflon. Most probably, the Teflon insulation fire progressed into the electrical conduit tubing at the top of the tank, opening the tank to the service bay. With the burn-through of the conduit, the pressure increased in the bay resulting in separation of the panel which enclosed the bay. The panel separation from the bay probably caused sufficient shock to close the oxygen supply valves. In all likelihood, the oxygen system (in tank 1) developed a leak either as a result of the shock when the panel separated or from the dynamics of the events associated with the failure of the tank 2 electrical conduit. A photograph of the oxygen tank in the service module bay is shown in Figure 19.

Figure 18. - Wiring in oxygen tank.

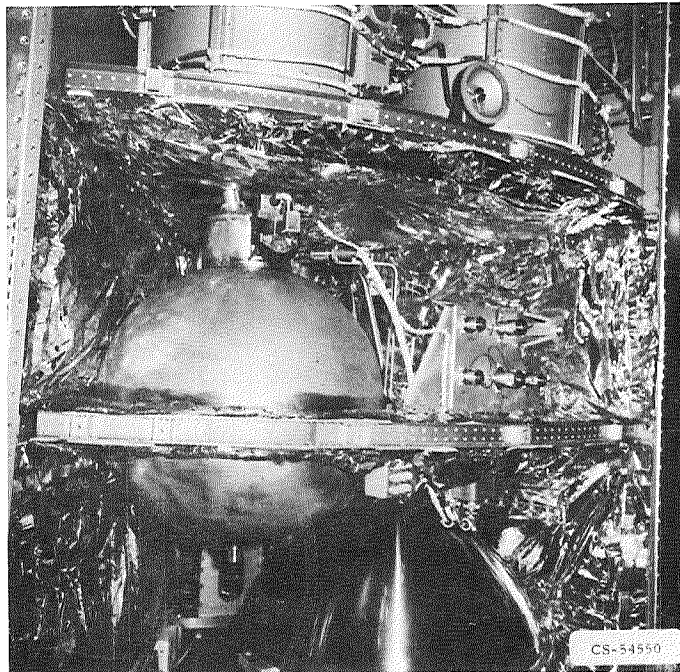
Figure 19. - Oxygen tank in service module bay.
