NASA TN D-5654

APOLLO COMMAND MODULE MOCKUP FLAMMABILITY TESTS

*Manned Spacecraft Center
Houston, Texas*

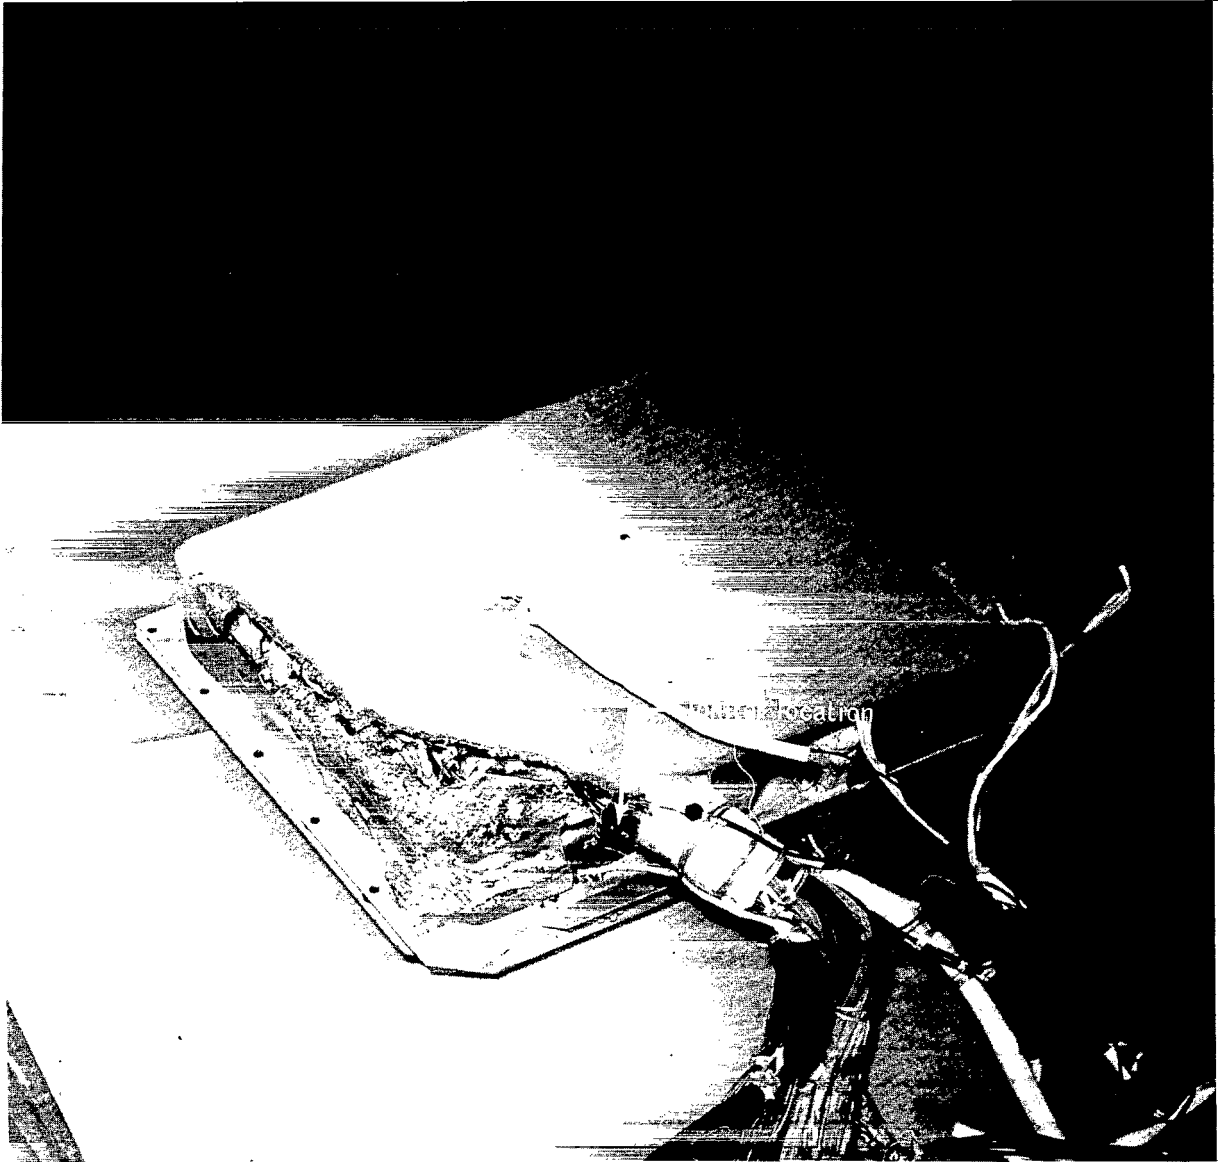
Figure 30. - Post-test damage (test 212).

Test 212: Inspection indicated that propagation occurred vertically and horizontally on the surface of the silicone-laminate cover (fig. 30).

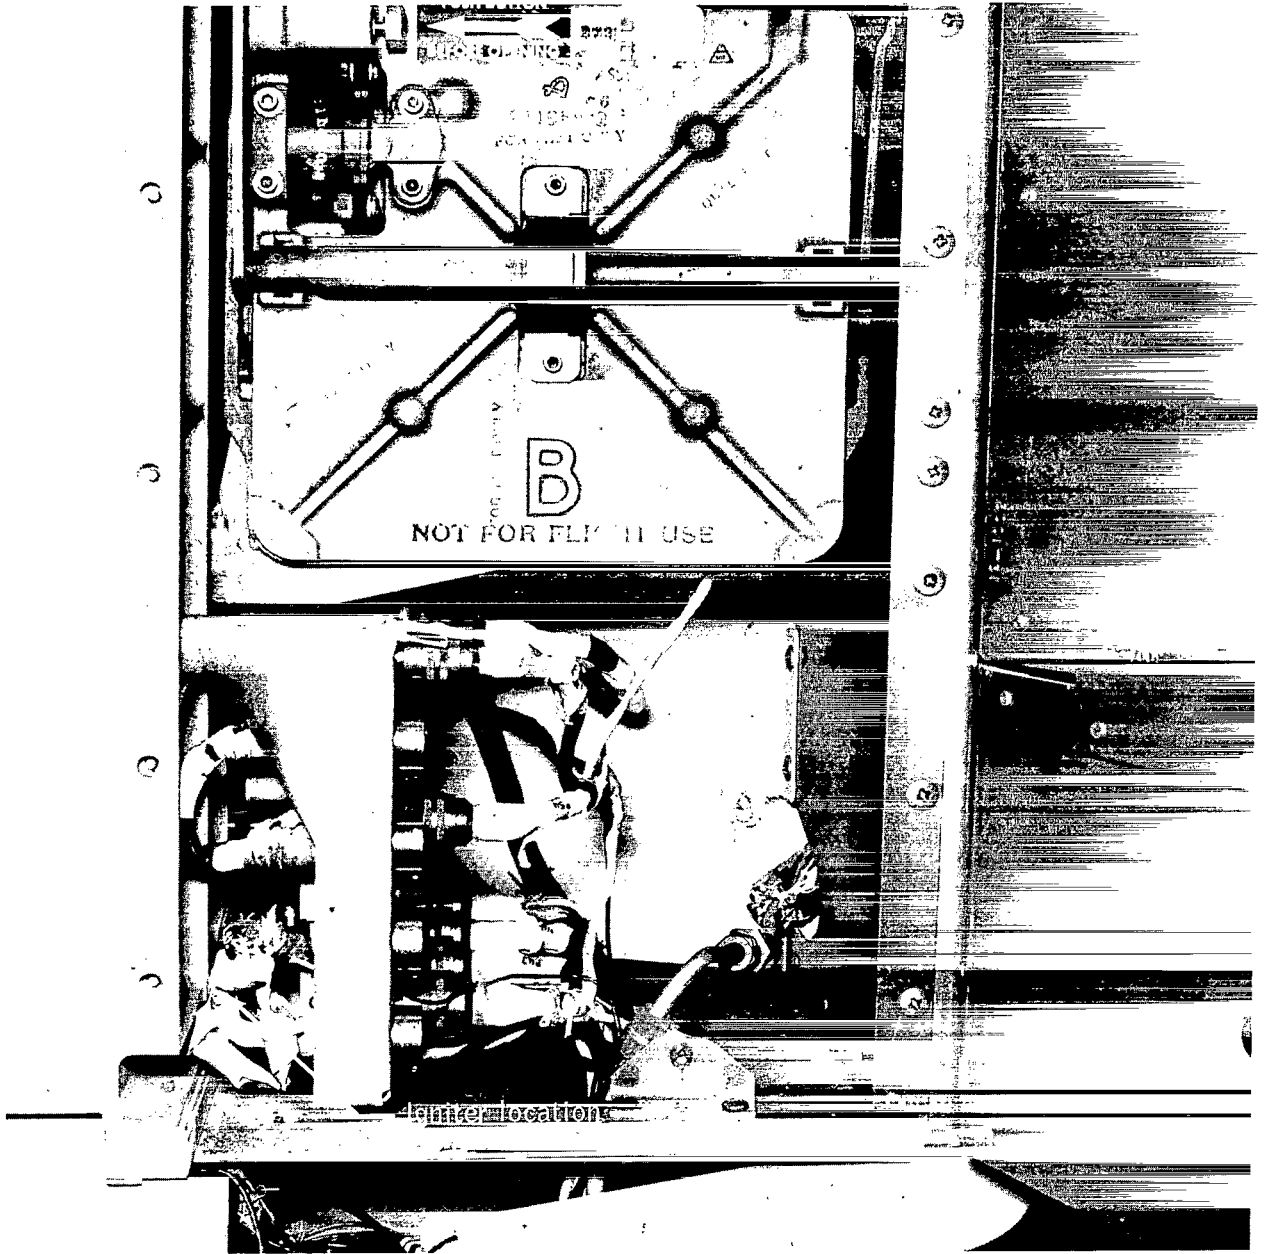
Figure 31. - Post-test damage (test 215).

Test 215: Inspection indicated that the Teflon wrap and some of the Teflon-braid insulation were destroyed. The damage was localized in an area approximately 2 inches in diameter in the ignition region (fig. 31).
