NASA TM X-52336

**CENTAUR SOLID STATE INVERTER FAILURE DURING SIMULATED  
FLIGHT IN AN ENVIRONMENTAL SPACE CHAMBER**

by Ralph F. Schmiedlin and B. J. Dastoli

Lewis Research Center  
Cleveland, Ohio

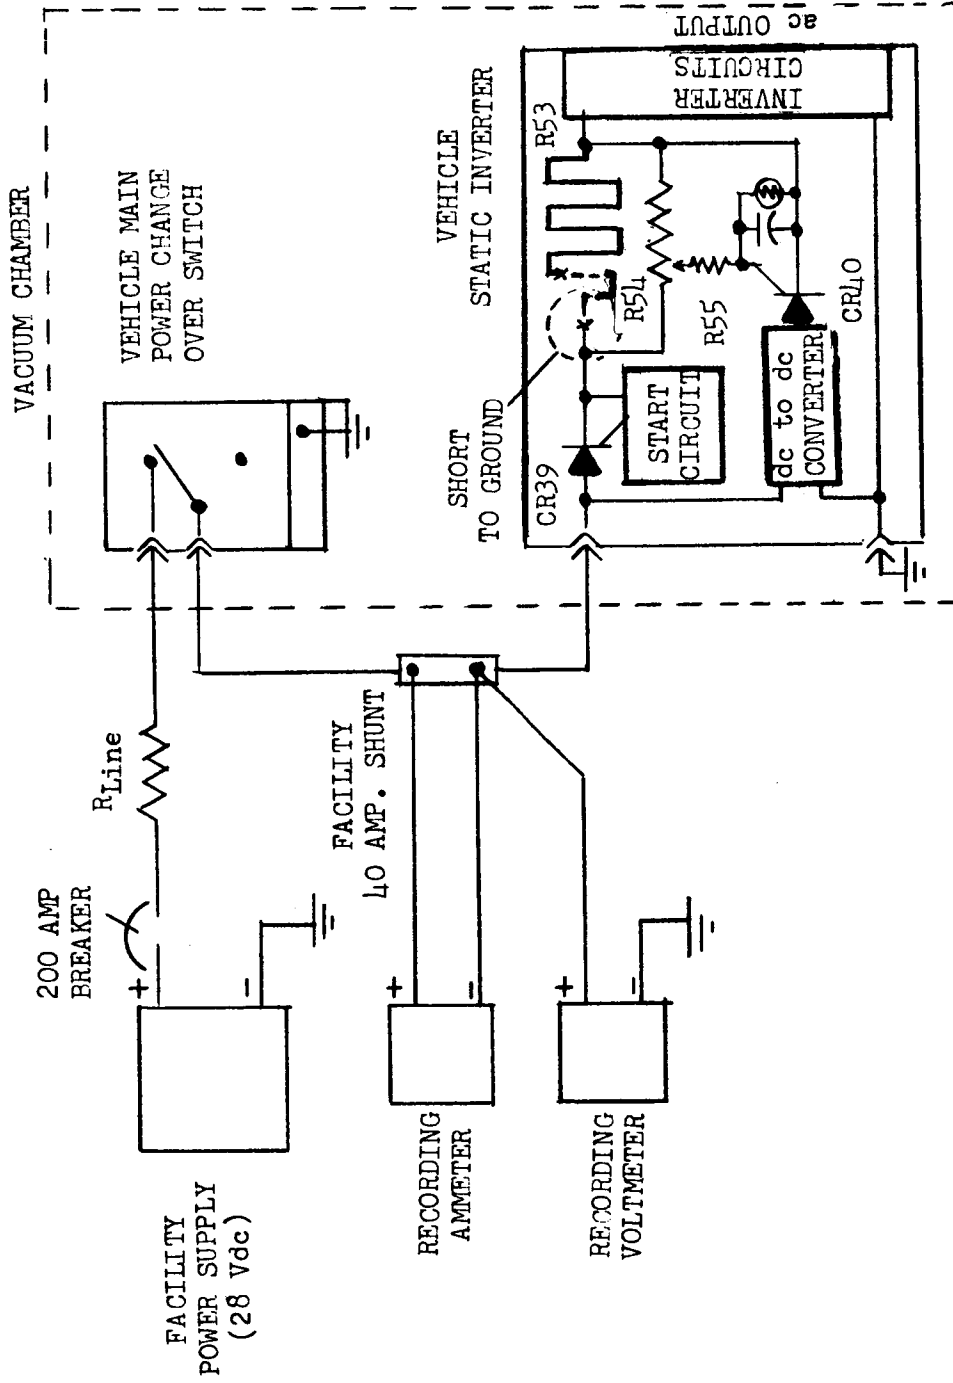
The solid state inverter failed while functioning as part of a Centaur vehicle system in a space thermal environment test. This inverter failure resulted in loss of the simulated mission and end-of-test. Total inverter operating time during the test was 79 minutes. The inverter is shown schematically in figure 2.

Subsequent inspection revealed that the inverter failure was the result of the overload sensing shunt melting open (fig. 5). Further examination of the inverter also revealed that the overload adjustment potentiometer R54 and resistor R55 (fig. 2) were damaged by excessive current. Replacement of these three components restored the inverter to operational condition.

Figure 2. - Simplified circuit diagram of instrumentation and power connections to inverter.
