Soils and Foundations

Damage to railway earth structures and foundations caused by the 2011 off the Pacific Coast of Tohoku Earthquake

Junichi Koseki^{a,*}, Masayuki Koda^b, Shinji Matsuo^c, Hideaki Takasaki^c, Torajiro Fujiwara^c

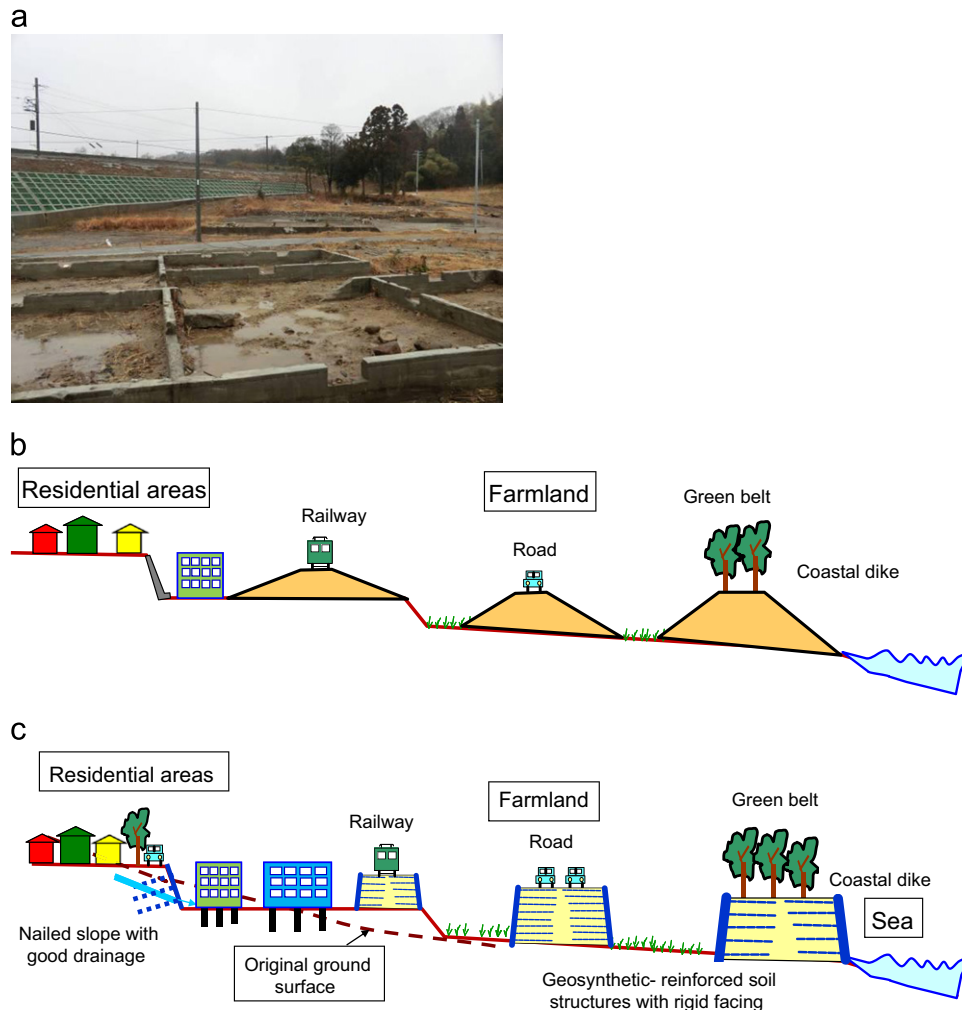
It should be noted that, in cases where the tsunami did not overflow, there was no major induced damage to railway embankments, as typically shown in Fig. 10(a). Considering as well the good performance of highway embankments that were able to effectively block the tsunami, it is proposed that railway embankments be utilized as part of the multiple defense facilities against tsunamis (Miyagi Prefecture, 2011),

Fig. 10. (a) Embankment along JR Joban line between Hisanohama and Suetsugi stations that blocked the tsunami; and schematic diagrams of multiple tsunami defense facilities showing applications of (b) conventional and (c) recent geotechnical technologies to the restoration program (after Japanese Geotechnical Society, 2011).

as schematically shown in Fig. 10(b). In doing so, it is also proposed that recent geotechnical technologies, such as reinforced soil walls (Japanese Geotechnical Society, 2011 and Railway Technical Research Institute, 2011), be employed, as shown in Fig. 10(c).

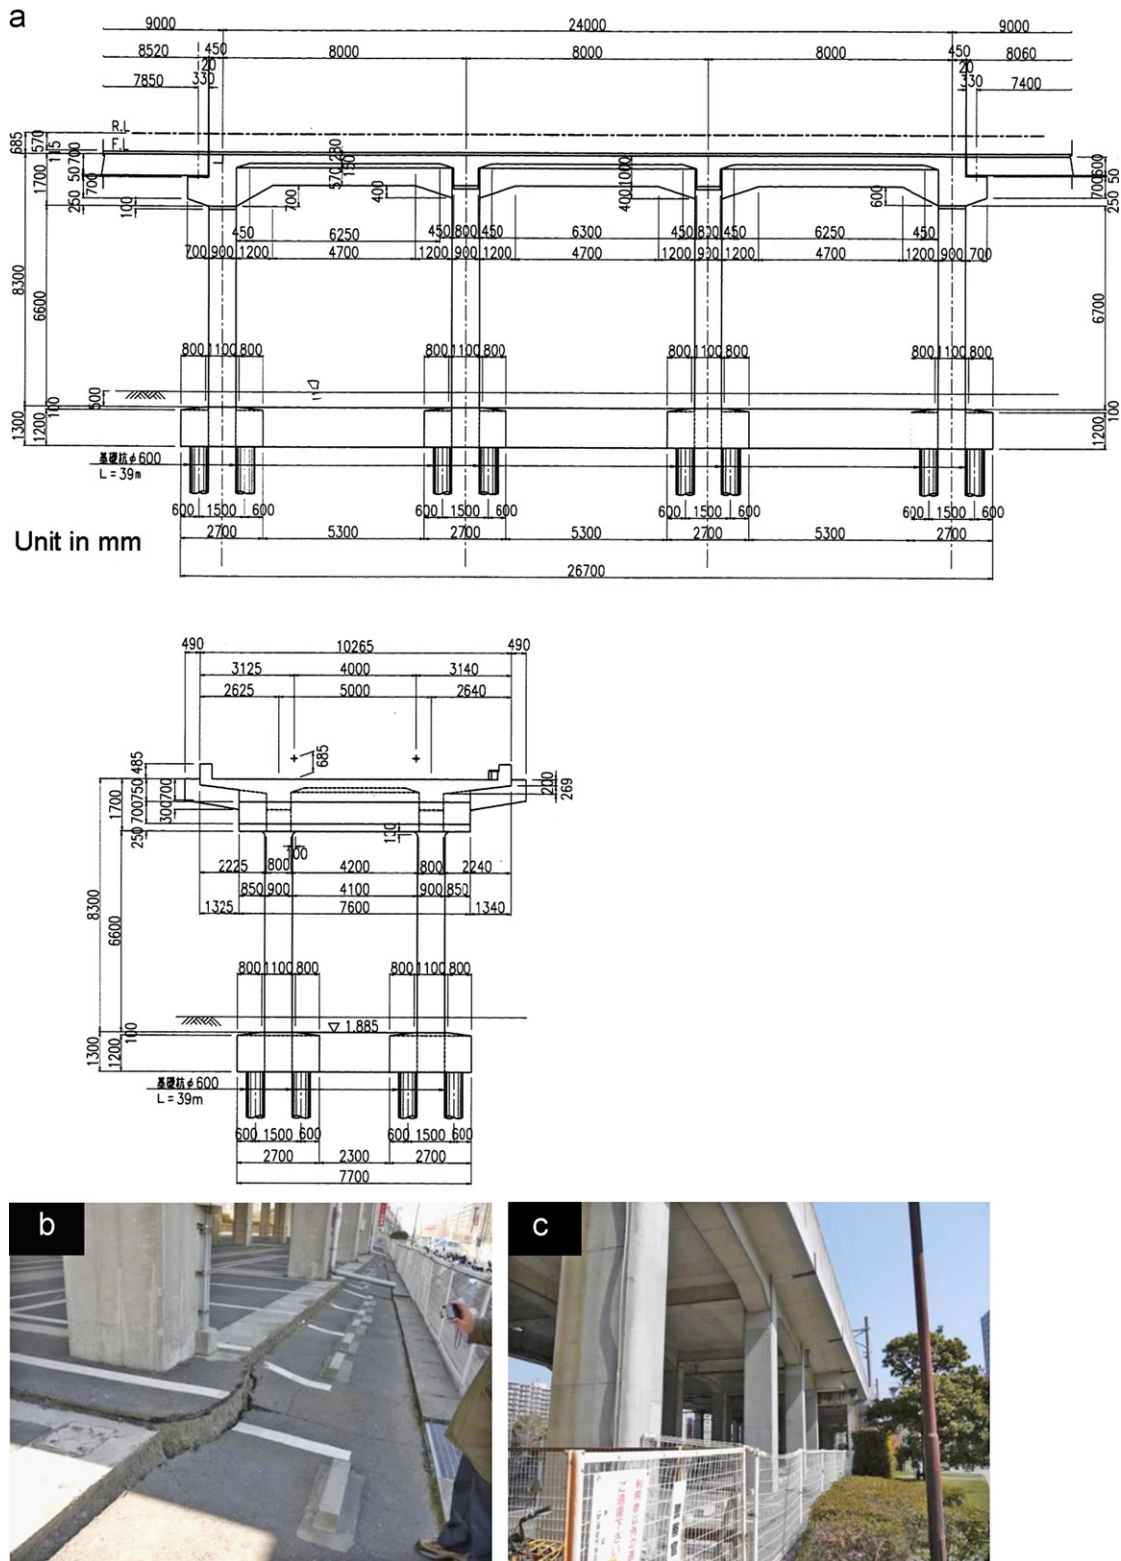
Fig. 17(a) shows side and front views of the Daini-Irifune (rigid frame) Viaducts near Shin-Urayasu Station at 16k060m on the JR Keiyo Line (Tokyo Office of Japan Railway Construction Public Corporation, 1991). They are station viaducts supported by end-bearing pile foundations, which consist of steel tube concrete piles (SC piles) for the upper piles and pre-stressed high-strength concrete piles (PHC piles) for the lower piles. Considering the possible occurrence of liquefaction, they had been designed without considering the subgrade reaction of the soil layers from the surface to a depth of 10 m. Due to the earthquake, liquefaction did take place, inducing a residual ground surface settlement of 100–300 mm around these viaducts, while they did not suffer any structural damage, as shown in Fig. 17(b) and (c).

Fig. 17. (a) Side and front views of Daini-Irifune rigid frame viaducts near Shin-Urayasu station at 16k060m on JR Keiyo line (Tokyo Office of Japan Railway Construction Public Corporation, 1991), (b) ground settlement around the viaducts and (c) no damage to the viaducts.

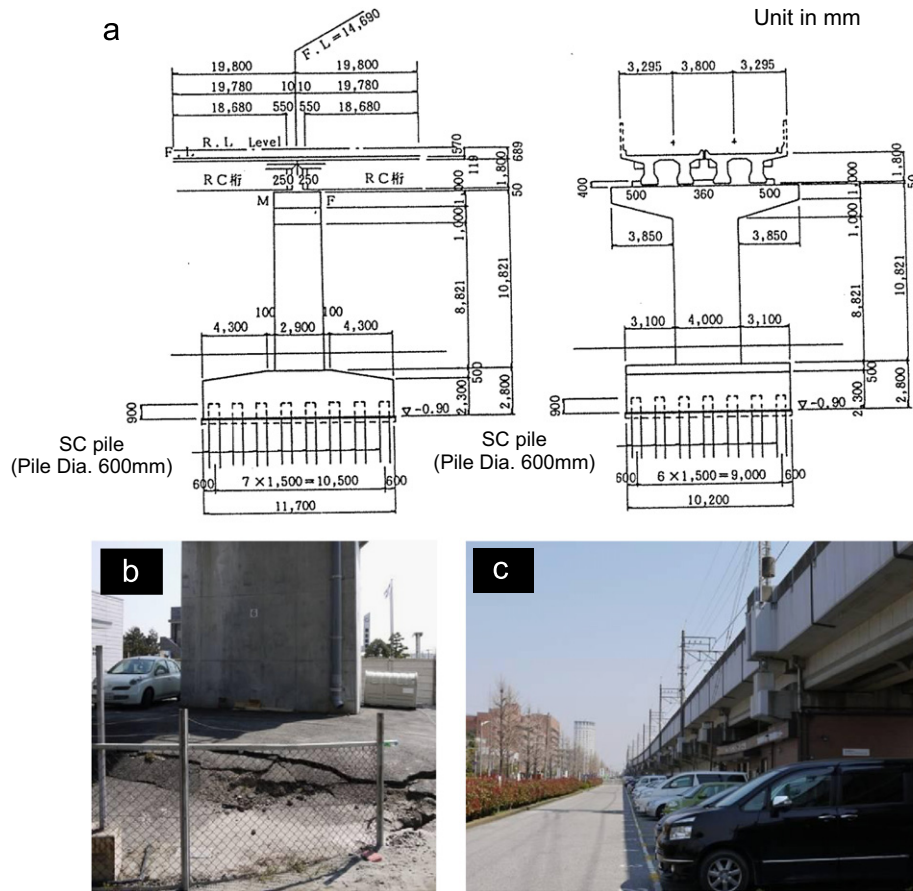
Fig. 18(a) shows side and front views of the Daini-Urayasu (beam type) Viaducts at 13k899m on the JR Keiyo Line (Tokyo Office of Japan Railway Construction Public Corporation, 1991). Except for the station viaducts mentioned above, the viaducts of the JR Keiyo Line in between Shinkiba and Ichikawa-Shiohama Stations are supported by pile foundations using long friction piles. They had been designed considering the effects of negative friction, caused by residual settlement, which would occur after the completion of the construction work. In addition, they had been designed without considering the skin friction to be mobilized in the uppermost layers from the surface to a depth of 10 m by assuming the possible occurrence of liquefaction. Due to the earthquake, liquefaction-induced ground surface settlement of 100 to 300 mm took place around the viaducts, while

they did not suffer any structural damage, as shown in Fig. 18(b) and (c).

Fig. 18. (a) Side and front views of Daini-Urayasu beam type viaducts at 13k899m on JR Keiyo line (Tokyo Office of Japan Railway Construction Public Corporation, 1991), (b) ground settlement around the viaducts and (c) no damage to the viaducts.
