Procedia Engineering 132 (2015) 190 – 196

The Manufacturing Engineering Society International Conference, MESIC 2015

Experimental study of tapping wear mechanisms on nodular cast iron

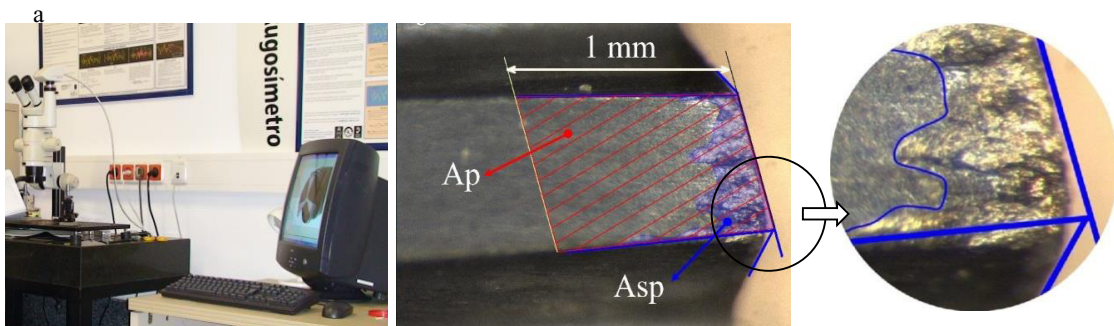
Fig. 2. (a) Leica microscope; (b) Wear (A_{sp}); control (A_p) areas in the clearance face

where A_p is the area of clearance face on each tooth along 1mm length of thread and A_{sp} is the wear area of clearance face in A_p (see Figure 2b). Both are calculated by the Leica IM software.
