# Case Studies in Engineering Failure Analysis

# Failure analysis of firewater pipeline

This paper presents the failure analysis of a fire water pipe line from a petrochemical industry. Leakages were noticed at the top portion of the pipeline. Severe deep pits were observed at the top inner surface and deposits found at the bottom inner surface of the pipe line. Visual inspection, microscopic examination, chemical and water analyses were employed in the present failure analysis. The analysis results showed that the failure occurred due to the severe oxygen corrosion attack at the top portion of the pipe while the bottom surface of the pipe suffered from under deposit corrosion. The fire water pipe line was made of low carbon steel.

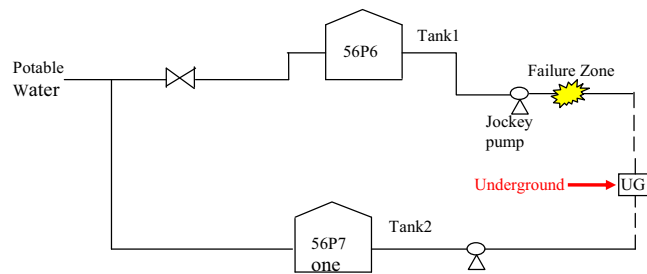
There are two identical storage tanks, 56 P6 and 56 P7, with two main pumps. Jockey pump which is located close to 56 P6 tank, plays major roles of this system as maintaining the constant system pressure and a continuous circulation of the water inside the pipe. Schematic diagram of fire water line piping system is shown in Fig. 1 and it is representing the two tanks, pumps and location of the leakages. These leakages were located only in the area after the discharge of the pump as reference 56 P7 tank.

Fig. 1. Schematic diagram of the firewater piping system.
