# Case Studies in Engineering Failure Analysis

# Failure investigation of a taper roller bearing: A case study

K. Gurumoorthy, Arindam Ghosh\*

R&amp;D, National Engineering Industries Limited, Jaipur, Rajasthan, India

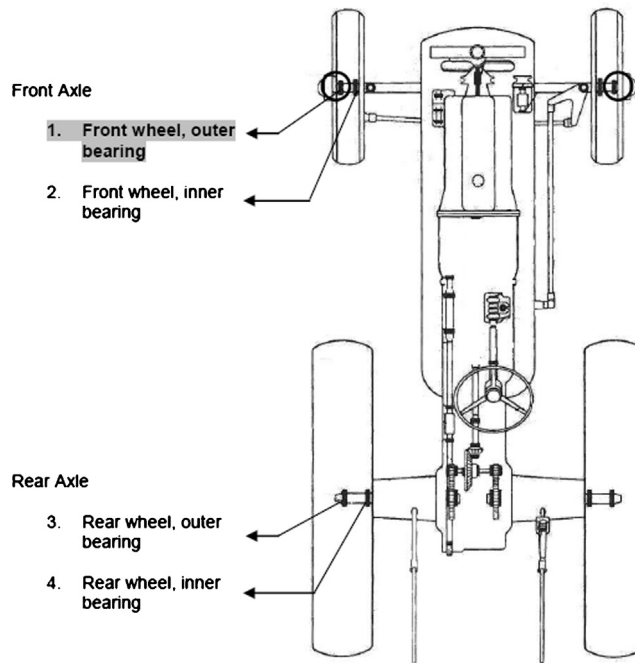
Fig. 1. A skeletal arrangement of tractor; investigated front wheel outer bearing is highlighted in circles (component number 1).

In the present study, damage analysis made on the prematurely failed front wheel outer tapered roller bearing is discussed. A schematic view of tractor is shown in Fig. 1 and the location of front wheel outer bearing is highlighted in circles (in Fig. 1).

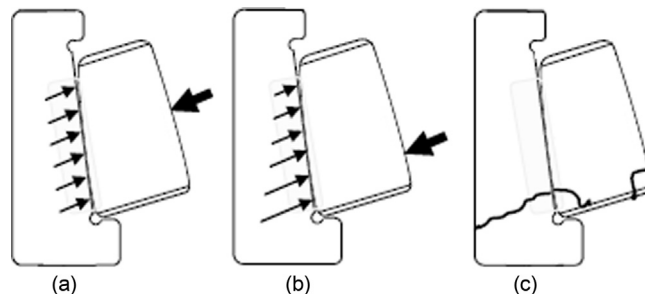
The chemical composition of the bearing was in conformity with SAE 52100 material specification. The deep groove on the cone raceway and severe damage on one side of the rollers showed that there was uneven distribution of load with the roller tip experiencing higher stress during operation.

In general, load will be evenly distributed over the length of the roller and necessary crowning will be provided to accommodate any possible slight misalignment during assembly. Rahnejat and Gohar [6], studied the effect of misalignment and radial contact pressure distribution on tapered roller bearing and suggested that tapered roller bearing can be operated with misalignment, only to certain extent, by making appropriate design of ribs and axial profiling by providing crowning on the taper roller over its length. Sudden failure of roller bearing due to misalignment as result of shaft deflection above a critical point was reported in literature [5]. Andreason [7], studied the load distribution on tapered roller bearing and stated that bearing life can be reduced due to improper load distribution on the roller as a result of misalignment and this effect will be more pronounced if the rollers and raceways were not axially profiled (Non-crowned).

This abnormal stress level at the tip of the roller can lead to boundary lubrication situation and direct metal to metal contact between the roller and the cone surface generating wear debris. The damage initiates at the tip of the roller, as the stress concentration is higher at the roller tip due to its size being smaller than the cone diameter. The above proposed mechanism is illustrated in Fig. 5.

Fig. 5. Schematic illustration of load distribution: (a) evenly distributed load without any misalignment; (b) uneven distribution of load as a result of misalignment; (c) as a consequence of uneven load distribution, stress level at the roller tips increases causing severe damage near the tip of the roller.
