# Report on a reconnaissance survey of damage in Kathmandu caused by the 2015 Gorkha Nepal earthquake

Mitsu Okamura<sup>a,\*</sup>, Netra P. Bhandary<sup>a</sup>, Shinichiro Mori<sup>a</sup>, Narayan Marasini<sup>a</sup>, Hemanta Hazarika<sup>b</sup>

#### Abstract

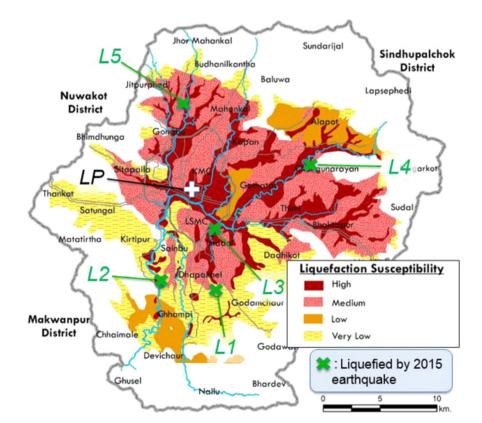
The authors tried extensively to identify the liquefied area from 3 May until 7 May. Because no news of liquefaction had practically been reported on TV and newspapers until then, the authors visited many places where the liquefaction susceptibility is high and medium. Meanwhile SNS was utilized to collect information. The following five locations shown in Fig. 15 were identified to have liquefied. Liquefaction-induced damage to structures in these areas was not found except in the case of the Nepal Engineering College (L4) where buildings suffered subsidence. All these areas are in the high or medium liquefaction susceptibility zone with the exception of Jharuwarashi area (L1).

Fig. 15. Liquefaction susceptibility map prepared by UNDP (1994) together with identified locations of liquefaction by the 2015 earthquake.

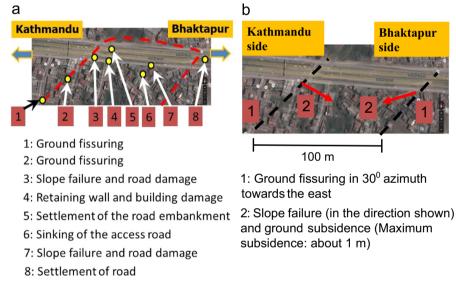
Our survey focused only on the damaged part of the road located near the Lokanthali area (Fig. 21), covering a length of about 400 m. The state of the road before and after the earthquake is shown in Fig. 22. The various locations, types and extent of damage of the surveyed area are shown in Fig. 23. On the Kathmandu side, heaving and subsidence of the road, slope failures in the main road and access road, ground fissuring, retaining wall damage and damage to the residential buildings close to the access road were observed. Similarly, on the Bhaktapur side, heaving and subsidence of the main road, slope failures in the access road and ground fissuring were observed.

Fig. 23. Locations of the damaged area in the main road and the access road (source map URL: http://www.maps.google.com).
