Post mortem analysis of a tungsten coated tile from the outer divertor strike point region of ASDEX upgrade

E. Fortuna-Zalesna^{a,*}, M. Andrzejczuk^a, L. Ciupinski^a, K. Rozniatowski^a, K. Sugiyama^b, M. Mayer^b, K.J. Kurzydowski^a, ASDEX Upgrade. Team

In the present study, the structure and the composition of co-deposited layers developed at the outer divertor strike point tile 1 in ASDEX Upgrade during three campaigns from 2009 to 2013 were examined. The samples were cut from representative locations which differed in received flux: private flux, strike point, the highest plasma fluence and “moderate” flux regions. High resolution scanning (SEM) and transmission electron microscopy (HRSTEM) combined with energy-dispersive X-ray spectroscopy (EDS) and optical profilometry have been used to identify deposits composition and morphology as well as to assess coating degradation. The aim of the post-mortem analyses was the evaluation of materials mixing and evidence of plasma-induced damage.

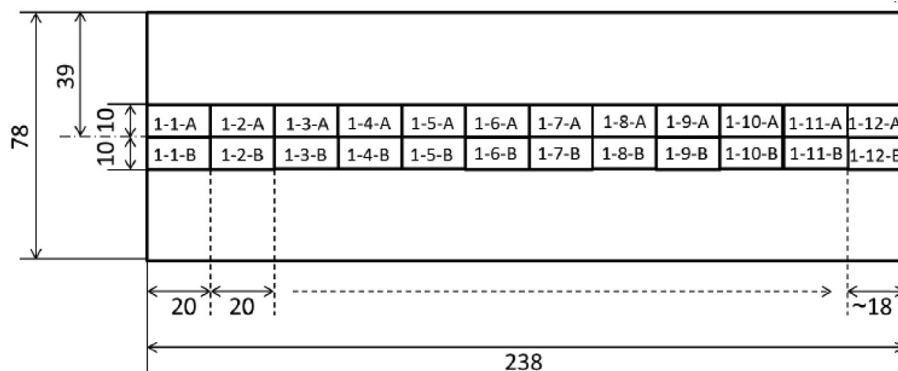
Fig. 1. Drawing of Tile 1 explaining sampling locations. All dimensions in mm.

The investigations were carried out at four samples from the outer divertor tile no 1 of ASDEX Upgrade, exposed to the conditions of three campaigns in the period 2009–2013. These samples were cut from representative locations and differed in the received flux, as described in Table 1 and in Fig. 1. The total fluence onto the outer divertor was in the range of 10^{26} m^{-2} . The machine operated with relatively low heating power input in 2009, mostly below 10MW. Higher heating power was exercised in the later campaigns. For details concerning particular experimental campaigns see [7–9]. The tile was coated with a tungsten layer using the combined magnetron sputtering and ion implantation method (CM-SII) [10]. The initial thickness was approximately 12 μm . A 2–3 μm thick Mo interlayer was deposited between the tungsten layer and
