Metallurgical analysis of SA-106 Gr. B pipe failure during hot bending

A.H.V. Pavan^{a,*}, K.S.N. Vikrant^a, G. Vimalan^b, Kulvir Singh^a^a Metallurgy Department, BHEL, Corporate R&D Division, Vikasnagar, Hyderabad 500 093, India^b Welding Research Institute, BHEL, Tiruchirappalli 620 014, India

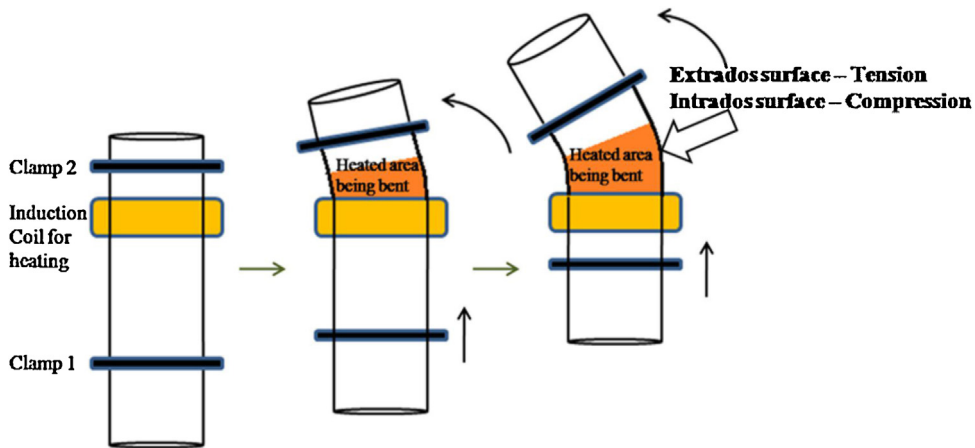
Fig. 1. Schematic of hot bending process adopted for bending SA-106 Gr. B pipe.

The intrados and extrados surfaces of the pipe located away from the bend angle, experience compressive and tensile stresses, respectively during bending as indicated in Fig. 1. Therefore, the temperature hike which led to localized melting of base metal, seeped out through the cracks developed from the inclusions, into the intrados surface due to compressive stress, thus, forming metallic globules.
