The Finite Element Analysis and The Optimization Design of The Yj3128-type Dump Truck's Sub-Frames Based on ANSYS

Chen Yanhong, Zhu Feng

Mechanical and Electrical Engineering Institute of Kaifeng University, Kai Feng 475004, China

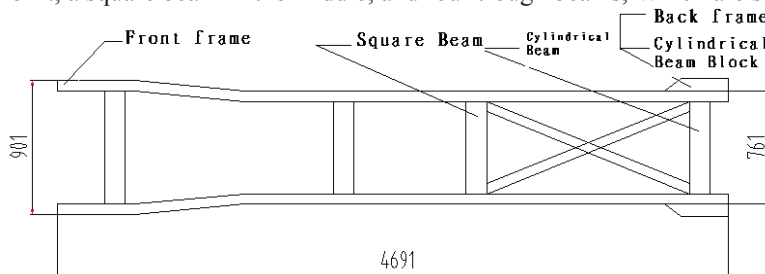
Figure 2 structure of the sub-frame

The YJ3128-type dump truck's frame is formed by the main-frame and the sub one, and they are all edge beam type. The vertical beam of the sub-frame is right up the main-frames', and they are connected by the U-bolts. The sub-frame of the truck is developed by the Co., and it's length is 4.7m, forth-width is 0.901m, and the back-width is 0.761m. The 8mm thick V-beam is trough, all its section is the same. There is a trough auxiliary beam flipping In it. There are six beams in the sub-frame, that are a cylindrical beam at the back of it, a square beam in the middle, and four trough beams, Which are showed in figure 2.
