Case Studies in Engineering Failure Analysis

Root cause analysis (RCA) of fractured ASTM A53 carbon steel pipe at oil & gas company

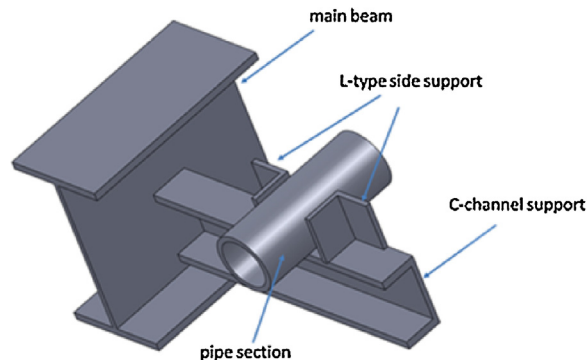
Fig. 2. Schematic details.

Upon the discovery of the incident location area, it was evident that the fractured piping was resting on a CS C-channel support that includes two L-shaped CS side supports and welded with the beam to form the major foundation for the main pipeline. The pipe was carrying raw gas at about 2500 PSI pressure, prior to shutdown. The fractured gas pipe was made of carbon steel manufactured with specification of API 5L. The surface texture of main failure region exhibits a blend of shiny and uneven profile. Excessive grinding was also observed at the C-channel support that was probably carried out to accommodate the pre-installed piping spool, in order to avoid the alteration in pipe position and to rest properly on support; this, however, leads to a severe pipe thickness loss adjacent to one of the L-shaped welded CS side support.
