Procedia Engineering 156 (2016) 219 – 226

9th International Conference „Bridges in Danube Basin 2016“, BDB 2016

The road steel bridge over Bosut river in Serbia Part 1: The assessment of the bridge

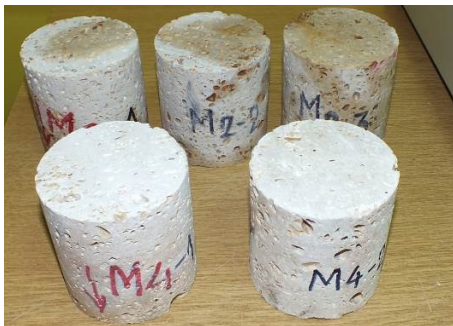
In order to evaluate the quality of material that river piers were built of, core samples were taken out (Figs. 10 and 11). The mean value of apparent bulk density (bulk density of wet stone) amounts around 2070 kg/m^3 , while mean value of stone compressive strength amounts 14.9 MPa . Based on obtained results, it was concluded that examined material is classified as medium heavy stone, according to bulk density, while, according to compressive strength, it is classified as stone with low compressive strength.

Fig. 10. Stone cylinders prepared for testing of compressive strength

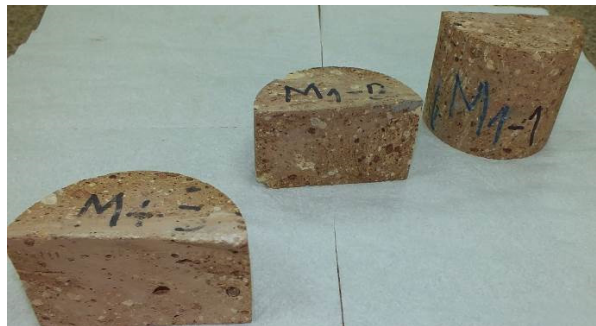
Fig. 11. Brick's semi-cylinders prepared for testing the bulk density and water absorption

Water absorption was determined by using a gradually immersion method defined in SRPS B.B8.010. The mean value of ceramics' bulk density (bulk density of ceramics in the dry state) amounts around 1570 kg/m^3 , while the mean value of its water absorption amounts around 22 %. Based on obtained results, it was concluded that examined bricks were made of terracotta - rough and porous ceramics.

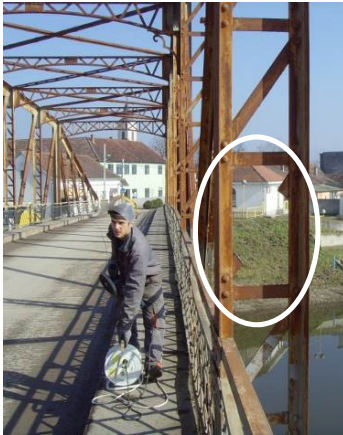
Quality of steel, used for the bridge's upper structure was unknown. Therefore, subsequent determination of steel quality was performed, in order to conduct the control static and dynamic calculation and bridge condition evaluation in terms of its bearing capacity and stability. For this purpose, steel samples from individual steel structural elements were taken (Figures 12 and 13), and, later, examined in the laboratory.

Fig. 12. Extraction position of steel samples

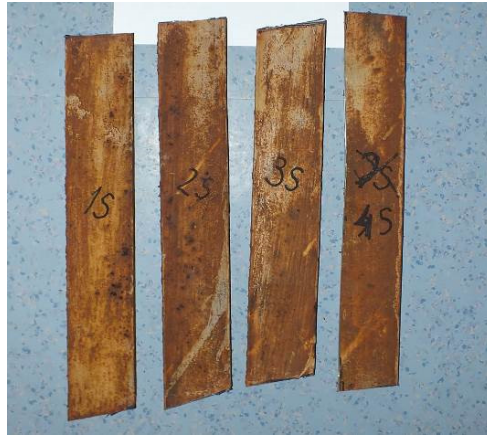
Fig. 13. The appearance of cut steel samples

Macroscopic examination of steel samples showed that there are no severe corrosion or deformation of samples. Only surface rust was detected, as well as spot corrosion of local character. Mechanical properties of steel were determined on the standard specimens and results are given in Table 1.

Steel cut from the diagonal rod (sample 4S) suffered longitudinal crack propagation, occurred in the middle of the sample. Rest of the samples showed ductile fracture. Since the chemical composition was not determined, designation of structural steel can not be accurately given, but steel roughly corresponds to the S235 quality, according to its mechanical characteristics.
