## Earthquake-resistant performance investigation for rural buildings in Zhongxiang area, China

**Abstract:** We carried out a census of the rural residential buildings of Zhongxiang area's 17 towns. Next, we conducted a sample survey in four townships: Huji, Shipai, Zhangji, and Jiuli. According to the census and sample survey data of the rural residence buildings, we evaluated the quality and earthquake-resistant performance of the rural buildings for the various local rural residential structural types. The results showed that there are four main factors affecting the seismic performance of the local rural residences: (1) Foundations are not made appropriately (such as by compaction or some other fill) but are built directly in the farming soil. (2) Seismic measures are not completely implemented. Structure construction measures are not in place at the junction of the vertical and horizontal wall. The vertical wall joints are not the result of the same masonry techniques as the horizontal joints. There are no lintels above the door and window openings, or if there are any, the length of the lintels is less than 240 mm. (3) The brick masonry wall has low strength. The greatest h

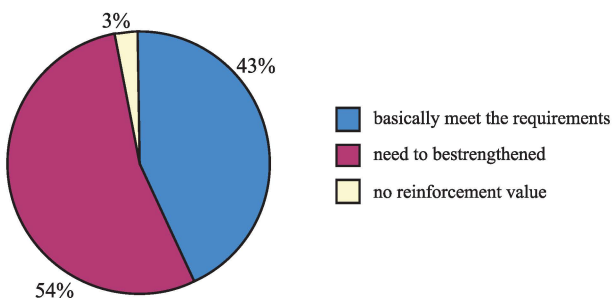
beams, structural columns, cast-in-place floor (roof) panels, and a framework structure. These houses are basically in line with seismic requirements. However, parts of these houses are not adequately designed. Seismic measures are not in place, the construction quality is poor, and low strength mortar is used. Rural residences that do not conform to seismic requirements need to be strengthened. The assessment results are shown in figure 3.

Figure 3 Existing farmhouse earthquake-resistant performance assessment results for Zhongxiang area

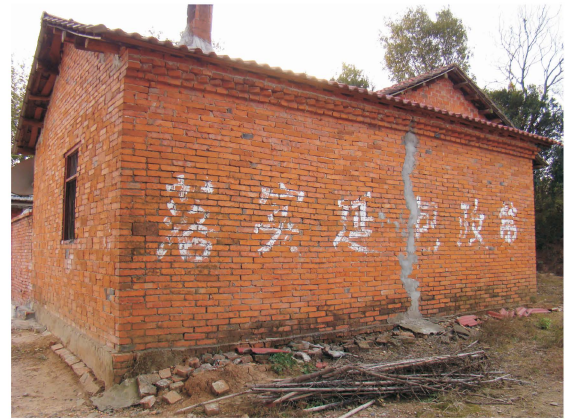
There are two main types of foundation. The first is a bad foundation, such as collapsible foundation soil, which does not meet the appropriate ground treatments for housing. The second is a shallow foundation, which does not reinforce or change the fill processing, and is located directly in the farming soil. This foundation is influenced by the temperature and humidity, and the large deformation of the upper load can be observed shortly after the completion of the housing wall cracking caused by the uneven settlement of the foundation, mainly a result of vertical and diagonal cracks in the wall (Fig. 4) [7].

Figure 4 Wall vertical crack
